## **Report on Geotechnical Investigation**

**Proposed Residential Development  
65 Muston Street, Mosman**

**Prepared for Prosker Property Pty Ltd**

**Project 236982.00**

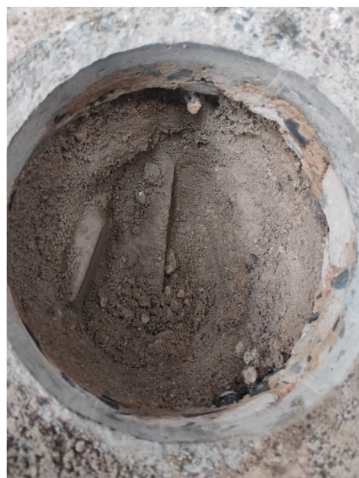
Bricks at the base of borehole

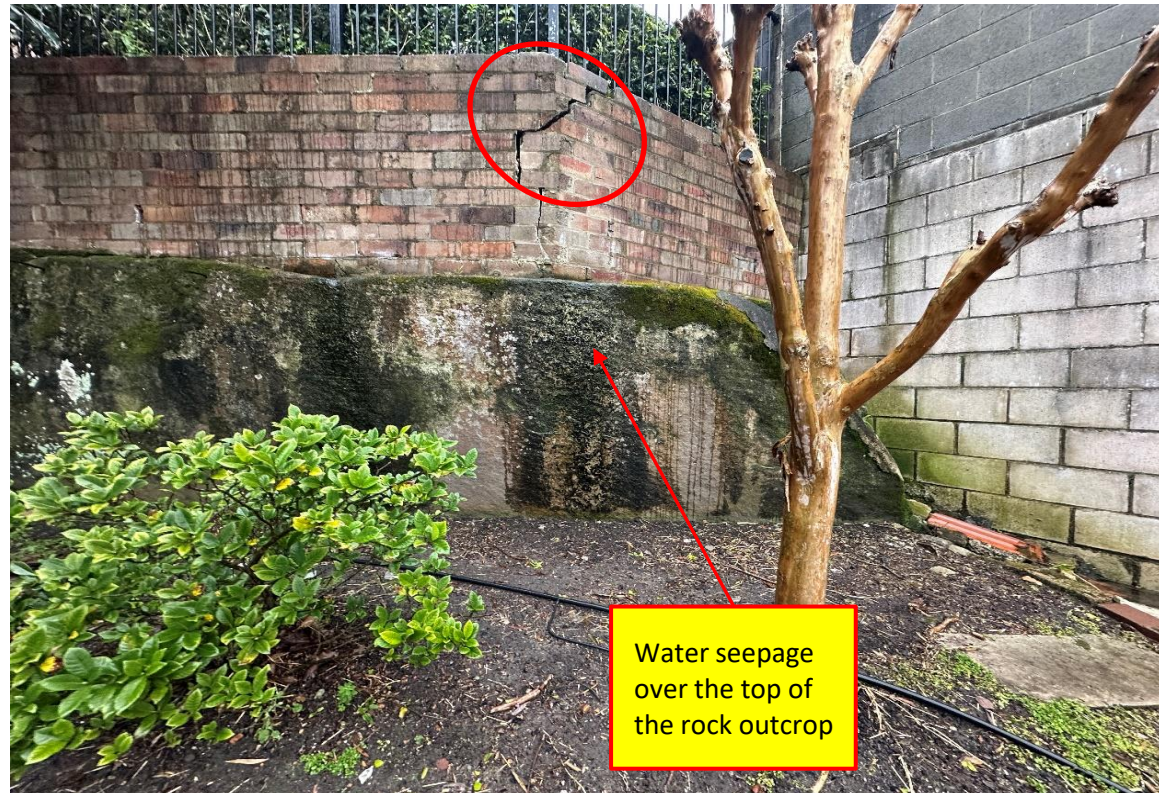
- Cracking and displacement of the return corner within the brick retaining wall built above the rock outcrop (refer Plate 2, Photo 4);
- Retaining walls supporting low height garden beds. Some walls exhibit bulging (refer Plate 2, Photo 6) and cracking along mortar joints;

- Some minor water seepage on the exposed rock (refer Plate 2, Photo 4) was observed during the inspection which is likely water seepage over the top of rock.

The cracks and bulging observed in garden retaining walls are likely to be due to poor design and construction rather than an indicator of slope movement and instability.

Photo 4: Cracked brick retaining wall and water seepage

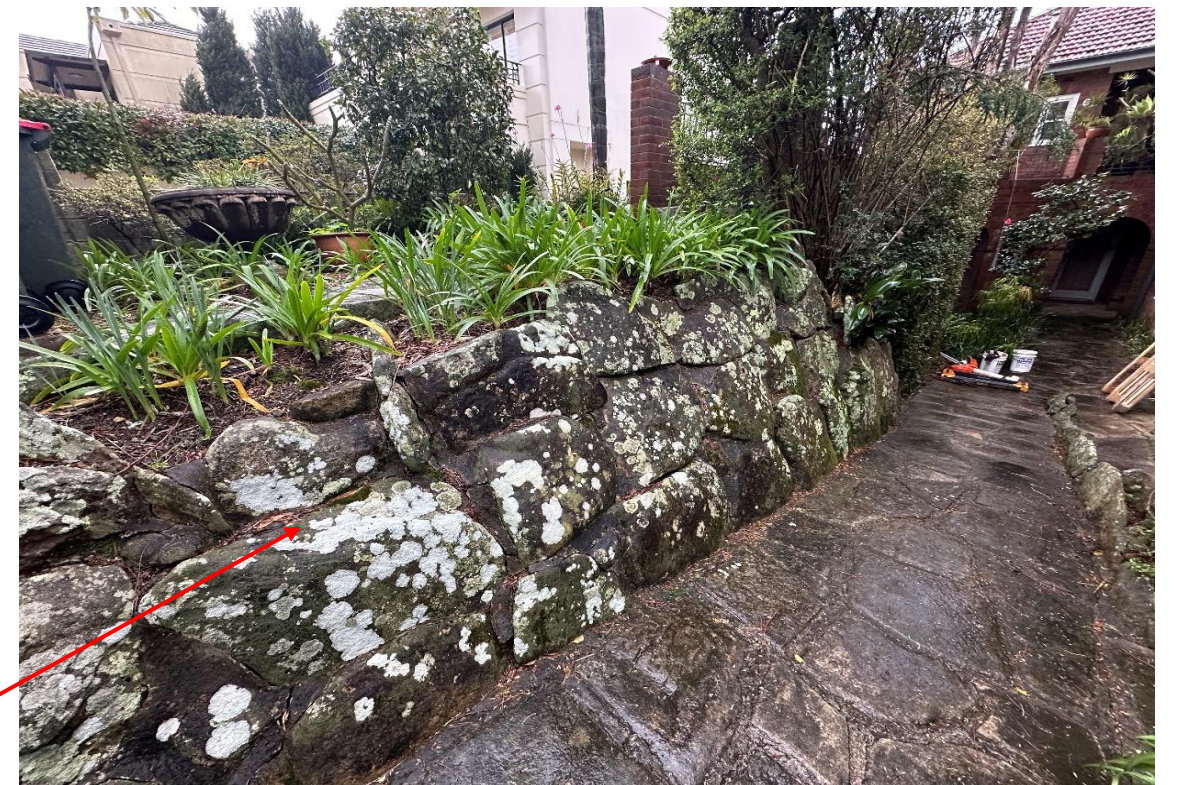
Photo 6: Bulging garden bed retaining wall
