<p style="text-align: center;">Marsden Park Public School -Dilapidation Report- January 2020.</p>		
Item No.	Description	Photo location
<p>Northbourne Drive</p>		
1	(Start at corner of Northbourne Drive and Bolwarra Drive heading East) Trailing Dirt on roadway

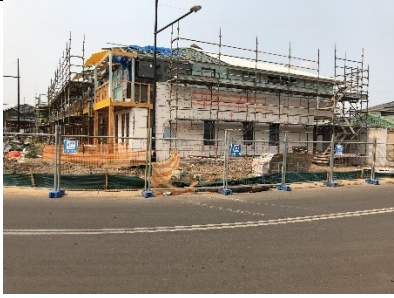
Houses-Enmore st		
53	<p>Lot ?</p> <p>-Multi attached dwelling project. - 70% completed and under construction. Temp fence located in gutter on roadway</p>

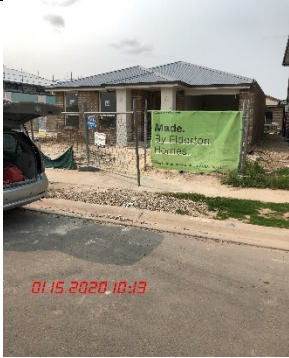
54	<p>Lot 2923 –</p> <p>-90% complete and under construction. Temp fence located on boundary line</p>

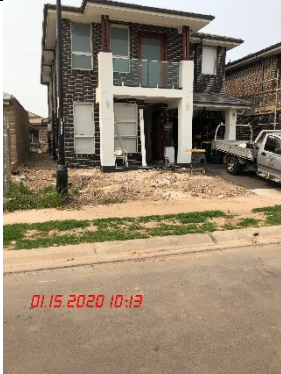
55	<p>Lot 2922</p> <p>-100% complete and resident occupied, external landscape works to be completed.</p>

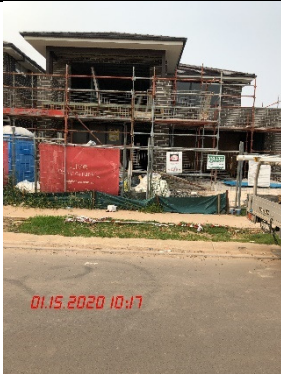
56	<p>Lot 2921</p> <p>-50% complete and under construction Temp fence on boundary line.</p>

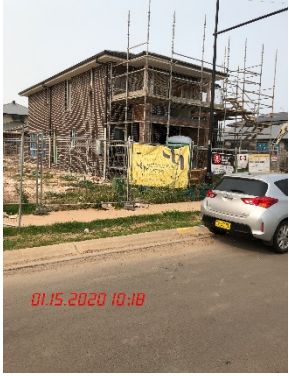
<p>57</p>	<p>Lot 2919 -70% complete and under construction Temp fence on boundary line.</p>

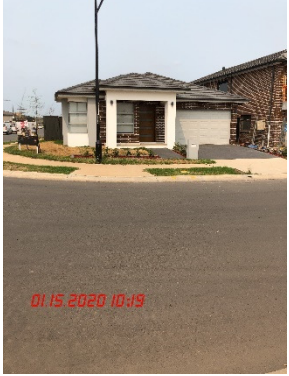
<p>Houses – Beale st.</p>		
<p>58</p>	<p>Lot ? -100% complete, No residents at present Minor damage areas to footpath and noted broken NBN pit on East side of house.</p>

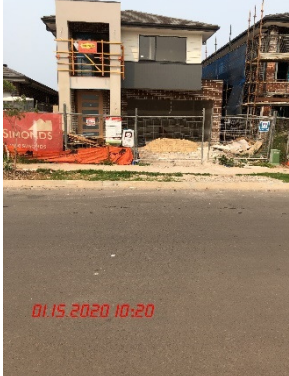
<p>59</p>	<p>Lot 2925 -50% Complete and under construction Temp fence on boundary line.</p>

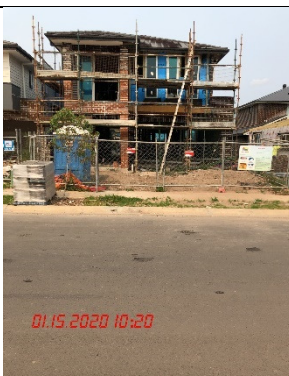
<p>60</p>	<p>Lot 2926 -40% complete and under construction Temp fence on boundary line.</p>
