**SAFE WORK &
ENVIRONMENTS**

ASBESTOS REGISTER

**37 BANCROFT AV,
ROSEVILLE, NSW 2069**

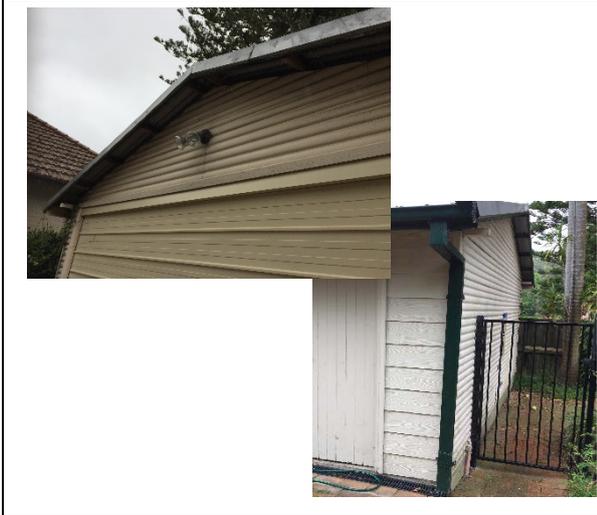
| Sample No. | Results | Photo ID | Description | Location | Asbestos Type | Condition | Treatment | Location | Accessibility / Activity | Risk Score | Action Priority | Quantity (Lm, m ² , m ³) | Comments/ Recommendations |
|---|---|---|---|---|---|---|---|---|---|---|---|---|---|
| S106051C.A04 | CH and CR | 1 | Fibre cement sheeting | Shed – External profiled wall sheeting on north and south sides | 2 | 2 | 2 | 1 | 2 | 16 | L | 10 m ² | Seal broken pieces with paint. Label material as asbestos. Reinspect condition on a regular basis. Remove prior to any refurbishment, demolition or other work that may disturb the material. |

Photograph 1, Shed - External profiled wall sheeting on north and south sides

| SWE Ref. | DATE ANALYSED | SAMPLE DESCRIPTION | DIMENSIONS (g/mm) | ANALYSIS RESULTS |
|---|---|---|---|---|
| S106051C - A04 | 27/01/2017 | A04 - Off-white fibre cement material | 25x10x2 mm | Chrysotile & Crocidolite Asbestos Detected |

- any minor breaks found in fibre cement profiled external and base walls sheeting to the shed should be sealed with paint; and
- fibre cement base sheeting in the shed should be sealed with paint.

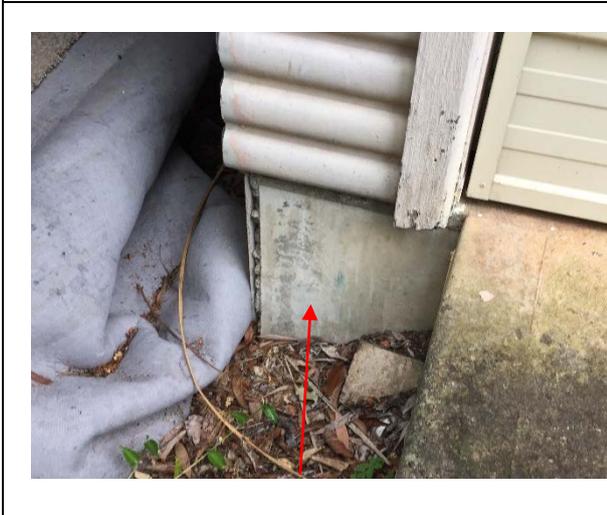
| Sample No. | Results | Photo ID | Description | Location | Asbestos Type | Condition | Treatment | Location | Accessibility / Activity | Risk Score | Action Priority | Quantity (Lm, m ² , m ³) | Comments/ Recommendations |
|---|---|---|---|---|---|---|---|---|---|---|---|---|---|
| S106051C.A05 | CH | 2 | Fibre cement sheeting | Shed – Fibre cement base cover | 2 | 1 | 3 | 1 | 2 | 12 | L | <1 m ² | Seal material with paint. Label material as asbestos. Reinspect condition on a regular basis. Remove prior to any refurbishment, demolition or other work that may disturb the material. |

Photograph 2, Shed - Fibre cement base cover

| SWE Ref. | DATE ANALYSED | SAMPLE DESCRIPTION | DIMENSIONS (g/mm) | ANALYSIS RESULTS |
|---|---|---|---|---|
| S106051C - A05 | 27/01/2017 | A05 - Grey fibre cement material | 10x7x2 mm | Chrysotile Asbestos Detected |

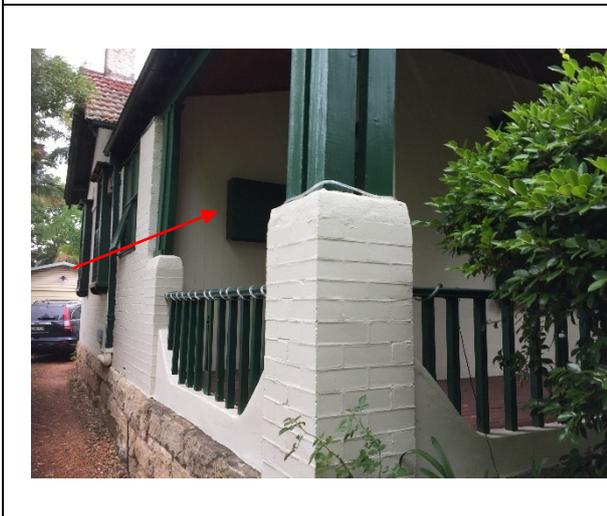
| Sample No. | Results | Photo ID | Description | Location | Asbestos Type | Condition | Treatment | Location | Accessibility / Activity | Risk Score | Action Priority | Quantity (Lm, m ² , m ³) | Comments/ Recommendations |
|--|---|---|---|--|---|---|---|---|---|---|---|---|--|
| VO | Presumed Asbestos | 3 | Electrical Mounting Board | House –Electric Fuse Box | 2 | 1 | 1 | 1 | 2 | 4 | L | <1 m ² | Label material as asbestos. Reinspect condition on a regular basis. Remove prior to any refurbishment, demolition or other work that may disturb the material. |

Photograph 3, House - Electrical Fuse Box

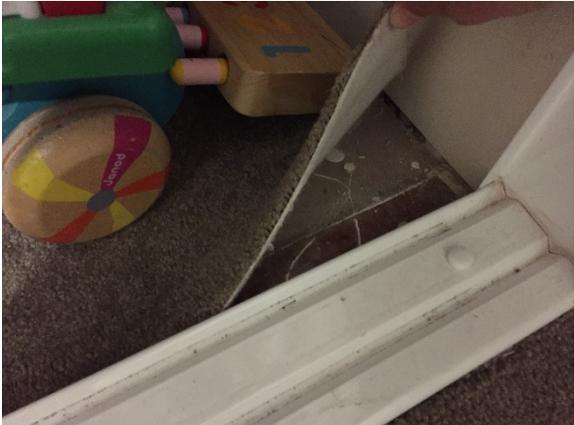
| Sample No. | Results | Photo ID | Description | Location | Asbestos Type | Condition | Treatment | Location | Accessibility / Activity | Risk Score | Action Priority | Quantity (Lm, m ² , m ³) | Comments/ Recommendations |
|--|---|---|---|--|---|---|---|---|---|---|---|---|--|
| S106051C.A02 | NAD | 5 | Underlay covering | House –Underlay covering below carpets in bedroom area | 0 | | | | | | N | | No Asbestos Detected |

| | <p>Photograph 5, House – Underlay covering below carpets in bedroom area</p> |

| SWE Ref. | DATE ANALYSED | SAMPLE DESCRIPTION | DIMENSIONS (g/mm) | ANALYSIS RESULTS |
|---|---|---|---|---|
| S106051C - A02 | 27/01/2017 | A02 - Dark brown compressed cement material | 7x5x2 mm | No Asbestos Detected |

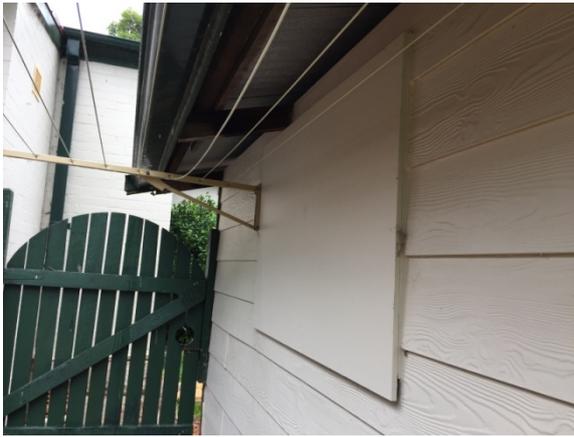
| Sample No. | Results | Photo ID | Description | Location | Asbestos Type | Condition | Treatment | Location | Accessibility / Activity | Risk Score | Action Priority | Quantity (Lm, m ² , m ³) | Comments/ Recommendations |
|--|---|---|---|--|---|---|---|---|---|---|---|---|--|
| S106051C.A03 | NAD | 6 | Fibre cement cladding | Shed – External wall cladding on east and west sides | 0 | | | | | | N | | No Asbestos Detected |

| | <p>Photograph 6, House – External wall cladding on east and west sides</p> |

| SWE Ref. | DATE ANALYSED | SAMPLE DESCRIPTION | DIMENSIONS (g/mm) | ANALYSIS RESULTS |
|---|---|---|---|---|
| S106051C - A03 | 27/01/2017 | A03 - Grey compressed cement material | 11x9x3 mm | No Asbestos Detected |
