# DARLINGTON PUBLIC SCHOOL REDEVELOPMENT

## Appendix S — Hazardous Materials Survey

Report on  
Hazardous Building Materials Assessment

Darlington Public School Upgrade  
Darlington Public School, Darlington, NSW

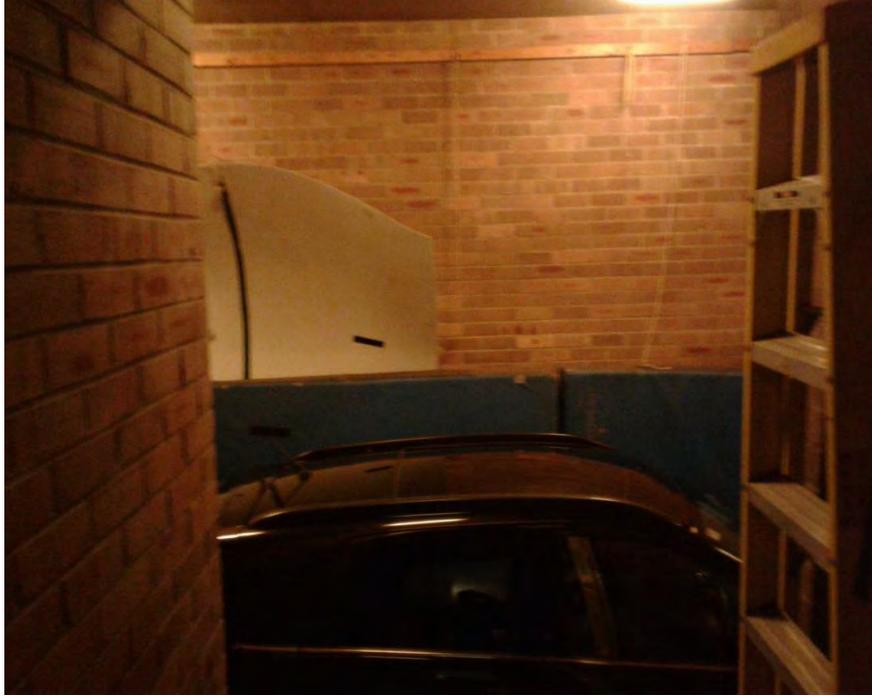
Photograph 1: B00A - R0002, Interior, Garage walls, Brick, nil hazardous materials identified.

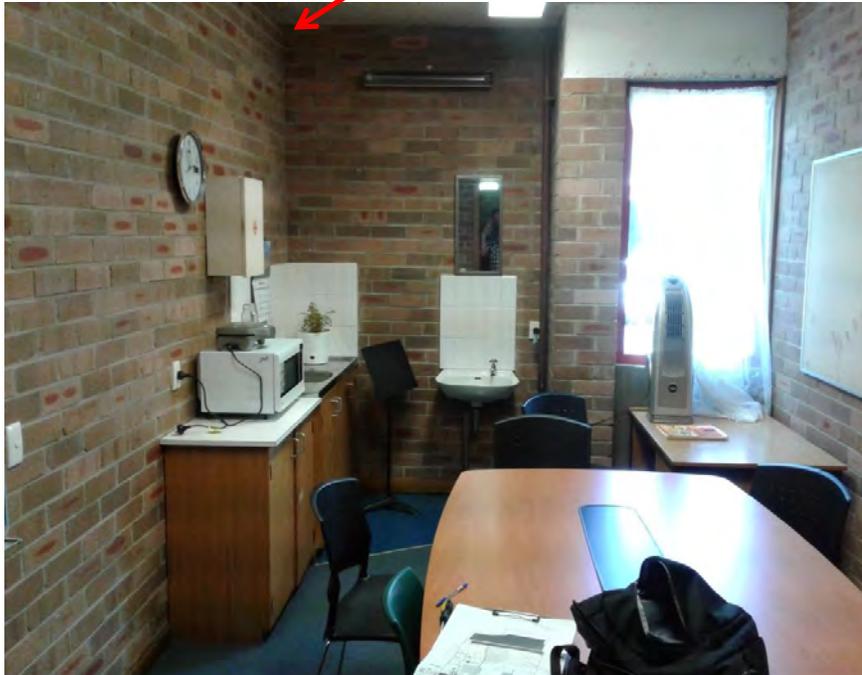
Photograph 2: B00A - R0006, Interior, Ceiling structure, Vermiculite, no asbestos detected by analysis.

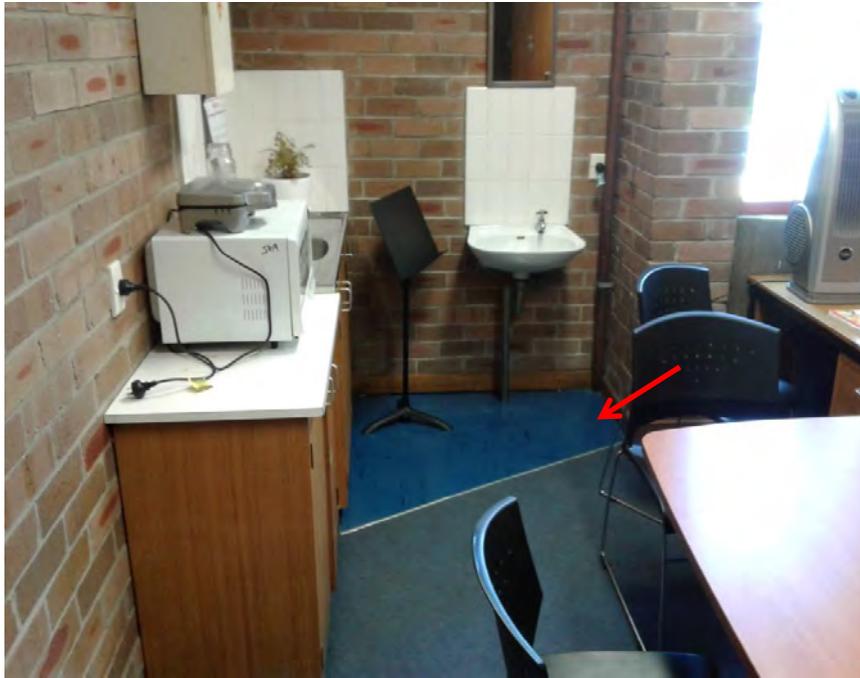
Photograph 3: B00A - R0006, Interior, Flooring material, Vinyl tiles, no asbestos detected by analysis.

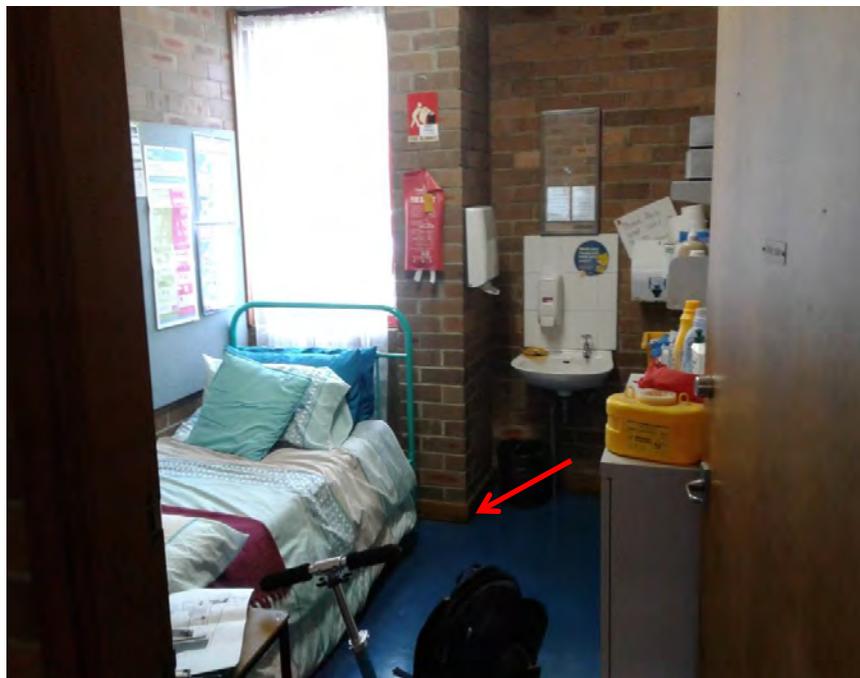
Photograph 4: B00A - R0009, Interior, Flooring material, Vinyl tiles, no asbestos detected by analysis.

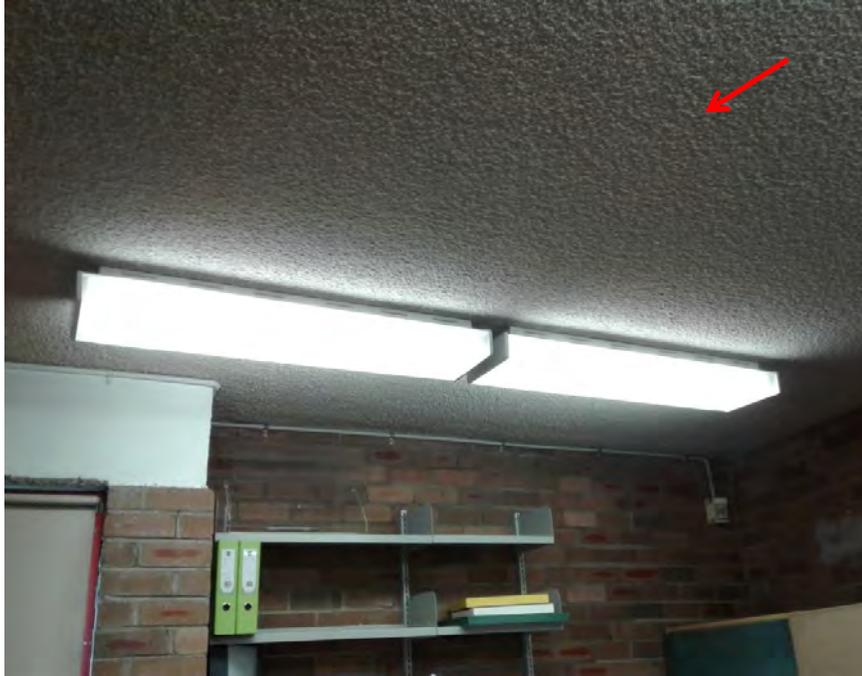
Photograph 5: B00A - R0011, Interior, Ceiling structure, Vermiculite, no asbestos detected by analysis.

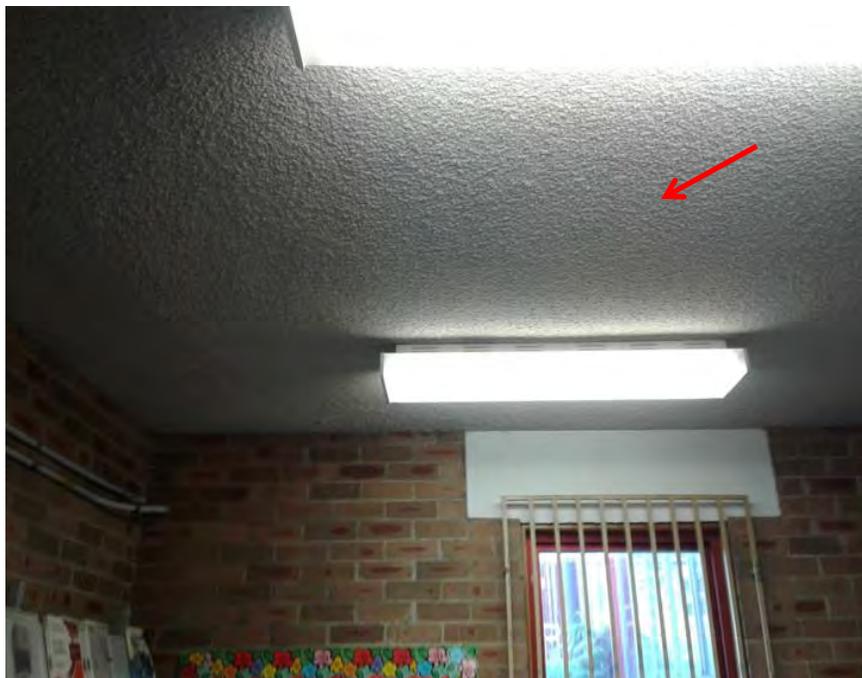
Photograph 6: B00A - R0017, Interior, Ceiling structure, Vermiculite, no asbestos detected by analysis.

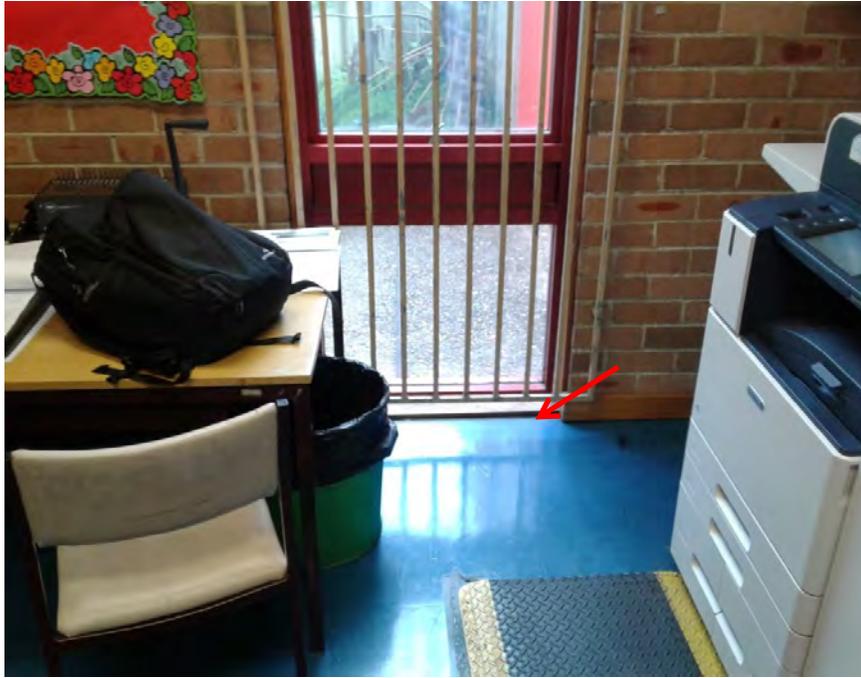
Photograph 7: B00A - R0017, Interior, Flooring material, Vinyl tiles, no asbestos detected by analysis.

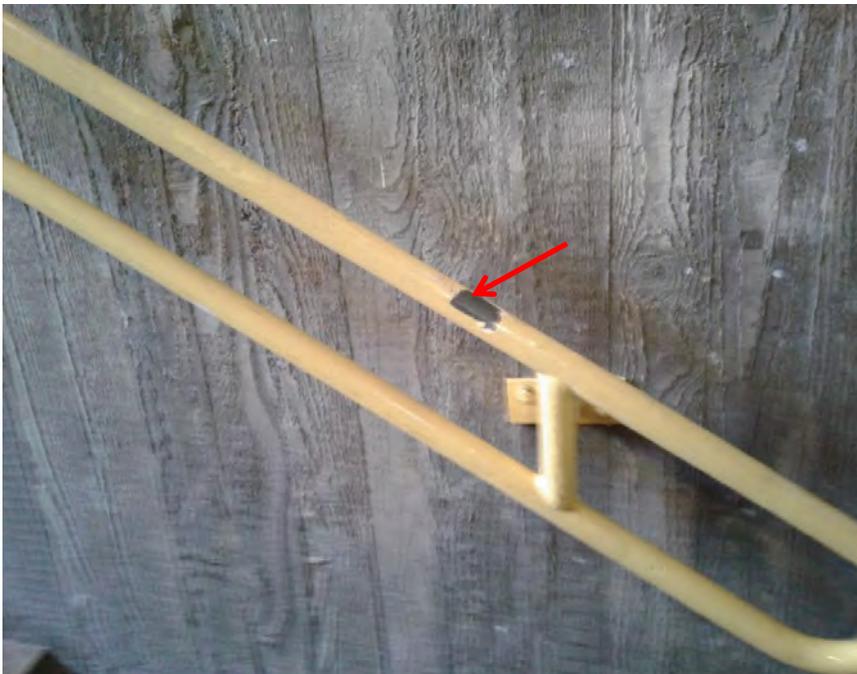
Photograph 8: B00A - R0019, Interior, Hand rails on stairs, Yellow paint, non-lead paint ( $\leq 0.1\%$  lead w/w).

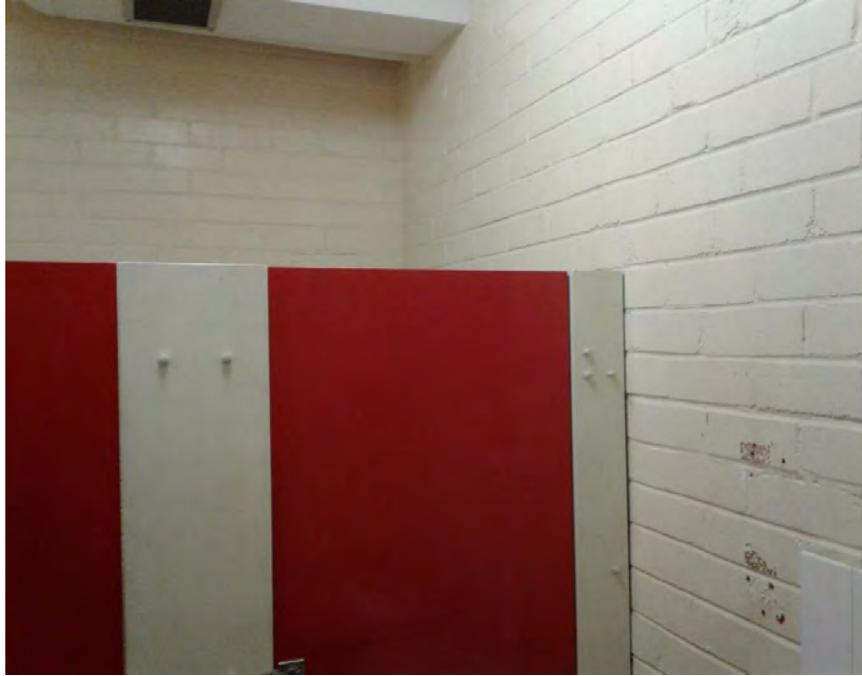
Photograph 9: B00A - R0021, Interior, Partitions in toilet, Compressed FCS sheeting, asbestos detected by analysis.

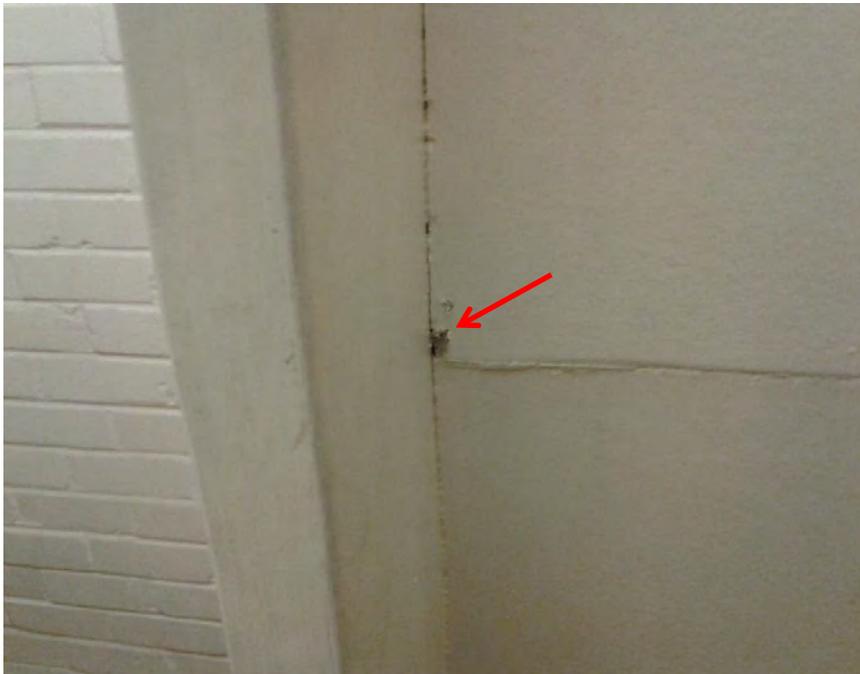
Photograph 10: B00A - R0022, Interior, Partitions in toilet, Compressed FCS sheeting, asbestos detected by analysis.

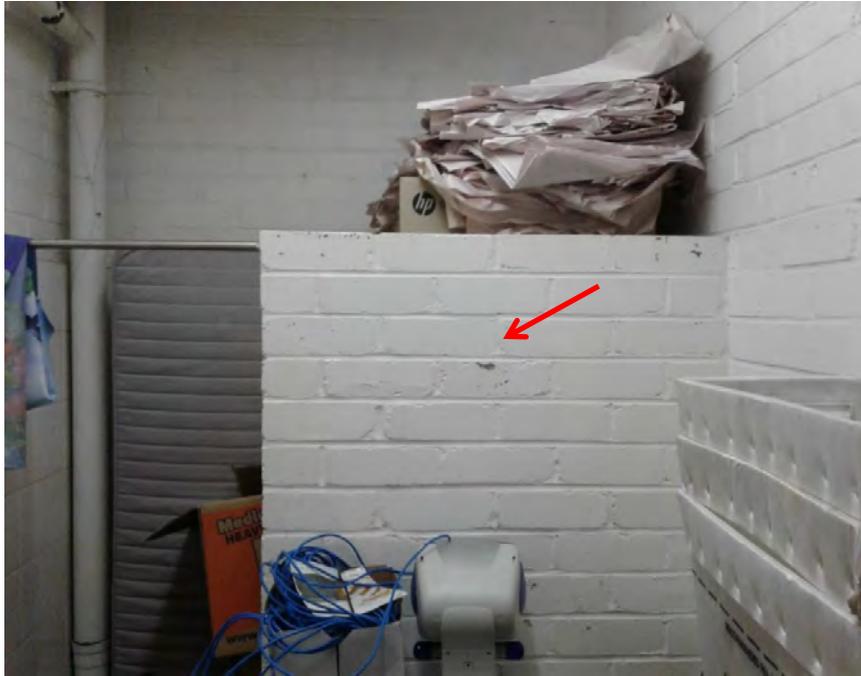
Photograph 11: B00A - R0023, Interior, Brick walls, Beige paint, non-lead paint ( $\leq 0.1\%$  lead w/w).

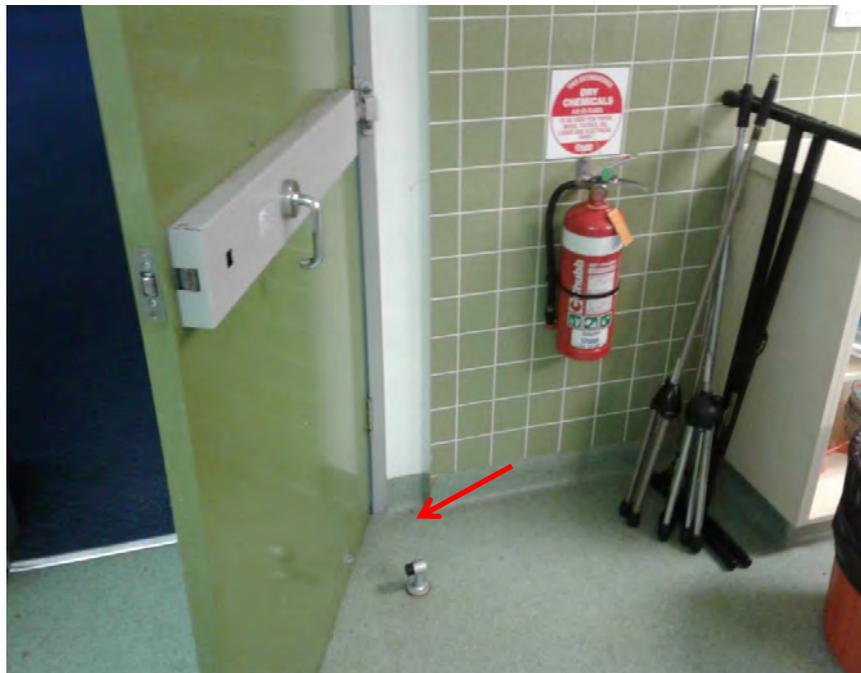
Photograph 12: B00A - R0025, Interior, Flooring material, Vinyl tiles, no asbestos detected by analysis.

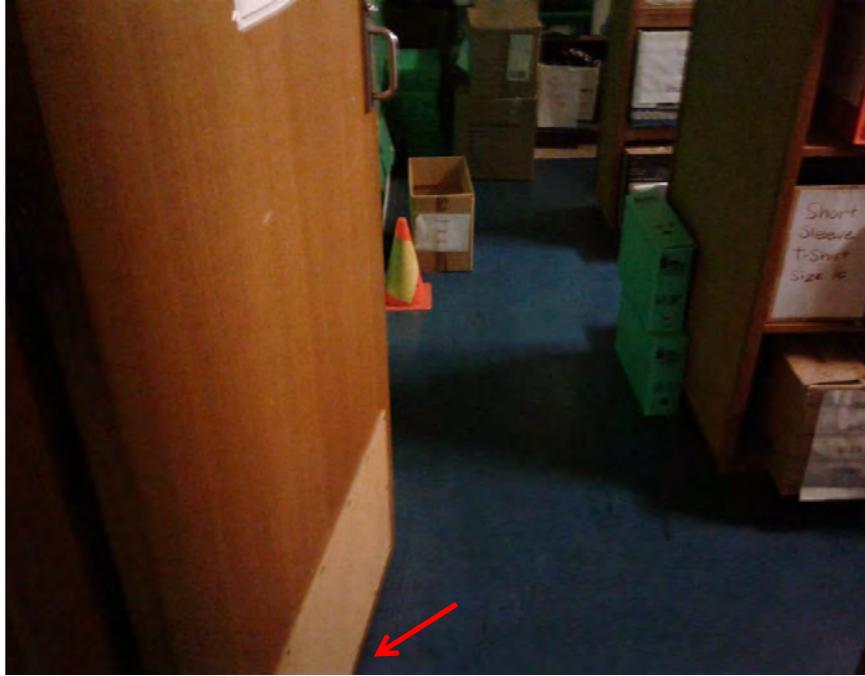
Photograph 13: B00A - R0032, Interior, Flooring material, Vinyl tiles under flooring, asbestos detected by analysis.

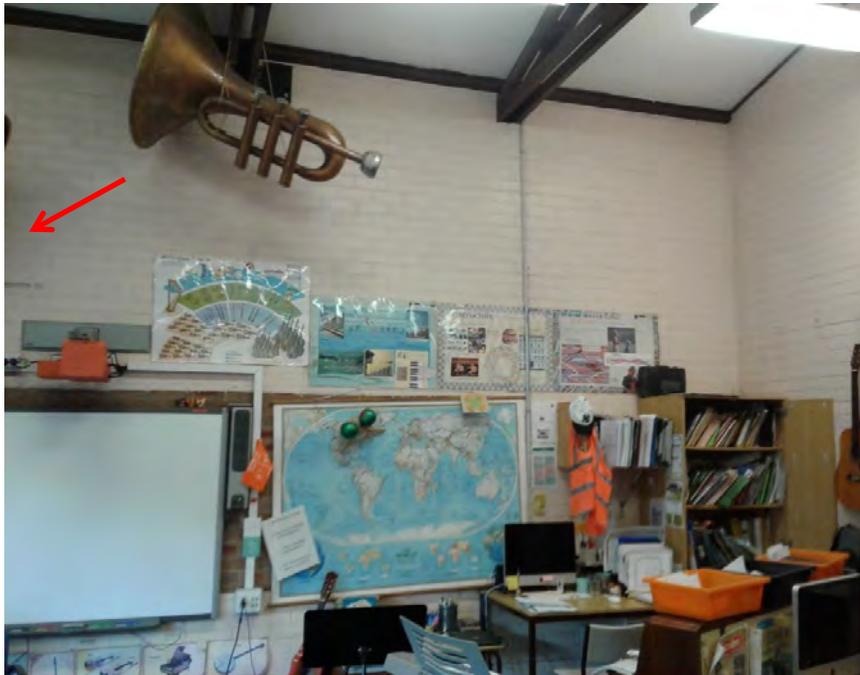
Photograph 14: B00A - R1001, Interior, Brick walls, Beige paint, non-lead paint ( $\leq 0.1\%$  lead w/w).

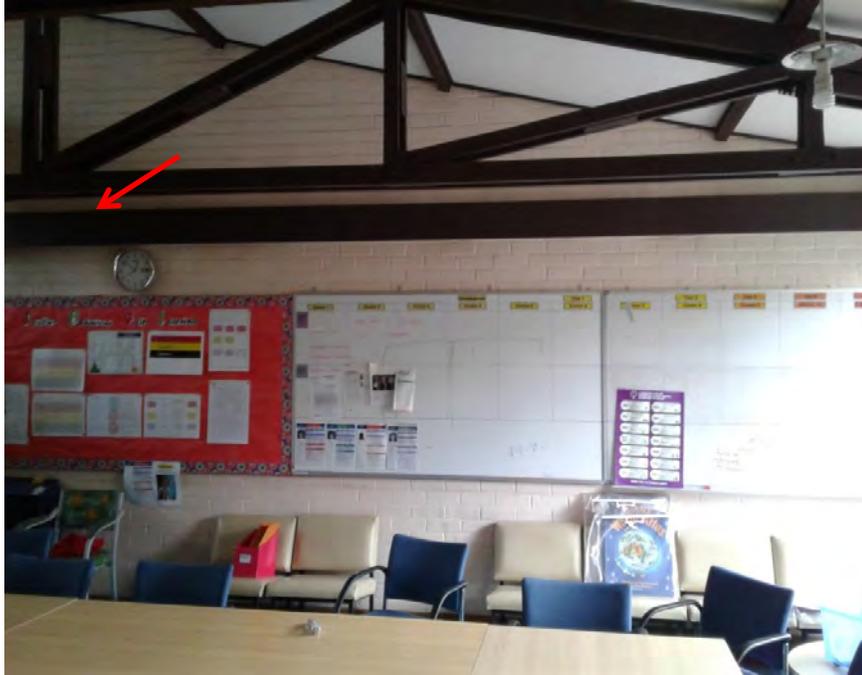
Photograph 15: B00A - R1002, Interior, Timber rafters, Dust above rafters, elevated lead (>0.5 mg/m<sup>2</sup>).

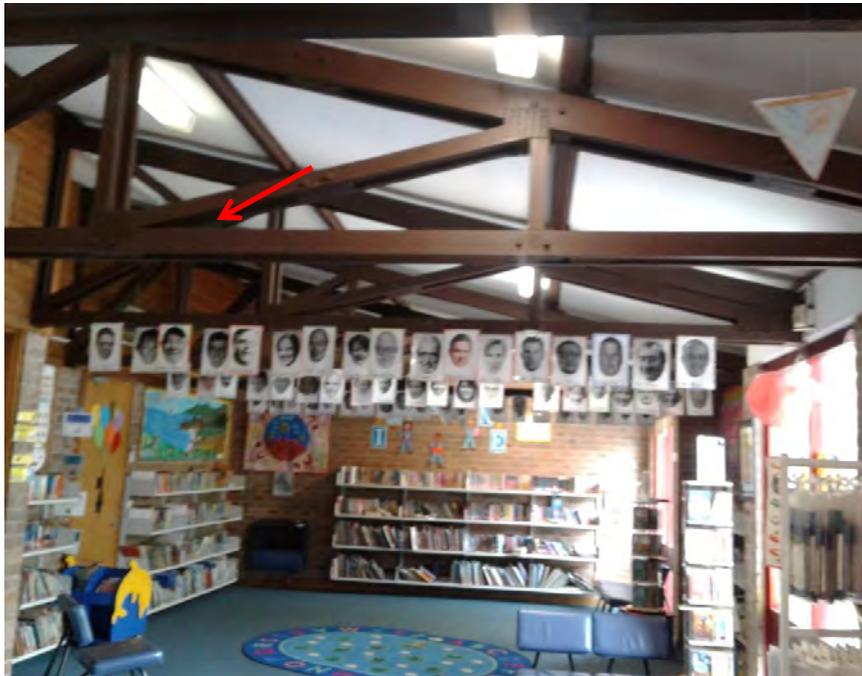
Photograph 16: B00A - R1003, Interior, Timber rafters, Brown paint, non-lead paint ( $\leq 0.1\%$  lead w/w).

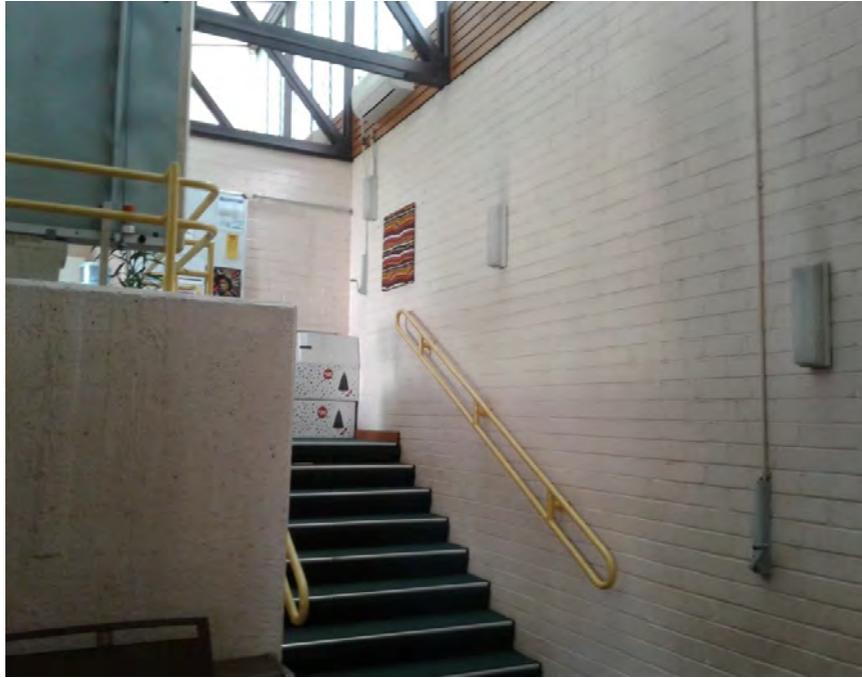
Photograph 17: B00A - R1017, Interior, -, -, nil hazardous materials identified.

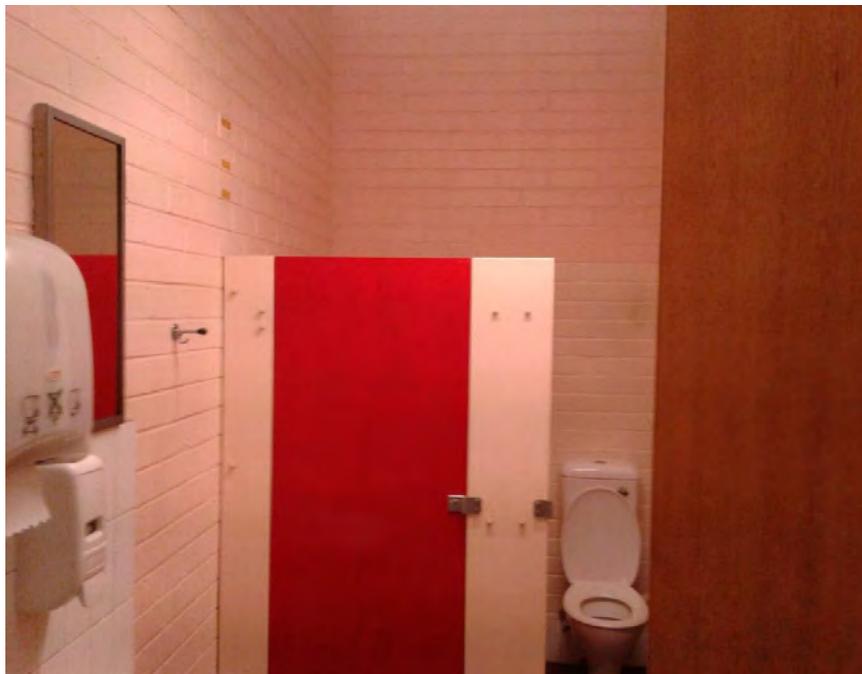
Photograph 18: B00A - R1018, Interior, Partitions in toilet, Compressed FCS sheeting, asbestos detected by analysis.

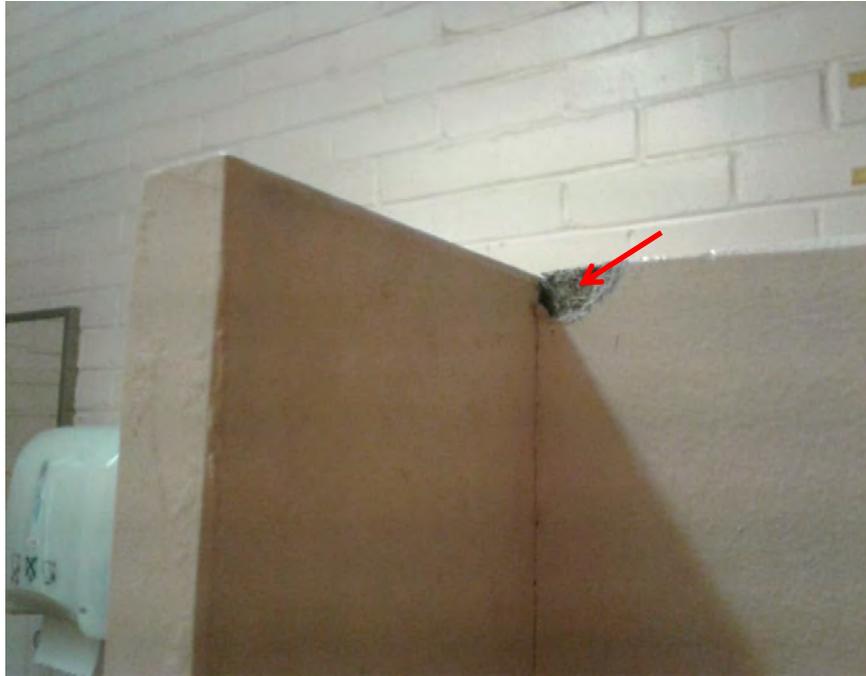
Photograph 19: B00A - R1019, Interior, Partitions in toilet, Compressed FCS sheeting, asbestos detected by analysis.

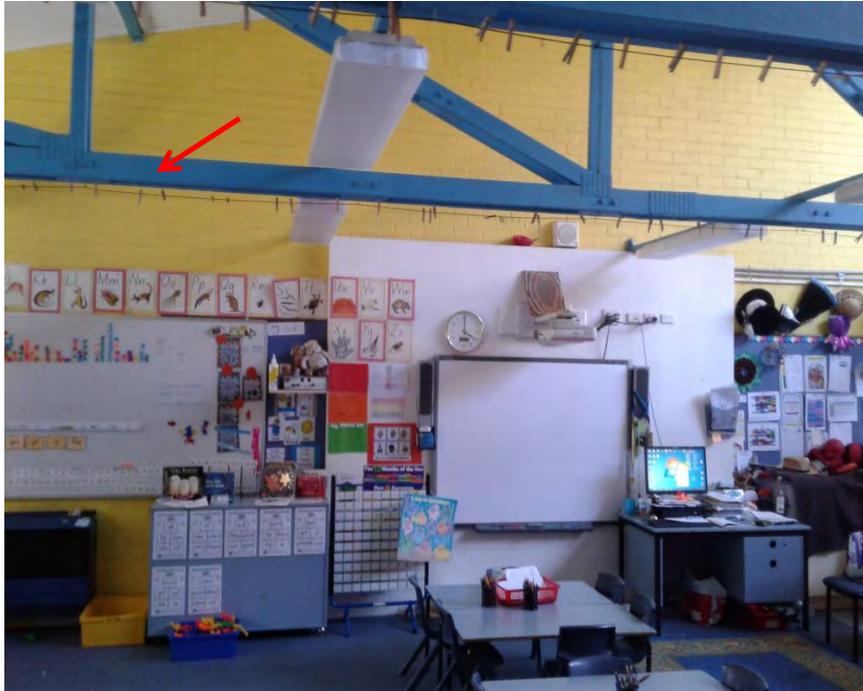
Photograph 20: B00B - R0020, Interior, Timber rafters, Blue paint, non-lead paint ( $\leq 0.1\%$  lead w/w).

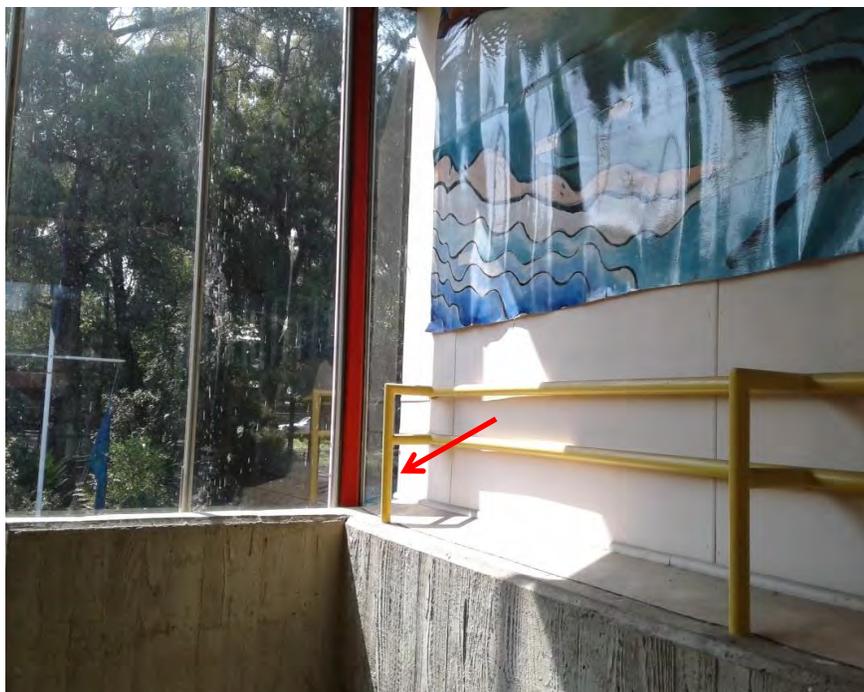
Photograph 21: B00B - R0025, Interior, FCS sheathing on wall, FCS sheathing, no asbestos detected by analysis.

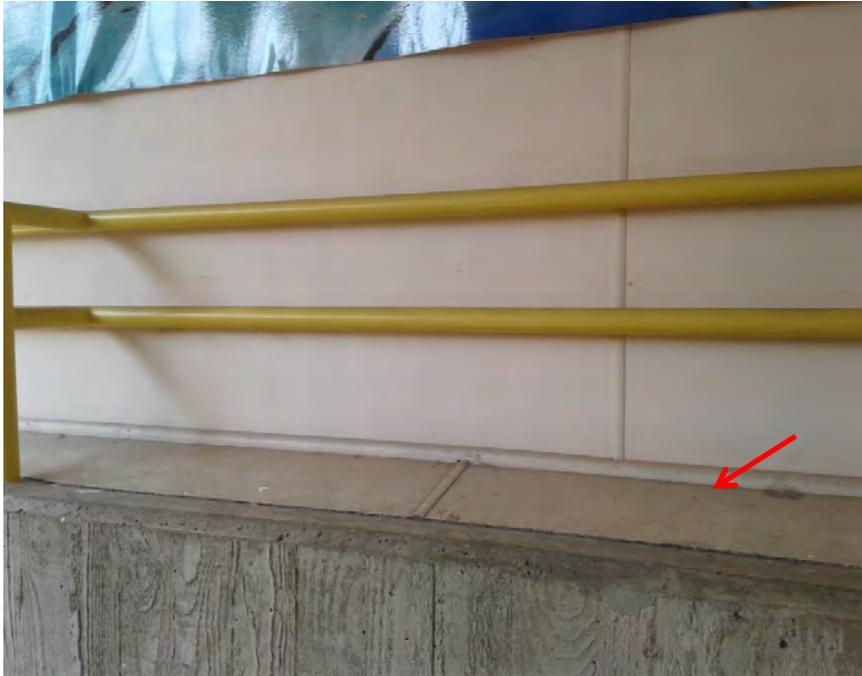
Photograph 22: B00B - R0025, Interior, FCS sheeting on wall, FCS sheeting, no asbestos detected by analysis.

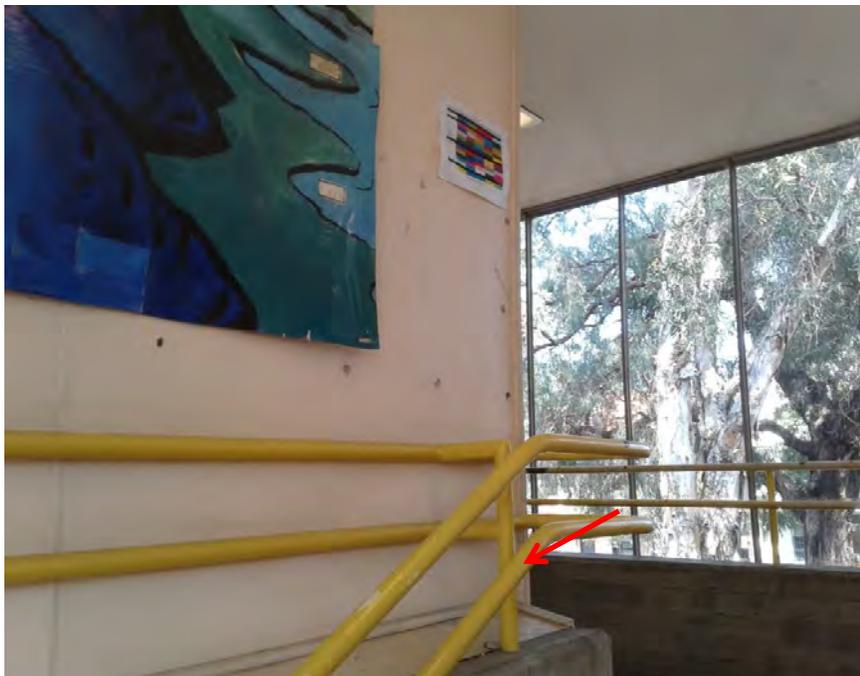
Photograph 23: B00B - R0025, Interior, FCS sheeting on wall, FCS sheeting, no asbestos detected by analysis.

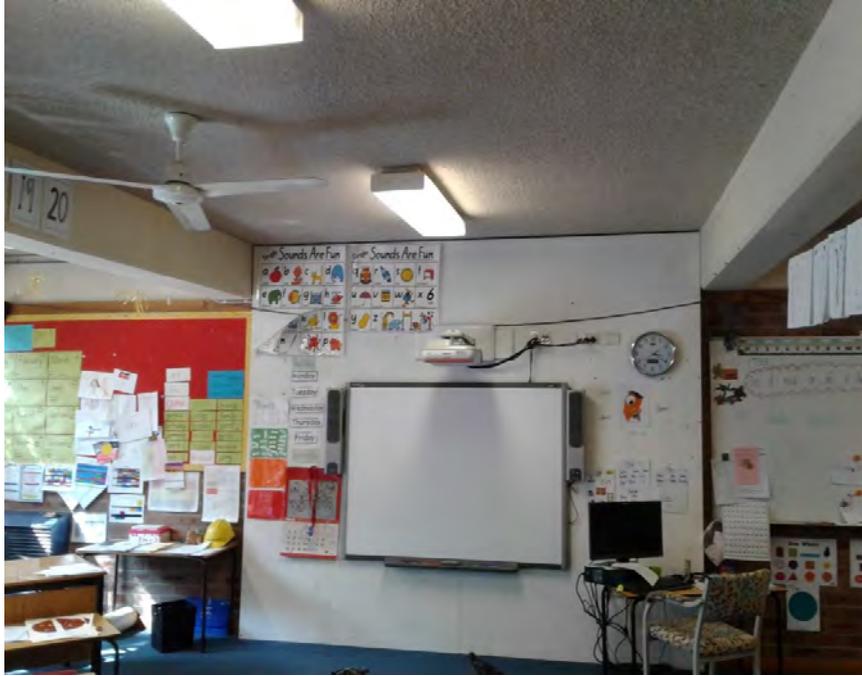
Photograph 24: B00B - R1002, Interior, Flooring material, Vinyl tiles under flooring, asbestos detected by analysis.

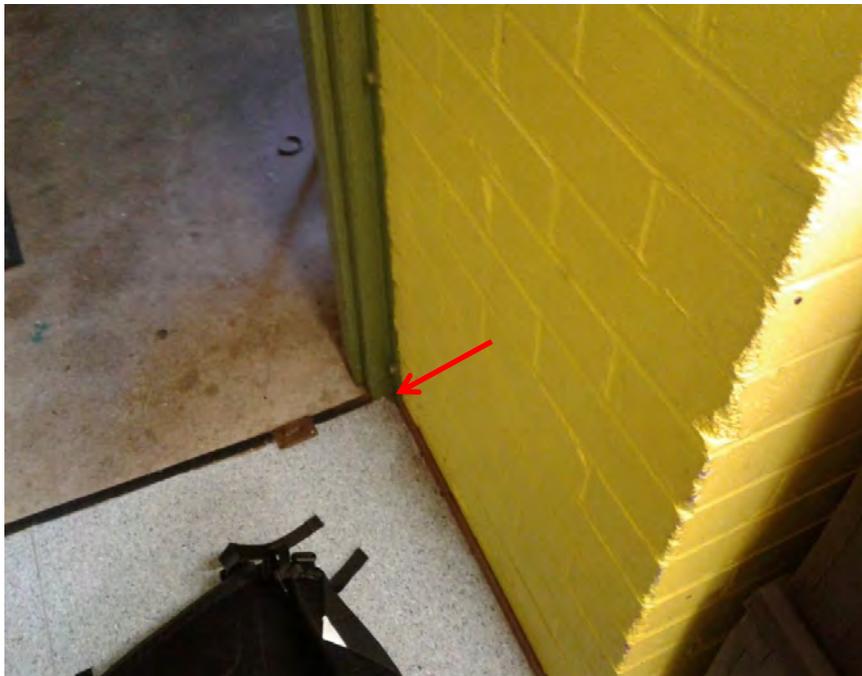
Photograph 25: B00B - R1003, Interior, Flooring material, Vinyl tiles under flooring, no asbestos detected by analysis.

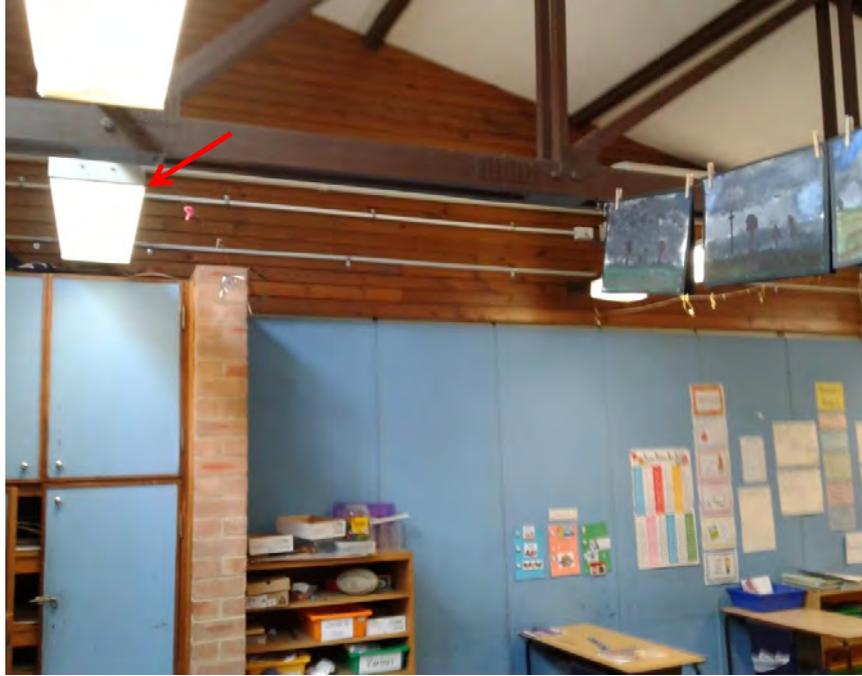
Photograph 26: B00B - R1003, Interior, Light fitting, Dust above light fitting, elevated lead (>0.5 mg/m2).

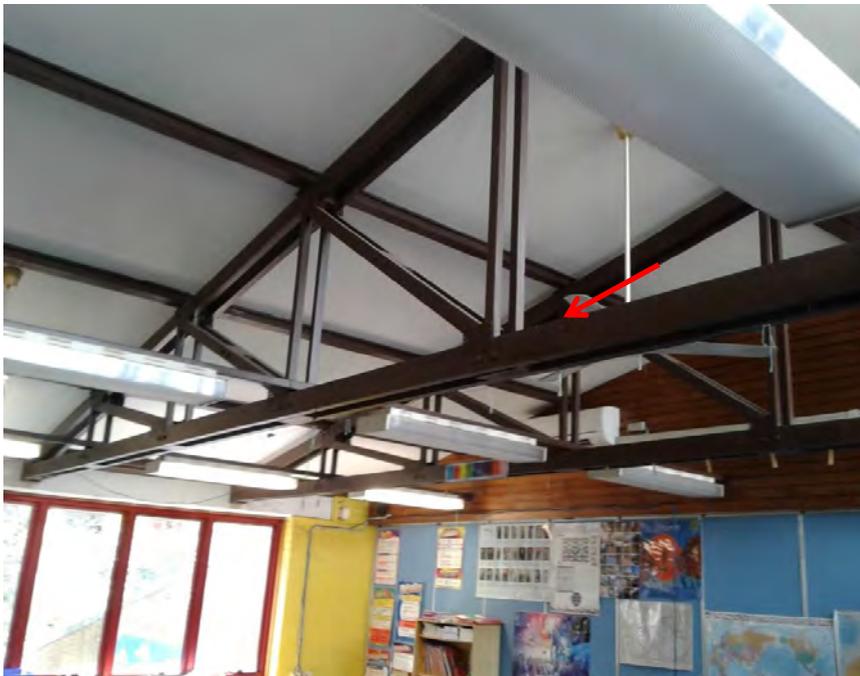
Photograph 27: B00B - R1008, Interior, Timber rafters, Brown paint, non-lead paint ( $\leq 0.1\%$  lead w/w).

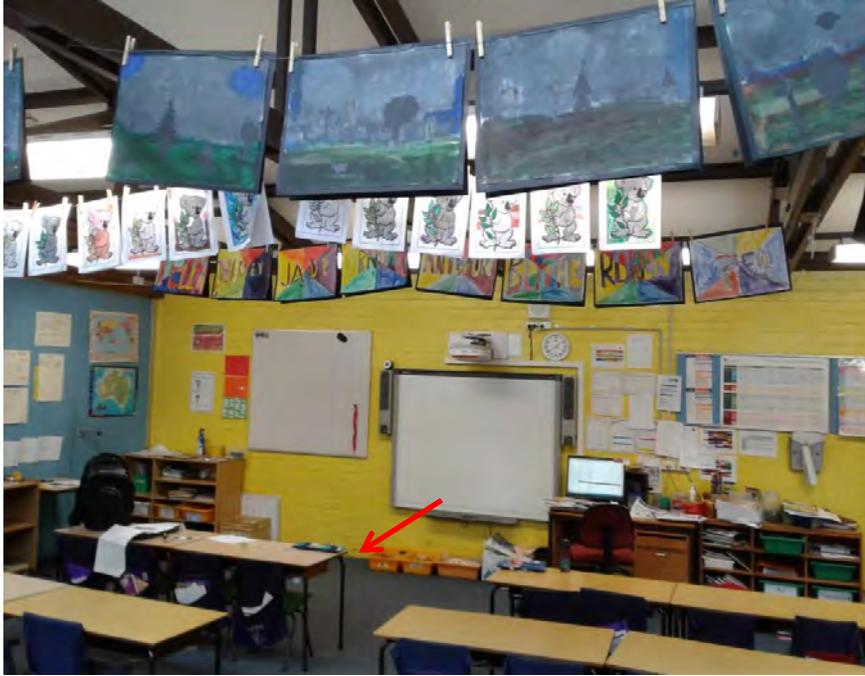
Photograph 28: B00B - R1011, Interior, Timber skirting board near flooring, Yellow Paint, non-lead paint ( $\leq 0.1\%$  lead w/w).

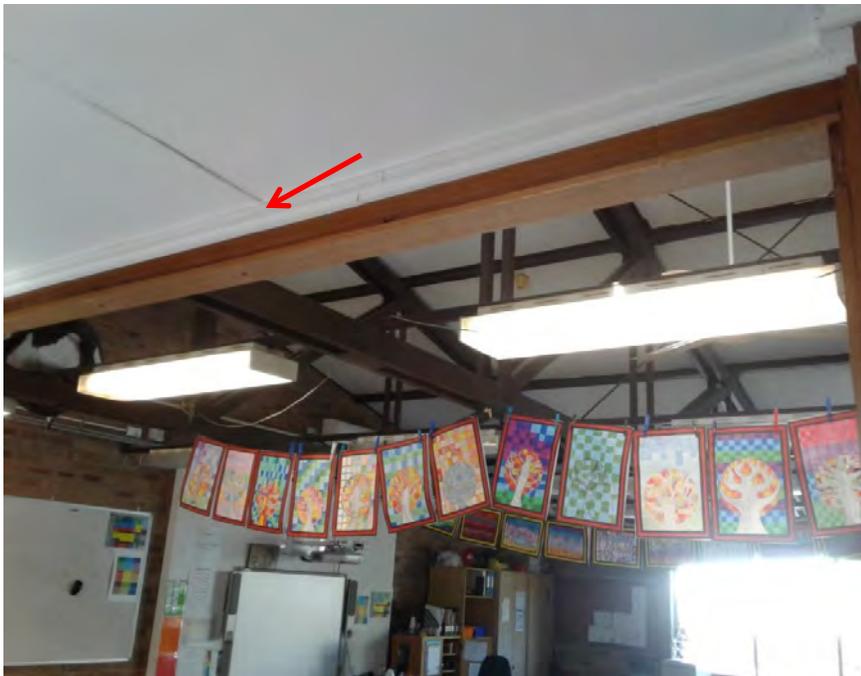
Photograph 29: B00B - R1014, Interior, Ceiling structure, White Flaking Paint, non-lead paint ( $\leq 0.1\%$  lead w/w).

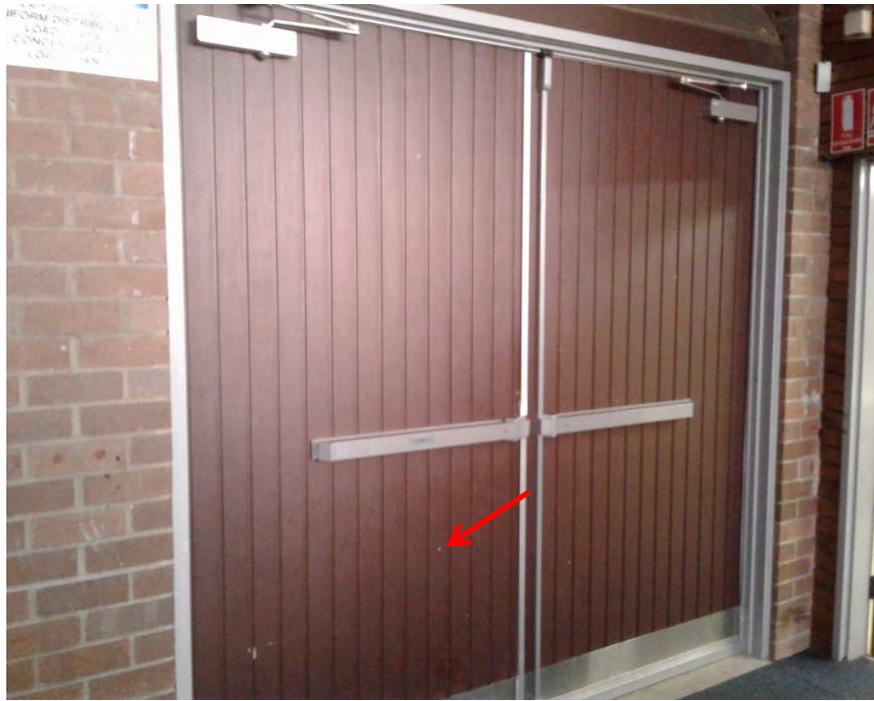
Photograph 30: B00C - R0001, Interior, Timber door frame, Brown Paint, non-lead paint ( $\leq 0.1\%$  lead w/w).

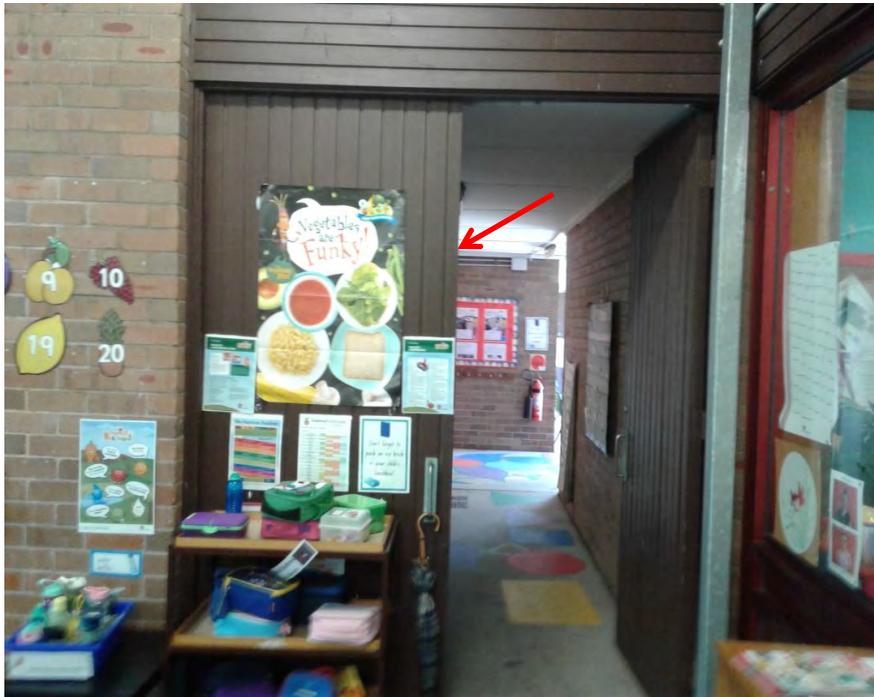
Photograph 31: B00C - R0002, Interior, Timber door frame, Brown Paint, non-lead paint ( $\leq 0.1\%$  lead w/w).

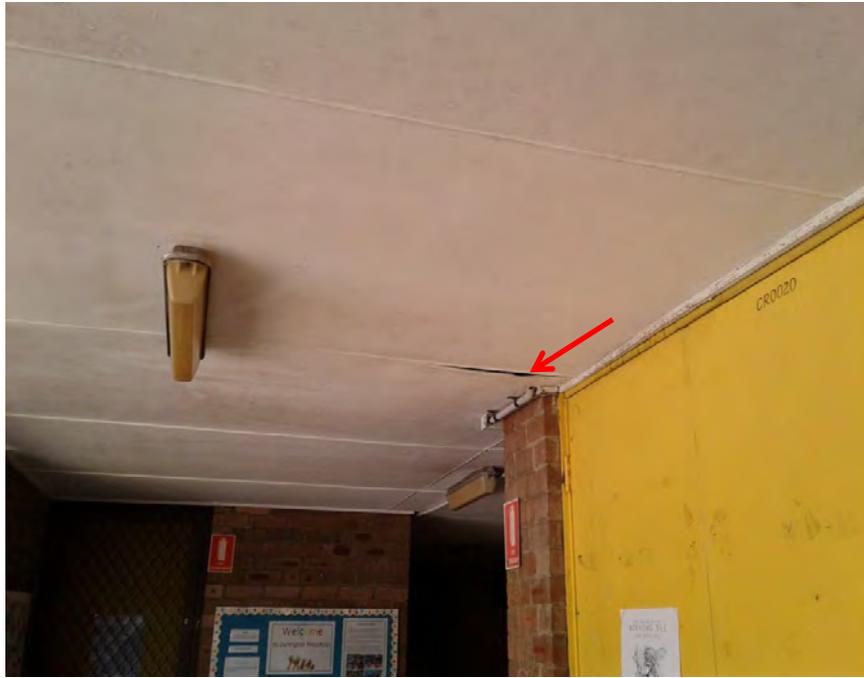
Photograph 32: B00C - R0005, Interior, Ceiling structure, FCS sheeting, no asbestos detected by analysis.

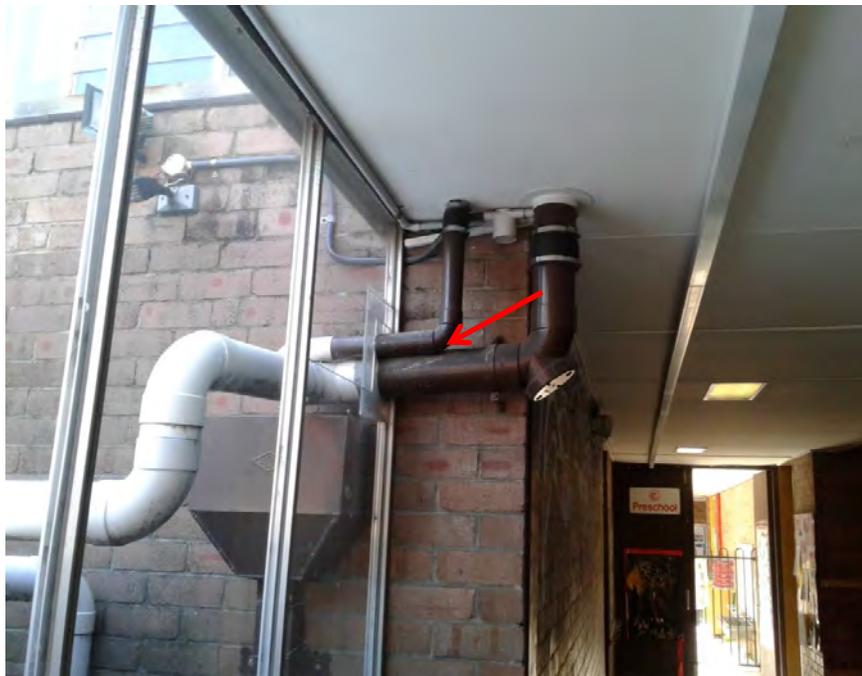
Photograph 33: B00C - R0005, Interior, Ceiling structure, Dust above water pipe, elevated lead (>0.5 mg/m2).

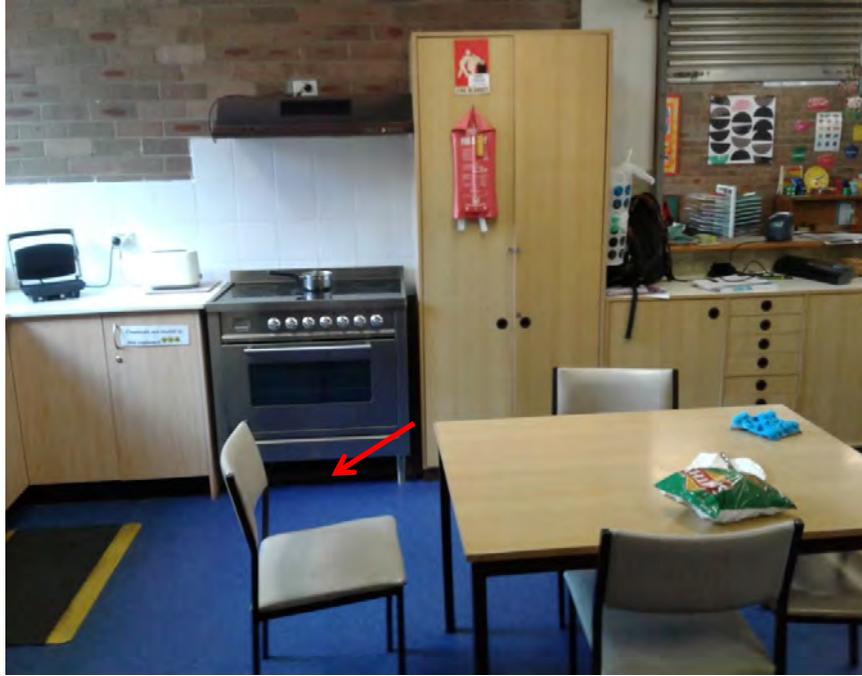
Photograph 34: B00C - R0006, Interior, Flooring material, Vinyl tiles, no asbestos detected by analysis.

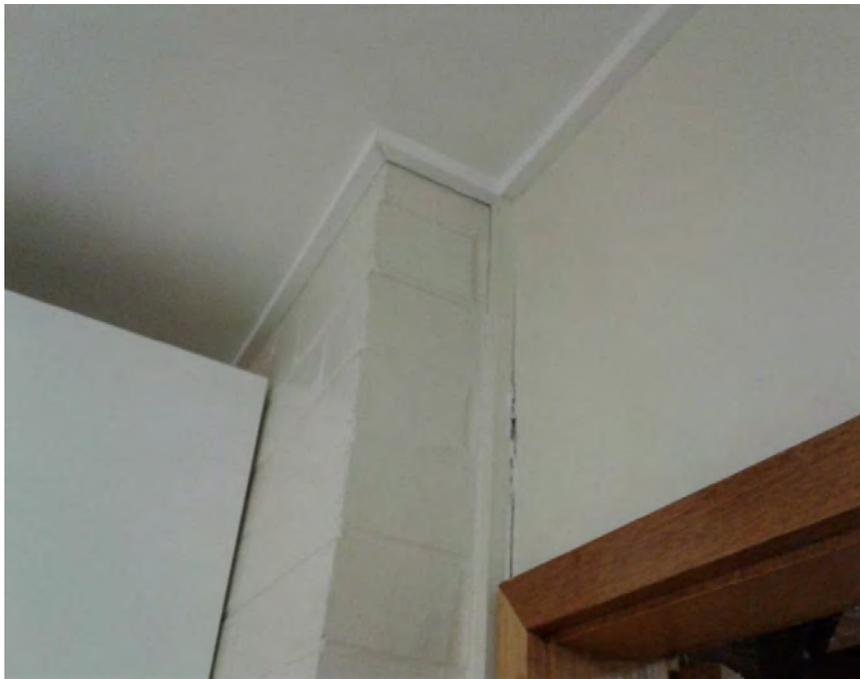
Photograph 35: B00C - R0010, Interior, Partitions in toilet, Beige Paint, non-lead paint ( $\leq 0.1\%$  lead w/w).

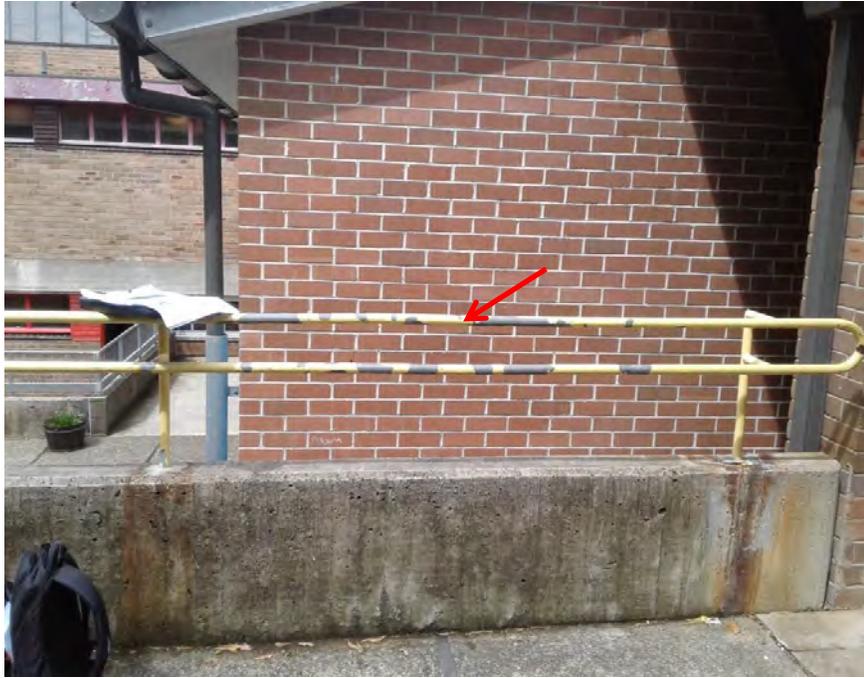
Photograph 36: B00C - R0024, Exterior, Hand rails, Yellow Paint, lead paint (>0.1% lead w/w).

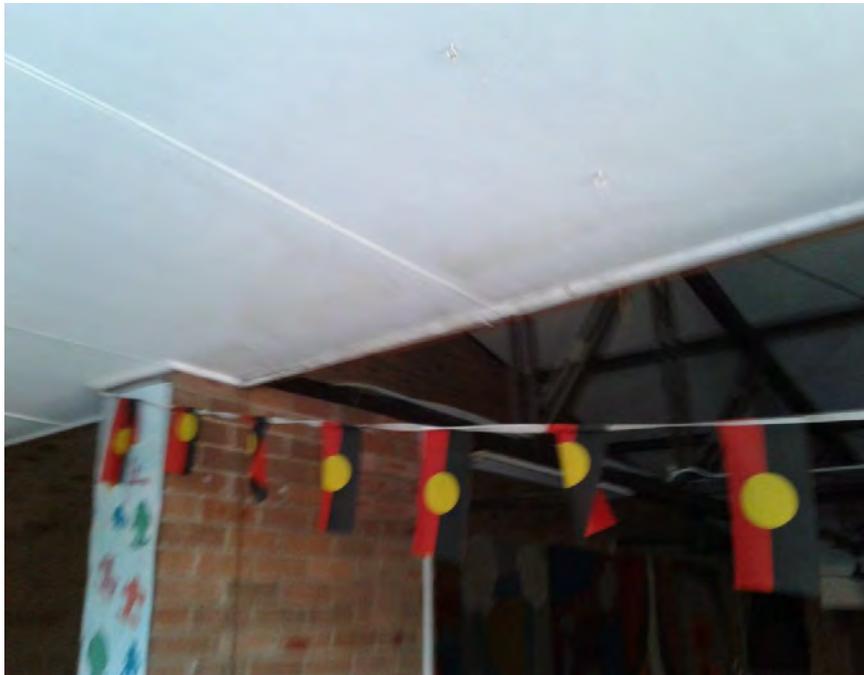
Photograph 37: B00C - R0025, Interior, Brick column, Dust above column, elevated lead (>0.5 mg/m2).
