# DARLINGTON PUBLIC SCHOOL REDEVELOPMENT

## Appendix S — Hazardous Materials Survey

Report on  
Hazardous Building Materials Assessment

Darlington Public School Upgrade  
Darlington Public School, Darlington, NSW

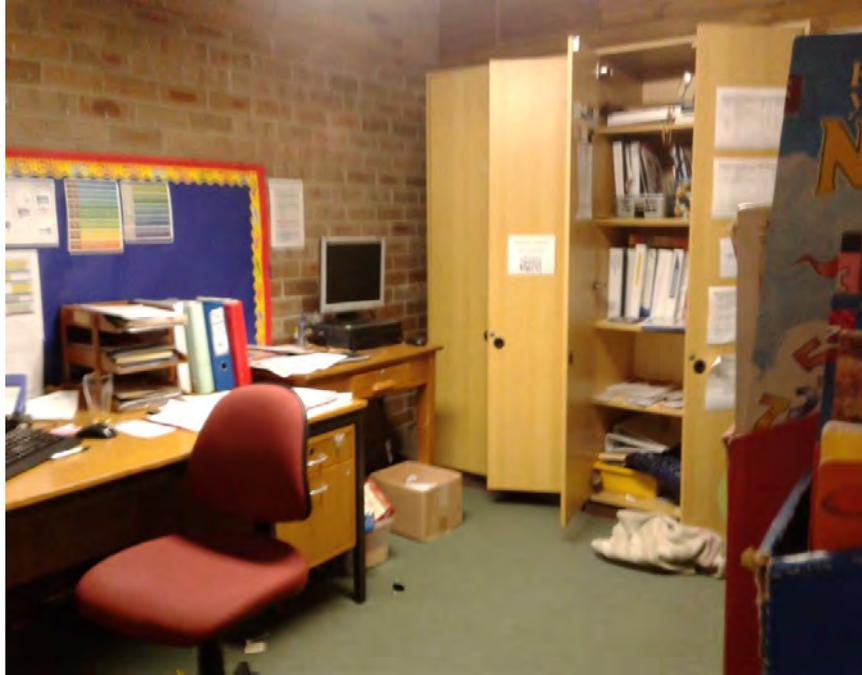
Photograph 38: B00C - R0029, Interior, Flooring material, Vinyl tiles under flooring, no asbestos identified visually.

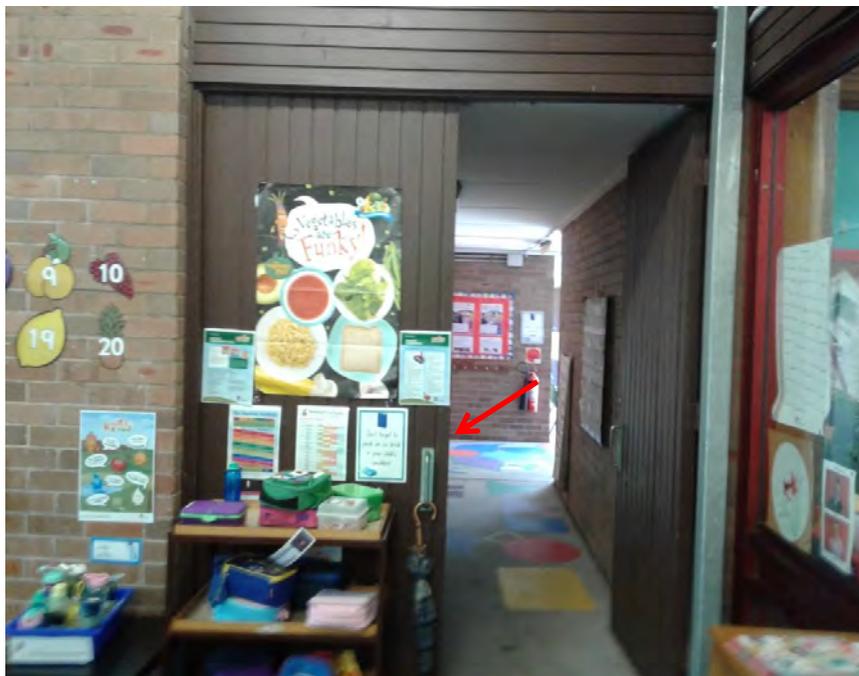
Photograph 39: B00C - R0034, Interior, Timber door, Brown Paint, non-lead paint ( $\leq 0.1\%$  lead w/w).
