# HAZARDOUS MATERIALS SURVEY

**173-183 Rickard Road  
Leppington NSW 2179**

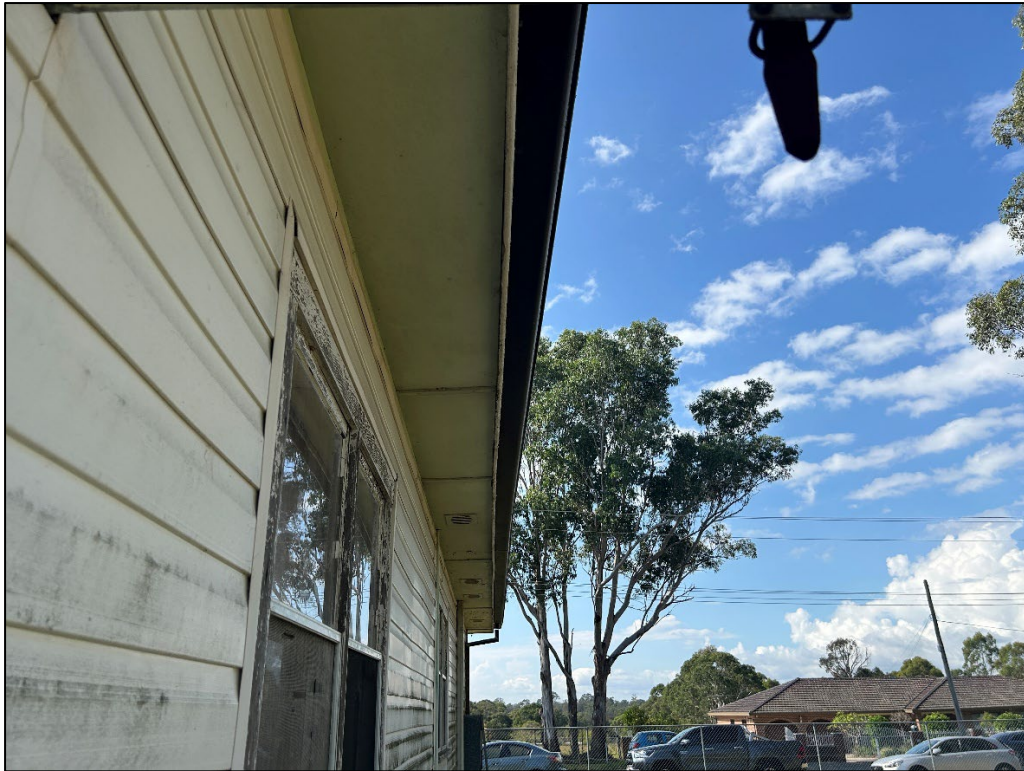
### **5.1 173 Eaves**

| <b>Site Address:</b> | | <b>173 &amp; 183 Rickard Road, Leppington NSW 2179</b> | | | | | | | | |
|---|---|---|---|---|---|---|---|---|---|---|
| 173 House | Eaves | Fibrous cement material | | 5.1 | Assumed asbestos | Good | 20 | Low | P3 | Remove prior to demolition |

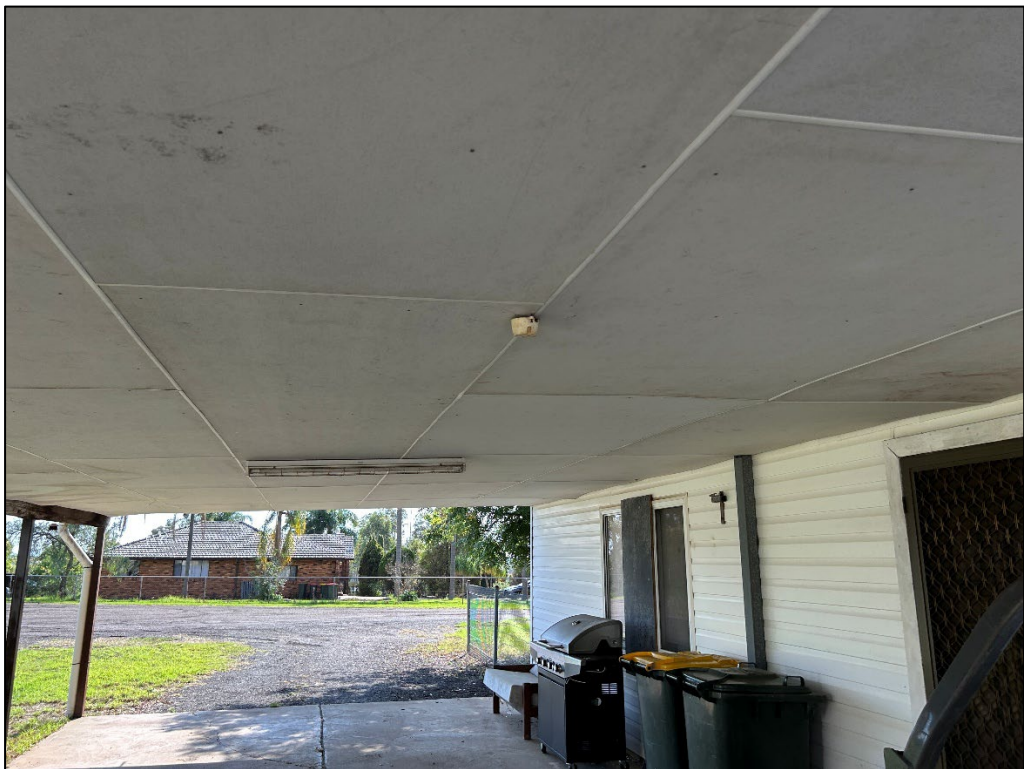
### **5.2 Rear Awning Lining**

| <b>Site Address:</b> | | <b>173 &amp; 183 Rickard Road, Leppington NSW 2179</b> | | | | | | | | |
|---|---|---|---|---|---|---|---|---|---|---|
| | Rear awning lining | Fibrous cement material | S3 | 5.2 | Not asbestos | | | | | |

| Client Sample ID | Eurofins Sample No. | Date Sampled | Sample Description | Result |
|---|---|---|---|---|
| S3 | 25-Ap0070290 | Apr 29, 2025 | Approximate Sample 8g / 40x30x5mm<br>Sample consisted of: Off-white plaster cement material | No asbestos detected.<br>No trace asbestos detected. |

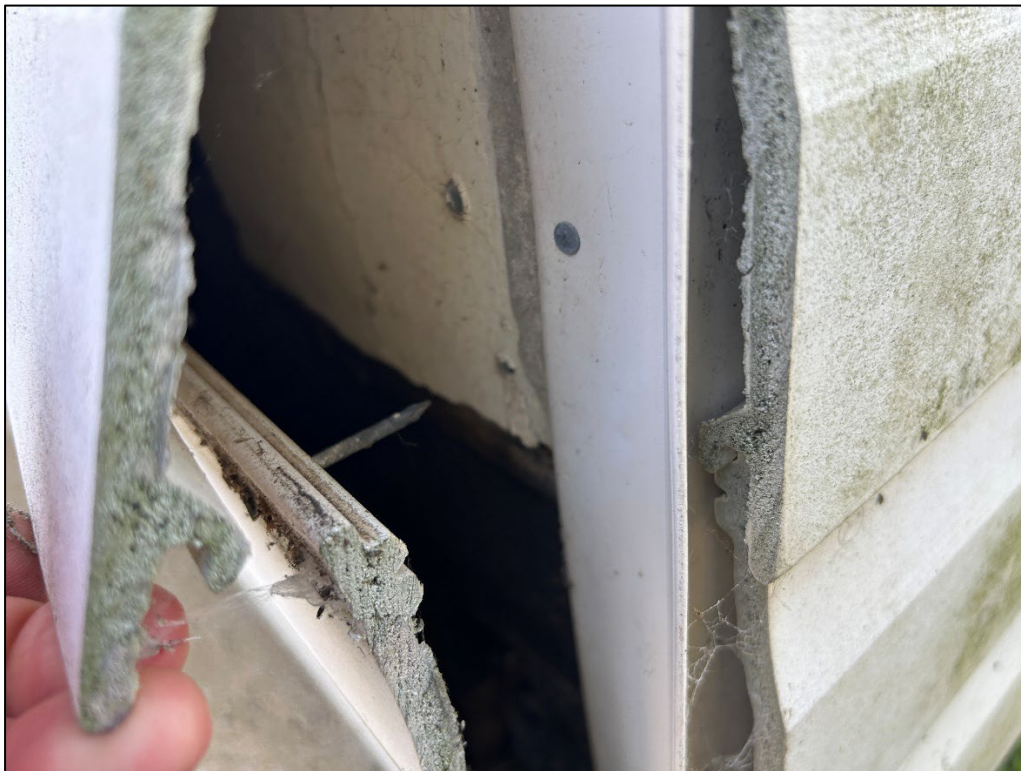
### 5.3 Cladding under weatherboards

Asbestos containing material was identified in cladding material including as a secondary layer under the external cladding of the house at 173 Rickard Road and the external bathroom. It is considered likely that additional covered cladding will be located including within the front awning structure.

| <b>Site Address:</b> | | <b>173 &amp; 183 Rickard Road, Leppington NSW 2179</b> | | | | | | | | |
|---|---|---|---|---|---|---|---|---|---|---|
| | Cladding under weatherboards | Fibrous cement material | S4 | 5.3 | CH & AM | Poor | 120 | Low | P3 | Remove prior to demolition |

| Client Sample ID | Eurofins Sample No. | Date Sampled | Sample Description | Result |
|---|---|---|---|---|
| S4 | 25-Ap0070291 | Apr 29, 2025 | Approximate Sample <1g / 20x6x4mm<br>Sample consisted of: Grey compressed fibre cement material | Chrysotile and amosite asbestos detected. |

The identification of asbestos cladding under external cladding will require careful removal of the more recent material (outer cladding) and then subsequent removal of the asbestos material. It is expected that there will be fragments of broken asbestos material within the wall cavities resulting from the fixing of one layer of cladding over an existing layer (refer to figure 5.3 showing a nail used to fix cladding over cladding).

All fragments of broken cladding must be removed prior to general demolition. This will require the use of appropriate filtered vacuum cleaners.

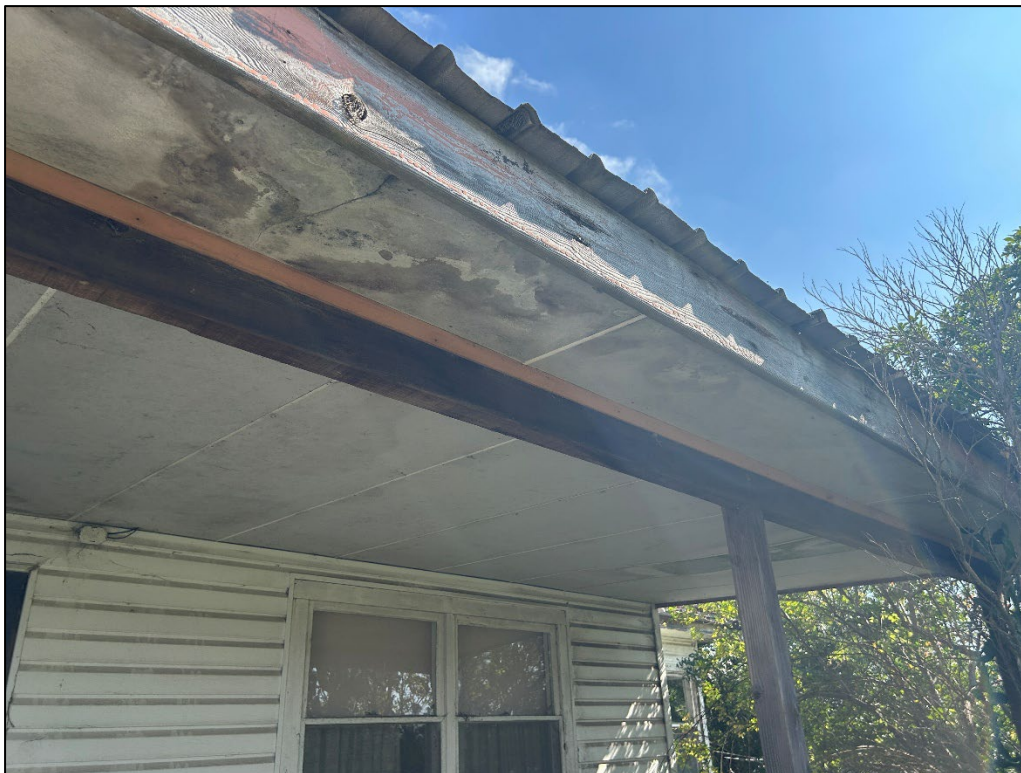
### 5.4 Front Awning Lining

| <b>Site Address:</b> | | <b>173 &amp; 183 Rickard Road, Leppington NSW 2179</b> | | | | | | | | |
|---|---|---|---|---|---|---|---|---|---|---|
| | Front awning lining | Fibrous cement material | | 5.4 | Not asbestos | | | | | |

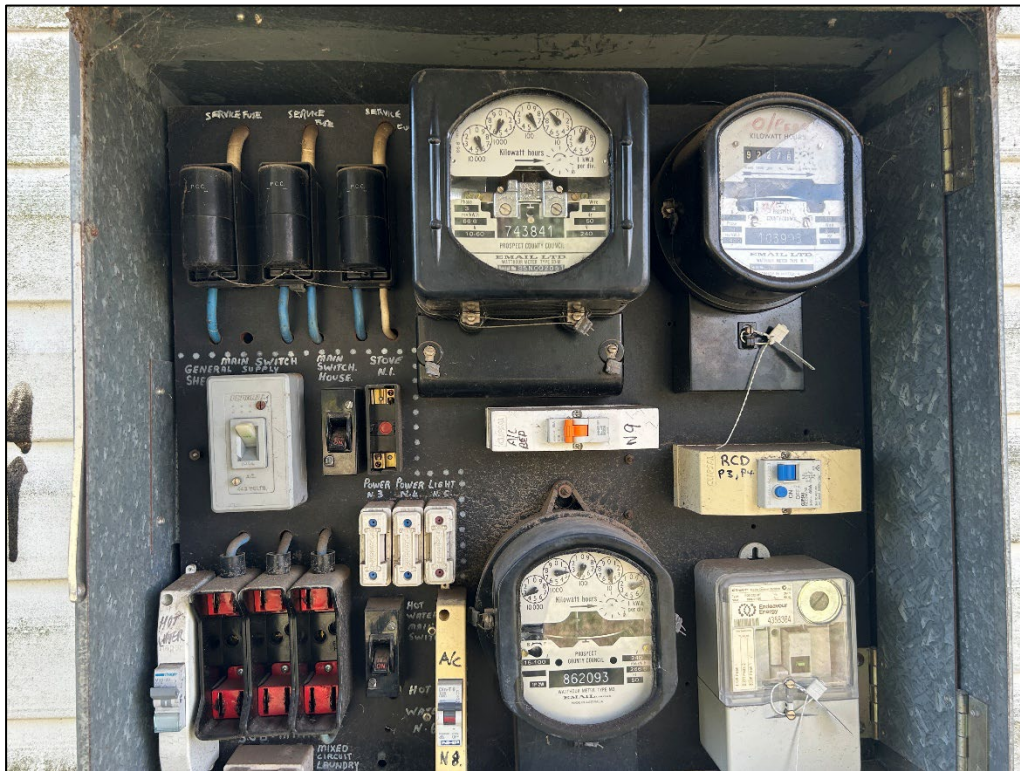
## 5.5 Switchboard

The switchboards at both houses are considered to be asbestos.

| <b>Site Address:</b> | | <b>173 &amp; 183 Rickard Road, Leppington NSW 2179</b> | | | | | | | | |
|---|---|---|---|---|---|---|---|---|---|---|
| | Switchboard | Electrical board | | 5.5 | Assumed asbestos | Good | 0.5 | Low | P3 | Remove prior to demolition |

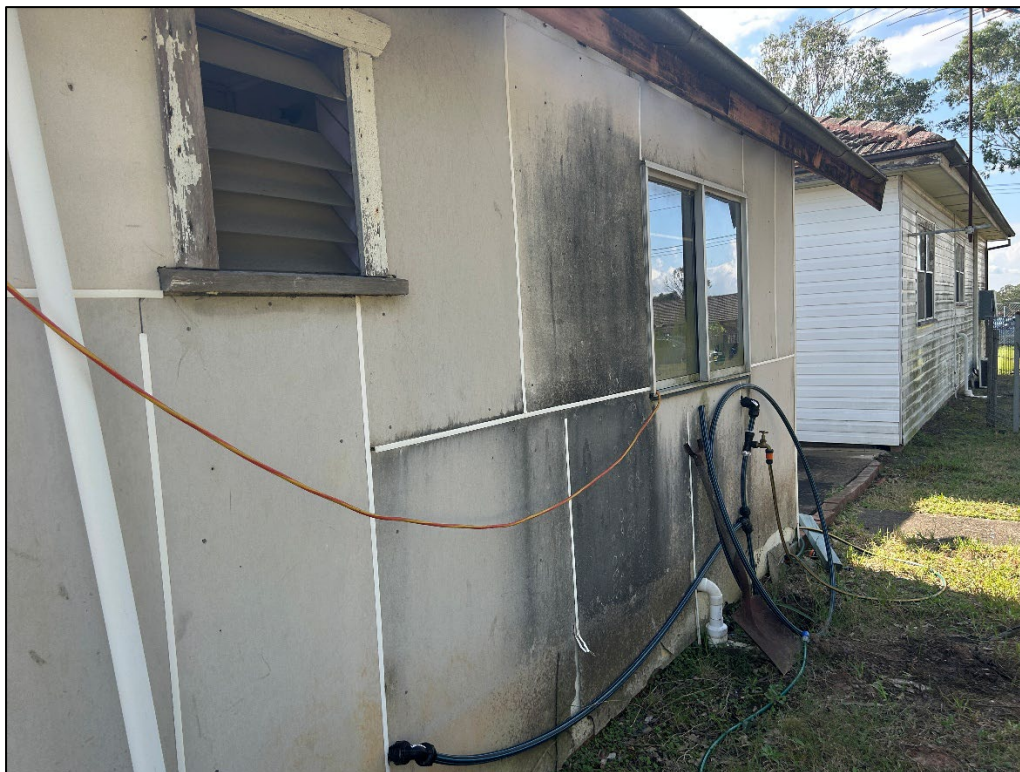
## 5.6 Bathroom External Cladding

| <b>Site Address:</b> | | <b>173 &amp; 183 Rickard Road, Leppington NSW 2179</b> | | | | | | | | |
|---|---|---|---|---|---|---|---|---|---|---|
| Bathroom | External cladding | Fibrous cement material | S1 | 5.6 | Not asbestos | | | | | |

| Client Sample ID | Eurofins Sample No. | Date Sampled | Sample Description | Result |
|---|---|---|---|---|
| S1 | 25-Ap0070288 | Apr 29, 2025 | Approximate Sample 14g / 60x35x5mm<br>Sample consisted of: Off-white plaster cement material | No asbestos detected.<br>No trace asbestos detected. |

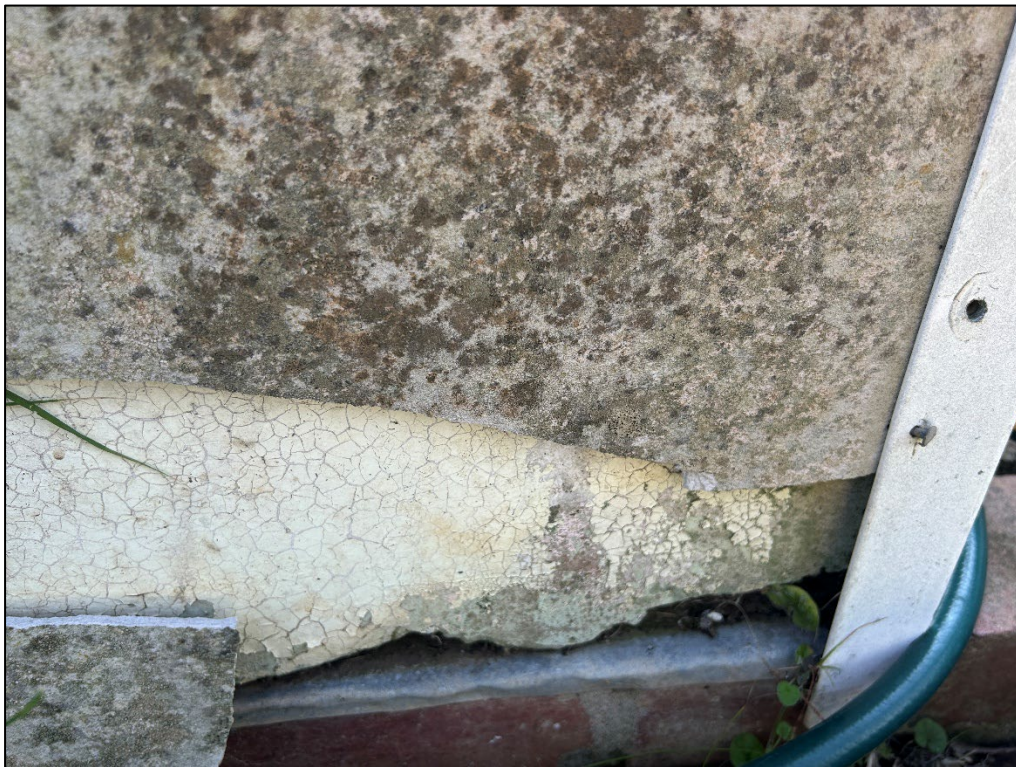
## 5.7 Bathroom Under Cladding

| <b>Site Address:</b> | | <b>173 &amp; 183 Rickard Road, Leppington NSW 2179</b> | | | | | | | | |
|---|---|---|---|---|---|---|---|---|---|---|
| | Under cladding | Fibrous cement material | S2 | 5.7 | CH & AM | Poor | 80 | Low | P3 | Remove prior to demolition |

| Client Sample ID | Eurofins Sample No. | Date Sampled | Sample Description | Result |
|---|---|---|---|---|
| S2 | 25-Ap0070289 | Apr 29, 2025 | Approximate Sample 2g / 30x15x5mm<br>Sample consisted of: Grey compressed fibre cement material | Chrysotile and amosite asbestos detected. |

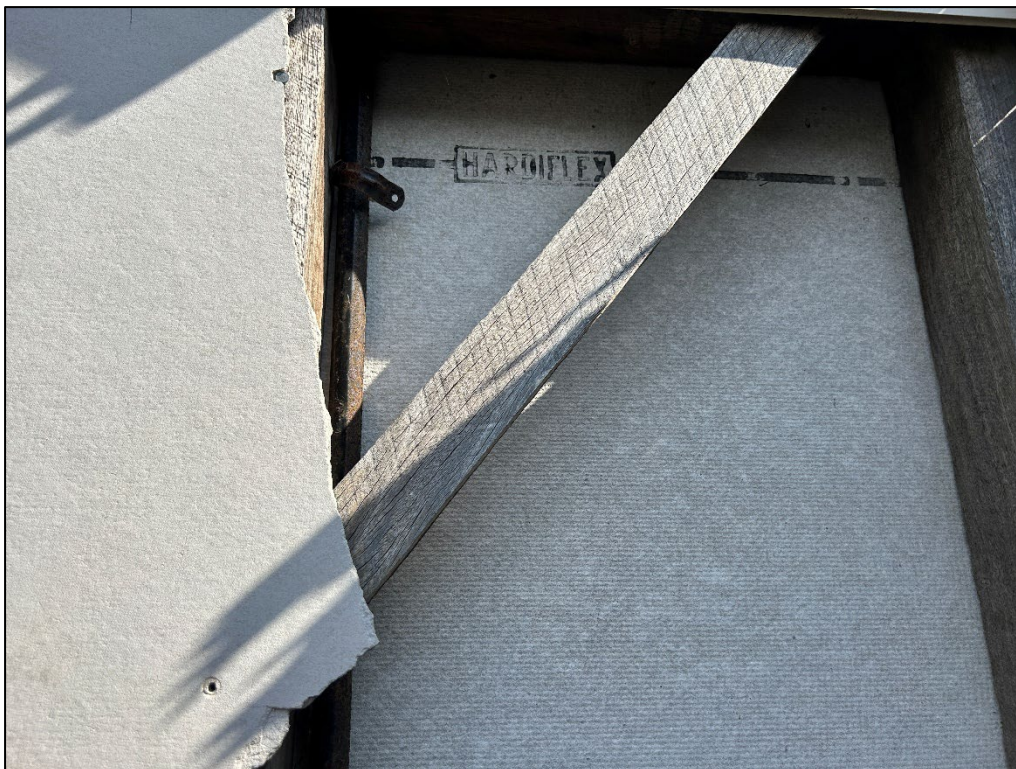
## 5.8 Bathroom Lining

| <b>Site Address:</b> | | <b>173 &amp; 183 Rickard Road, Leppington NSW 2179</b> | | | | | | | | |
|---|---|---|---|---|---|---|---|---|---|---|
| | Internal lining | Fibrous cement material | | 5.8 | Assumed asbestos | Good | 80 | Low | P3 | Remove prior to demolition |

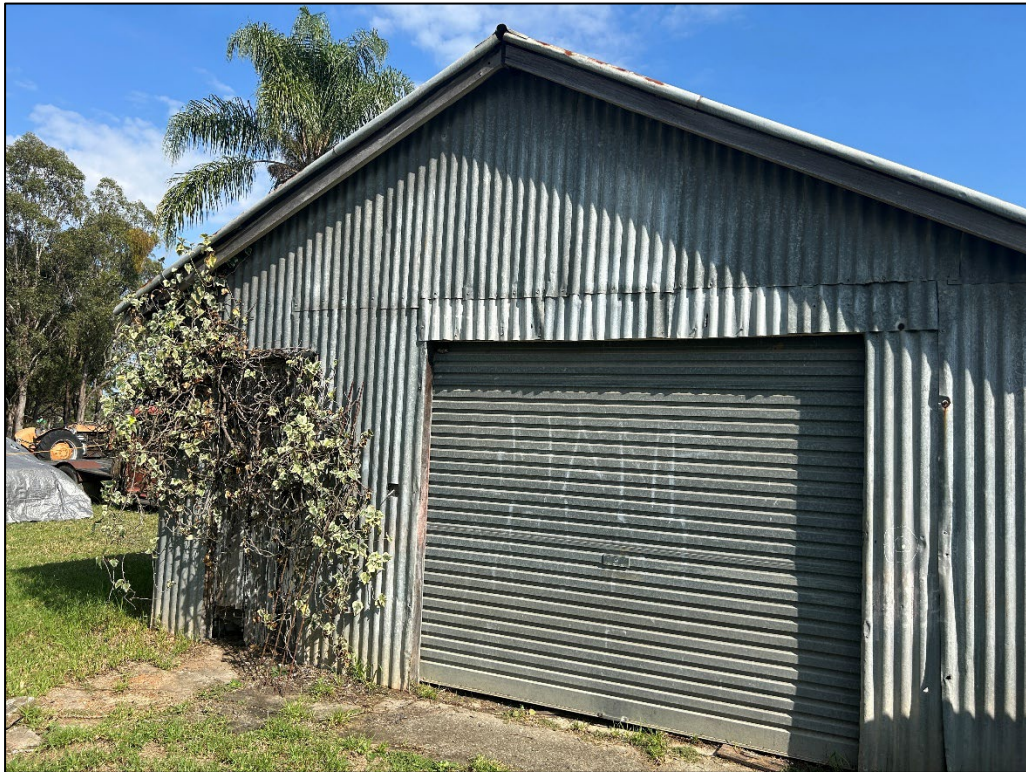
## 5.9 Shed 2

| <b>Site Address:</b> | | <b>173 &amp; 183 Rickard Road, Leppington NSW 2179</b> | | | | | | | | |
|---|---|---|---|---|---|---|---|---|---|---|
| Shed 2 | Cladding and roof | Corrugated metal | | 5.9 | Not asbestos | | | | | |

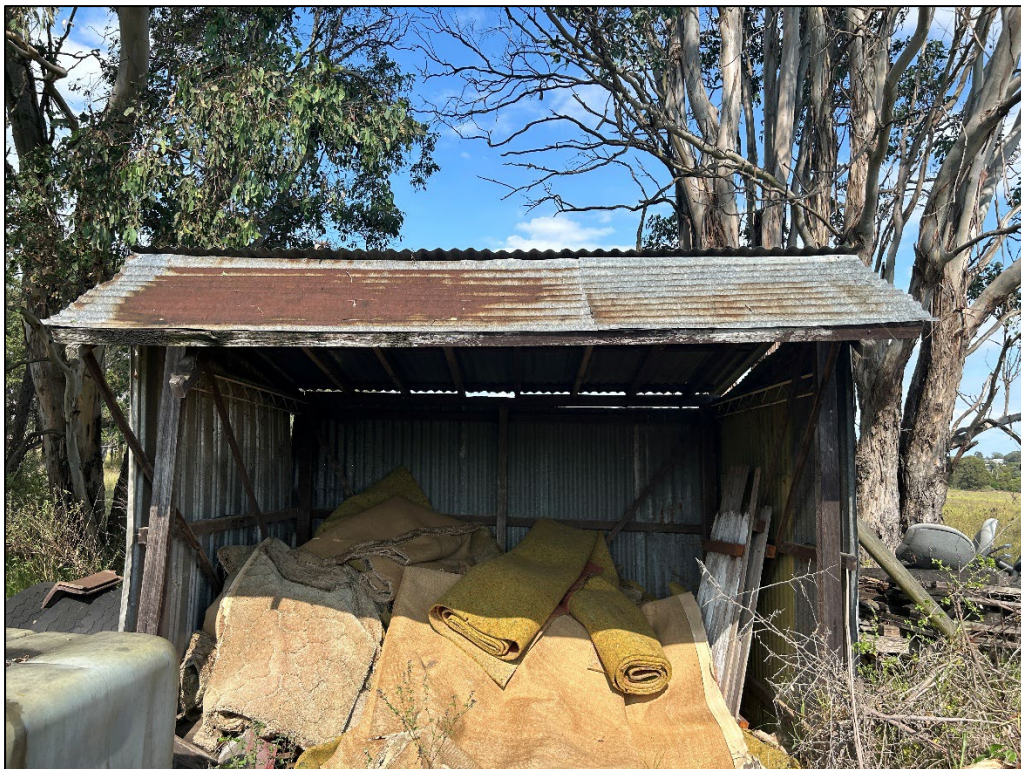
## 5.10 Shed 3

| <b>Site Address:</b> | | <b>173 &amp; 183 Rickard Road, Leppington NSW 2179</b> | | | | | | | | |
|---|---|---|---|---|---|---|---|---|---|---|
| Shed 3 | Cladding and roof | Corrugated metal | | 5.10 | Not asbestos | | | | | |

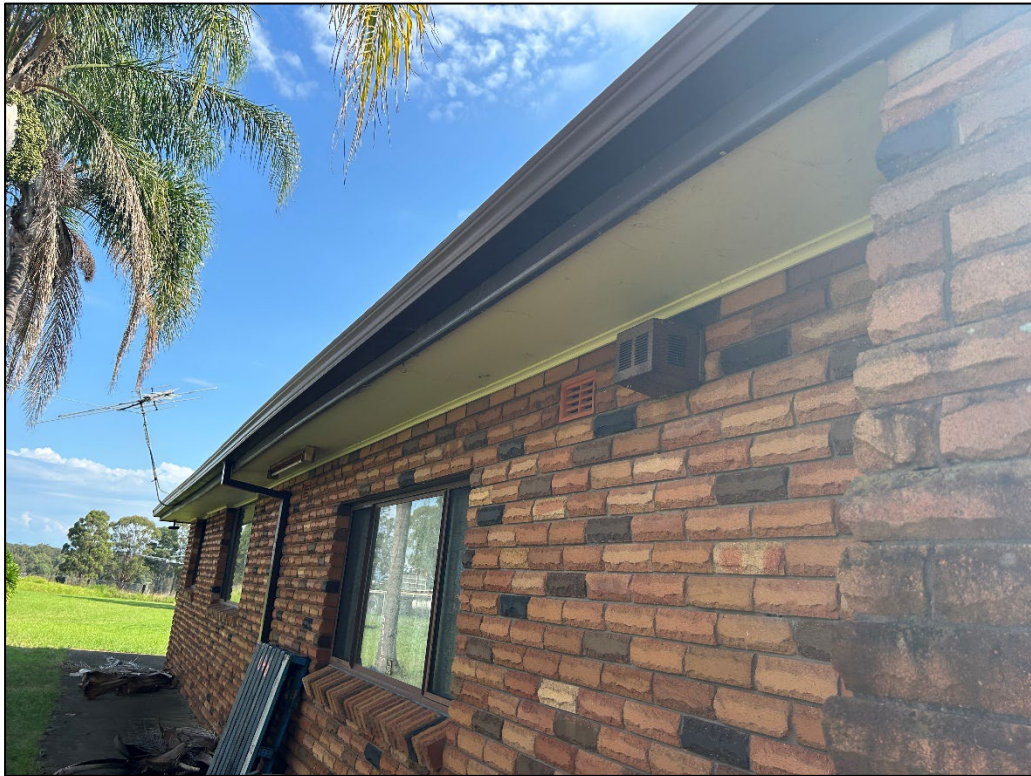
### 5.11 183 Eaves

| <b>Site Address:</b> | | <b>173 &amp; 183 Rickard Road, Leppington NSW 2179</b> | | | | | | | | |
|---|---|---|---|---|---|---|---|---|---|---|
| 183 House | Eaves | Fibrous cement material | | 5.11 | Assumed asbestos | Good | 30 | Low | P3 | Remove prior to demolition |

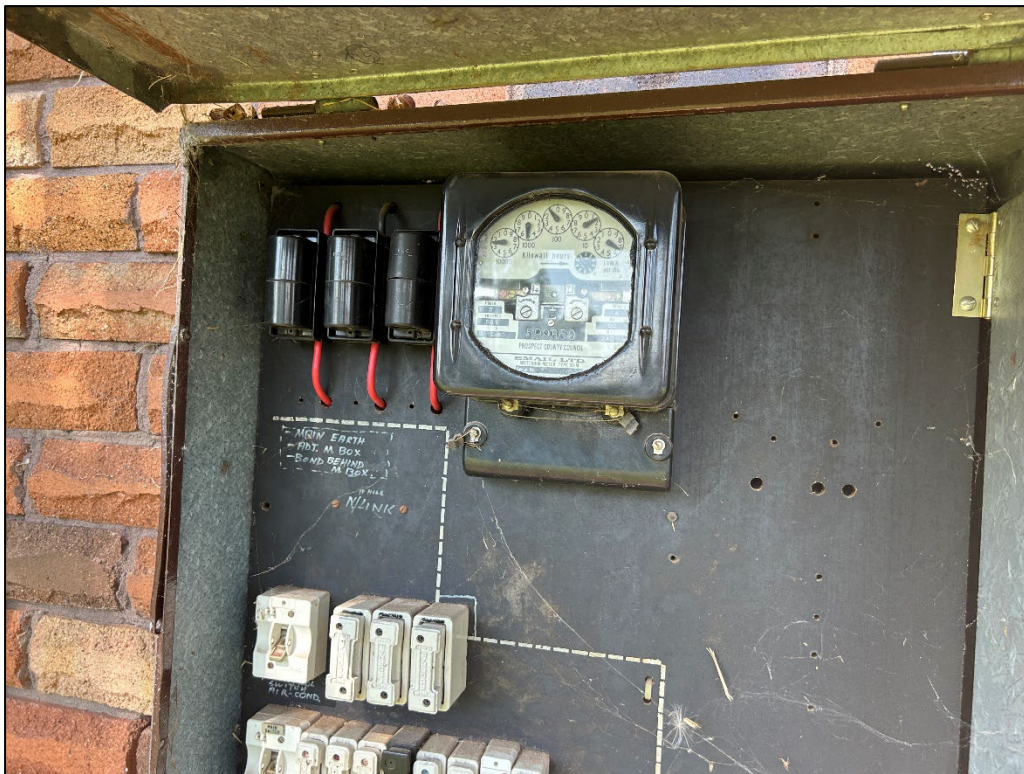
### 5.12 Switchboard

| <b>Site Address:</b> | | <b>173 &amp; 183 Rickard Road, Leppington NSW 2179</b> | | | | | | | | |
|---|---|---|---|---|---|---|---|---|---|---|
| | Switchboard | Electrical board | | 5.12 | Assumed asbestos | Good | 0.5 | Low | P3 | Remove prior to demolition |

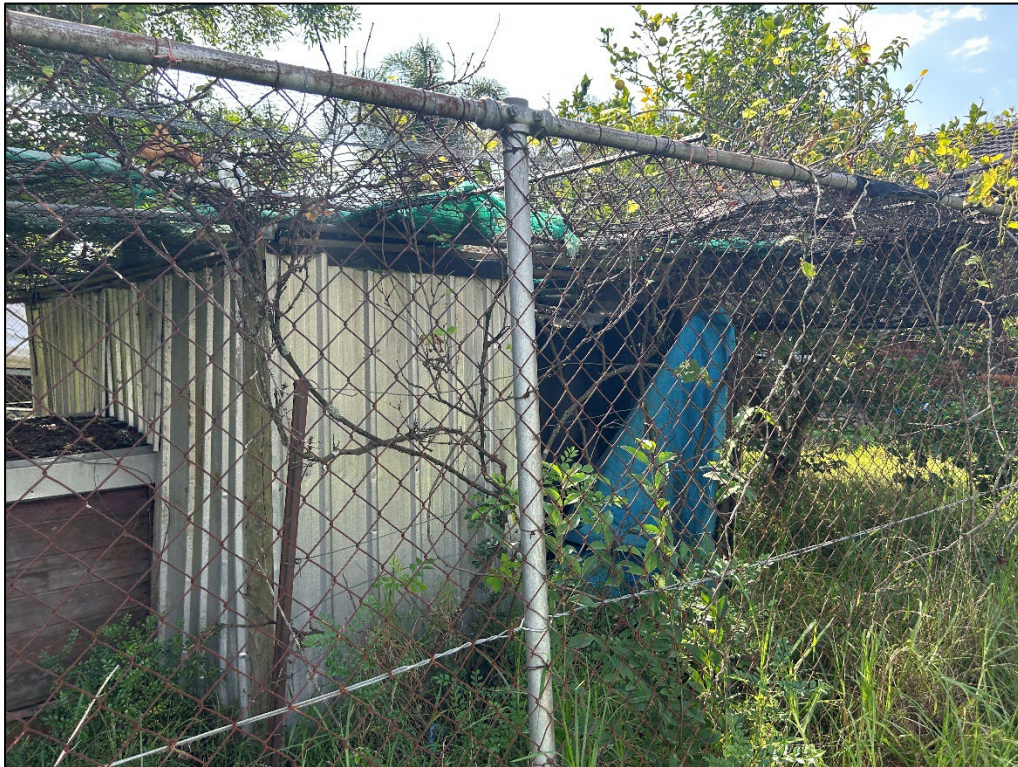
### 5.13 Lining Over Windows

| <b>Site Address:</b> | | <b>173 &amp; 183 Rickard Road, Leppington NSW 2179</b> | | | | | | | | |
|---|---|---|---|---|---|---|---|---|---|---|
| Shed 4 | Cladding and roof | Corrugated metal | | 5.13 | Not asbestos | | | | | |
