Appendix E Architectural heritage report

RE: HERITAGE ADVICE ON NOISE REDUCTION MITIGATION MEASURES
ASSOCIATED WITH WINDSOR BRIDGE REPLACEMENT PROJECT

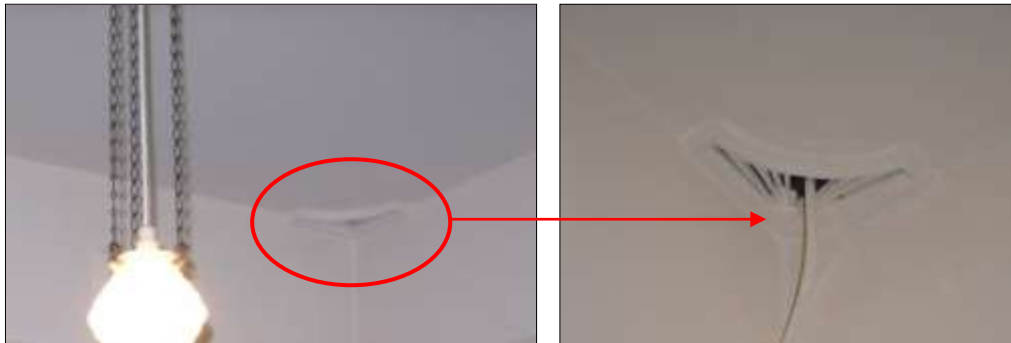
consultant in order to establish the locations for ducting registers. Images of an example of traditional corner ceiling vent, taken by the author from a house in Alexandria, have been provided below for reference. New detailing should not imitate this example but be a simple version of the traditional ceiling vent.

The ventilation system ducts / cabling can be placed within the roof cavity with only minimum required opening for the ducting registers at the agreed points of the ceilings. Consultation should be undertaken with an appropriately qualified heritage

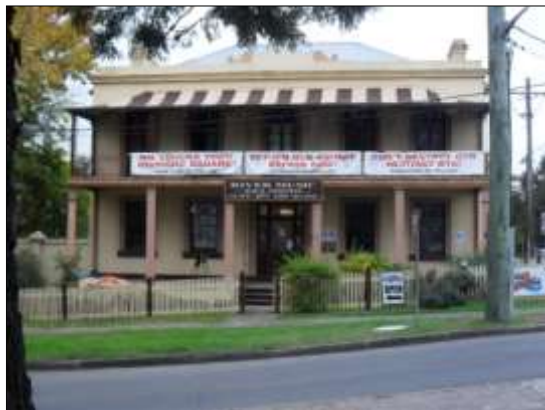
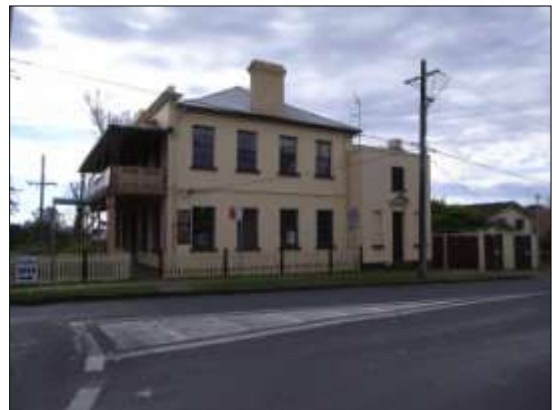
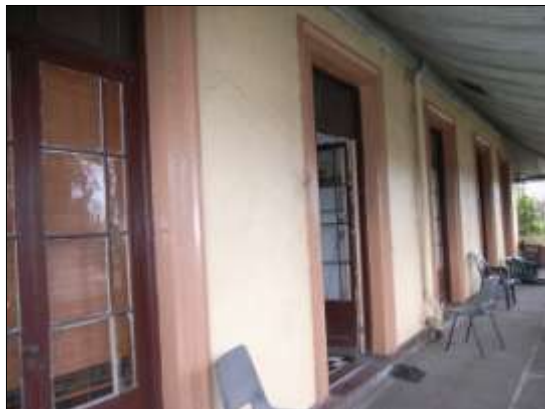
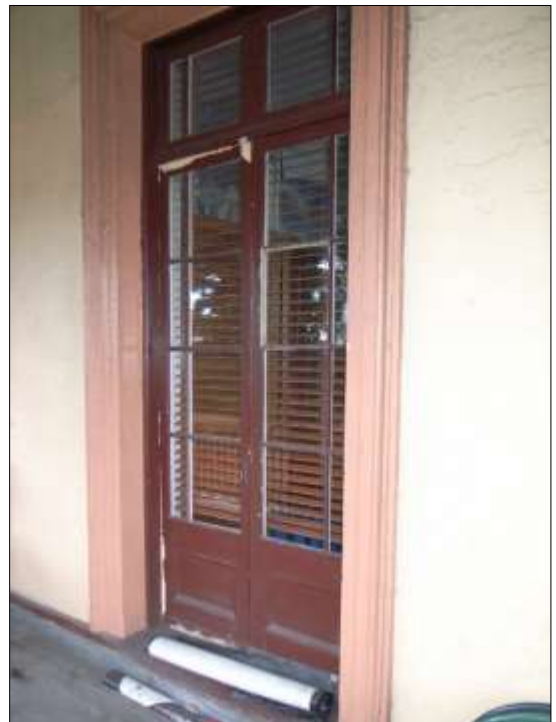
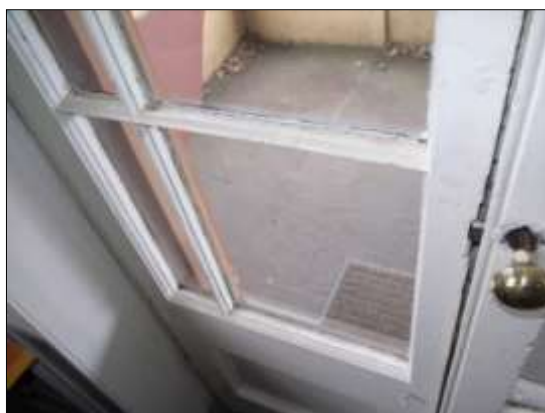
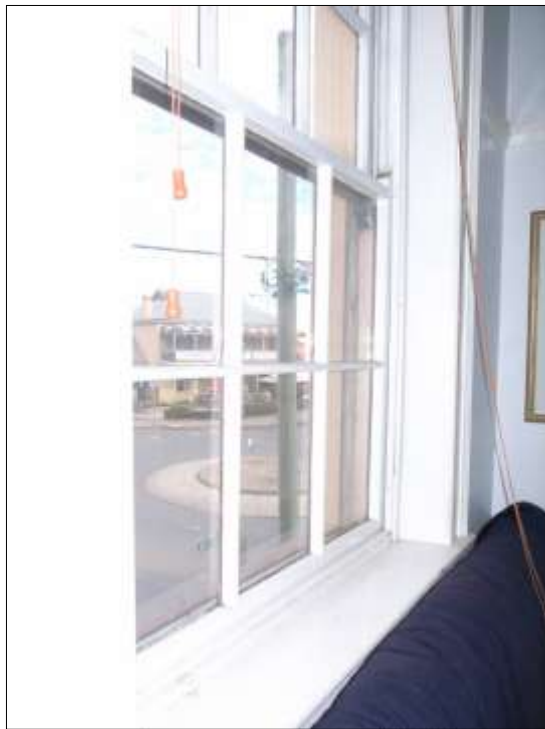
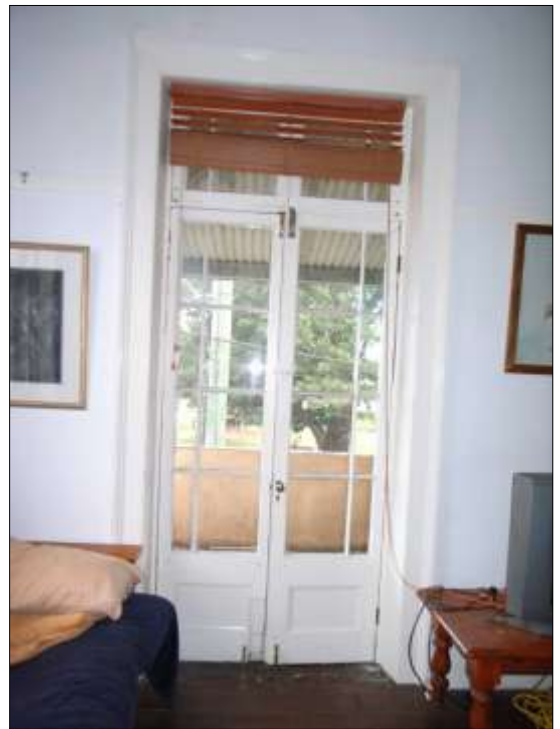
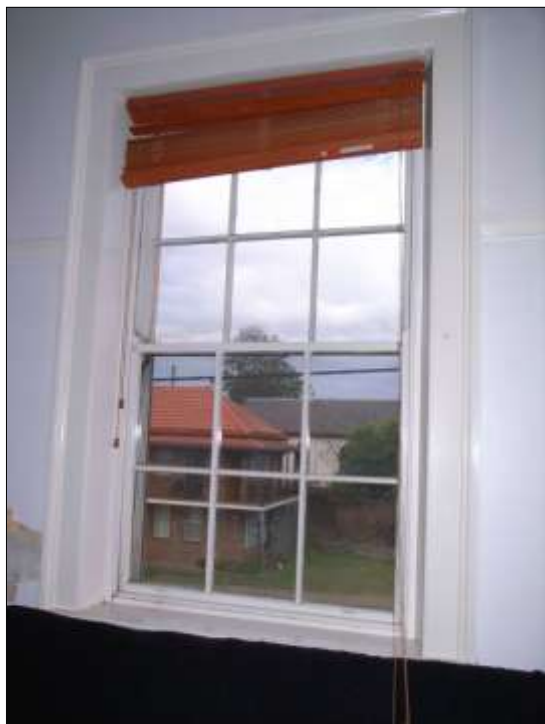
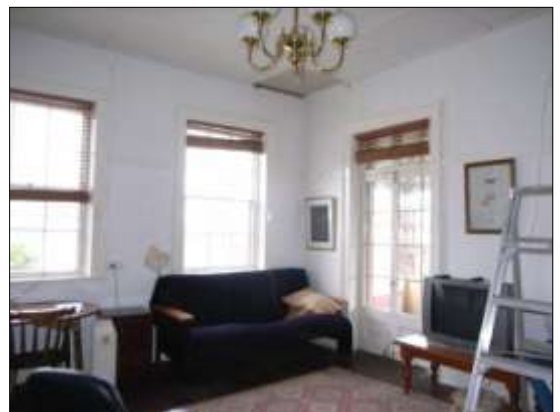
The subject house features highly intact timber door and window joinery to both ground and first floor main street facades. The windows to both levels are timber framed multi-paned double-hung windows with six-pane to each sash. The main street facade windows have deep splayed reveals.

The upper residential part of the premises features five (5) French doors opening onto the front timber balcony from each room facing Bridge Street. Each room on the upper level is rented to individual tenants and with the exception of the corner room the remainder of the rooms on bridge Street facade rely only on the French doors for ventilation and daylight. Therefore mitigation measures need to consider this constraint and allow for easy operation of the doors. The French doors feature four glazed panels with margin glazing to each door leaf and a fanlight above also with margin glazing. The majority of the existing glazing is original.

Similarly, the upper floor rooms facing George Street feature four (4) windows (2 to each room). All windows are operable and should be retained in operational condition. The profile of the existing glazing bars of the timber joinery (both French doors and windows) is very fine with a deep section that would allow insertion of a second custom made frame.

Views of the existing French doors and windows on the upper level of 10 Bridge Street, Windsor including external street views

Given consideration to the streetscape and internal presentation and importance of the existing joinery, it is thought that custom made individual glazed timber framed panels (Option 4 for windows and Option 3 for French doors) will be the most appropriate treatment. The custom made frames will create double glazing with air cavity sealed and fitted without any damage to the existing original glazing panels. The appearance of the joinery will be the same from both inside and outside thus aesthetic significance of the heritage item will not be affected. Furthermore the new frames can be removed without damage to the existing fabric if require in the feature.

Based on the above discussion the custom made individual glazed panels option will be our preferred option. It is recommended that an experienced carpenter with traditional joinery expertise be engaged to undertake a detailed inspection and measurement of the subject window and French doors joinery for the design of the most appropriate timber frame profile and sealant requirements to fit without any need for screw/nail fixing.
