Appendix C – Technical reports on the condition of existing Windsor Bridge

**B 415 Windsor Bridge
Follow-up Inspection
15.6.2011**

U/W Bridge Inspection

B 415 Windsor Bridge over Hawkesbury River

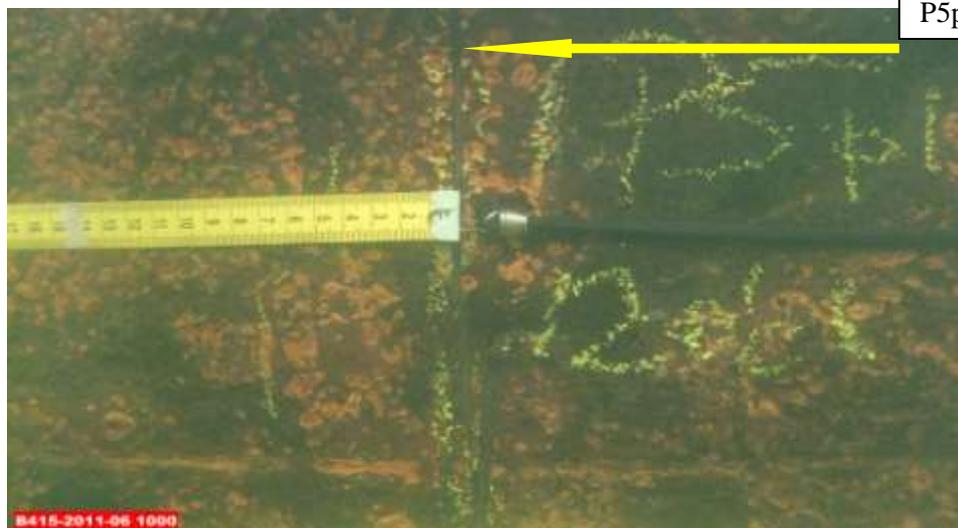
Start of reference tape measure, here P5p2, 12o'clock with reference grind

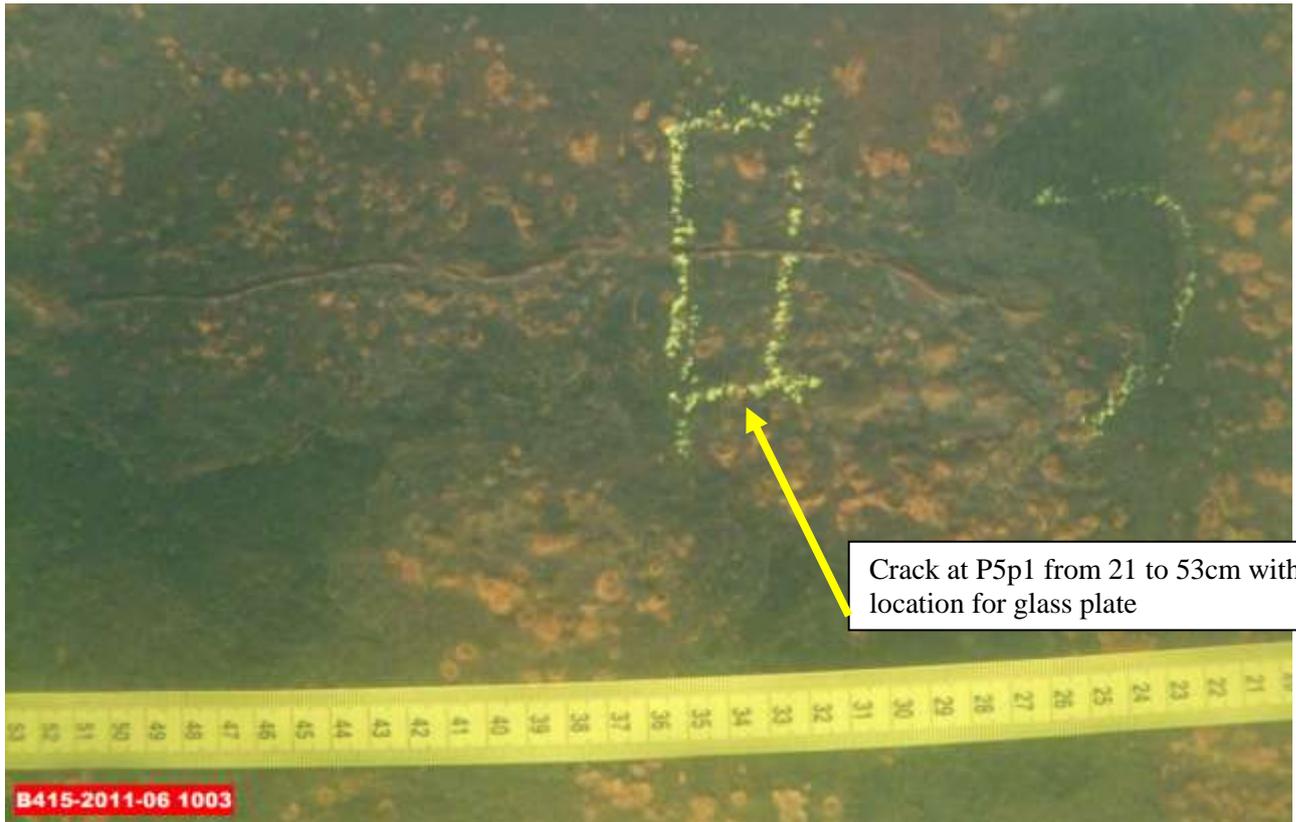
Crack at P5p1 from 21 to 53cm with location for glass plate

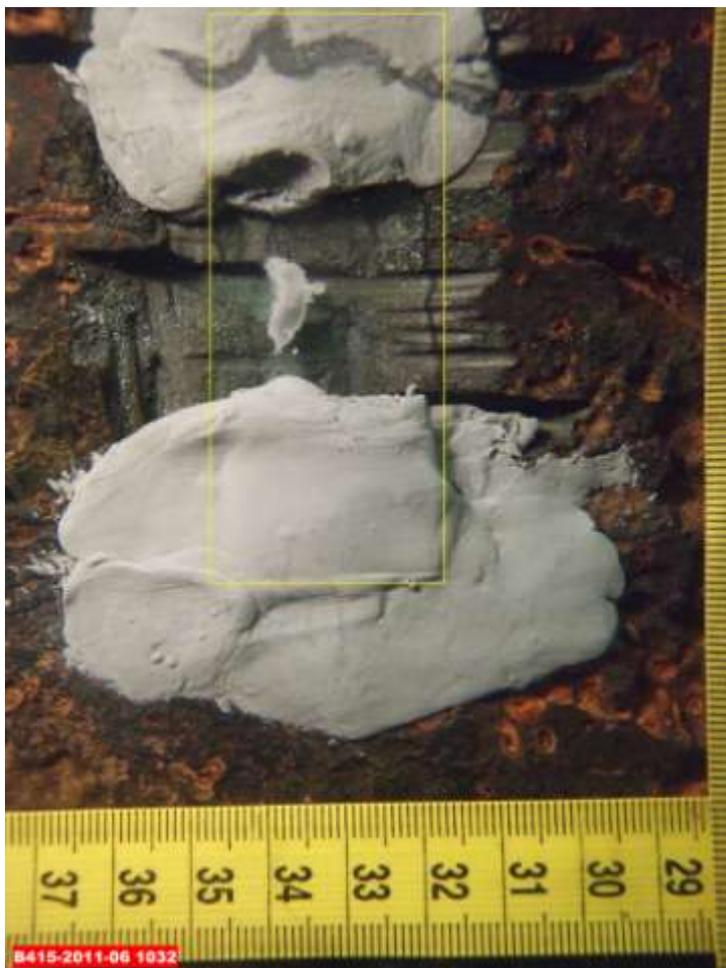
Glass plate on P5p1 at above location

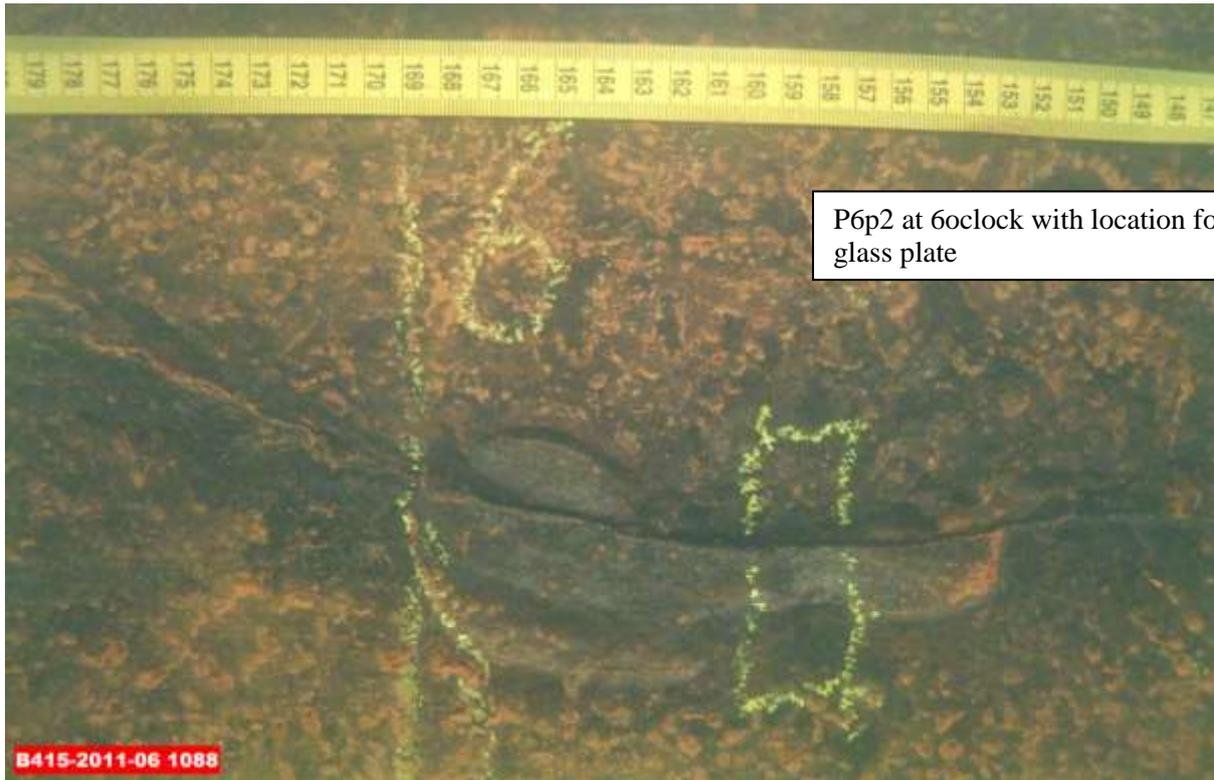
P6p2 at 6oclock with location for glass plate

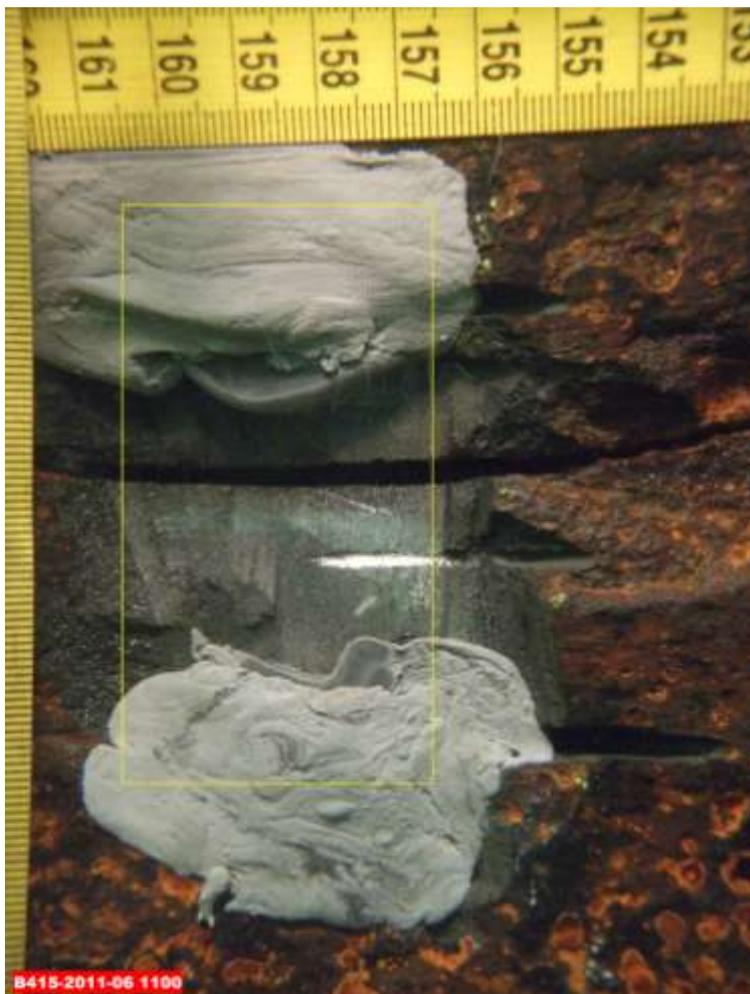
P6p2 with glass plate installed near 6o'clock

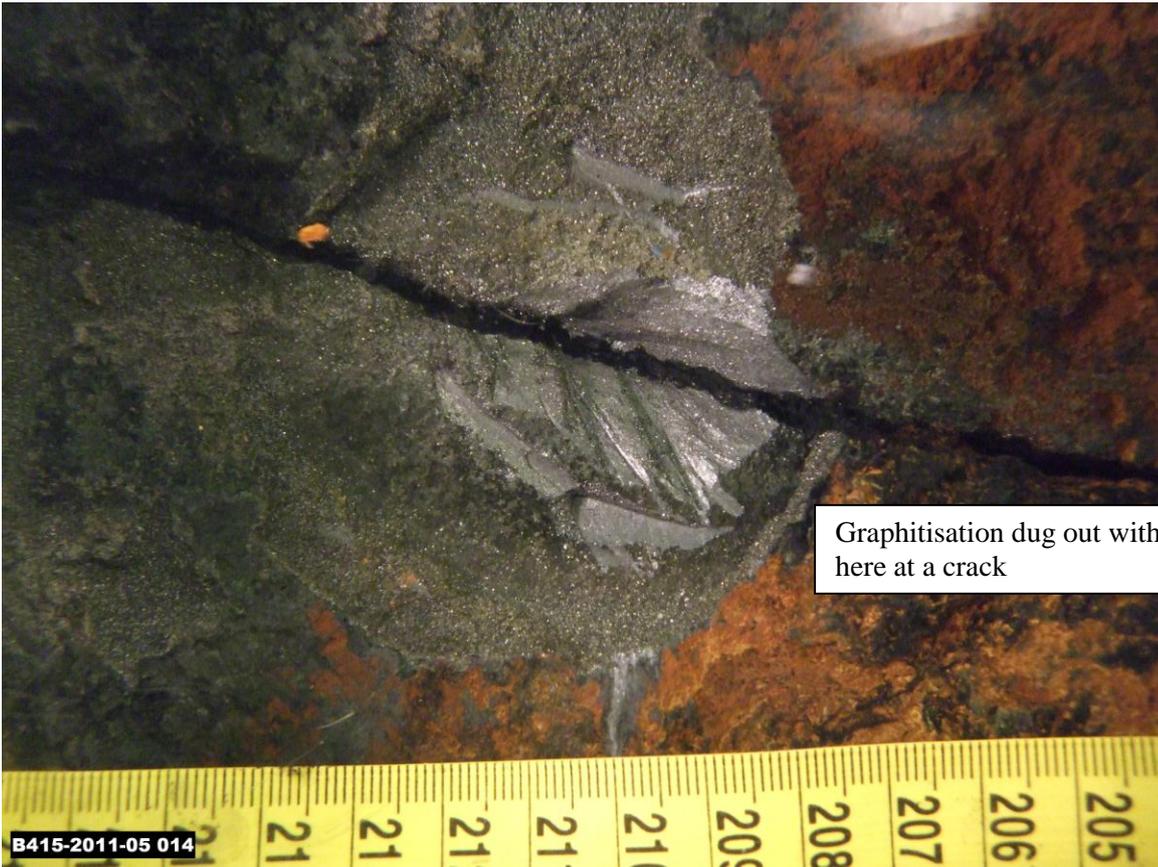
Graphitisation dug out with sharp edge, here at a crack

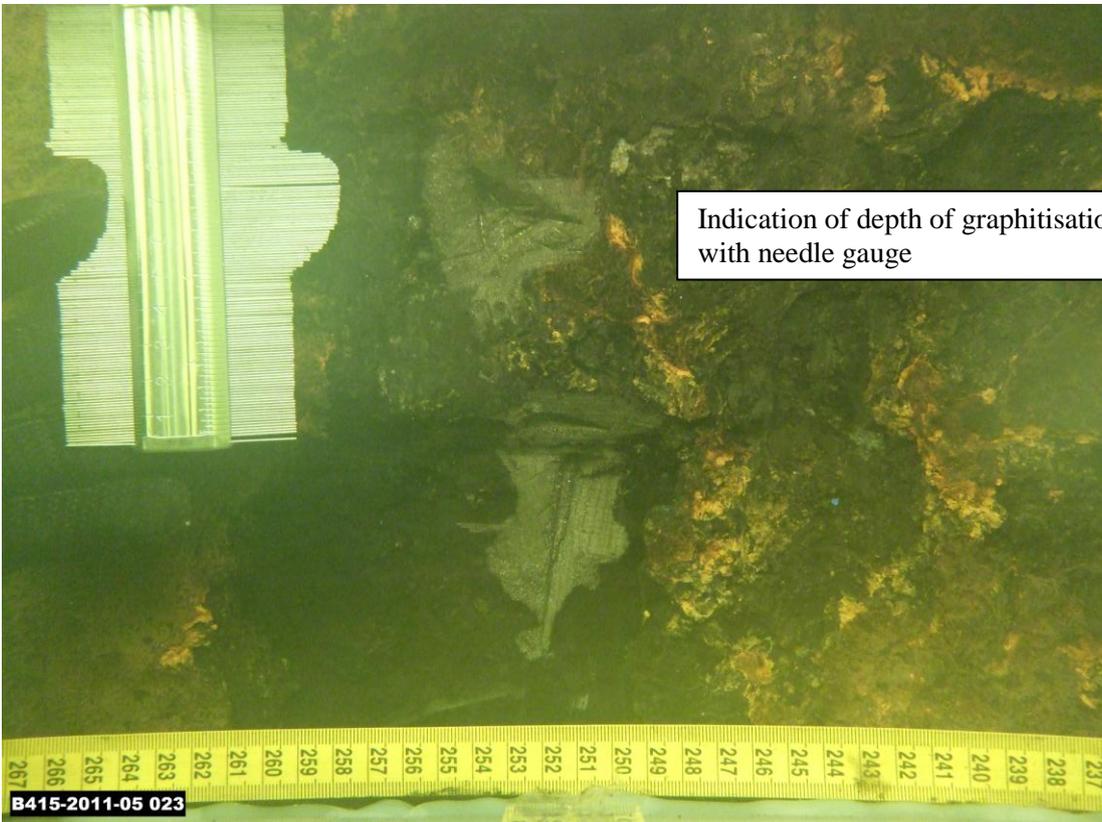
Indication of depth of graphitisation with needle gauge

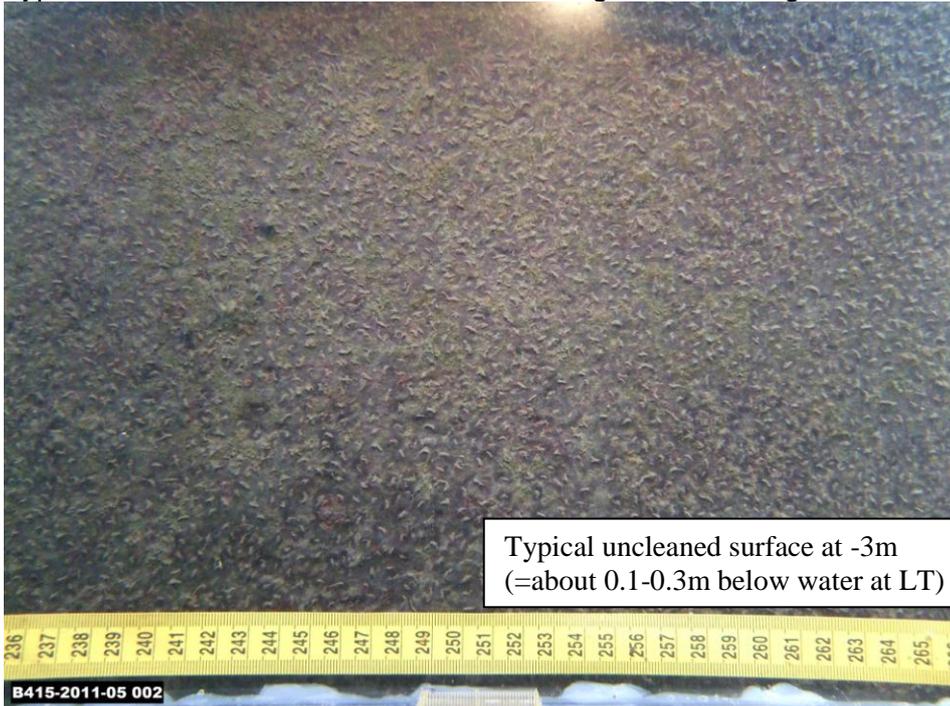
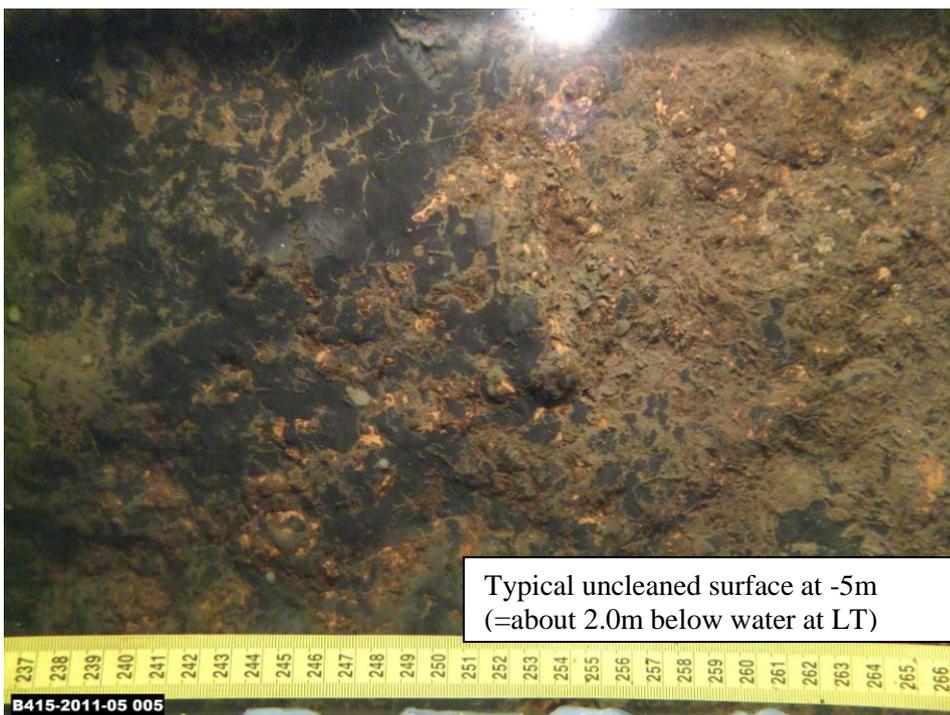
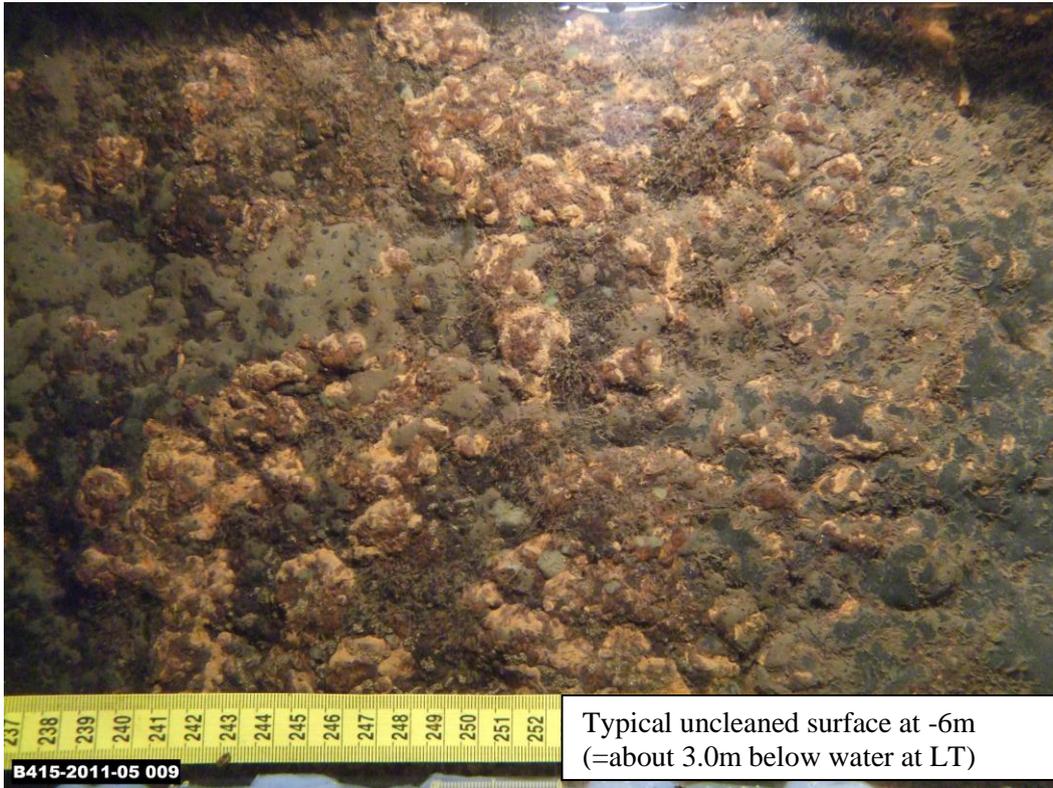
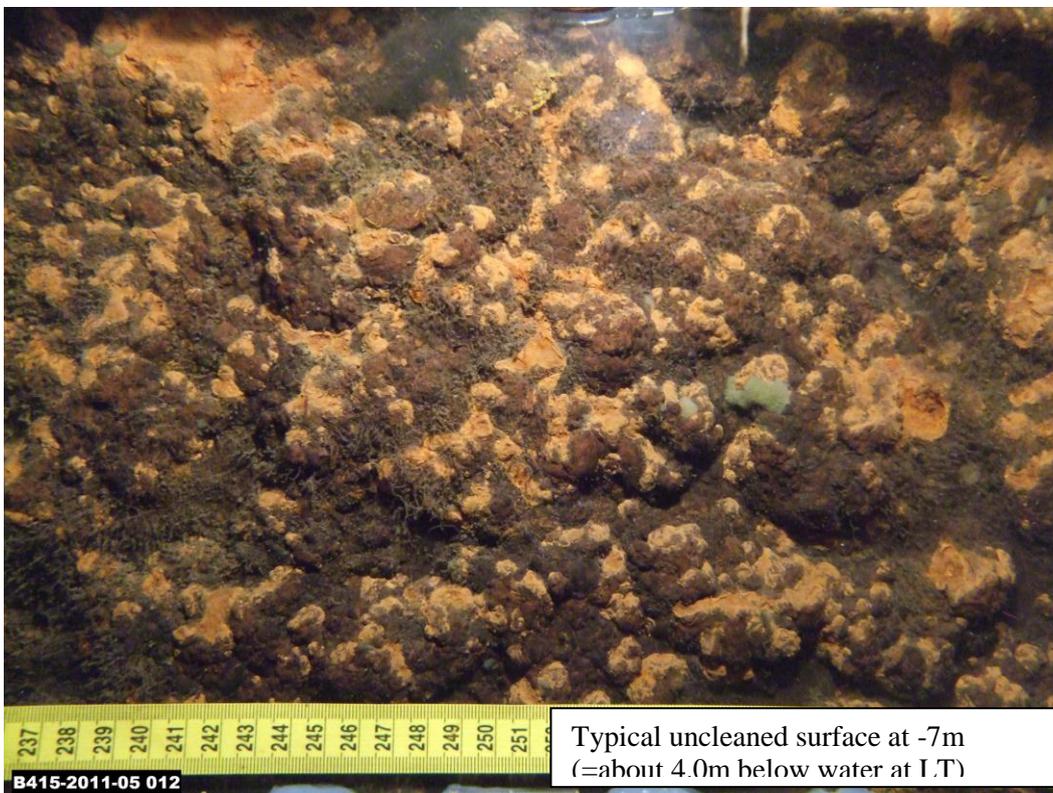
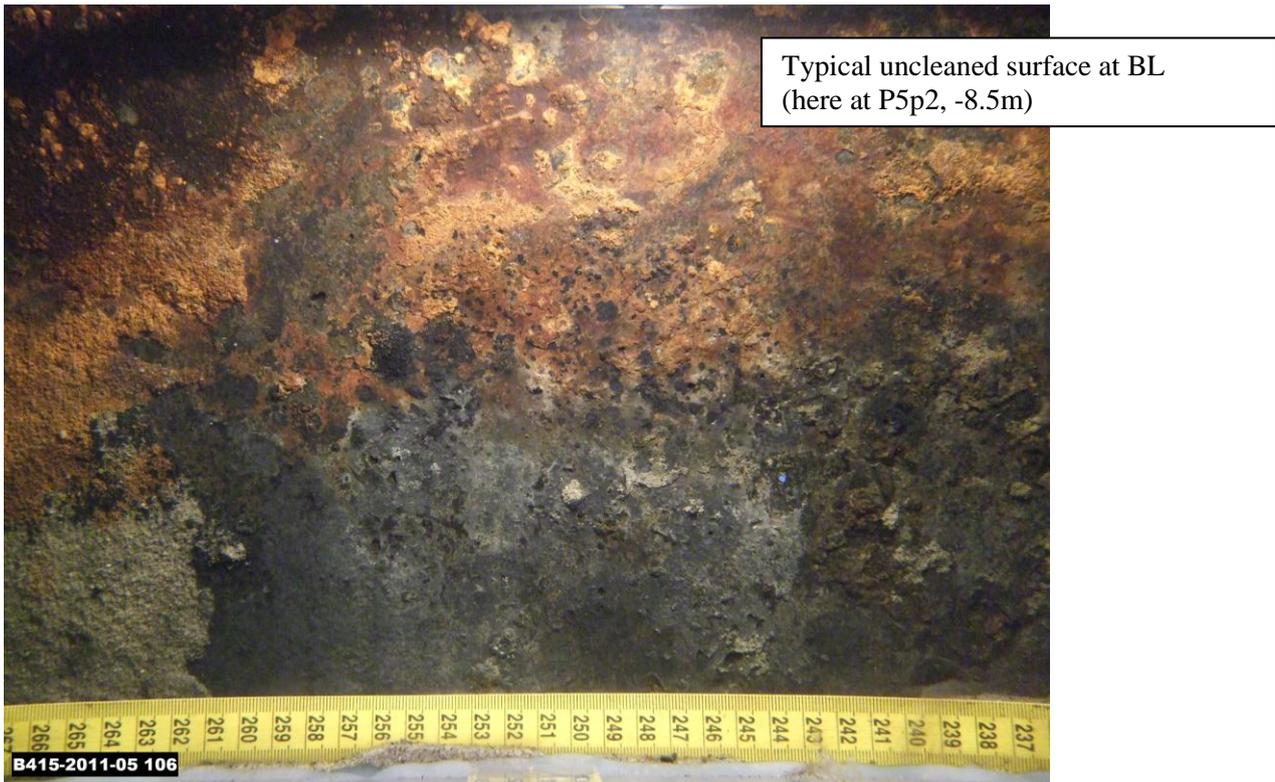
Typical uncleaned surface, note the different growth/noduling at various depths:

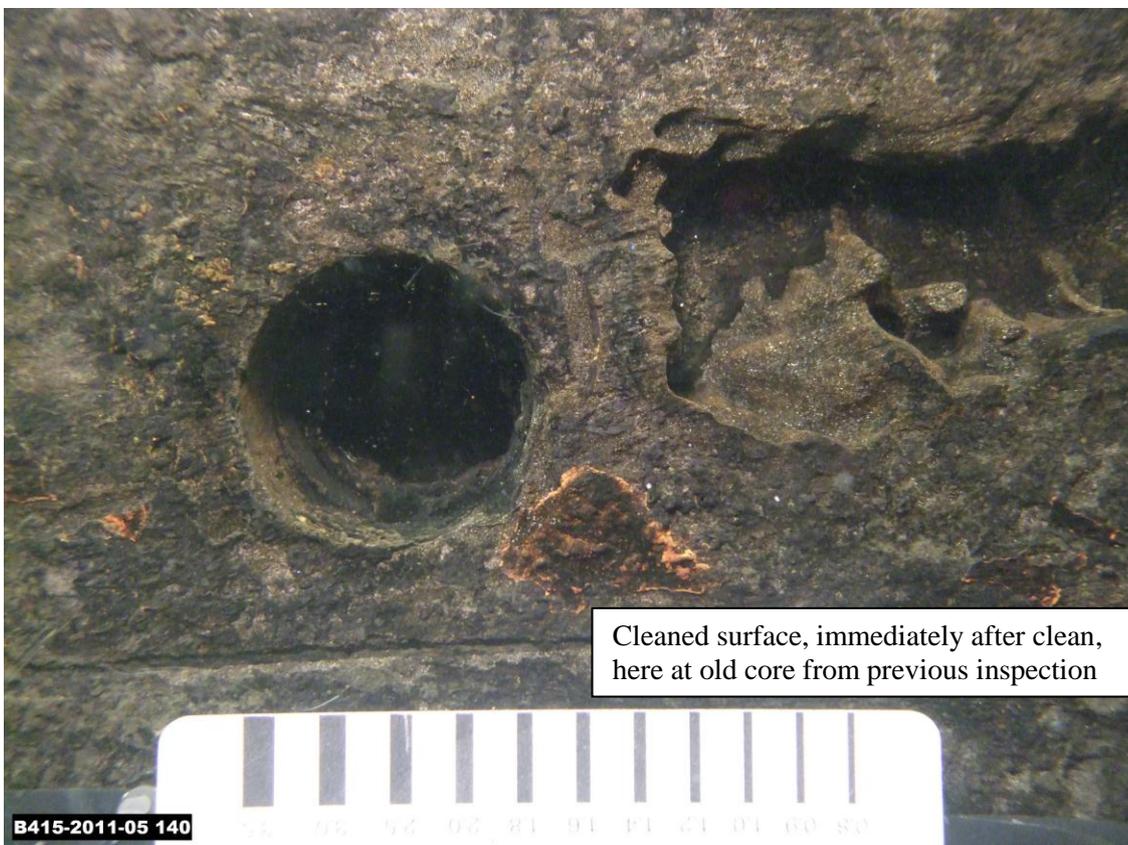
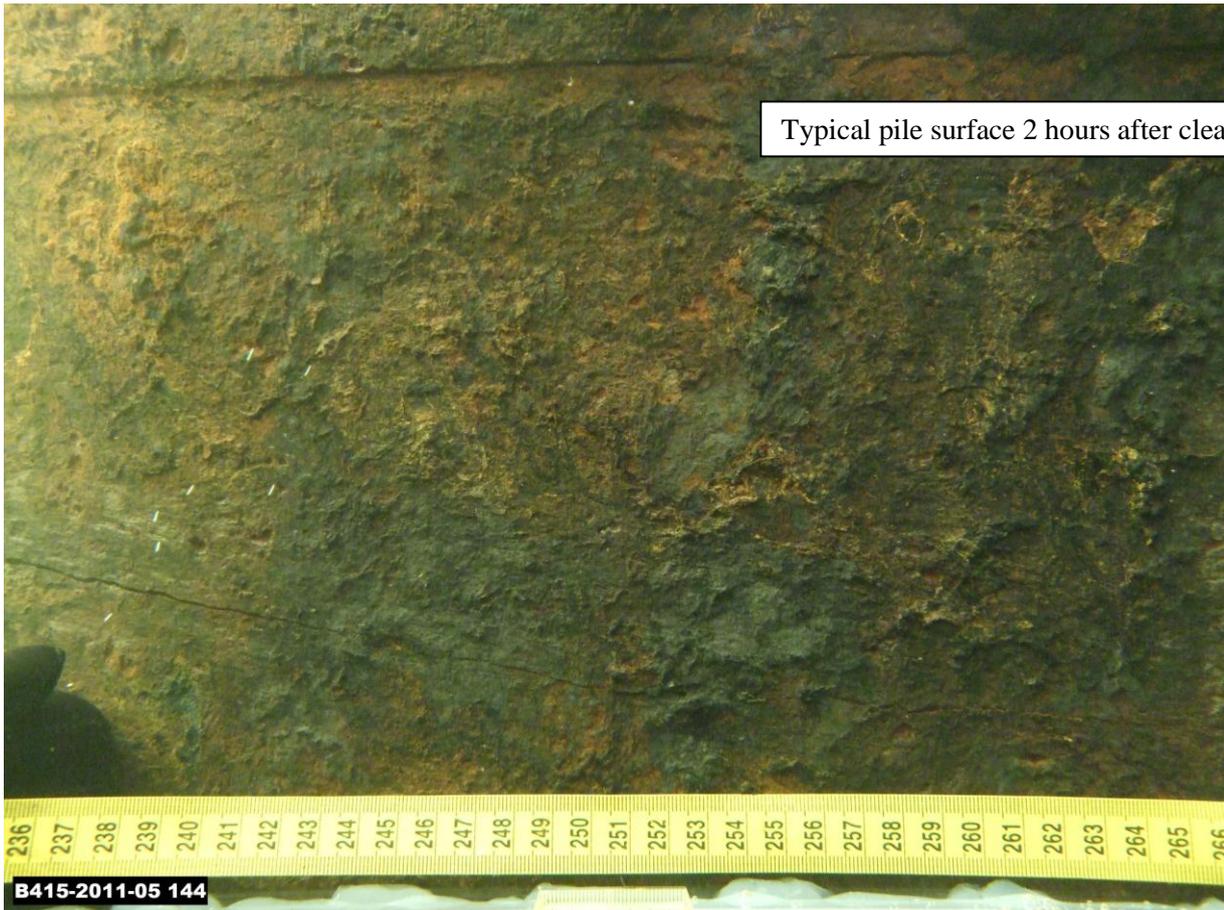
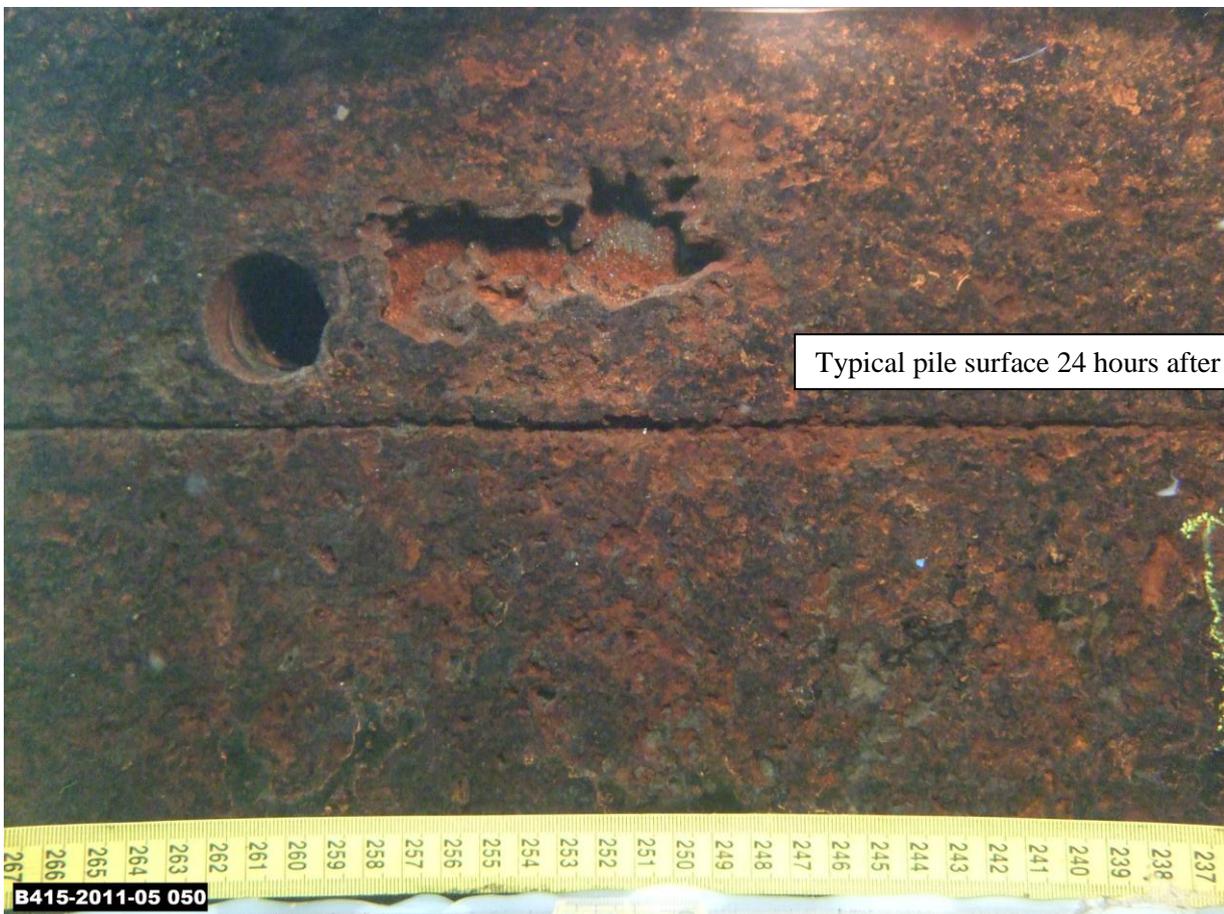
Once the pile surface was pressure cleaned, a black, clean graphitised surface presented. This surface only stayed black for a couple of hours before oxydising and appearing completely rusty 24 hours later:

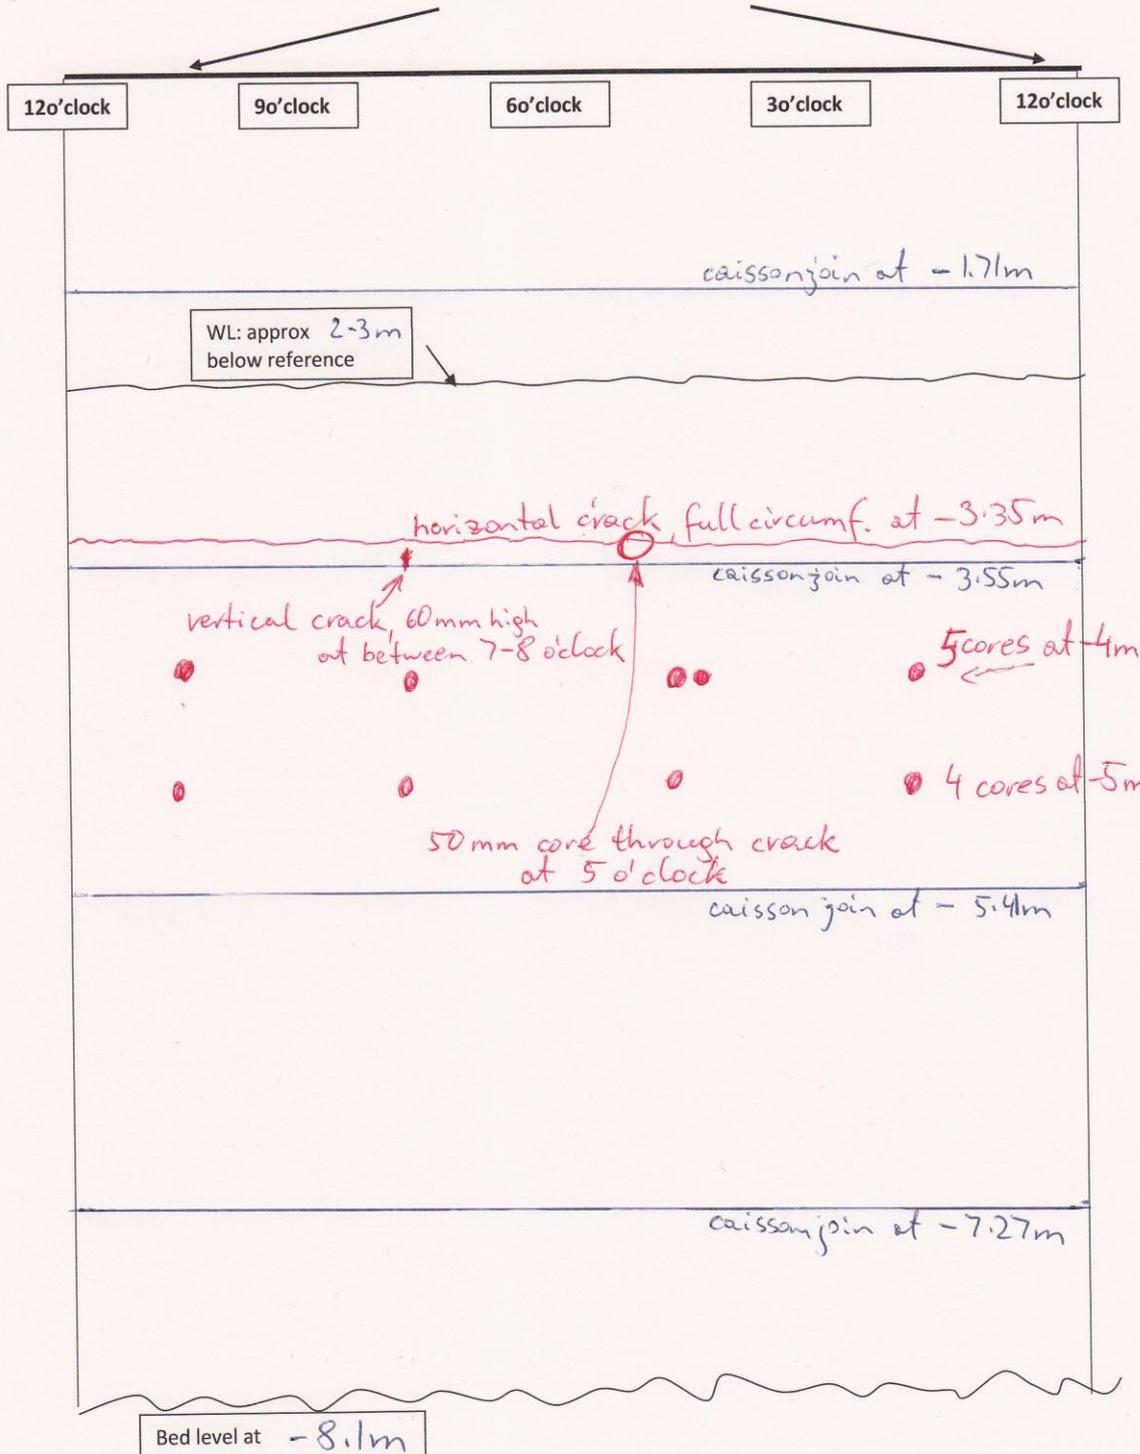
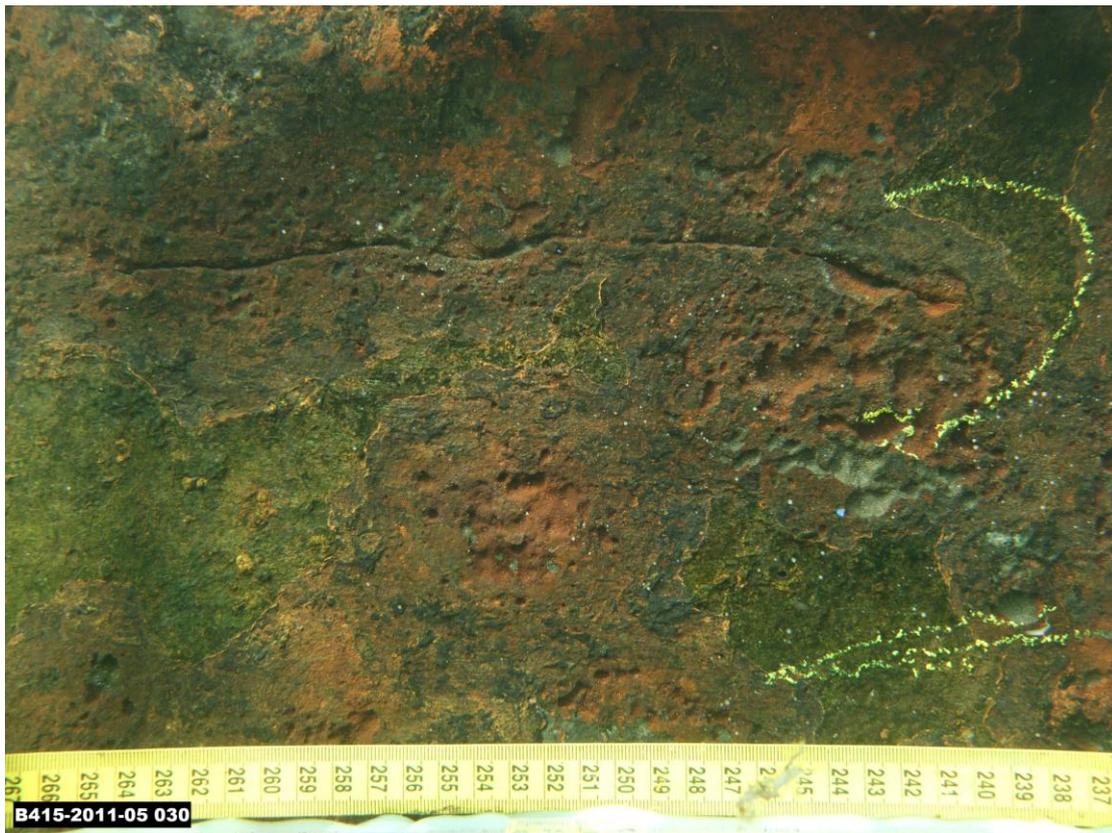
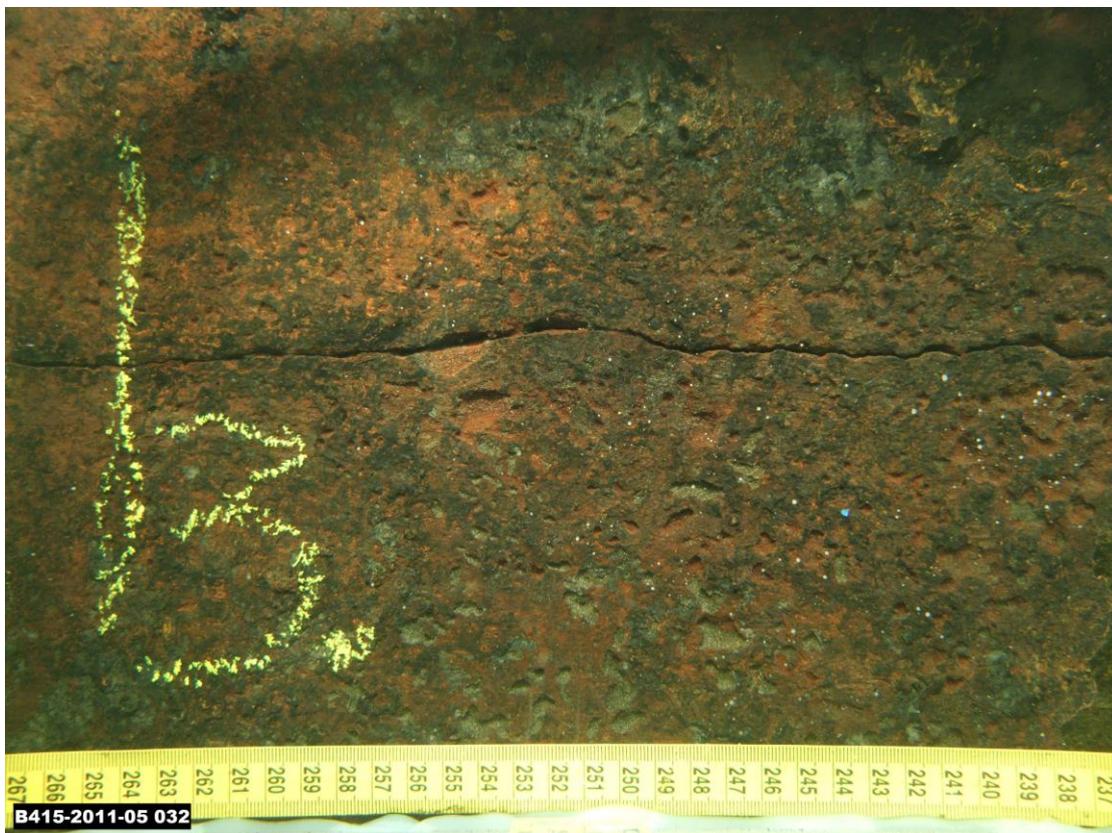
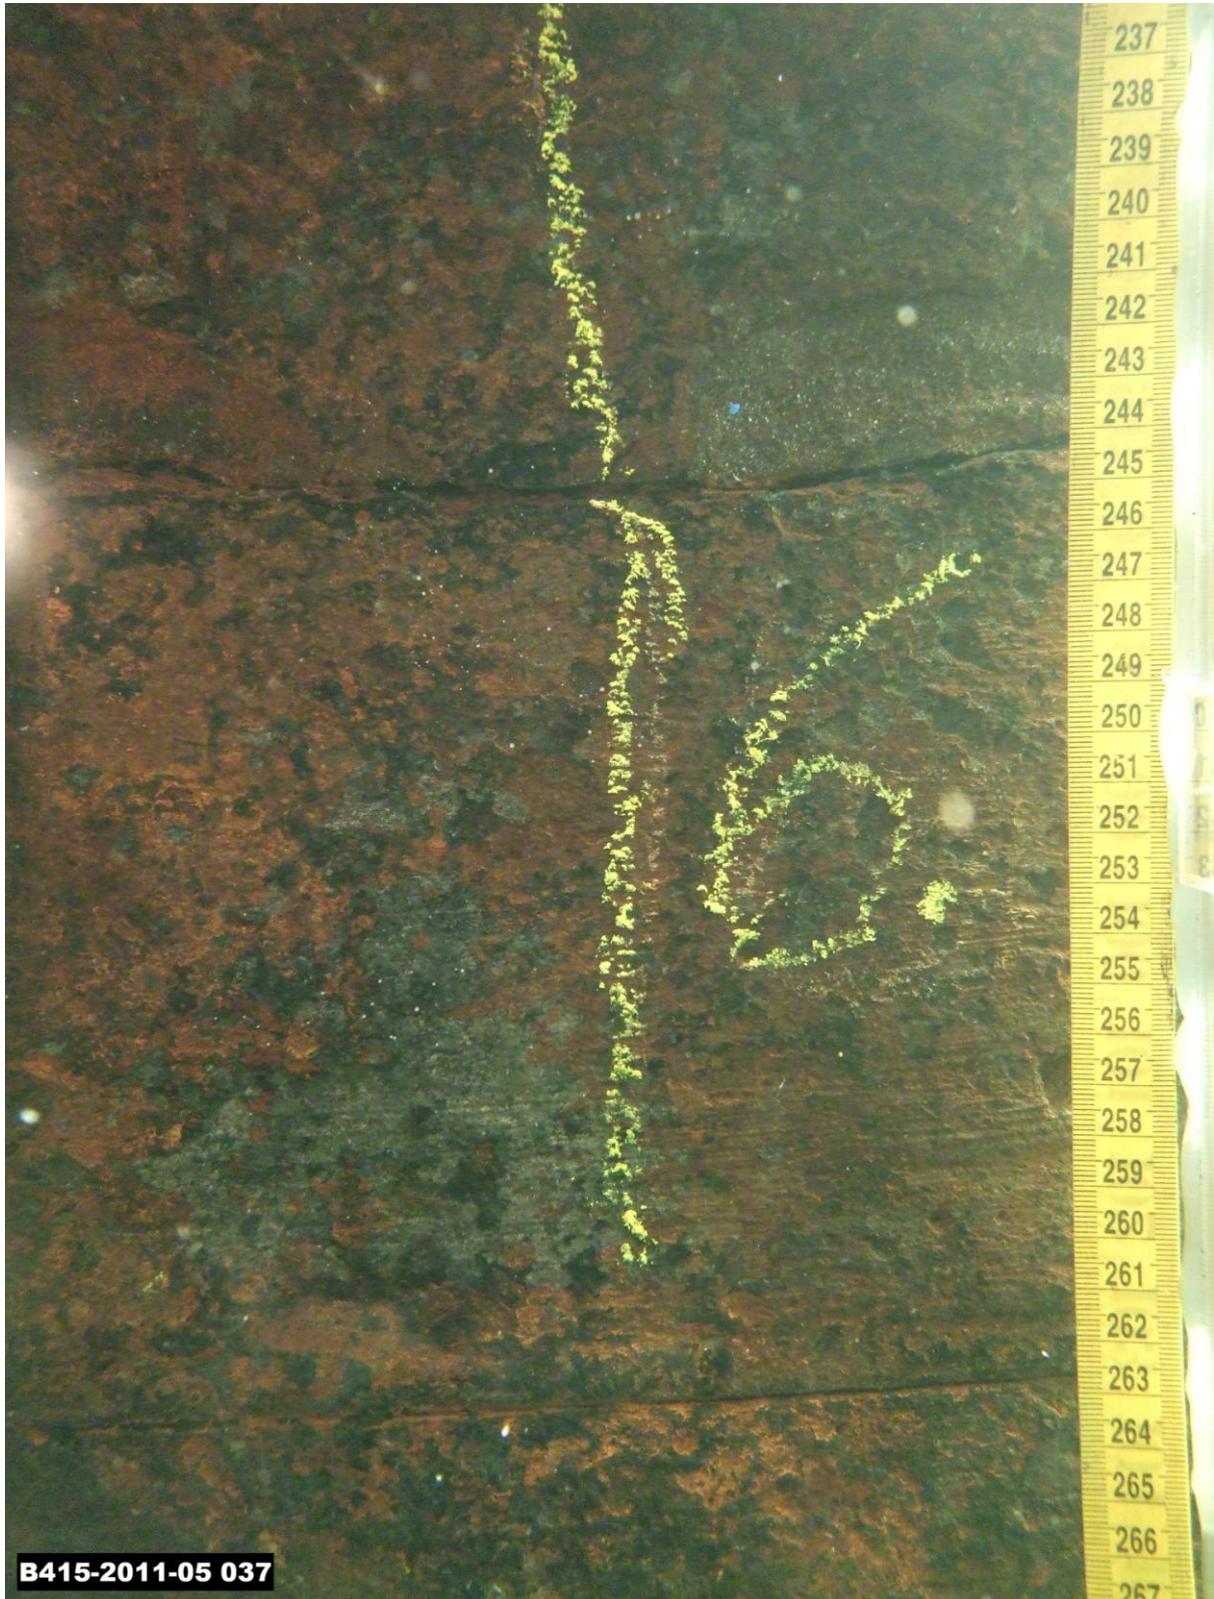
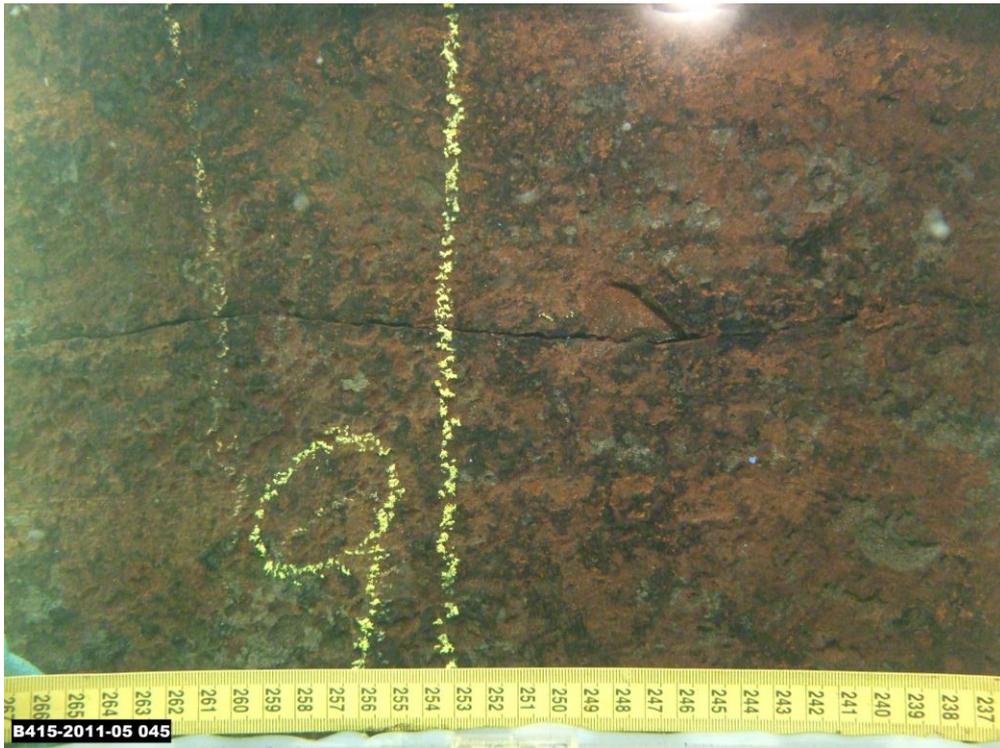
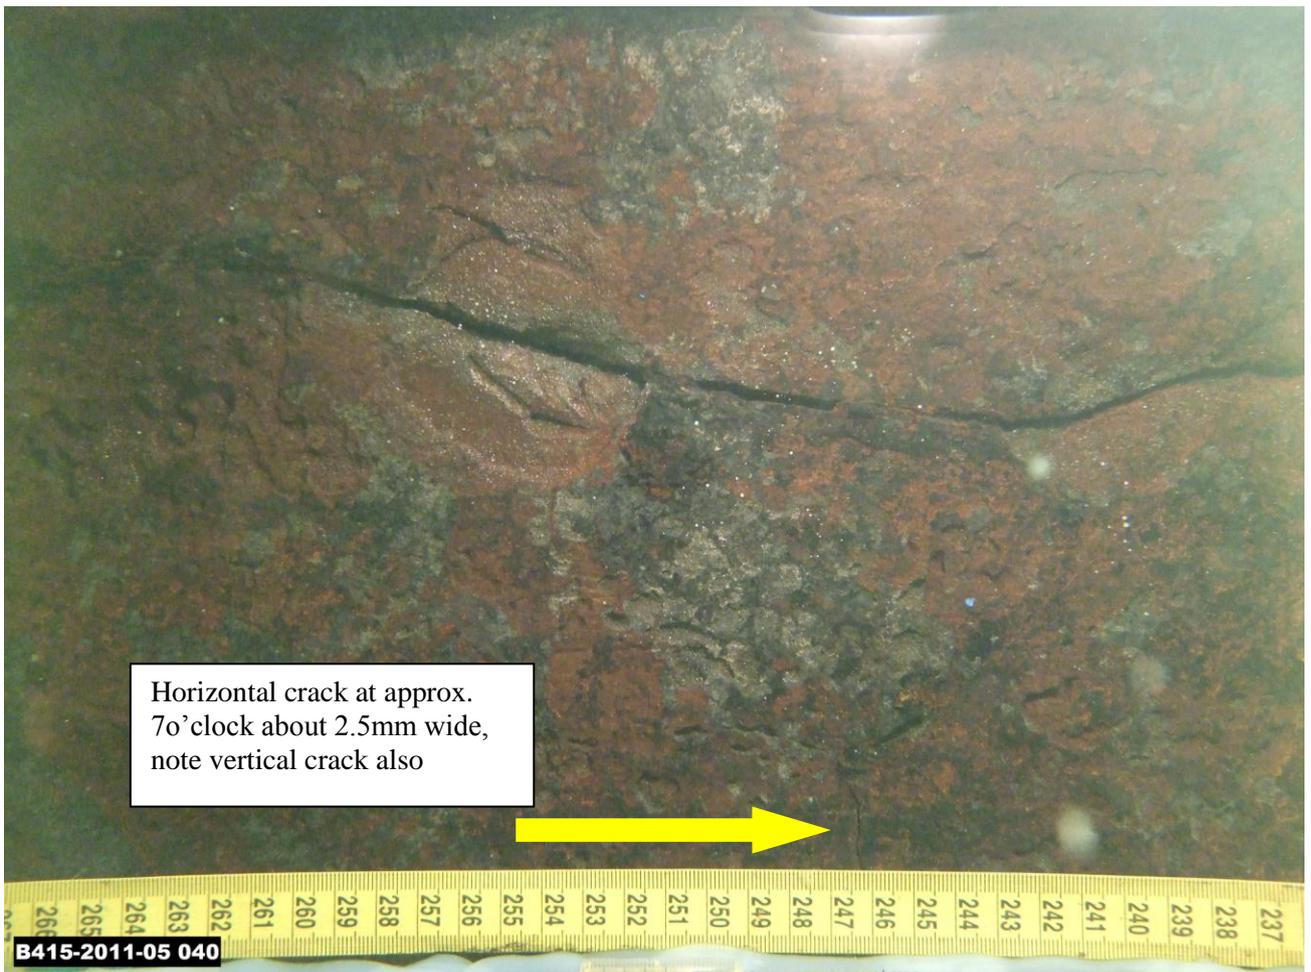
PILE: 1 (US)

Condition State	Estimated quantity in Condition State	Remarks
1		
2		
3	14m ²	Graphitisation over entire pile surface underwater, up to 20mm thick,
4	3m ²	Horizontal crack all round at about -3.35m
Total

Depth below reference (m)	Description of Defect or Condition	Condition State
	Caisson joins at: -1.71m, -3.55m, -5.41m, -7.25m	
	Entire underwater surface of pile is showing graphitisation. On probing, thickness of graphitised layer varies between 5 and 20mm	3
	10 core samples taken at locations shown next page	
2.0		
2.5		
3.0		
3.5	Horizontal crack all round about 200-250mm above caisson join	4
4.0		
4.5		
5.0		
5.5		
6.0		
6.5		
7.0		
7.5		
8.0	Bed level at pile: -8.1m
