Appendix C – Technical reports on the condition of existing Windsor Bridge

**B 415 Windsor Bridge
Follow-up Inspection
15.6.2011**

U/W Bridge Inspection

B 415 Windsor Bridge over Hawkesbury River

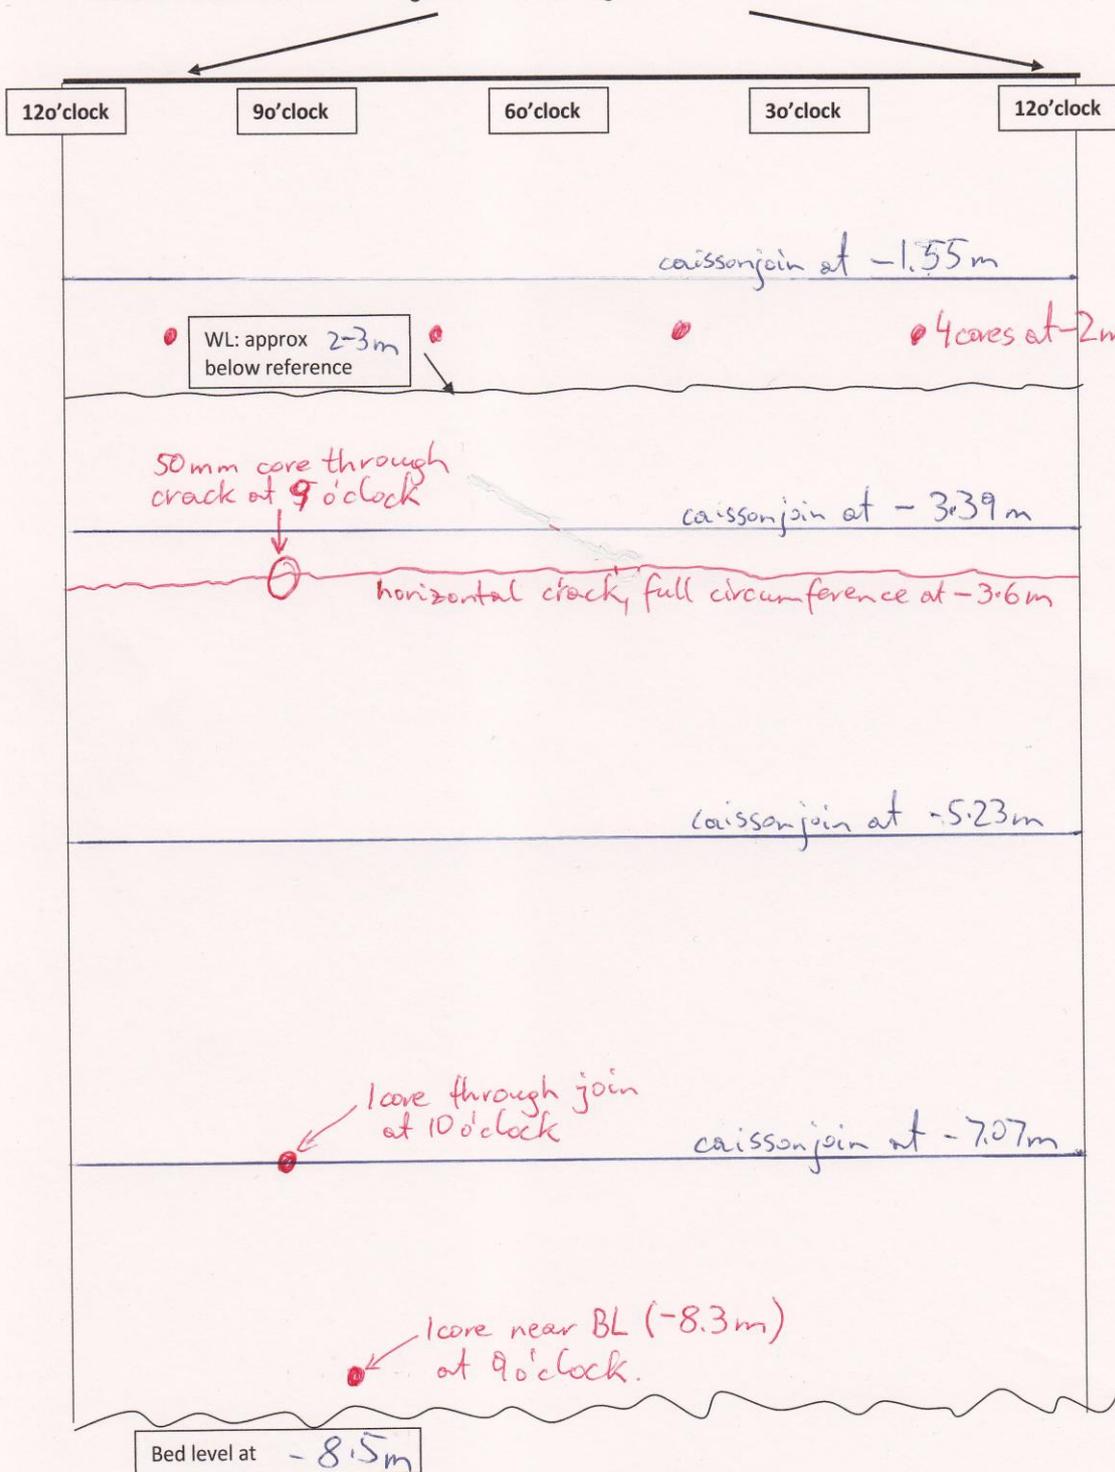
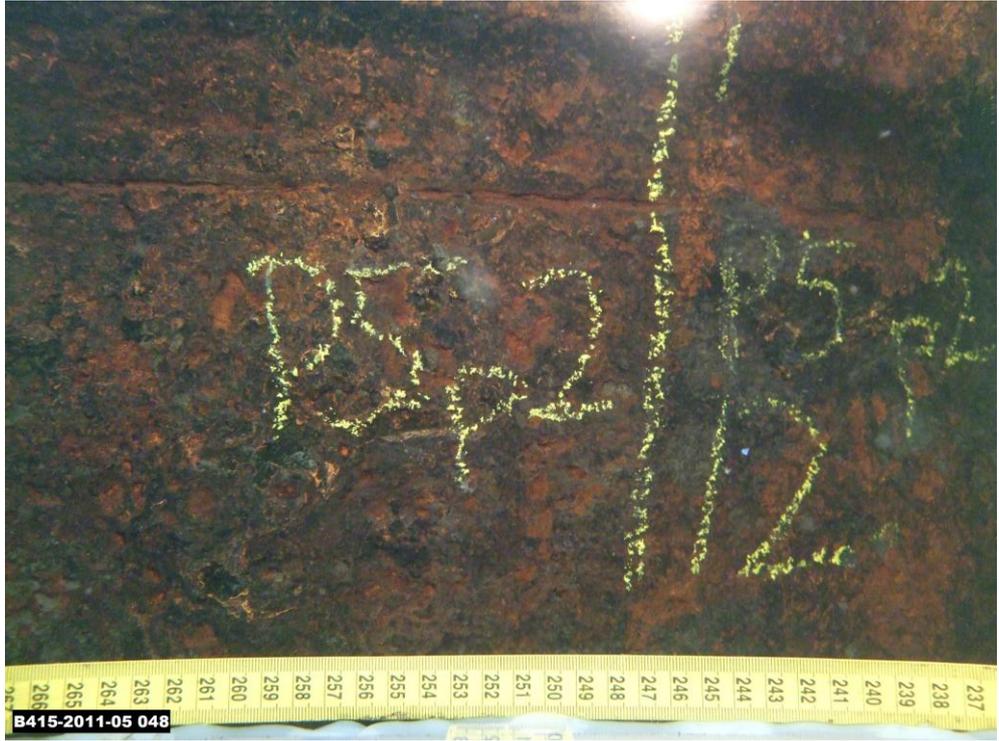
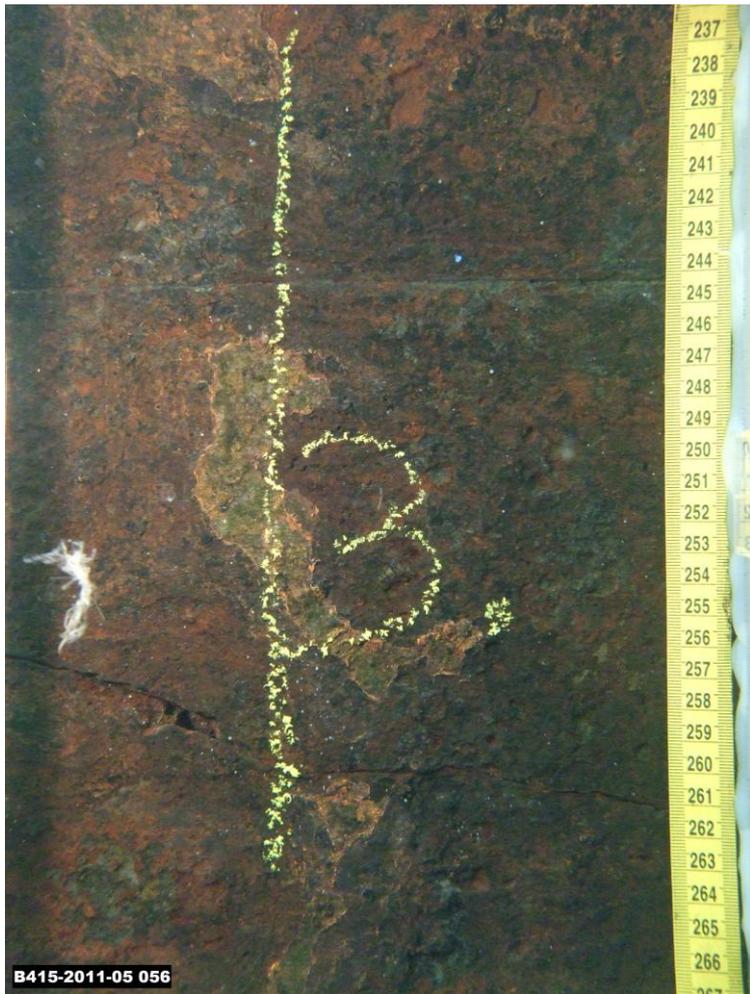
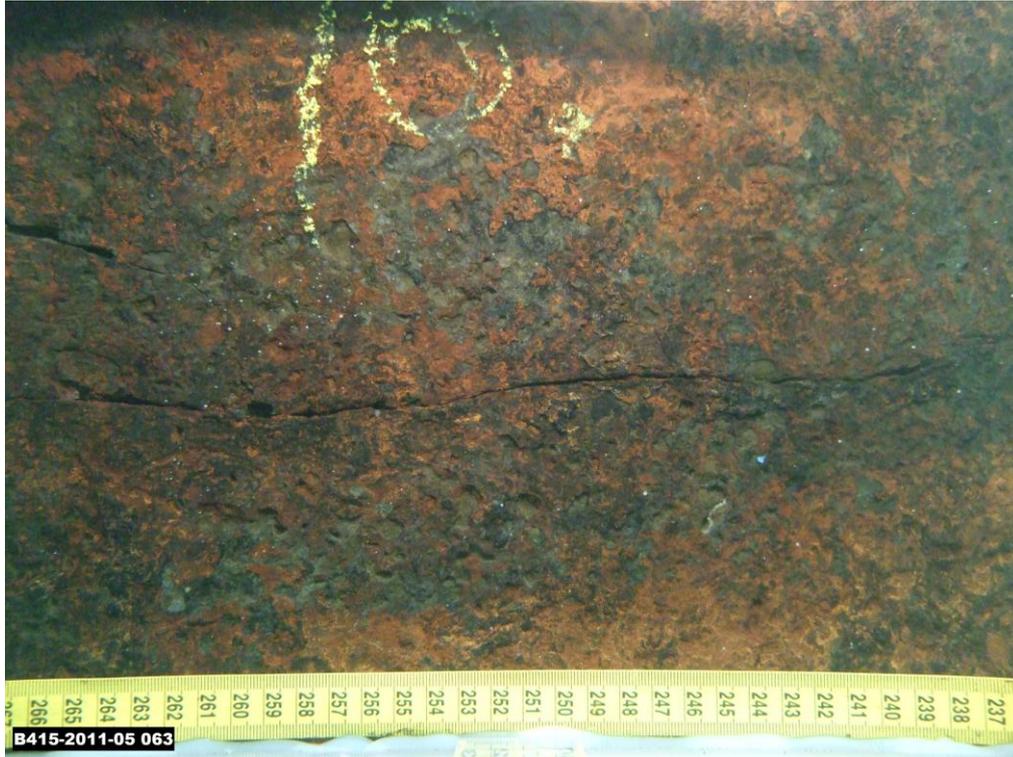
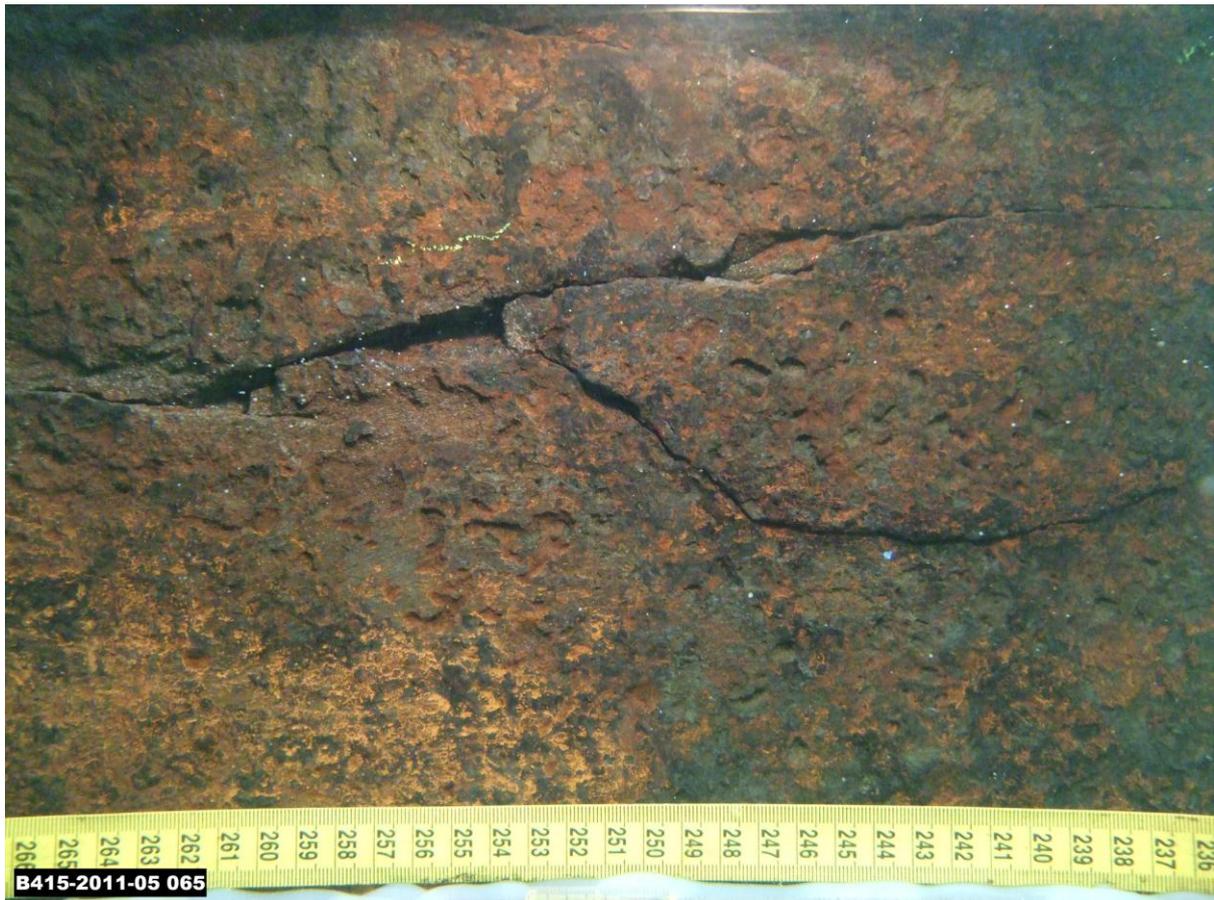
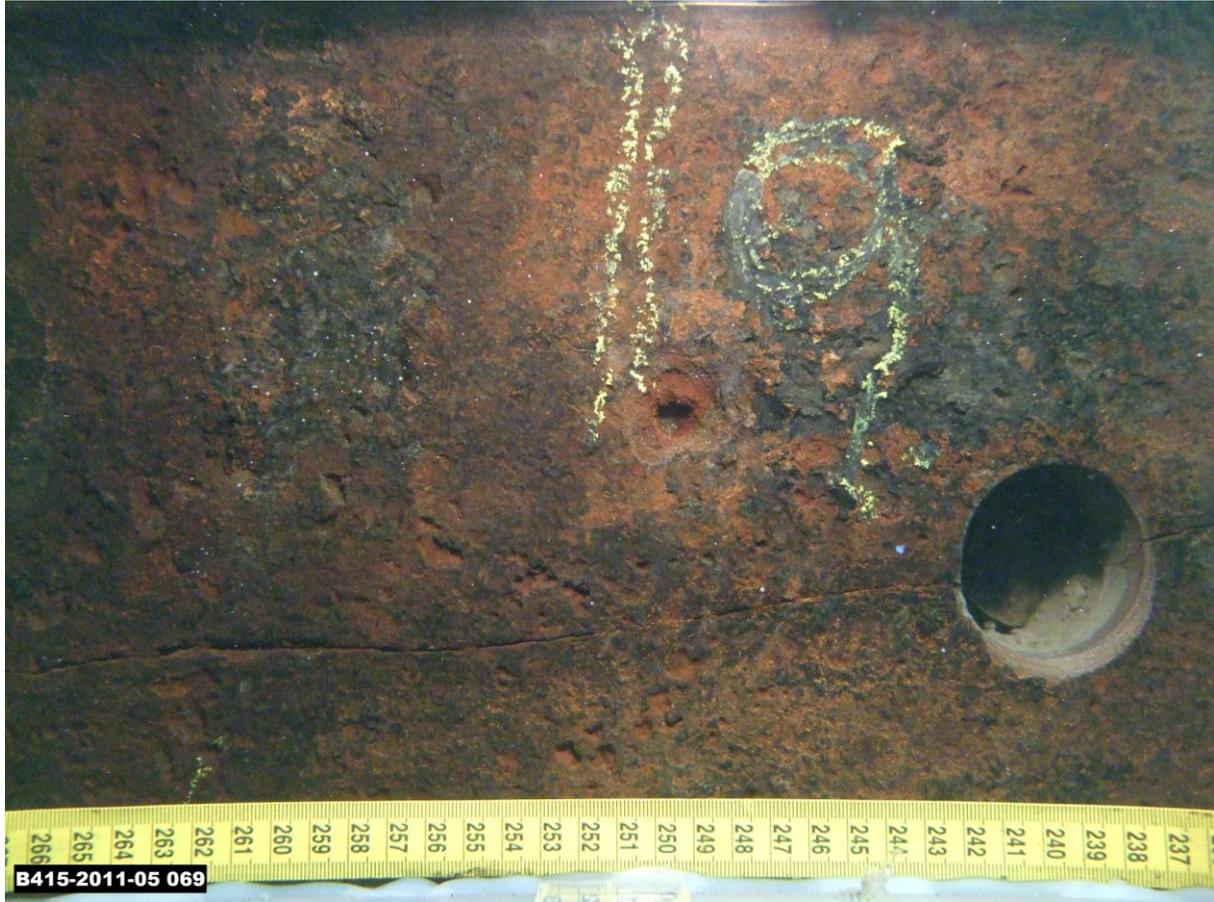
PILE: 2 (DS)

Condition State	Estimated quantity in Condition State	Remarks
1		
2		
3	15m ²	Graphitisation over entire pile surface underwater, up to 20mm thick,
4	3m ²	Horizontal crack all round at about -3.6m
Total

Depth below reference (m)	Description of Defect or Condition	Condition State
	Caisson joins at: -1.55m, -3.39m, -5.23m, -7.07m	
	Entire underwater surface of pile is showing graphitisation. On probing, thickness of graphitised layer varies between 5 and 20mm	3
1.5	7 core samples taken at locations shown next page	
2.0		
2.5		
3.0		
3.5	Horizontal crack all round about 200-250mm below caisson join at about -3.6m	4
4.0		
4.5		
5.0		
5.5		
6.0		
6.5		
7.0		
7.5		
8.0	Bed level at pile: -8.5m

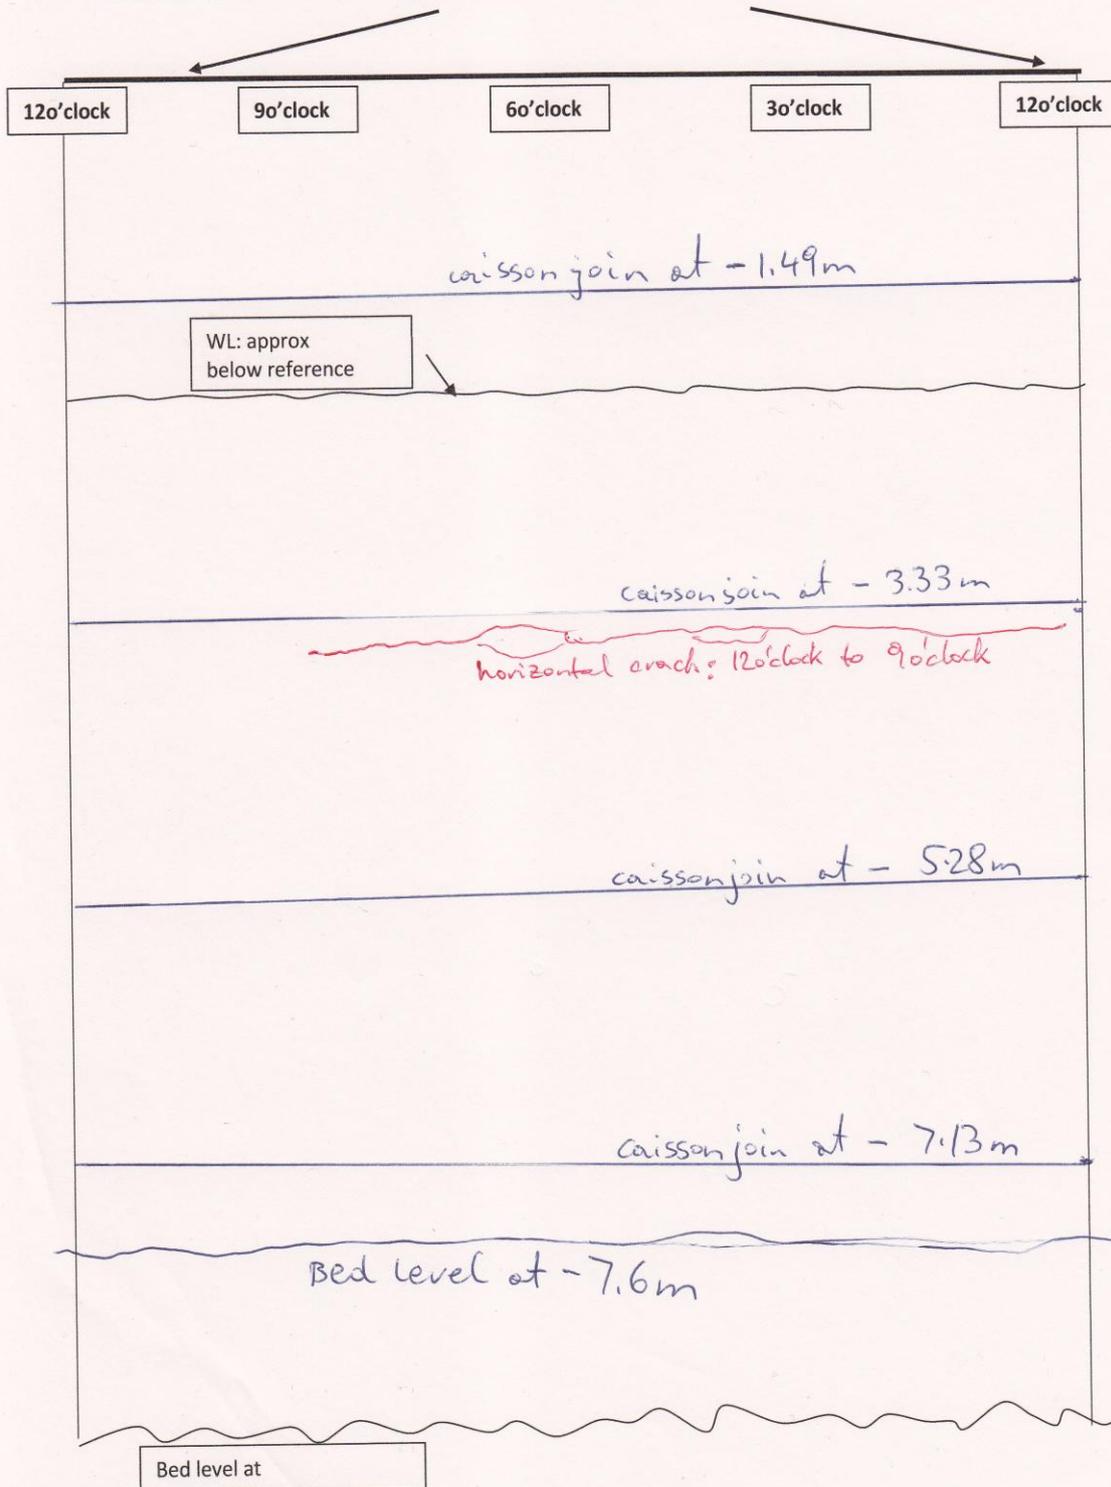
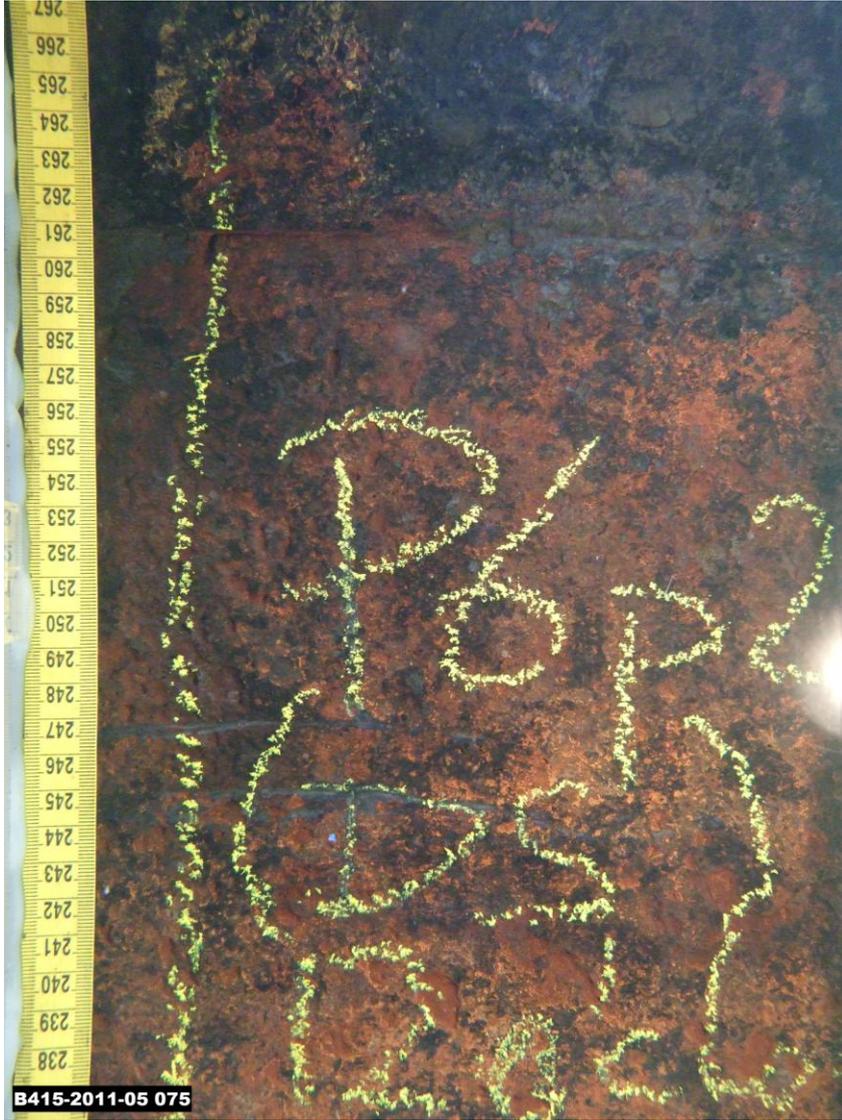
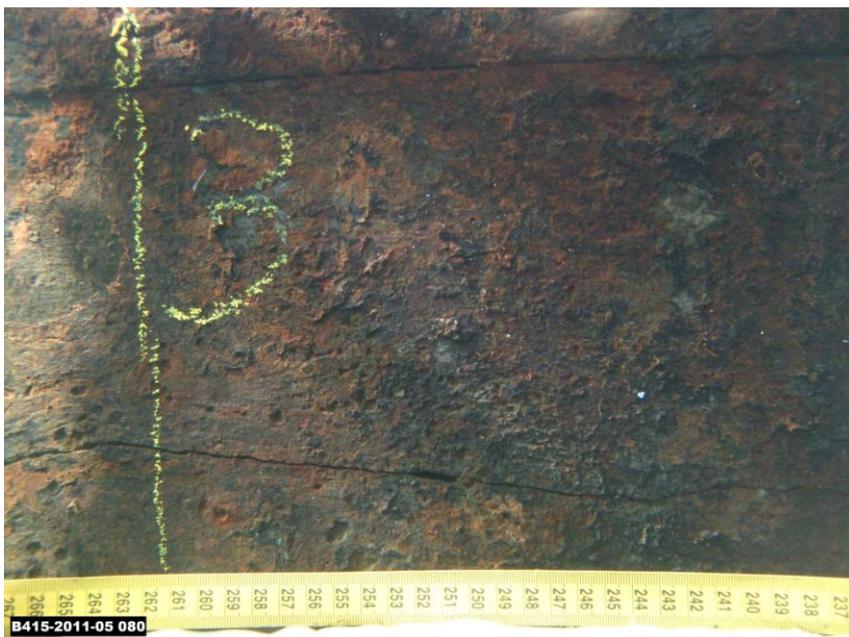
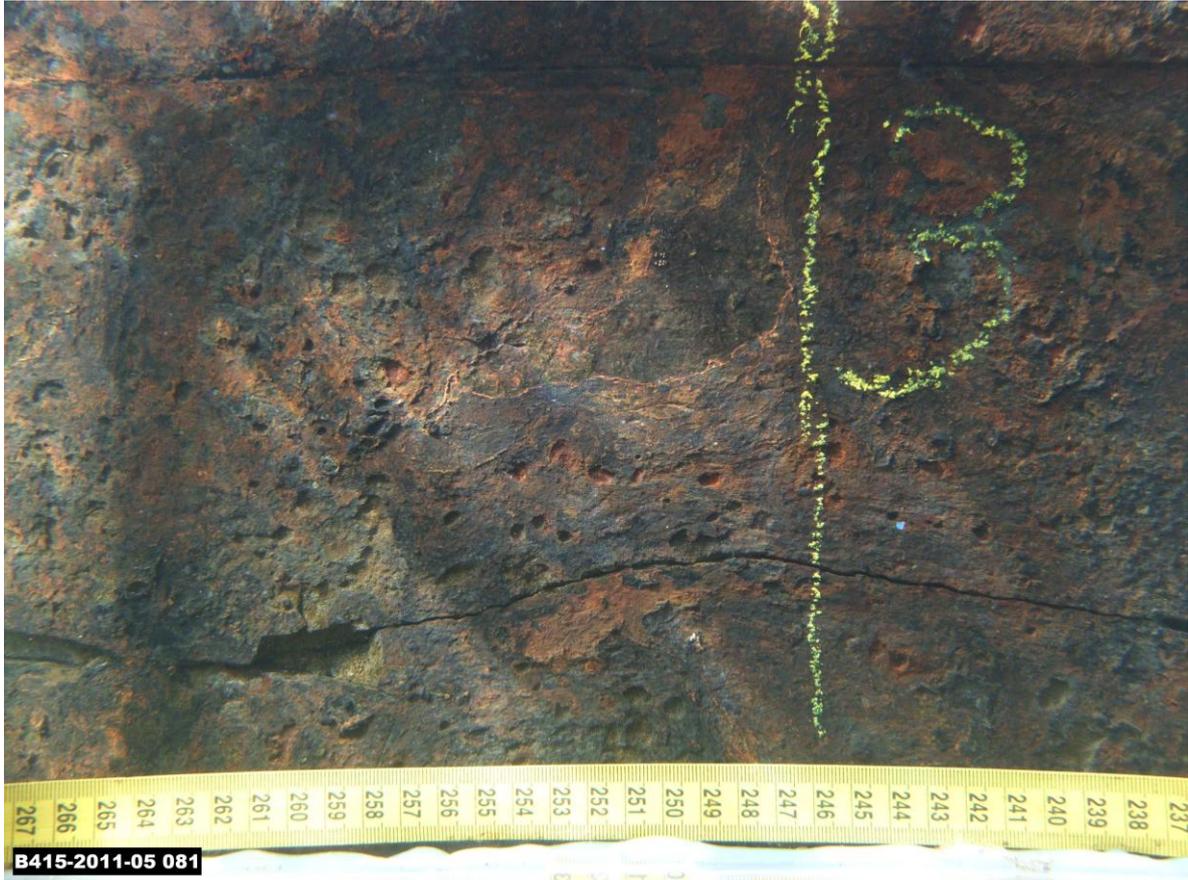
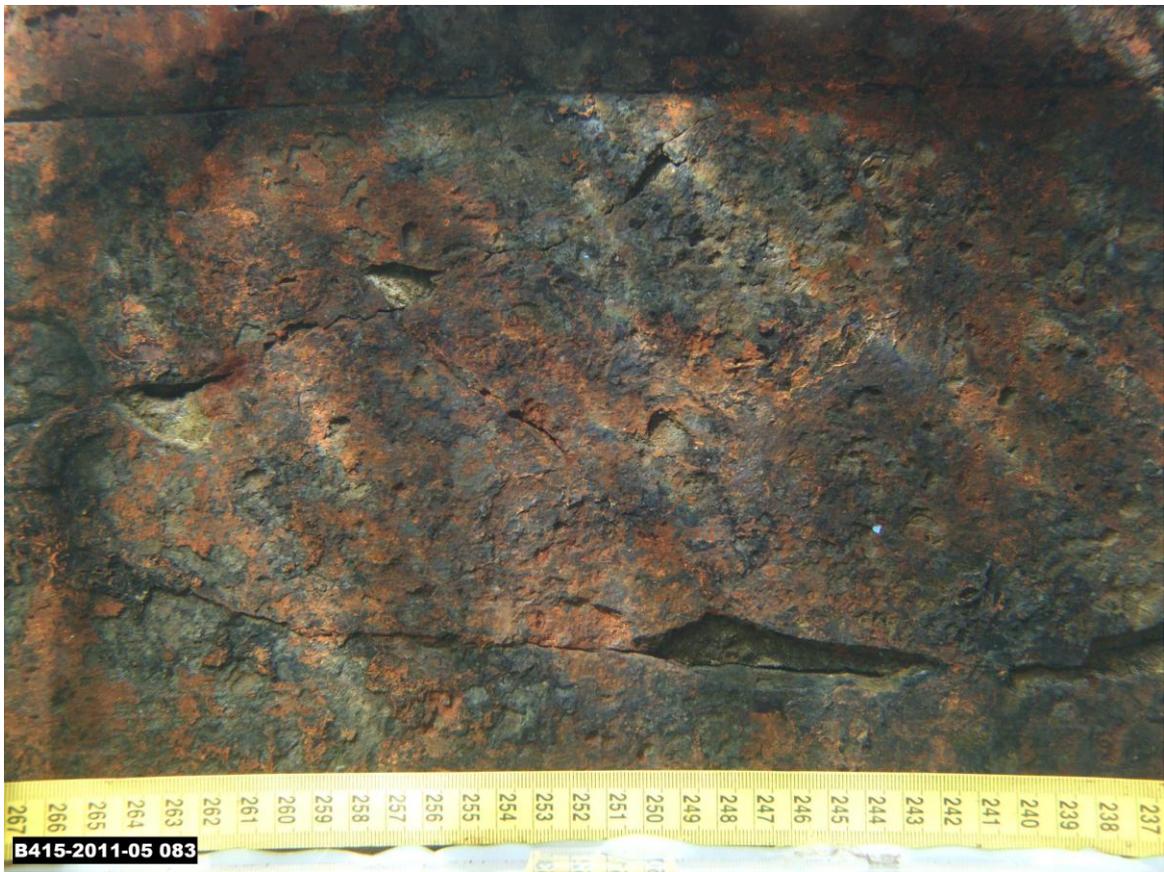
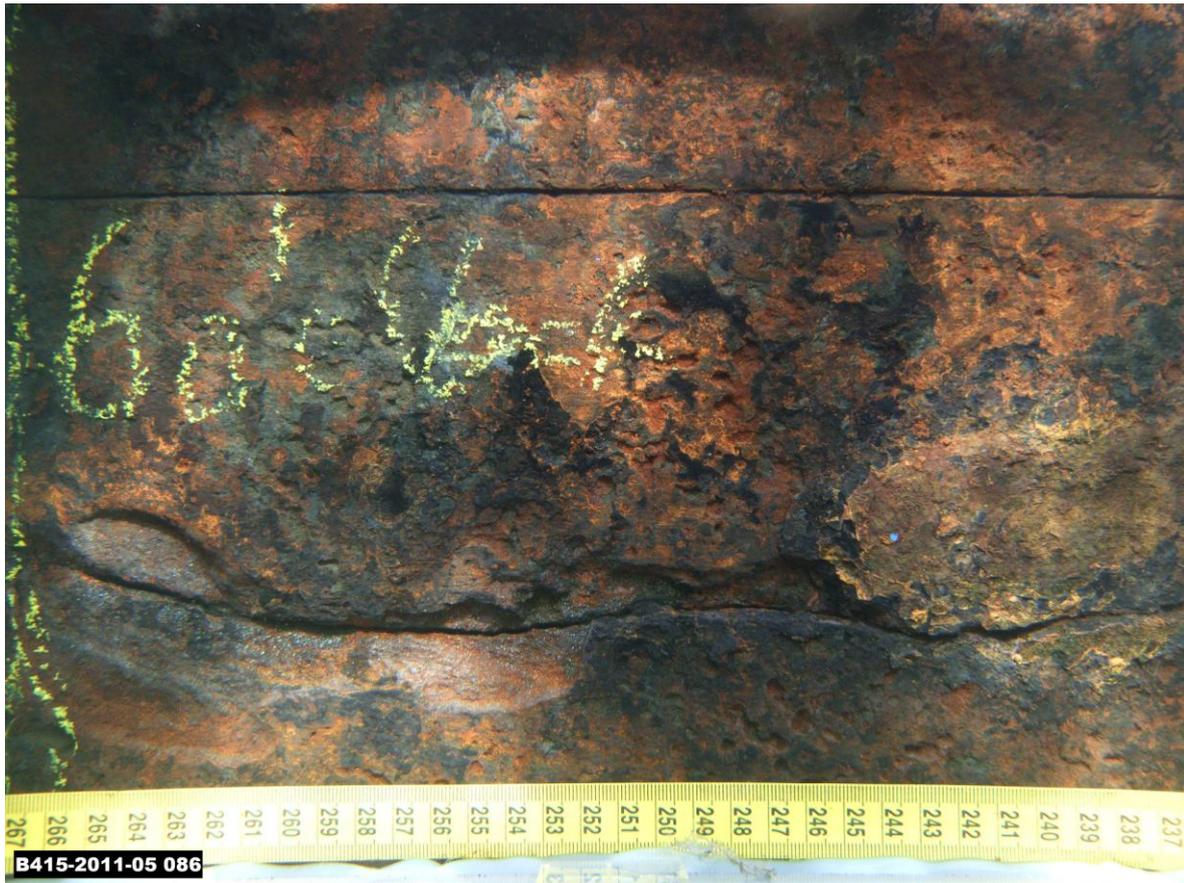
PILE: 2 (DS)

Condition State	Estimated quantity in Condition State	Remarks
1		
2		
3	12m ²	Graphitisation over entire pile surface underwater, up to 15mm thick,
4	3m ²	Horizontal crack from just after 12 o'clock to 9 o'clock at about -3.4m
Total

Depth below reference (m)	Description of Defect or Condition	Condition State
	Caisson joins at: -0.57m, -2.41m, -4.26m, -6.11m	
	Entire underwater surface of pile is showing graphitisation. On probing, thickness of graphitised layer varies between 5 and 15mm	3
1.5		
2.0		
2.5		
3.0		
3.5	Horizontal crack from just after 12 o'clock to 9 o'clock at about -3.4m	4
4.0		
4.5		
5.0		
5.5		
6.0		
6.5		
7.0		
7.5	Bed level at pile: -7.5m	
8.0
