Bridge over Hawkesbury River at Windsor Load Testing

Test Report

Graphitisation Investigation

Windsor Bridge

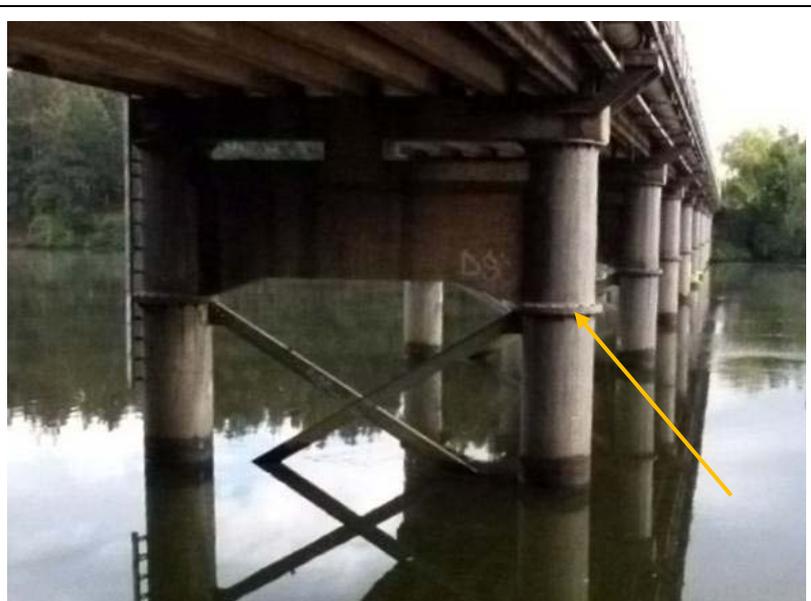
View of above water part of bridge pier showing lower flange used as reference level for recording height on piers

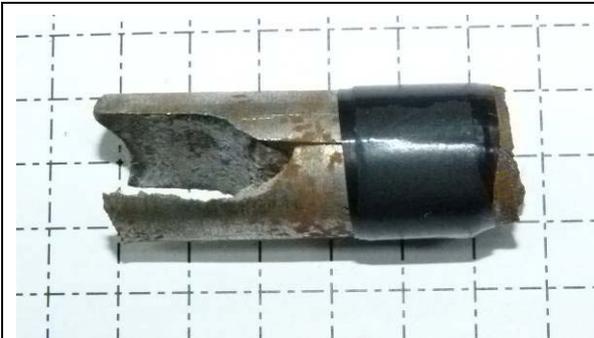
Core sampling into one of the seams (Pier 5 Downstream, mid-water level) revealed there to be an internal flange, with a bolt hole intersected by the core as indicated by the concave shape at its end. This confirms the castings are joined by internally bolted flanges.

Core from seam between sections as retrieved by divers - length > 50mm, with cast-in rebate for gasket (two halves taped together)

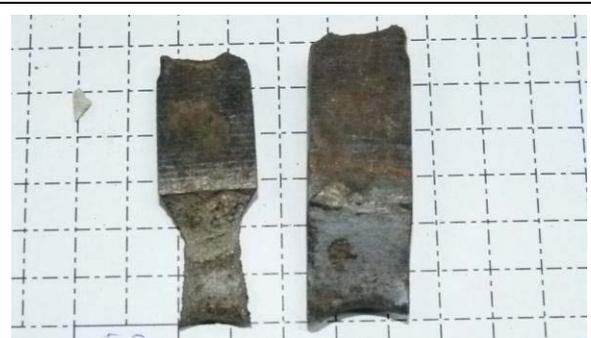
Inner ends of the two halves of the core were a concave shape, indicating the core intersected a bolt hole

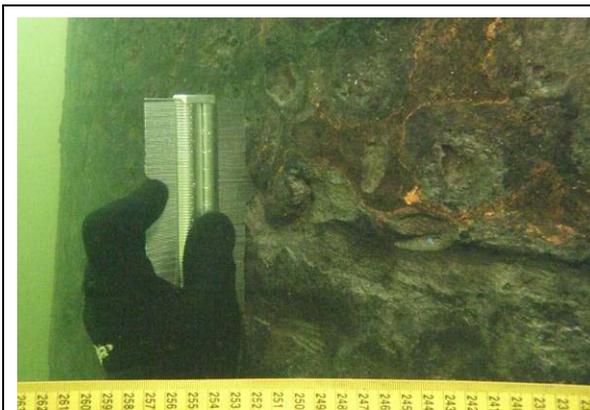
Measuring depth of graphitisation – diver pushing pins of profile gauge into excavation through graphite layer

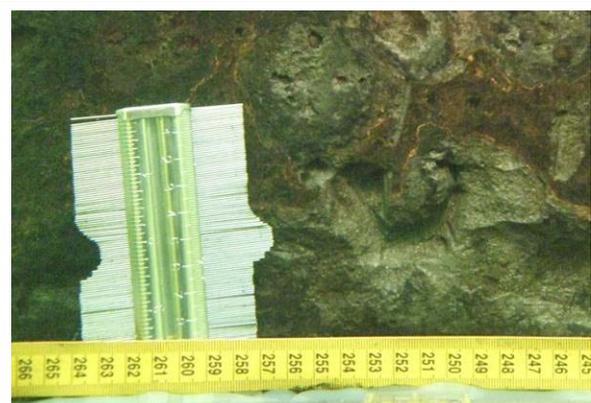
Profile gauge withdrawn from excavation allows depth of graphitisation to be measured

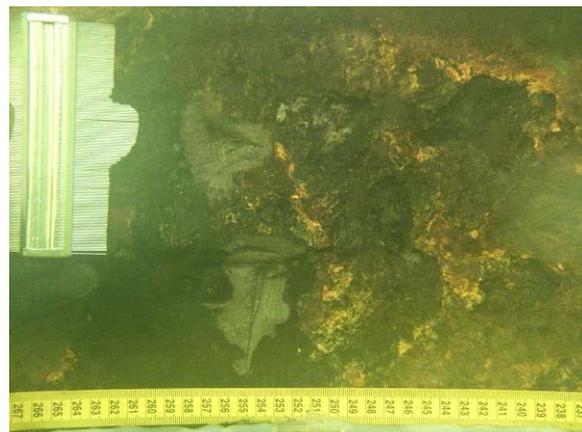
Profile gauge withdrawn from excavation allows depth of graphitisation to be measured

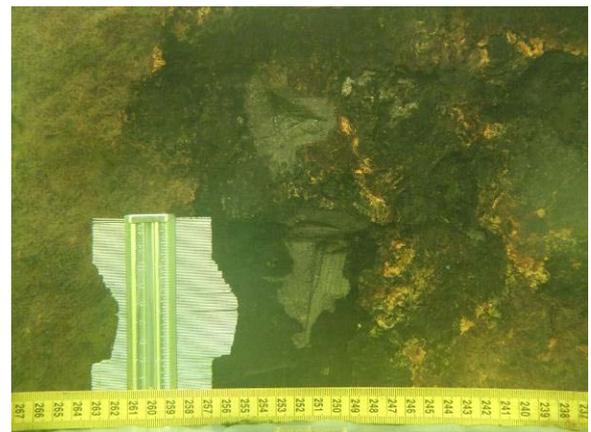
Profile gauge withdrawn from excavation allows depth of graphitisation to be measured

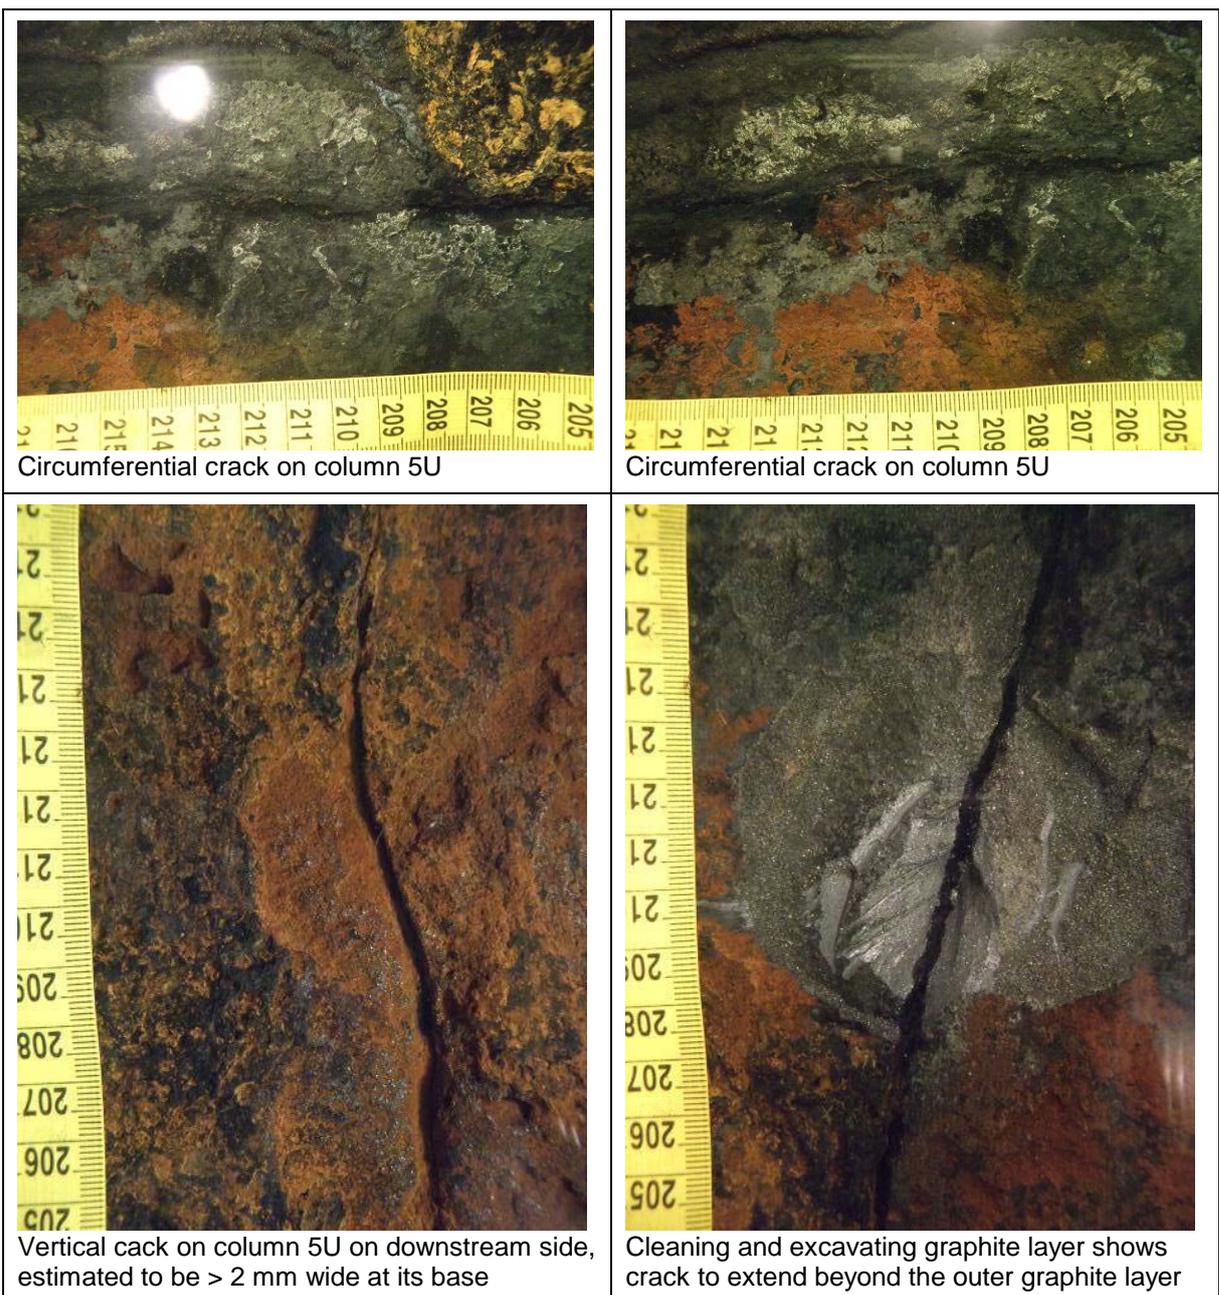
The Upstream Column of Pier 5 (5U) had a full circumferential crack, approximately 200mm above the seam at the top of first fully immersed section. This placed the crack just below the collar for the bracing, and it probably coincides with the beginning of the internal thickening of the casting to create the flange. The crack was at its widest on the downstream (6 o'clock) side of the pier, where it was estimated to be in excess of 1 mm.

There was also a vertical crack on the column, starting at the same seam (at 6 o'clock, east or downstream) and extending approximately 100 mm upwards. Its width was measured to be up to 2 mm wide at its base, tapering upwards.

Horizontal cracking is present in three of the columns, including both columns in pier 5. They occur at quite shallow depths, and may be related to the location of the bracing collars just above where they occur.

It appears that the cracks are not new and have been present for quite some time, at least a few decades and possibly longer.

Nevertheless such cracks would be expected to have a serious impact on the overall serviceability of the bridge, and a detailed structural analysis should be carried out to determine their probable impact on the bridge's capacity.

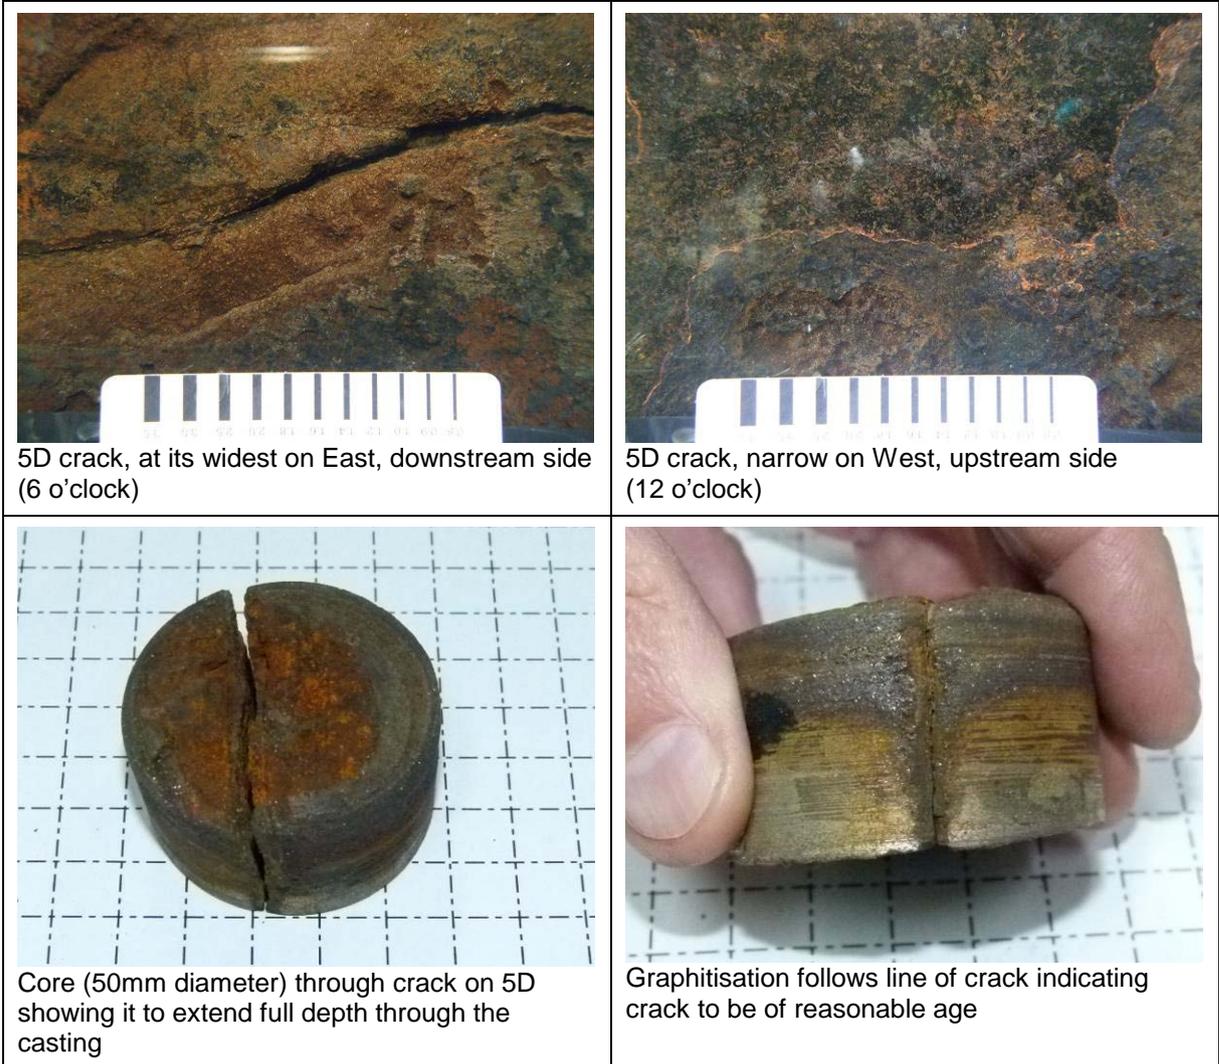
The Downstream column of Pier 5 (5D) also had a full circumferential crack but in this case, the crack was approximately 200mm below the seam at the top of the first fully immersed casting. The crack was cored using a 50mm diameter bit, and confirmed the crack to be full depth. Graphitisation had followed the line of the crack for some distance, indicating the crack to be of some age.

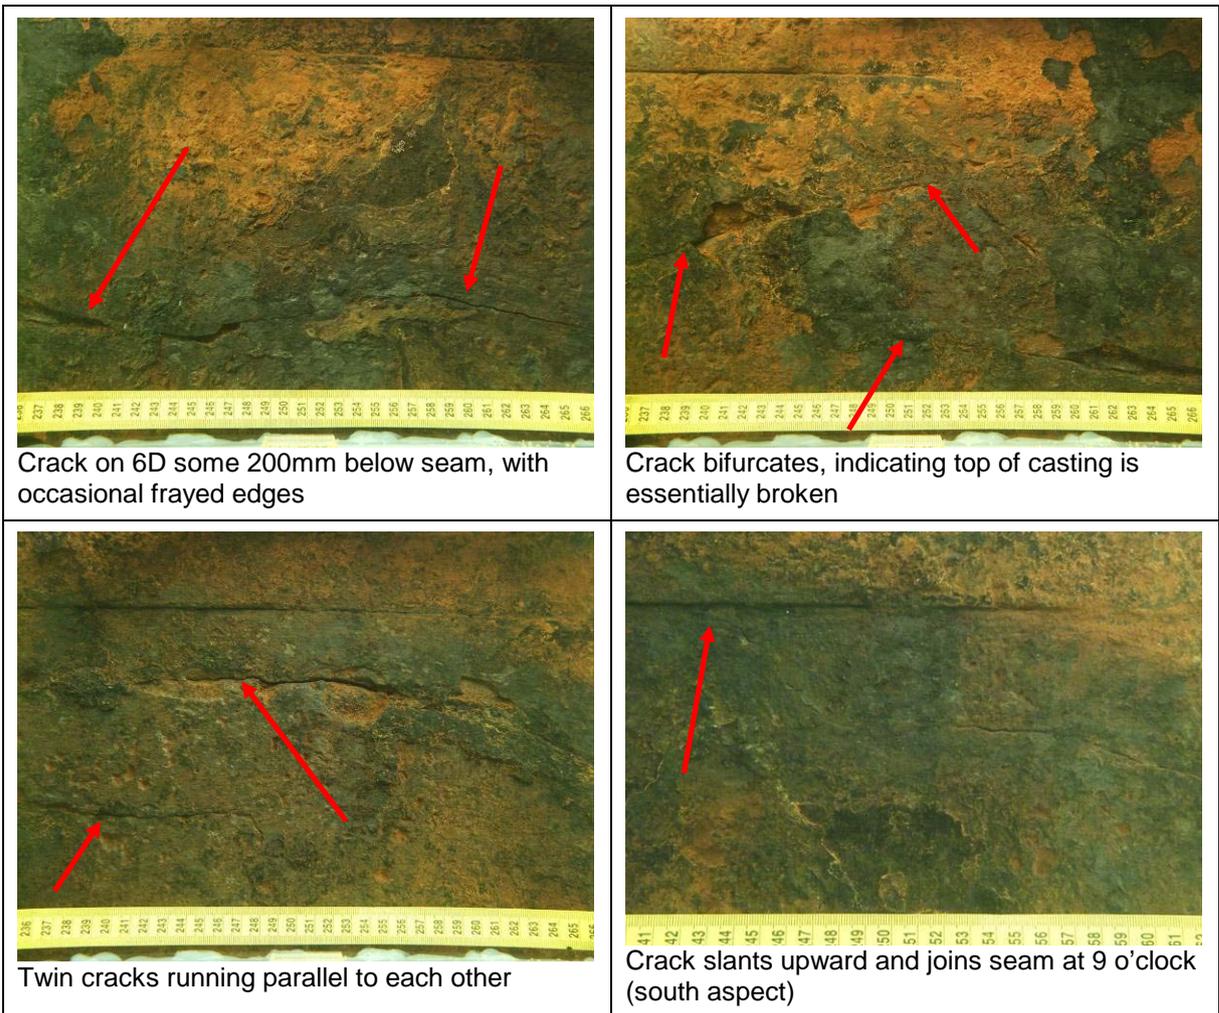
The third circumferential crack was on the downstream column of pier 6 (6D), also situated below the first immersed seam, and extended for three quarters of the circumference, from 12 o'clock to 9 o'clock.

This crack was more complex, bifurcating at approximately 6 o'clock and developing parallel cracks for some distance. This suggests significant damage to the upper casing including the internal flange.

At its southern end (9 o'clock), the crack slanted upwards and joined the seam.

Crack on 6D some 200mm below seam, with occasional frayed edges

Crack bifurcates, indicating top of casting is essentially broken

Twin cracks running parallel to each other

Crack slants upward and joins seam at 9 o'clock (south aspect)

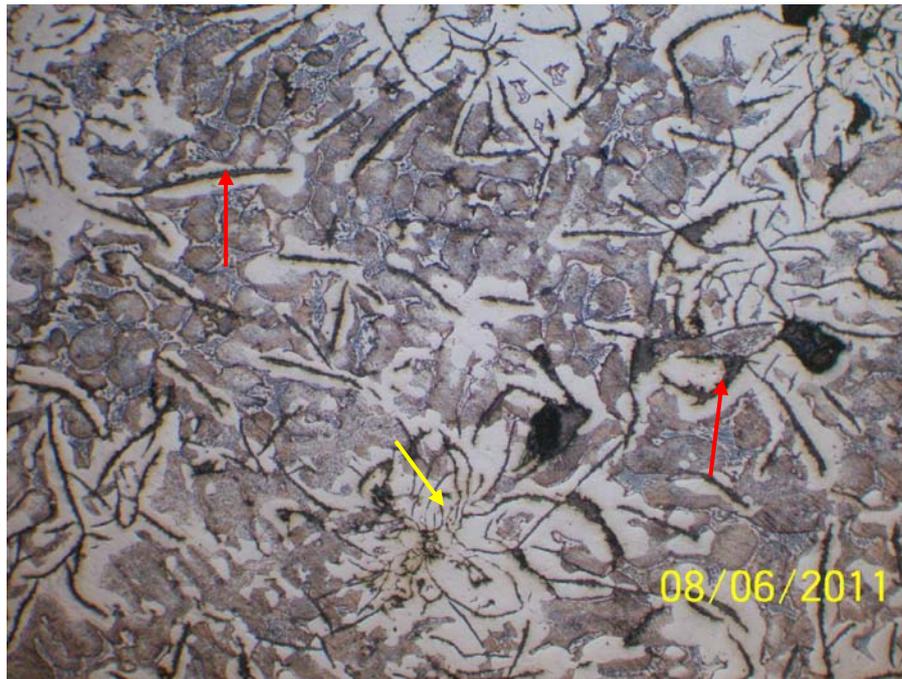
Figure 2 Core Sample CTI 38888 (etched) showing coarse graphite flakes (red arrow) and “rosettes” of medium and finer carbon flakes (yellow arrow) in a ferritic/pearlitic matrix. Magnification –X120; Etchant – 3% Nital.

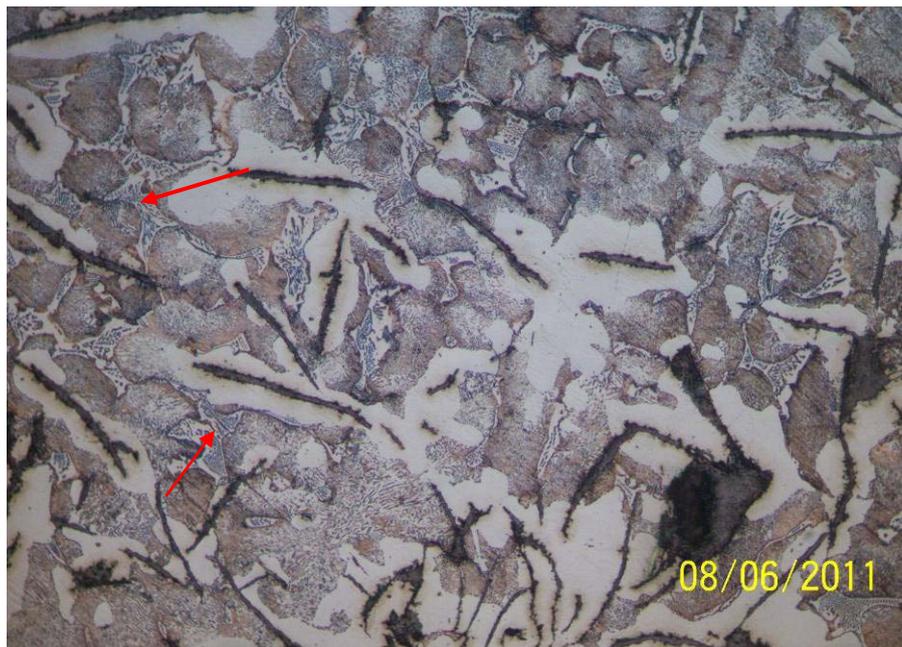
Figure 3 Core Sample CTI 38888 (etched) showing coarse and medium graphite flakes in a ferritic/pearlitic matrix containing relatively high levels of phosphide eutectoid (refer arrows). Magnification -X280; Etchant – 3% Nital.

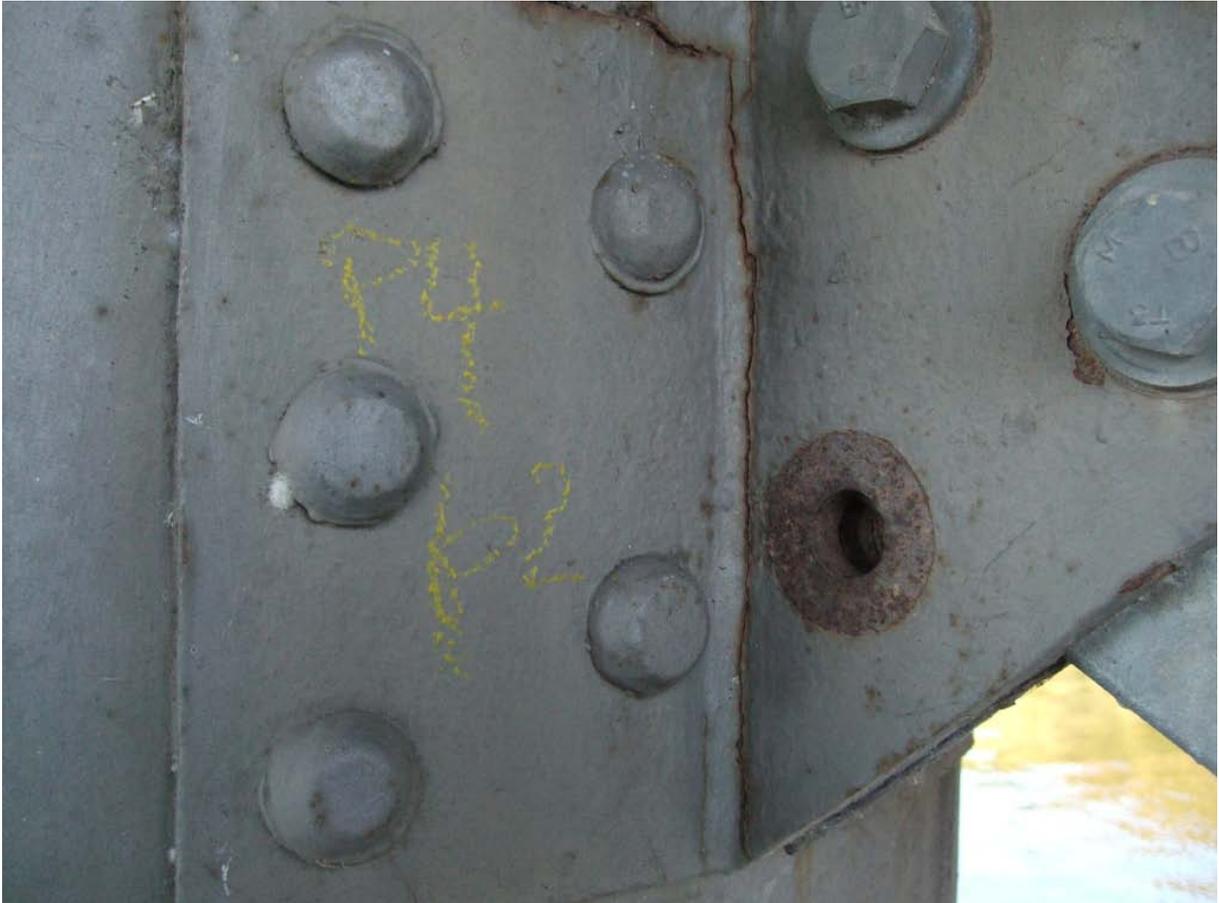
Although the scope of the investigation was limited to the underwater sections of the piers, it was noticed that on Pier 4, there are vertical cracks in the brackets securing the upper end of the diagonal bracing to the piles. Cracks are present in this bracket on both upstream and downstream columns.

The photograph below illustrates one of these cracks, on the downstream column of Pier 4. Note also that there is one bolt missing from this detail.
