**UPGRADE OF  
WARDELL ROAD BRIDGE  
OVER COOKS RIVER,  
DULWICH HILL NSW**

**MARRICKVILLE COUNCIL  
PO BOX 14  
PETERSHAM 2049**

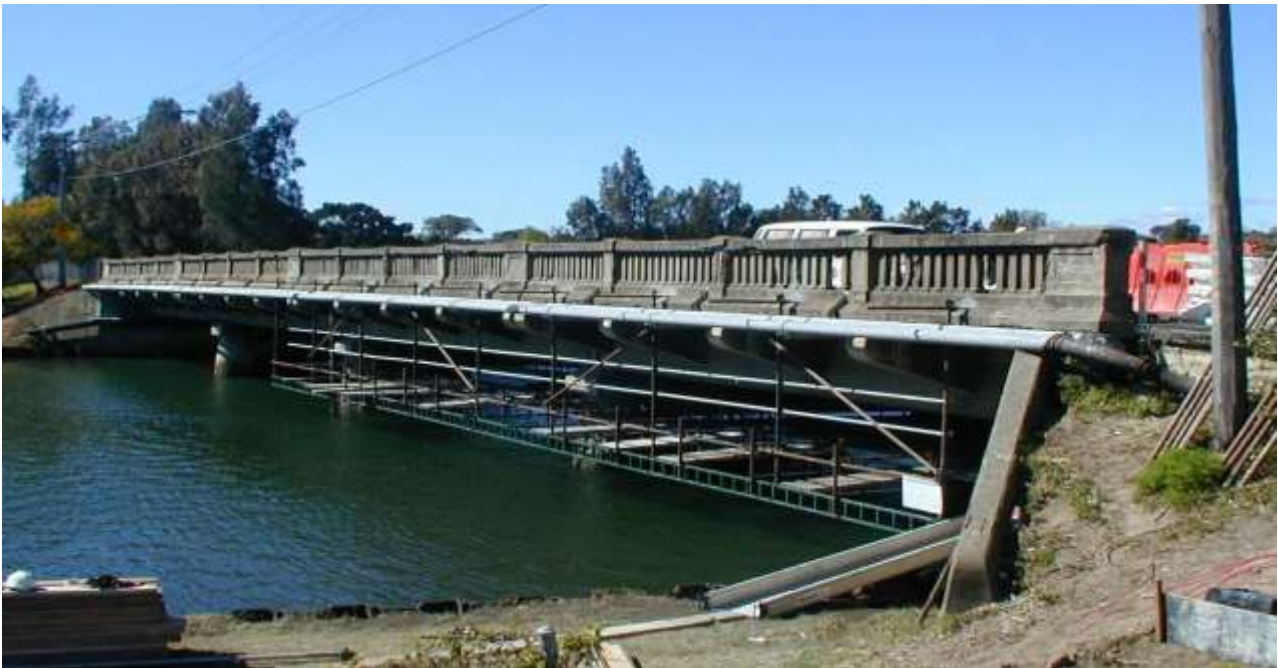
Wardell Road Bridge suffered extensive concrete deterioration since its construction in 1924 and is currently restricted to a maximum 12T weight limit. Consequently a joint venture by current stakeholders, Marrickville Council, Canterbury City Council and Roads and Traffic Authority was initiated to develop a program of works to rehabilitate the existing structure.

**View of the existing bridge structure prior to remedial treatment**

An initial assessment was undertaken by Taywood Engineering Limited (now GHD) to determine the type and extent of deterioration to the existing bridge piers and deck and provide a practical and cost effective remedial treatment. The remedial treatment chosen consisted of a mixture of impressed current cathodic protection, conventional repairs and realkalisation.

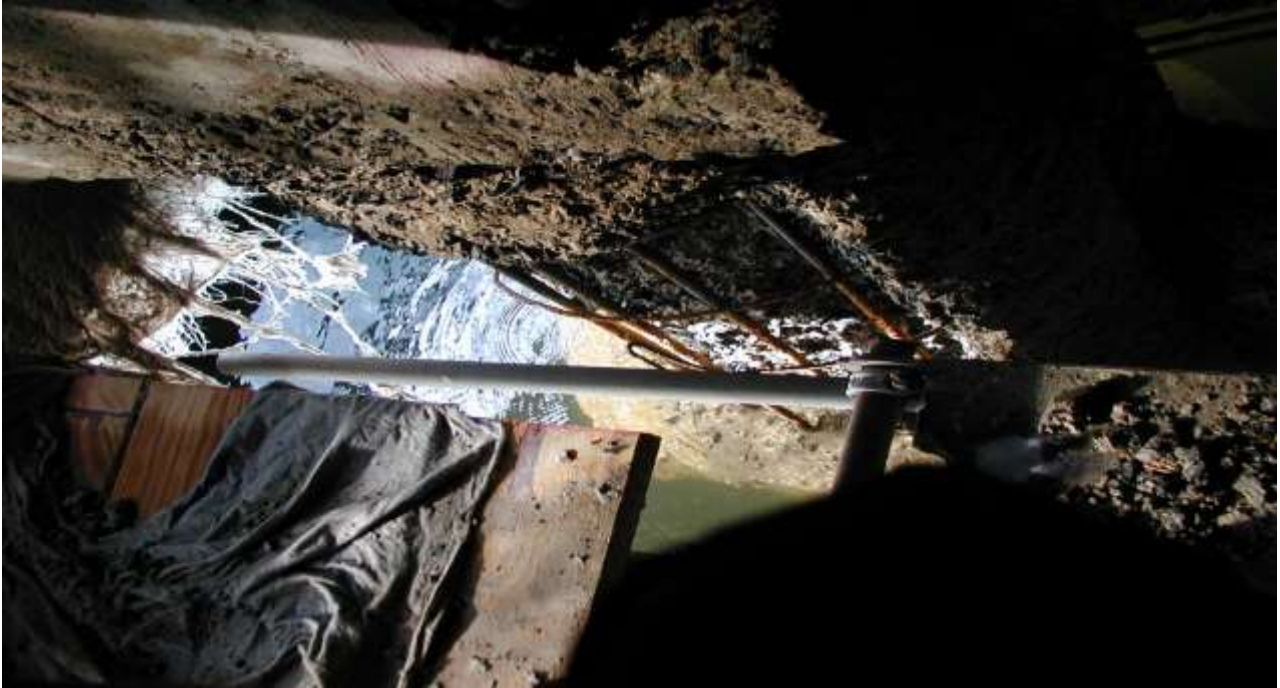
**Removal of dilapidated concrete from bridge pier prior to treatment**

The cathodic protection work undertaken on the tidal zone involved removing areas of dilapidated concrete using high pressure water hoses and attaching electrically charged anode strips to the exposed steel reinforcement. Where the steel had eroded by greater than 20% of its original size it was replaced with new reinforcement steel prior to attaching the anode strips. The dilapidated concrete removed was then replaced with approved concrete material and allowed to cure.

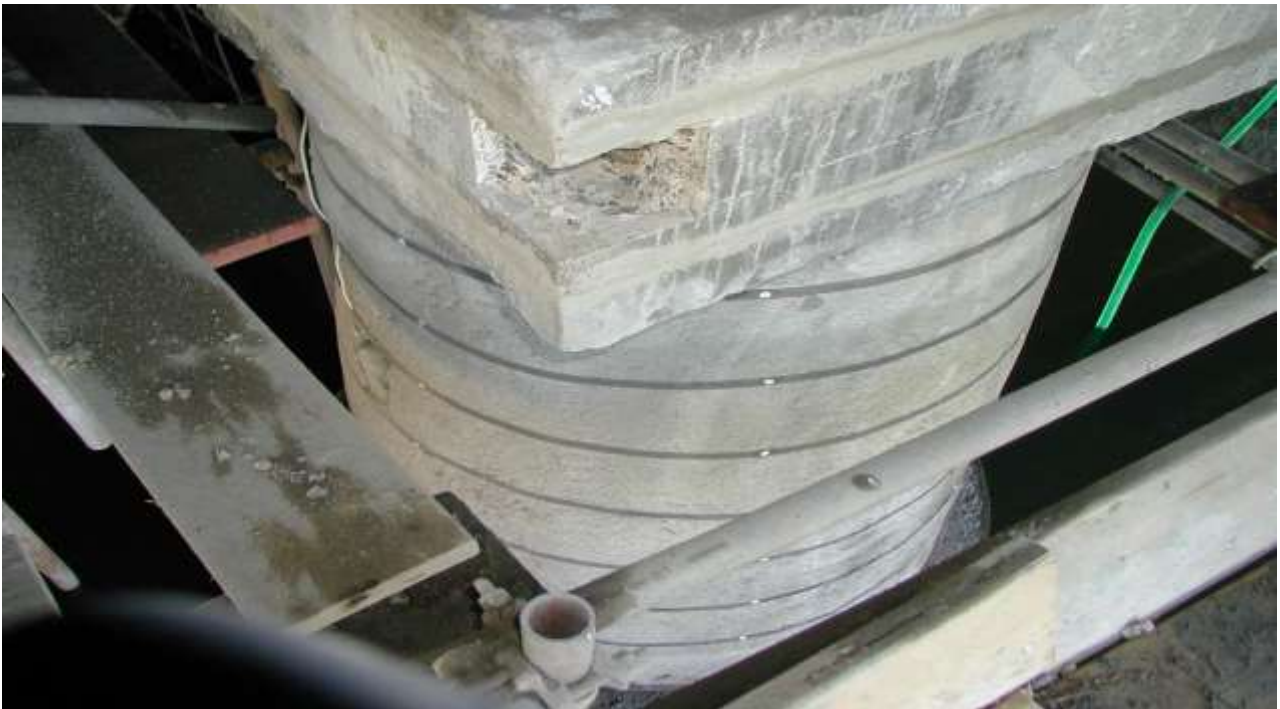
**Pier showing application of anode strips as part of the Cathodic Protection work prior to application of final concrete coating.**

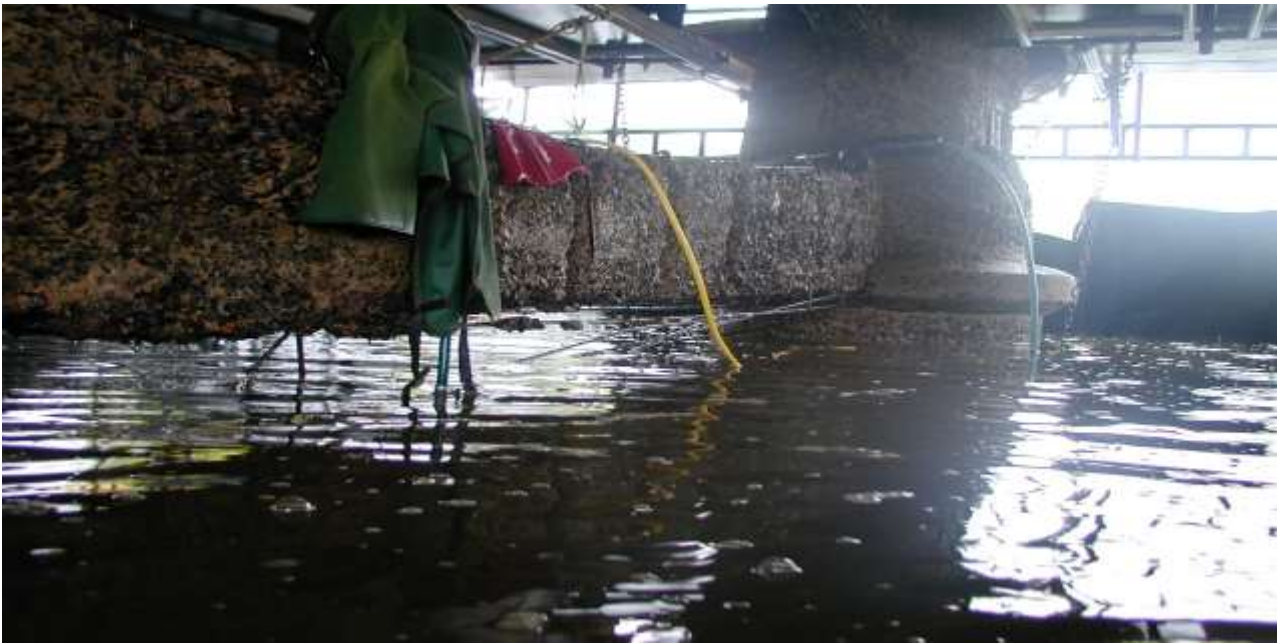
**One of the existing lower pier tie beams after removal of reinforcement concrete cover. Note the sheered main reinforcement and stirrups.**

The project was initially programmed for completion within six months however, due to an unforeseen increase in scope of works, which included replacement of all three existing pier tie-beams, the project was completed within 8 months.

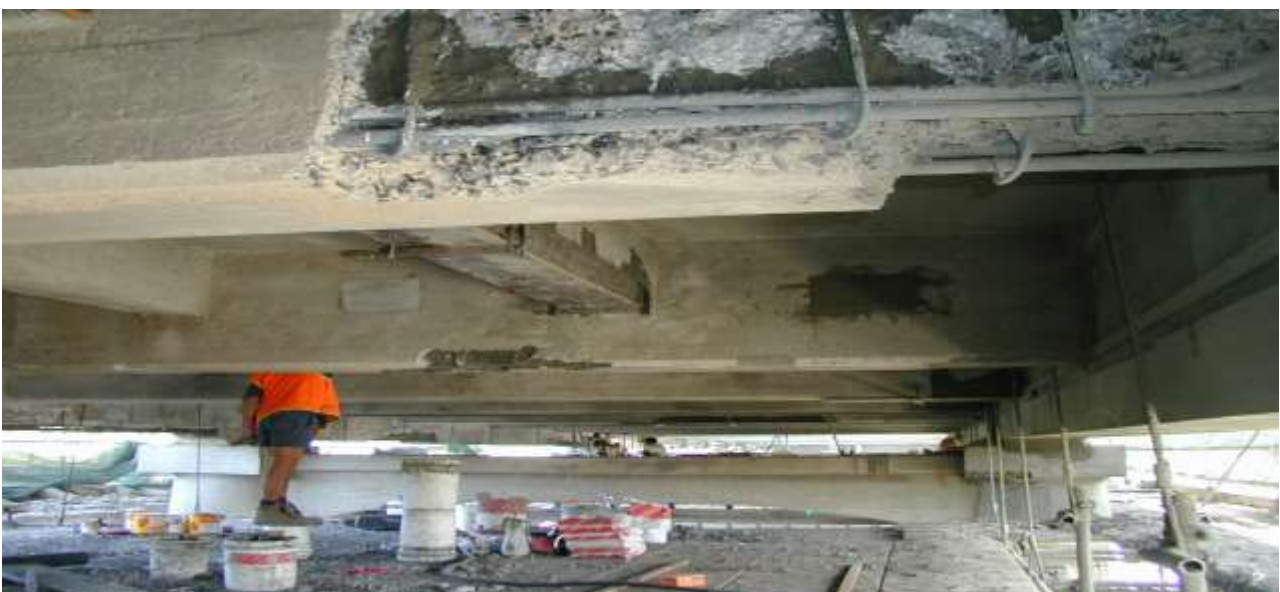
**Conventional repair work to the underside of the bridge. Sediment sheets were suspended below to trap loose debris which was then dumped into a barge.**

The conventional repair work applied to the atmospheric zone involved removing areas of cracked or dilapidated concrete from the edge beams and underside of the bridge deck. The process included cutting the existing concrete back behind the outer layer of steel reinforcement to ensure complete removal of any carbonated concrete between the atmosphere and steel reinforcement. The dilapidated concrete removed was then replaced with approved concrete material and allowed to cure.

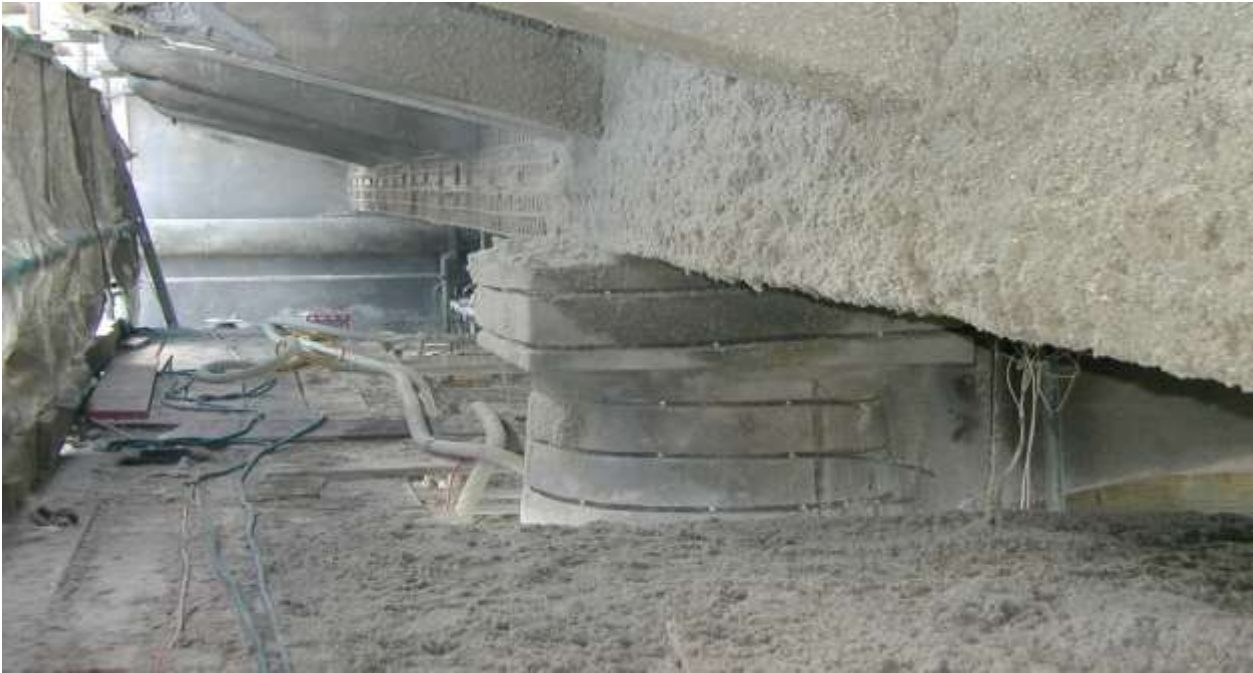
**Realkalisation treatment to existing edge beams**

Since the edge beams are subject to splash from the Cooks River it was decided that the most practical and cost effective way to preserve the integrity of the edge beams was to apply a no-cure realkalisation treatment to each girder after finishing all conventional repair work. This involved applying an alkali soaked Paper Mache, to a steel mesh which in turn was attached to the existing repaired edge beams. A current was then applied to the steel mesh to drive the alkaline solution into the concrete up to the face of the existing steel reinforcement.

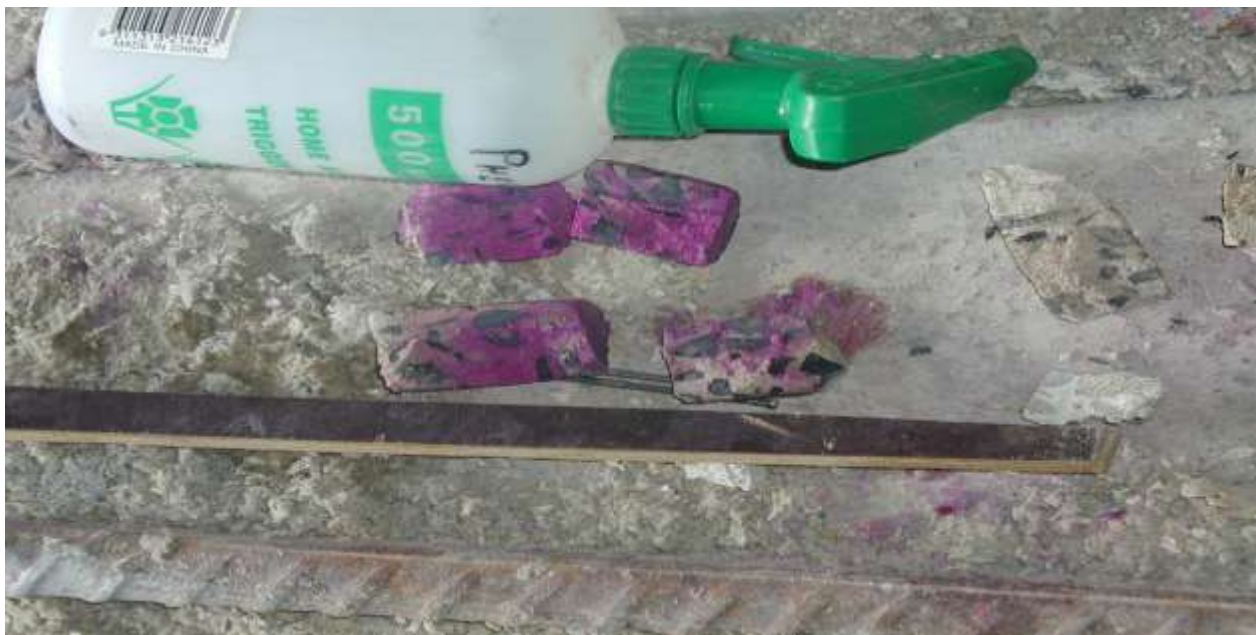
**Core samples showing the extent of realkalisation of concrete (purple) in the edge beams.**

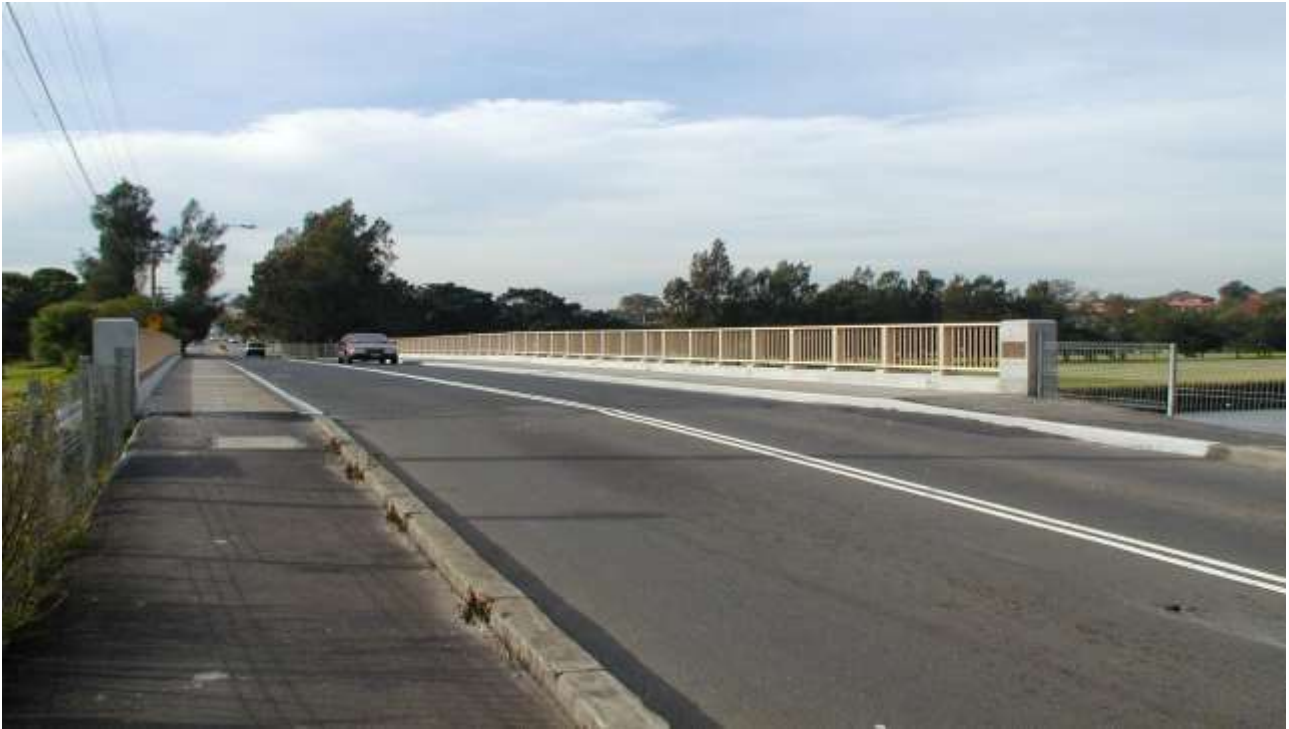
**Completed works**

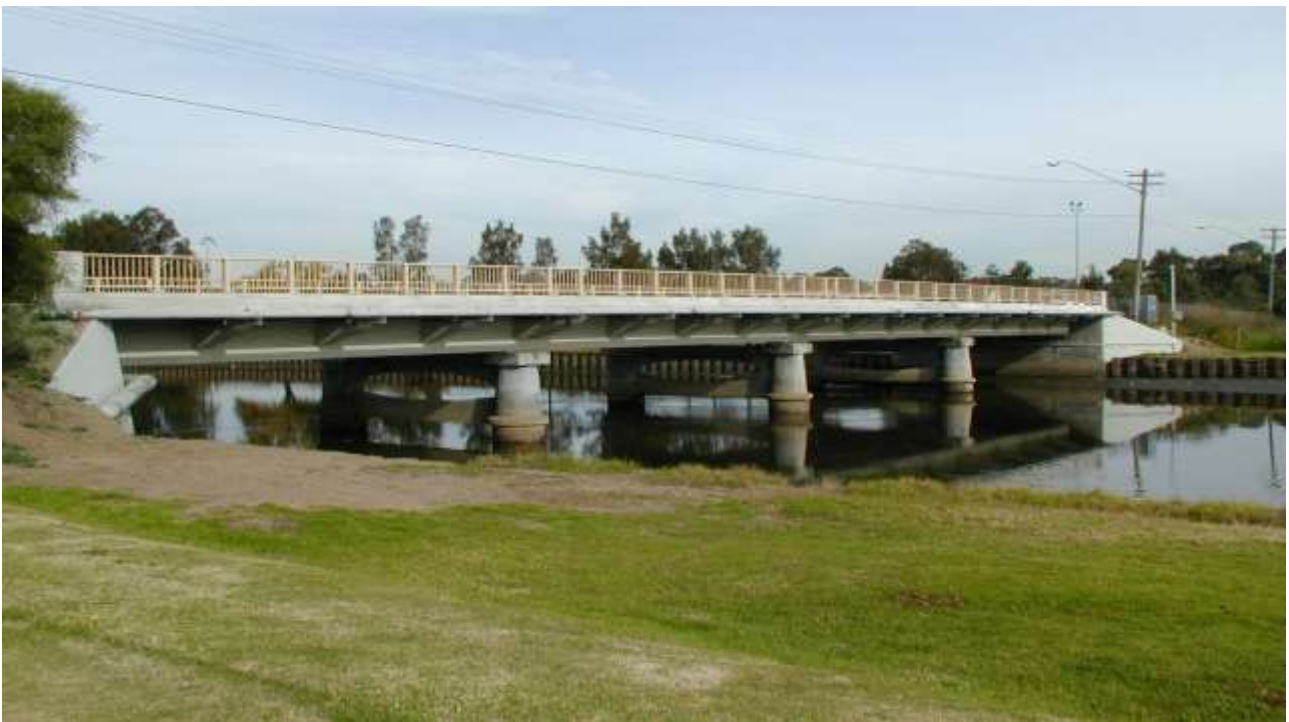
**Completed works**
