# Georgiou Group Dilapidation Report, Windsor Bridge Replacement Project, Windsor NSW

S-03139.DilapidationReport.001

**Pre-Dilapidation Photos Taken:** 20<sup>th</sup> June 2018

**Post-Dilapidation Photos Taken:** 8<sup>th</sup> July 2021

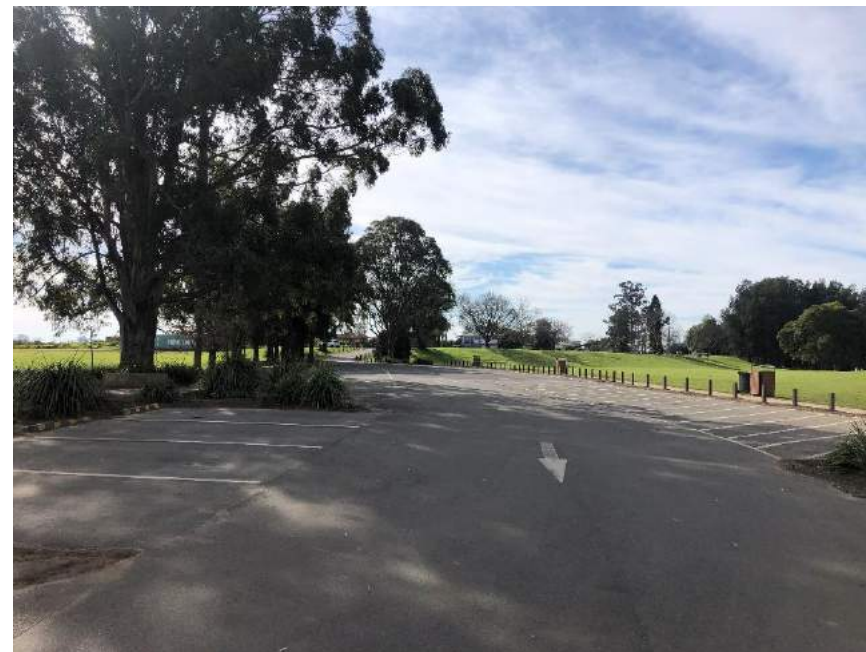
**2018:** General condition of far end of carpark – joints and cracking noticeable.

**2021:** General condition of far end of carpark – no detectable deteriorations to joints and cracking observed.

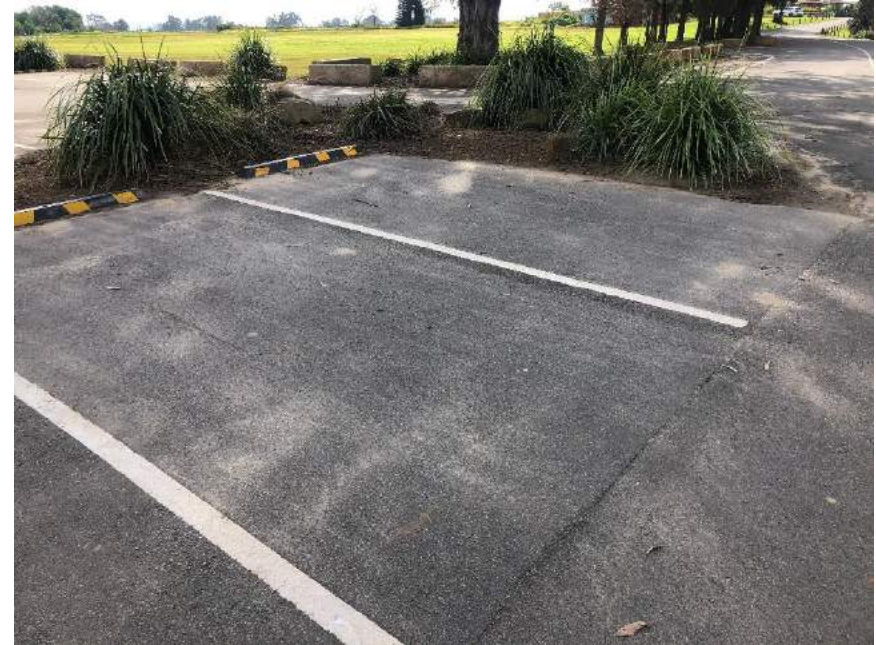
**2018:** Close up of joint/cracking in asphalt.

**2021:** Close up of joint/cracking in asphalt – little to no change observed compared to pre-construction survey conditions.

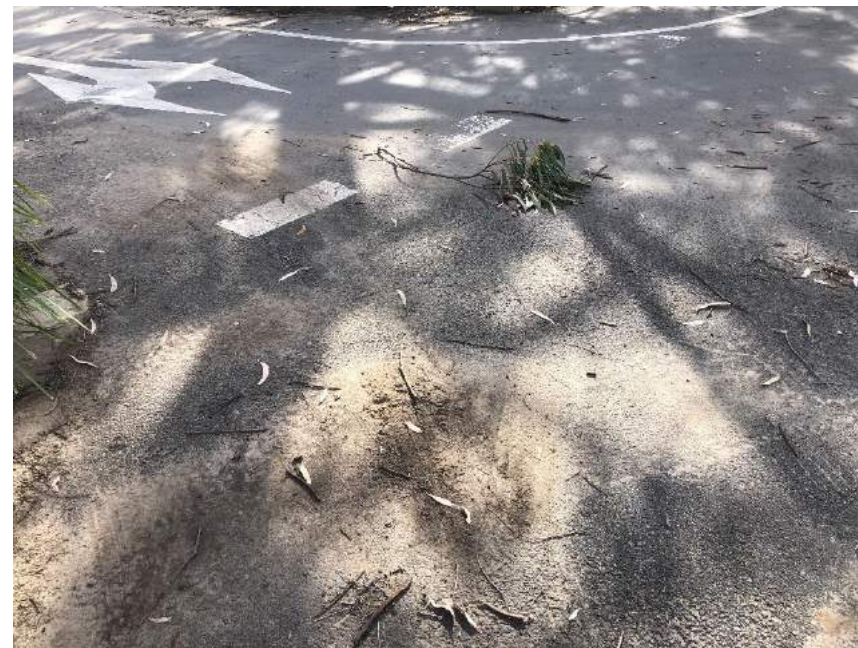
**2018:** Close up of joint/cracking in asphalt.

**2021:** Close up of joint/cracking in asphalt. Significant change not observed.  
Sand from recent flooding event, not construction related.

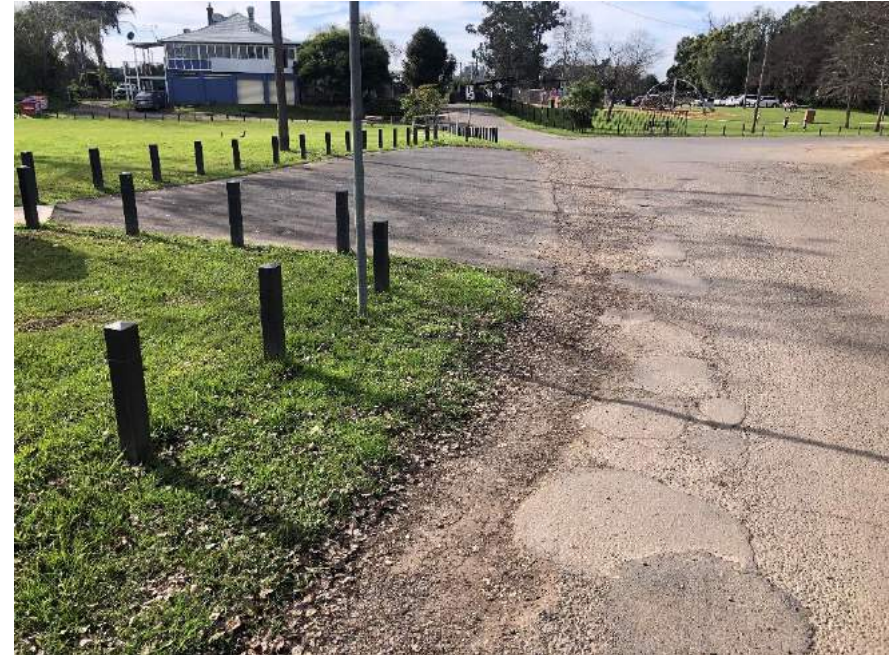
**2018:** Severe damage to asphalt.

**2021:** Consistent condition of asphalt compared to pre-construction survey conditions, improved fencing and grass coverage.

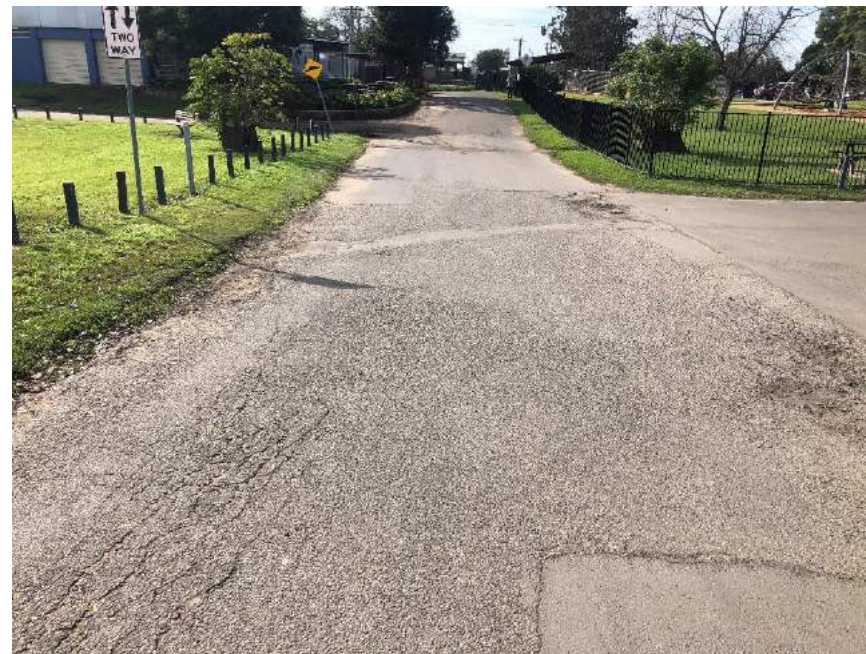
**2018:** Cracking present throughout carpark.

**2021:** Cracking present throughout carpark – little to no change observed compared to pre-construction survey conditions.

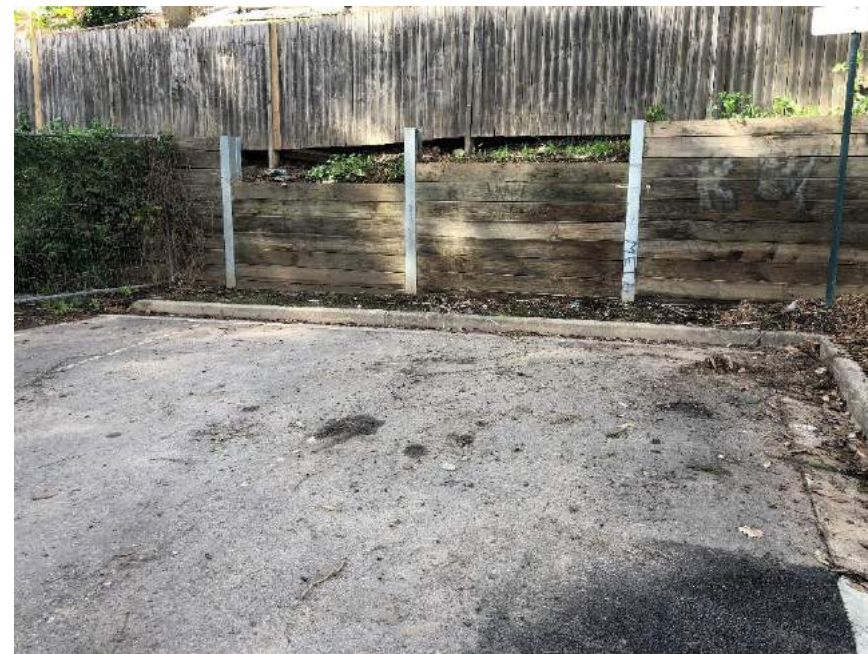
**2018:** First parking spot of carpark – retaining wall weathered and graffiti present. Line marking heavily worn.

**2021:** Parking spots of carpark – retaining wall and line marking weathered and graffiti present– little to no change observed compared to pre-construction survey conditions. Sand from recent flooding event, not construction related.

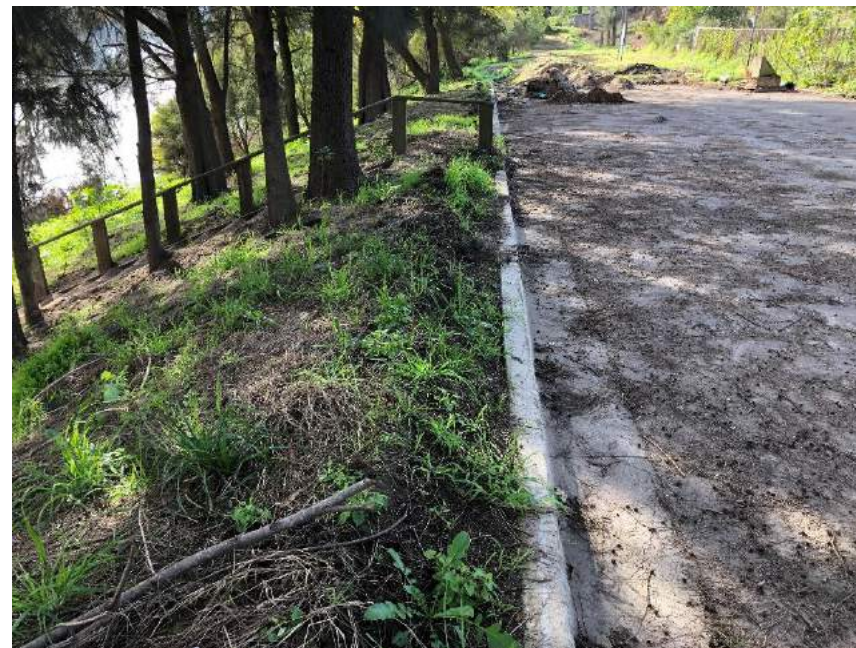
**2018:** Condition of kerb gutter – missing pit lid.

**2021:** Condition of kerb gutter – pit removed, asphalt and gutter in condition consistent with pre-construction survey. Increased sand and debris from recent flooding event and not construction related.

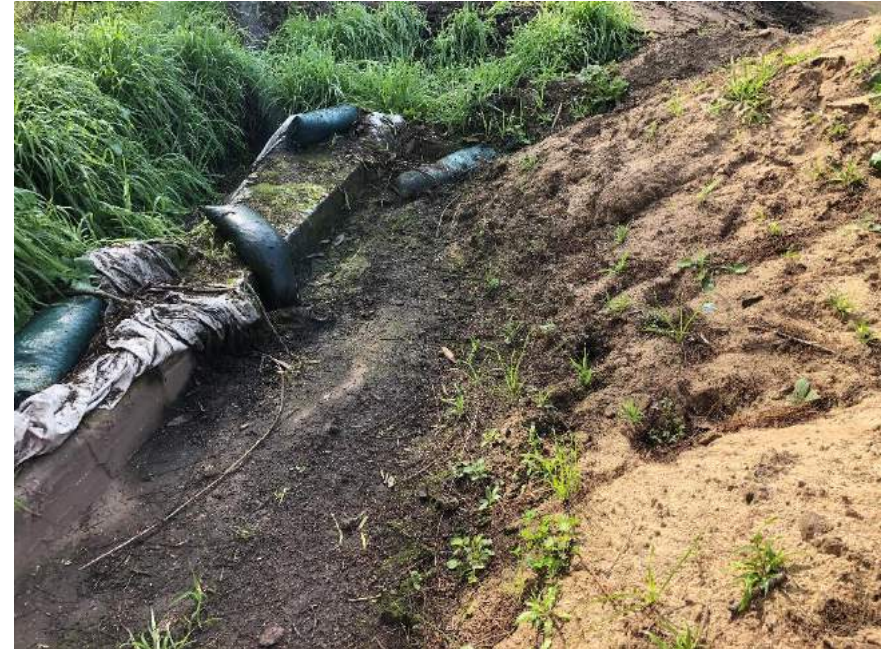
**2018:** Cracking on asphalt surface, kerb, and gutter.

**2021:** Geofabric and silt socks covering gutter drainage, with sand stockpile materials not associated with project.

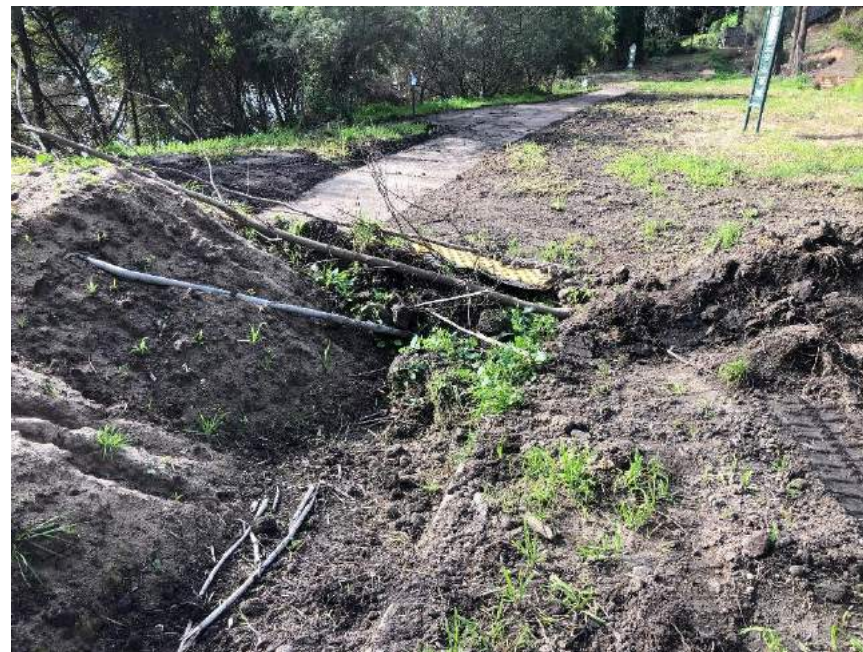
**2018:** Cracking on asphalt surface, kerb and gutter.

**2021:** Stockpiles of sand materials, debris and vegetation towards the rear of the carpark not associated with project.

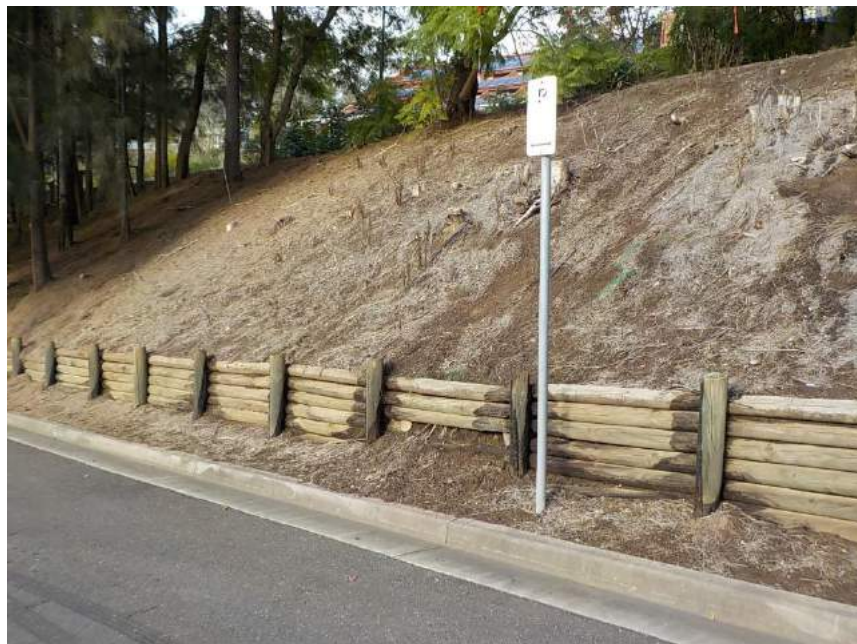
**2018:** Damage to log retaining wall – log missing and material coming through.

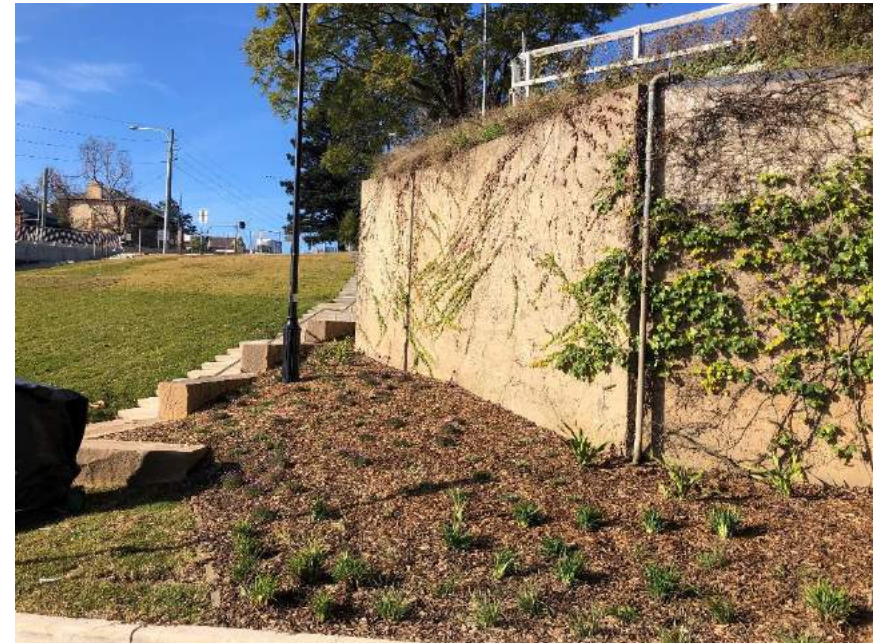
**2018:** General condition of retaining wall (Thompson Square located above wall) – cracking and patch repairs on asphalt surface.

**2021:** General condition of retaining wall (Thompson Square located above wall) consistent with pre-construction survey – improvements to surrounding asphalt and landscaping.

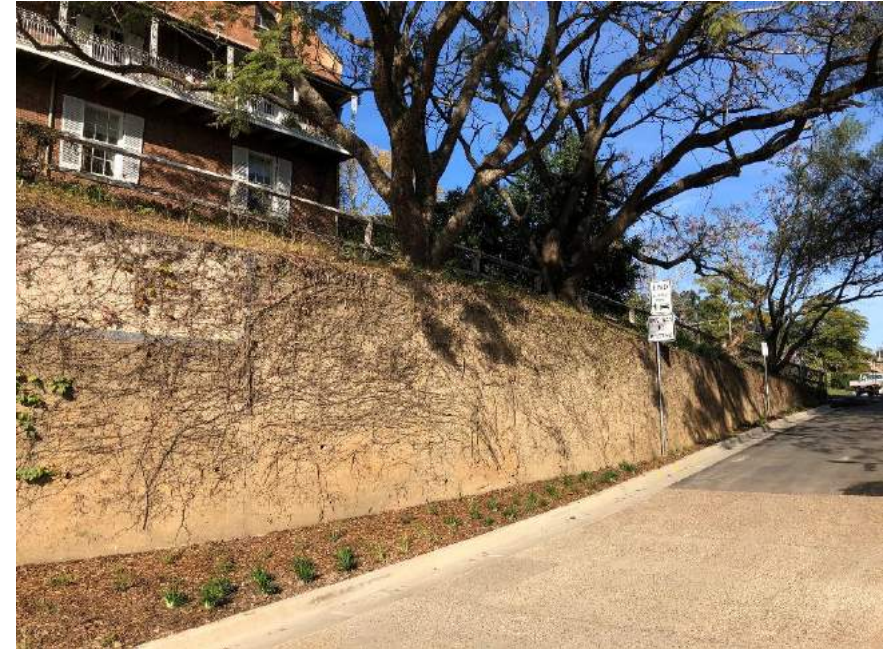
**2018:** General condition of retaining wall (Thompson Square located above wall) – cracking and patch repairs on asphalt surface – pit lid removed (temporary fence surrounding).

**2021:** General condition of retaining wall (Thompson Square located above wall) – little to no change observed compared to pre-construction survey conditions, with upgrades to surrounding landscaping and asphalt.

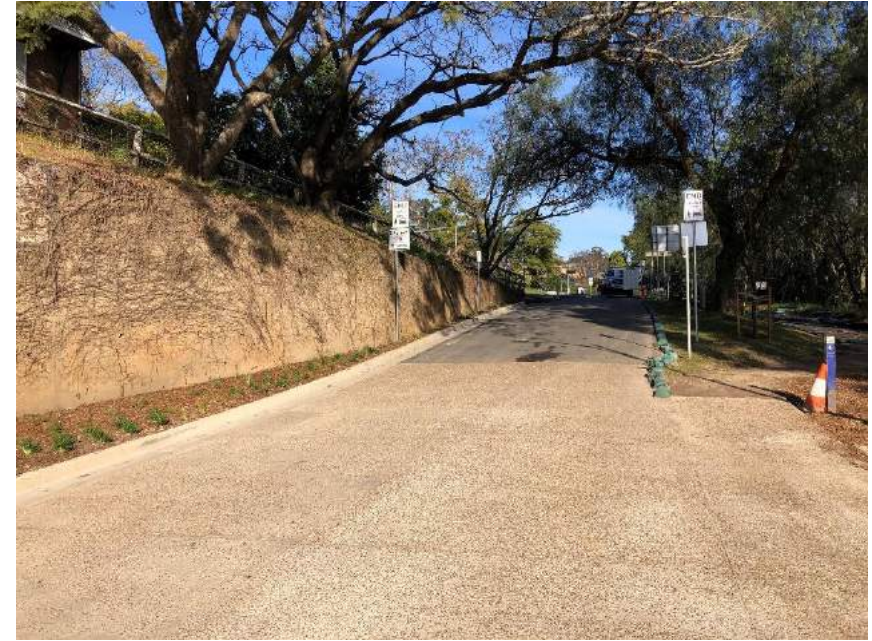
**2018:** Cracking and patch repairs on asphalt surface.

**2021:** Resurfacing of road leading away current bridge and upgrades to surrounding landscaping.

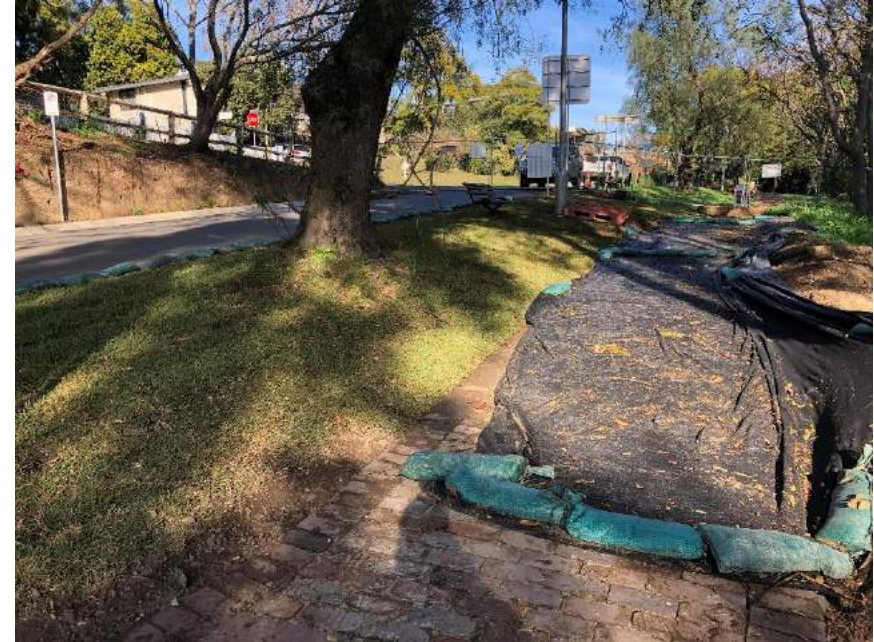
**2018:** General condition of existing footpath – bricks/stones missing from footpath  
-scouring on edges of footpath – damage to vegetation.

**2021:** General condition of existing footpath – bricks/stones missing from footpath, scouring on edges of footpath vegetation – little to no change observed compared to pre-construction survey conditions, however predominantly overlain by geofabric and silt socks during completion of surrounding construction works.

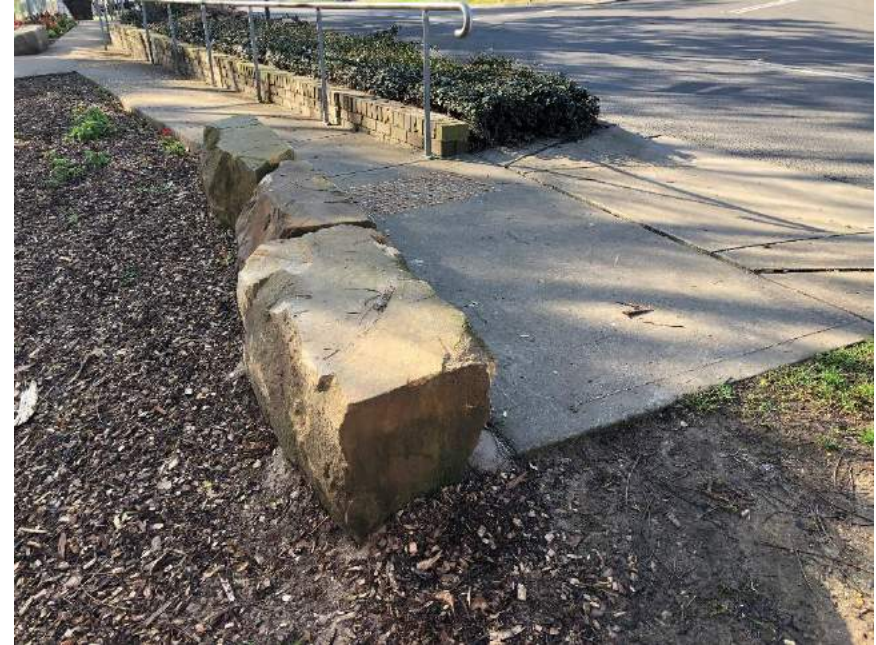
**2018:** Footpath not backfilled, exposing steel and blinding surface.

**2021:** Sandstone blocks added adjacent to footpath, concrete footpath in condition consistent with pre-construction survey.

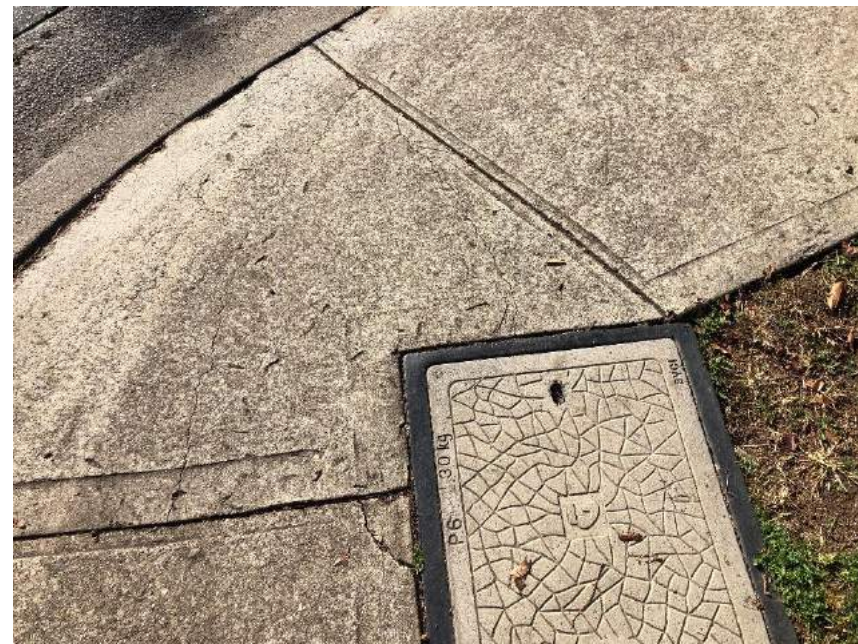
**2018:** Corner of Terrace St and Baker St – noticeable cracking in footpath.

**2021:** Corner of Terrace St and Baker St – noticeable cracking in footpath – little to no change observed compared to pre-construction survey conditions.

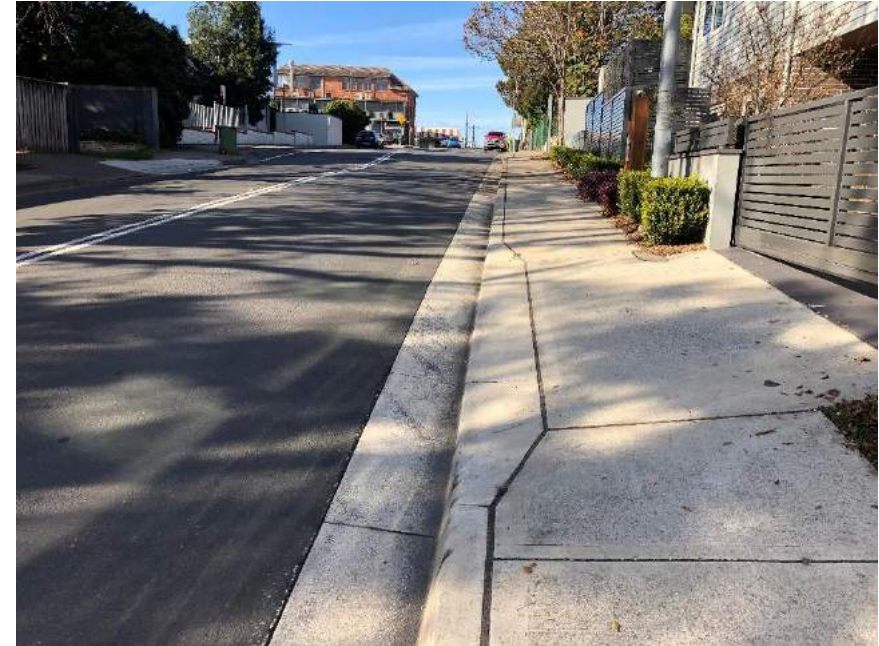
**2018:** General view of pavement and footpath – cracking in gutter.

**2021:** General view of pavement and footpath – cracking in gutter – little to no change observed compared to pre-construction survey conditions.

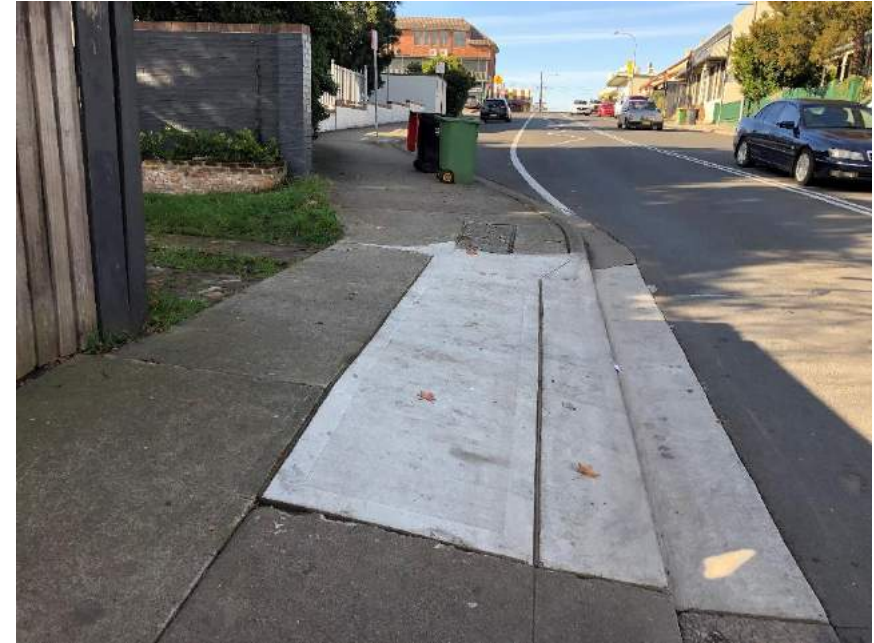
**2018:** cracking in footpath, ramp, kerb and gutter.

**2021:** Replaced concrete of cracked portion of footpath, ramp, kerb and gutter.

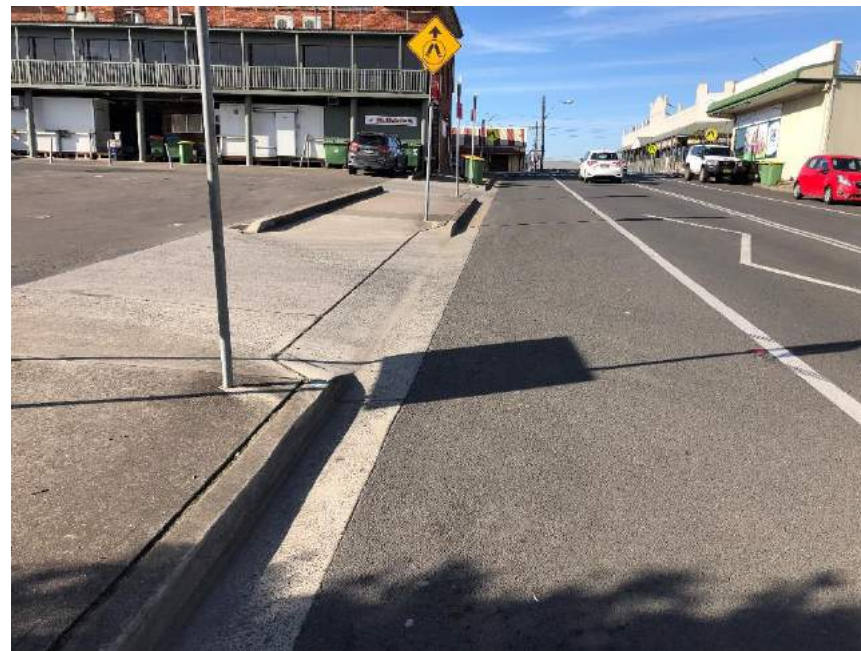
**2018:** Severe cracking on footpath/driveway.

**2021:** Cracking on footpath/driveway – little to no change observed compared to pre-construction survey conditions.

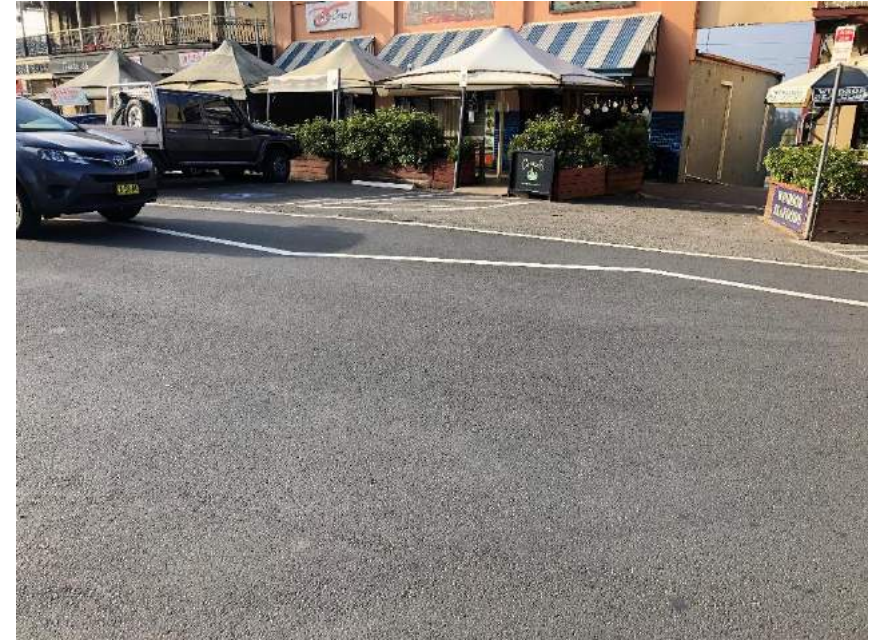
**2018:** Severe cracking and heaving on asphalt surface.

**2021:** Replacement of asphalt and remarking of lines of roadway surface.

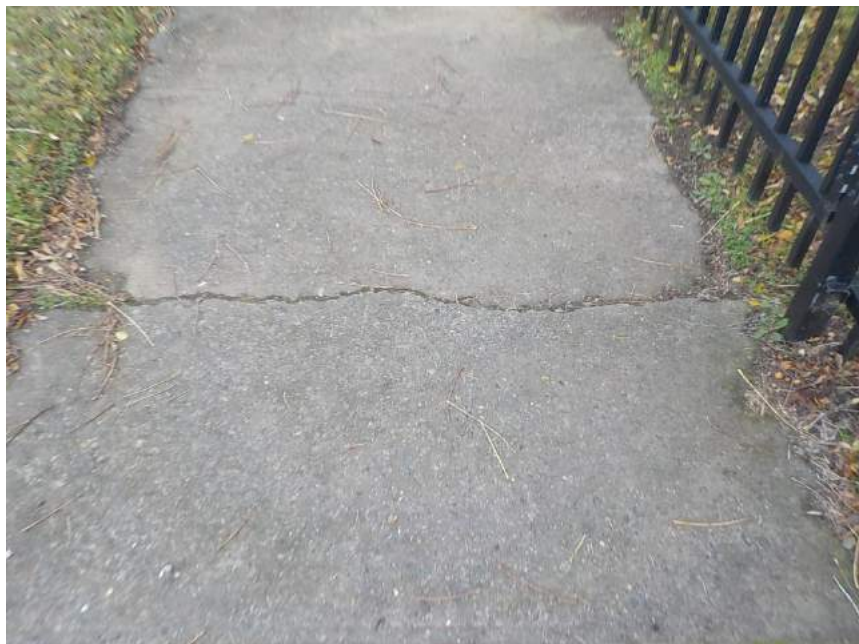
**2018:** Transverse cracking on footpath on Bridge St heading back up toward George St/roundabout.

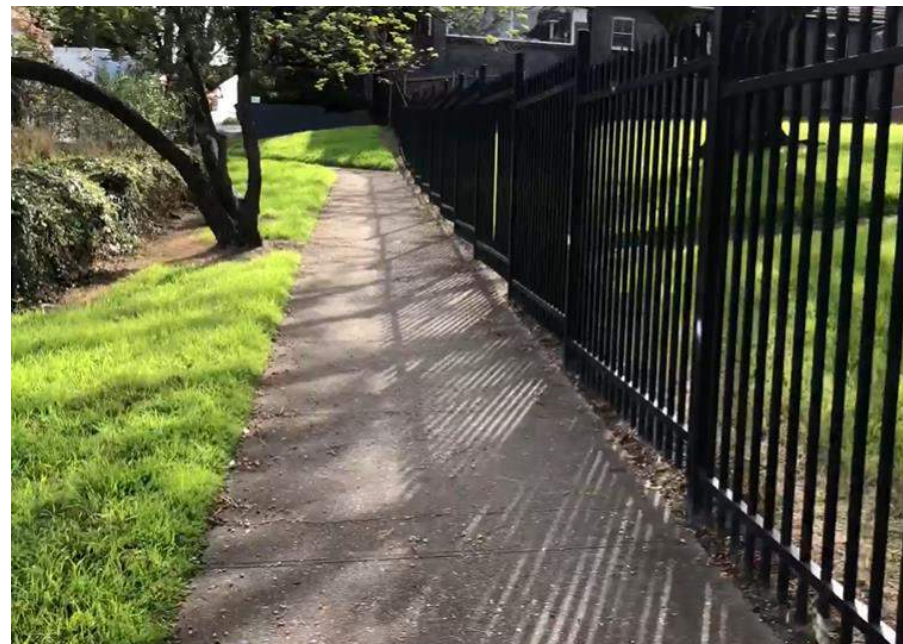
**2021:** Consistent condition of footpath on Bridge St heading back up toward George St – little to no change observed compared to pre-construction survey conditions.

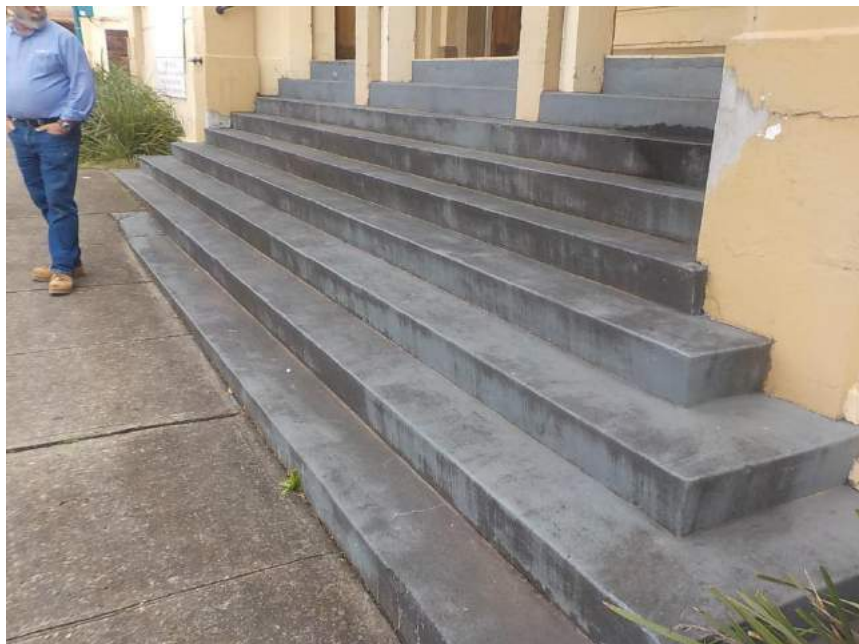
**2018:** General condition of footpath at stairs – fading and cracking of stairs and on existing walls.

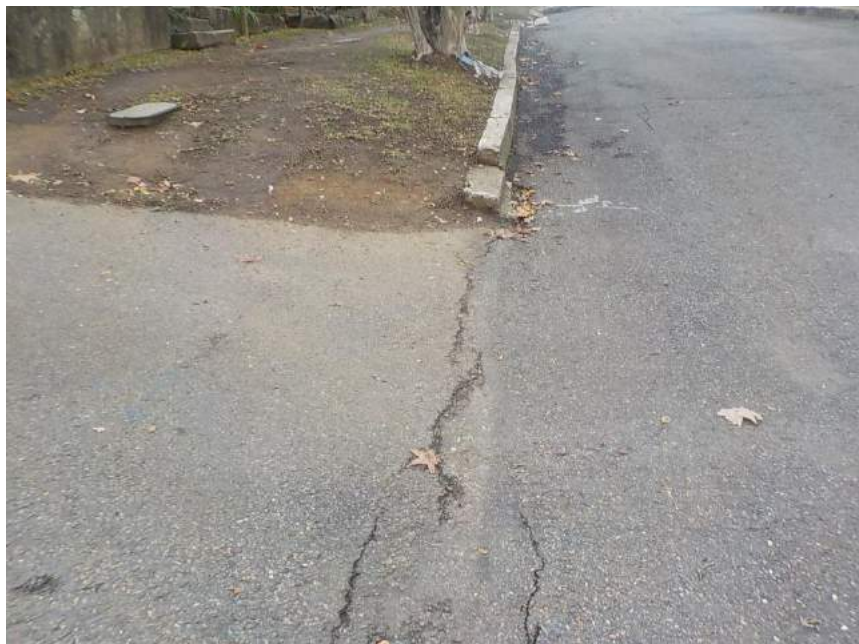
**2018:** Cracking in driveway.

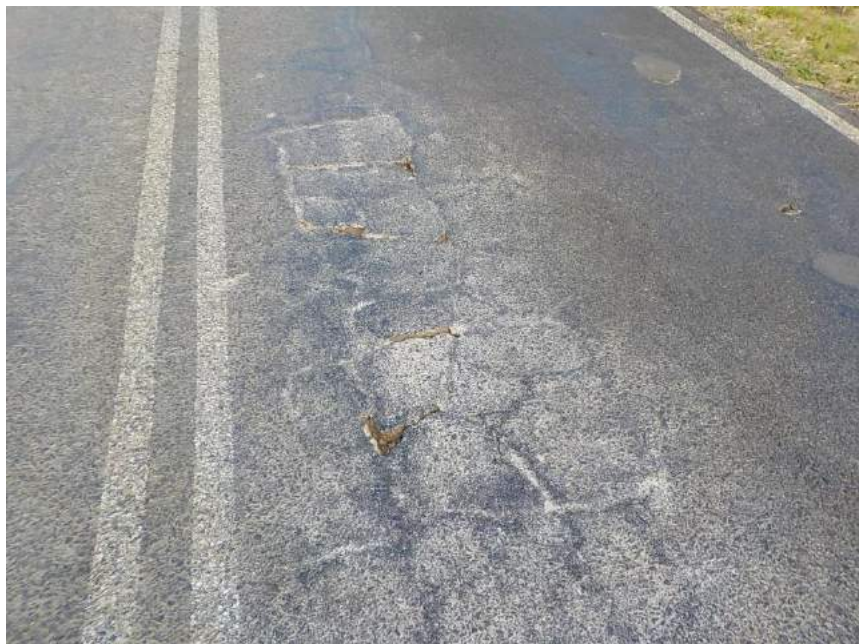
**2018:** Severe crocodile cracking and potholing on asphalt surface.

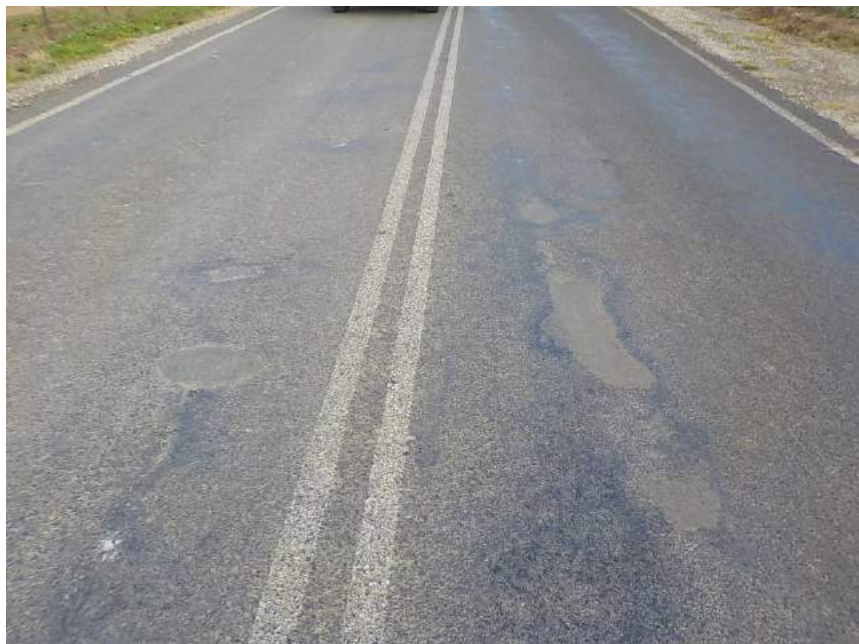
**2018:** Severe crocodile cracking, ravelling and patch repair work on asphalt surface.
