EDP Reference: S-03139.PCLCA.AreaB.001

09 August 2021

Post-Construction Land Condition Assessment – Area B, Windsor Bridge Replacement Project, Windsor NSW

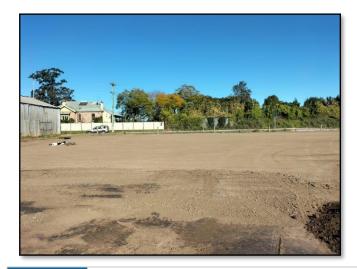
Photo I.

06/08/21 - Western portion of Area B, located adjacent to Freemans Reach Rd and to the north of President Turf Supplies warehouse, facing west.

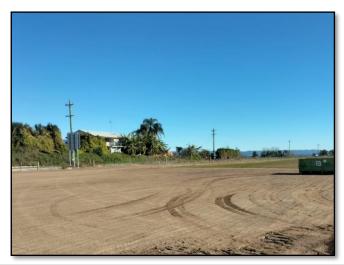
Photo 2.

06/08/21 - Open soils surfacing the north-western portion of Area B, adjacent to Freemans Reach Road to the west and turf supply lot to the north, facing northwest.

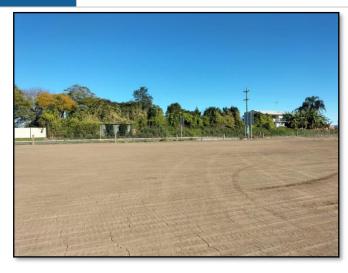
Photo 3.

06/08/21 - North-western portion of Area B with Freemans Reach Rd extending along the western boundary towards the new Windsor Bridge, facing west.

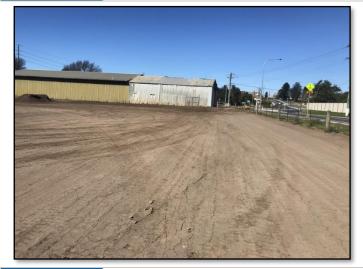
Photo 4.

06/08/21 - Southwestern portion of Area B, extending along Freemans Reach Road to newly constructed roundabout with President Turf Supplies warehouse to the south, facing south.

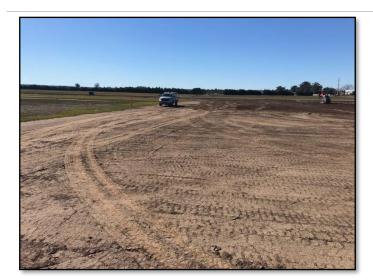
Photo 5. 07/08/2021 - North-eastern portion of Area B, observed as a vacant open space surfaced with topsoil, facing east.

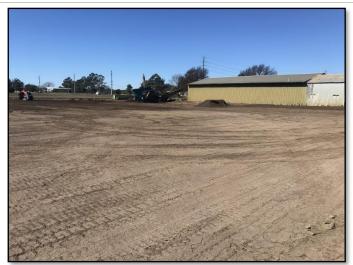
Photo 6.

07/08/2021 - South-eastern portion of Area B, adjacent to president Turf Supplies warehouse and Wilberforce Road, facing southeast. Soil materials to be used for levelling.
