our reference: 22000129-R-02
your reference:

14 June 2022

Review of Surface and Ground Water Quality: Windsor Bridge

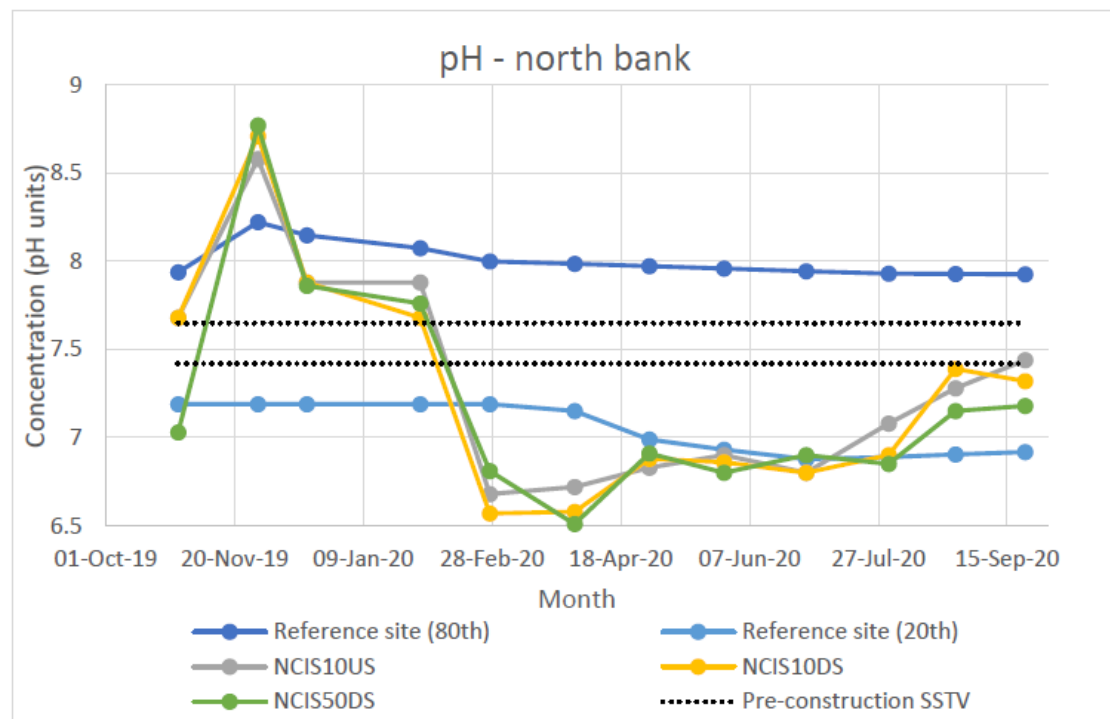
Figure 2: Example dry weather plots for pH at the north bank locations, construction phase.

The Jacobs report highlighted that although the SSTVs were not met, on most occasions the pH levels were within ANZECC trigger values and were only

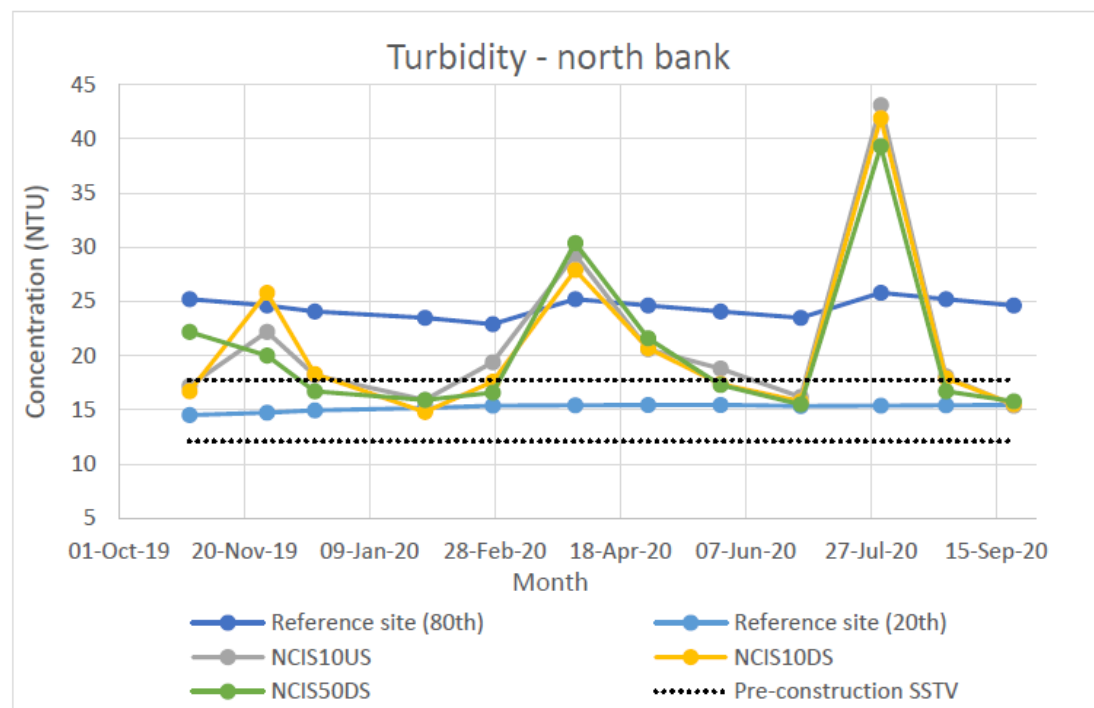
Figure 3: Example dry weather plots for Turbidity at the north bank locations, construction phase.

exceeded during large rainfall events. Turbidity levels were lower than the ANZECC trigger values and were generally within the SSTVs except after significant rainfall events.

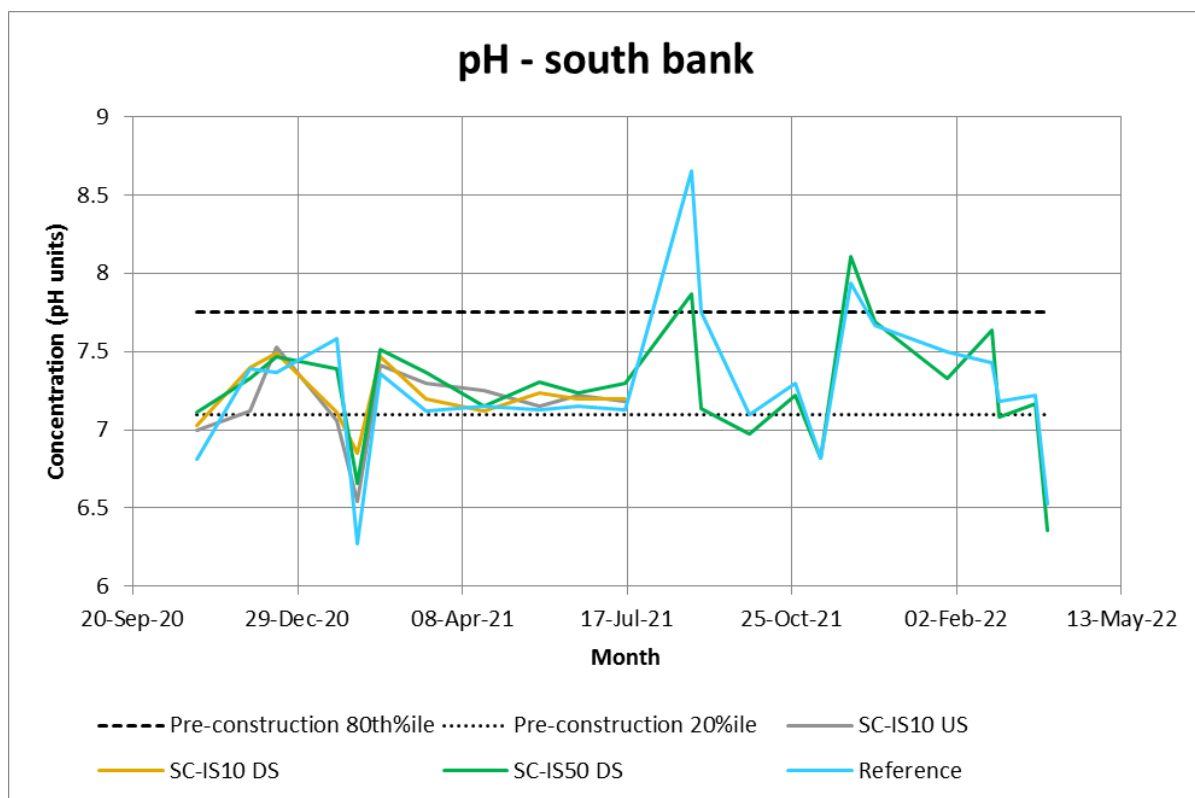
Figure 5: Plot of pH at the south bank locations, post construction phase.

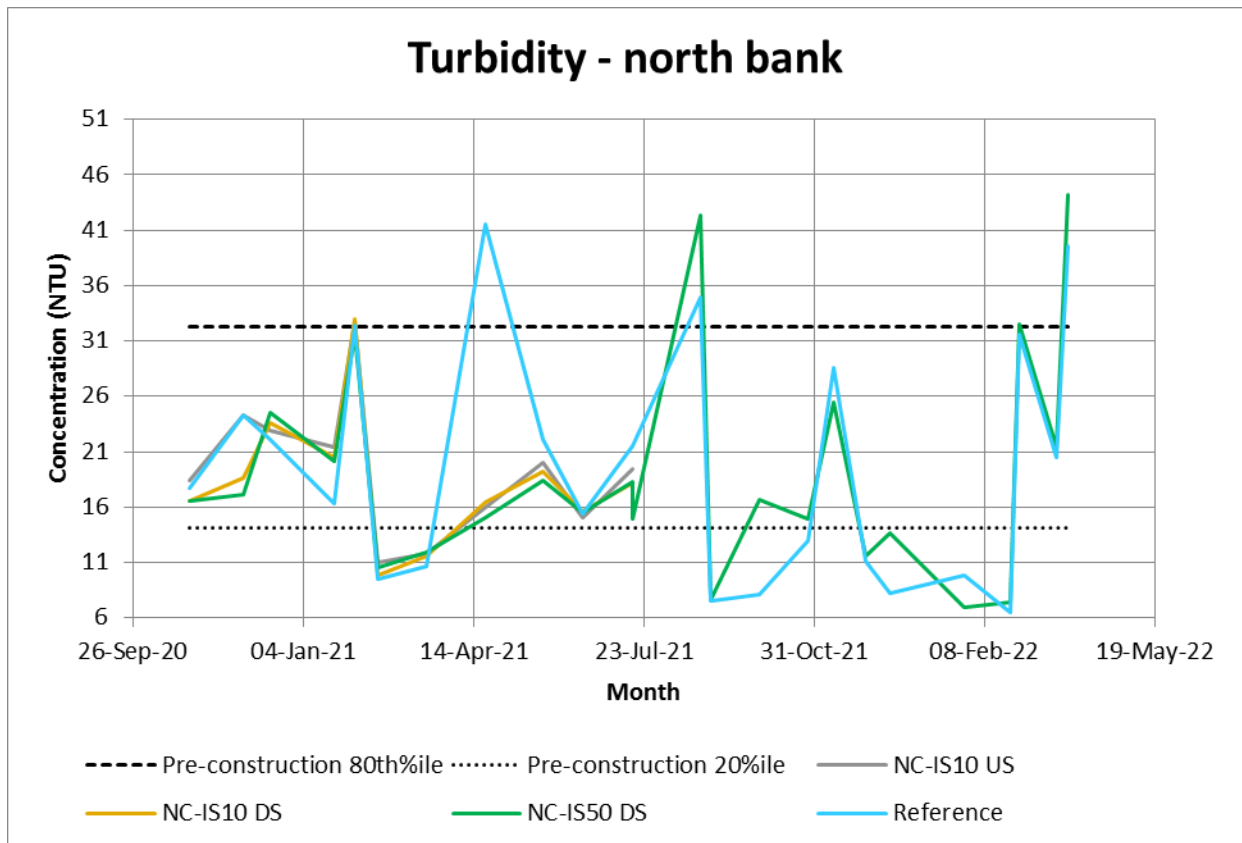
Turbidity was generally within the SSTVs and was lower than the ANZECC guideline value of 50 NTU. Turbidity only exceeded the SSTVs following rainfall and matched the change in turbidity observed at the upstream reference site.

Figure 6: Plot of Turbidity at the north bank locations, post construction.

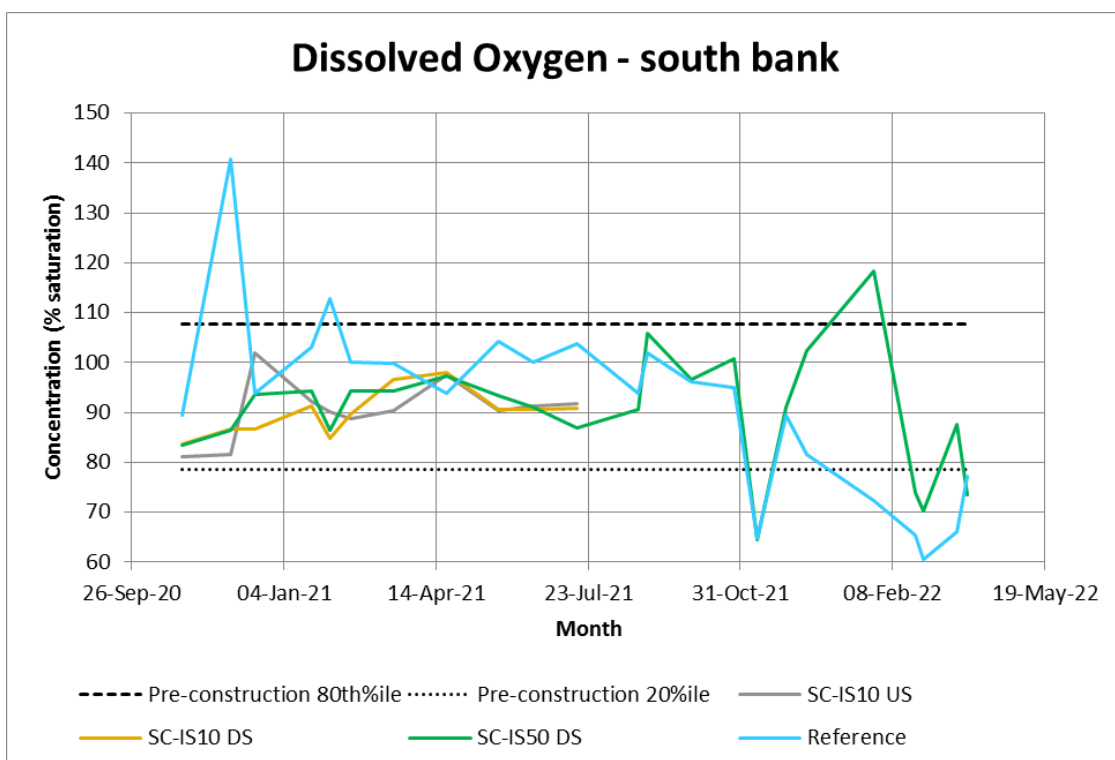
Figure 8: Plot of Dissolved Oxygen at the north bank locations, post construction.

Figure 9: Plot of Dissolved Oxygen at the south bank locations, post construction.

Dissolved oxygen was generally within the SSTVs. Values dropped below the SSTVs at the north bank between February and March however this trend also occurred at

the reference site indicating that it is unlikely that the project was the cause for the observed change in dissolved oxygen levels.
