## 6 Maritime archaeological investigations and assessment

## 6.3 Results and assessment

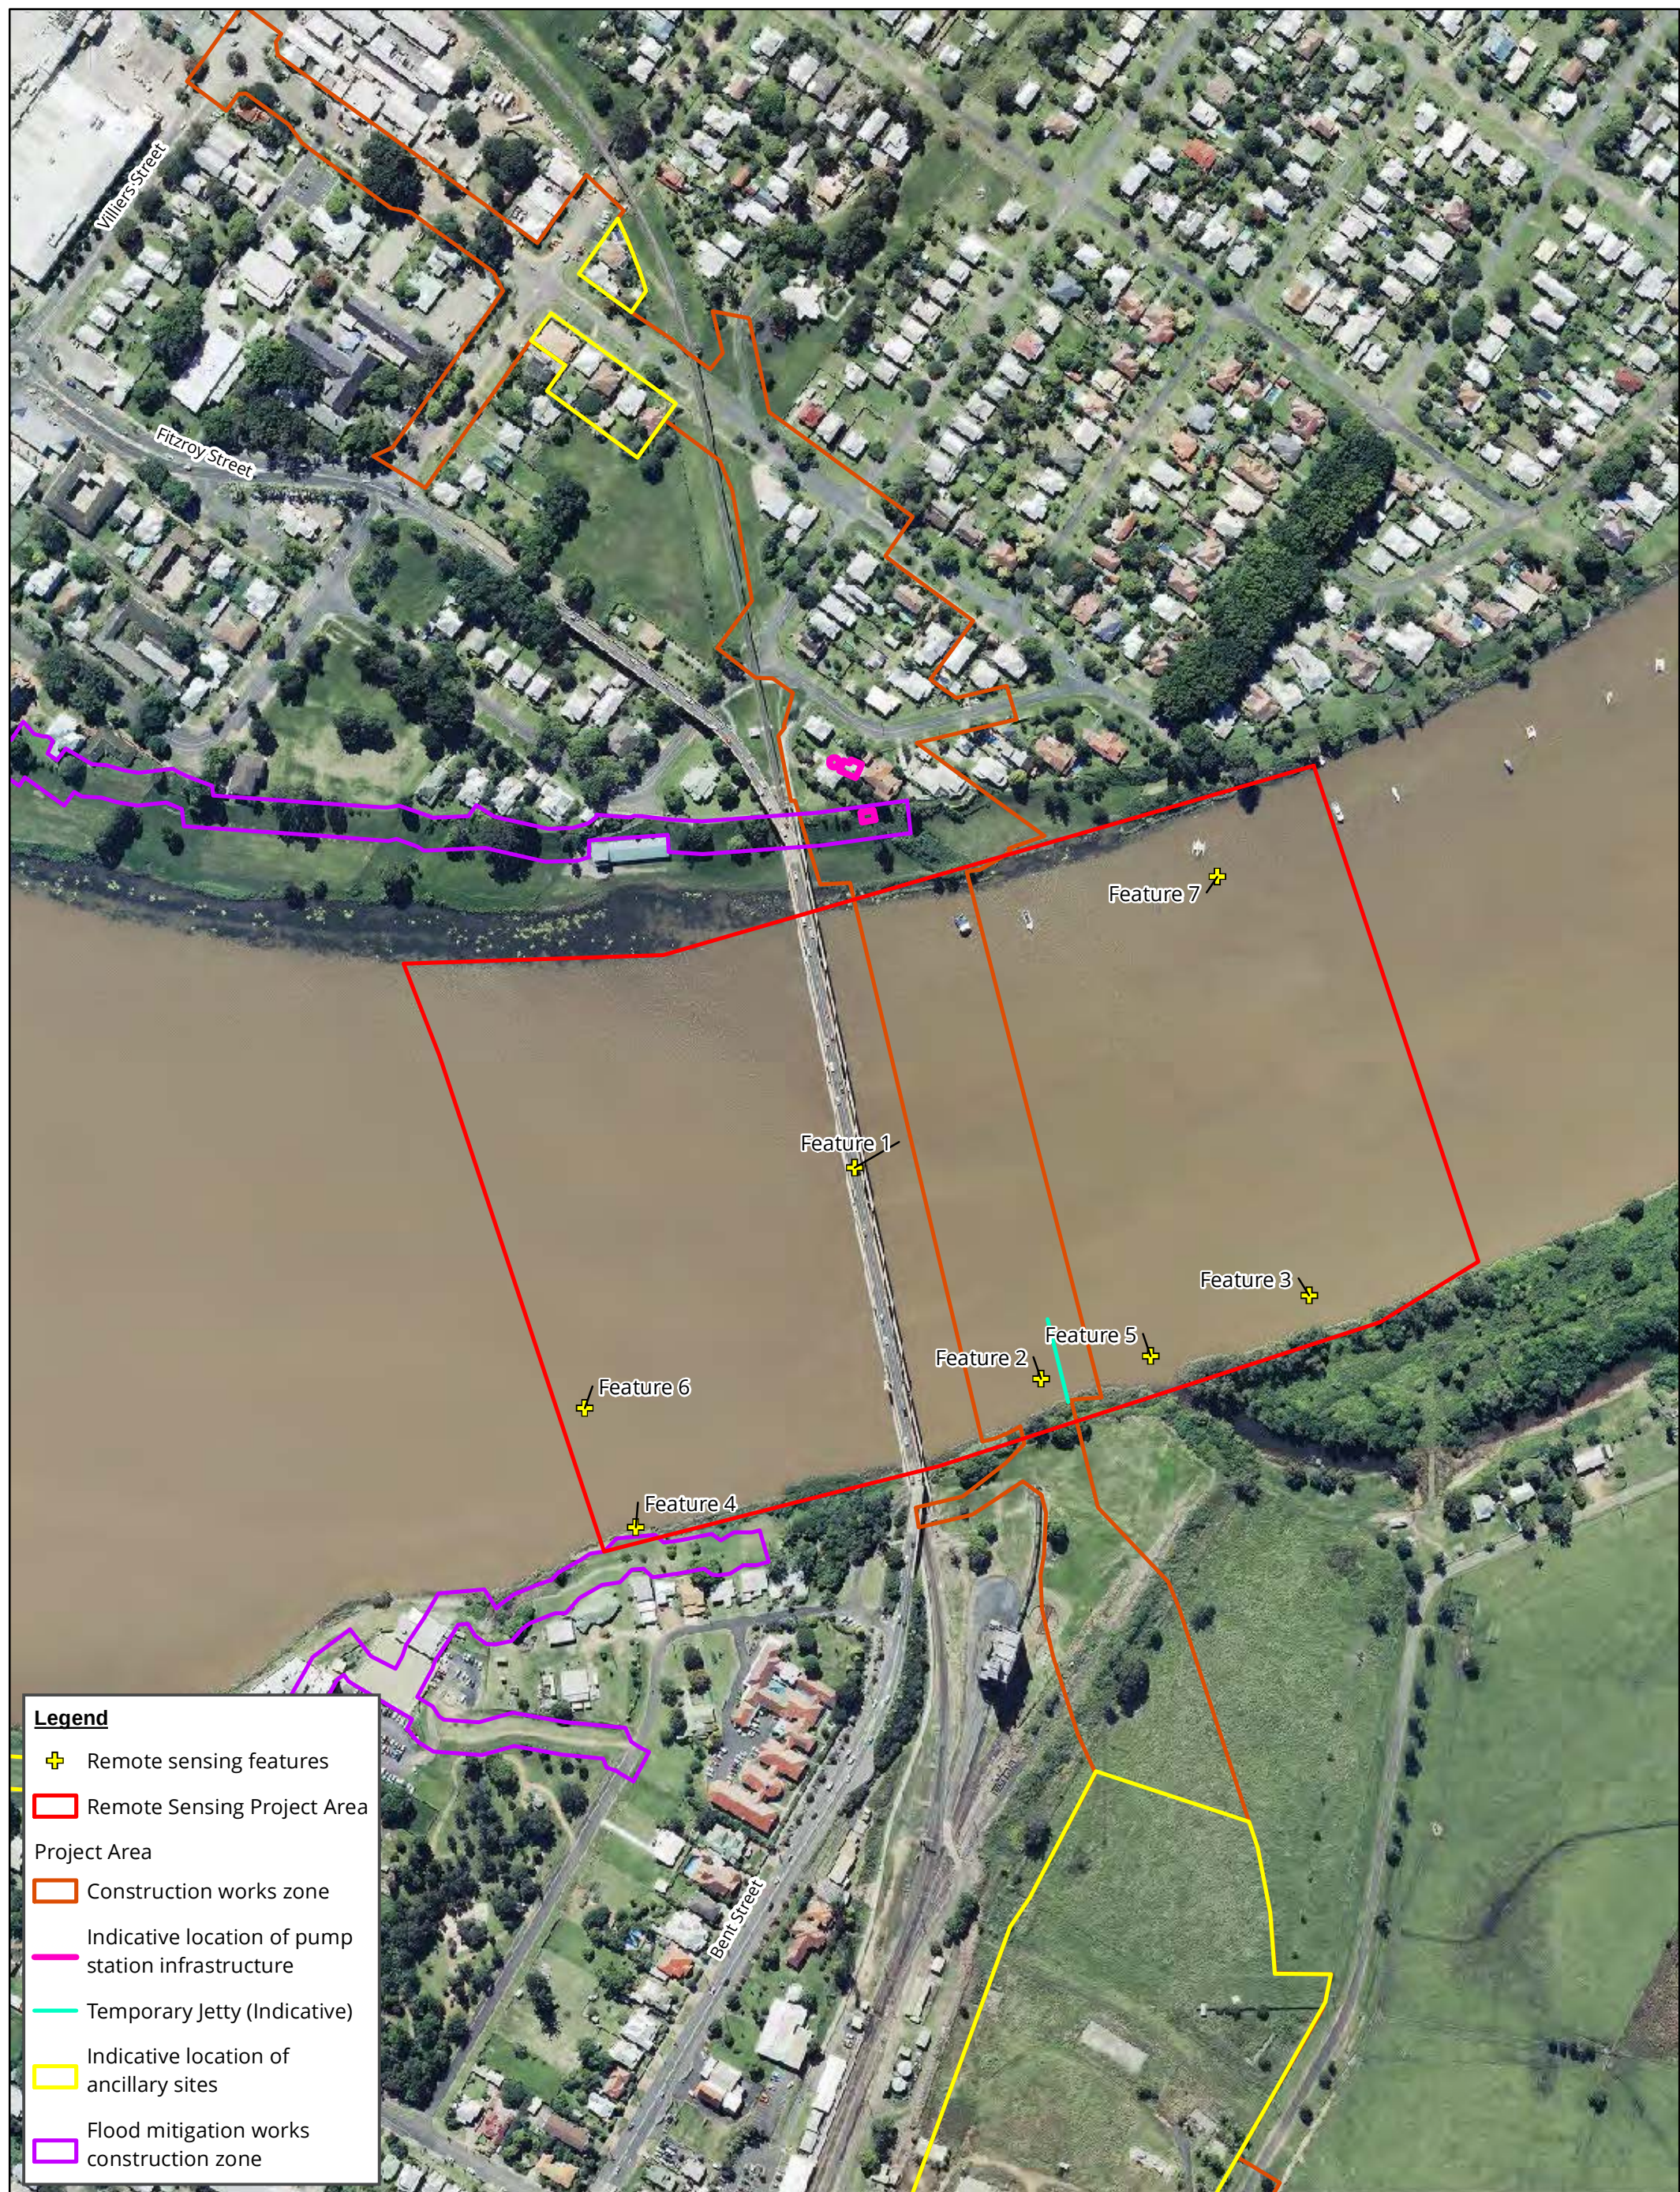
Figure 29: Results of the Remote Sensing Survey

Seven features were identified as a result of the remote sensing survey, these are summarised in Table 25 and displayed in Figure 29.

| Feature | Result | Assessment |
|---|---|---|
| 1 | This feature is around 1.2 metres in length and rises 0.8 metres from the river bed. It does not appear in the sub-bottom profile imagery, suggesting that it is insubstantial and not attached to additional structure. | This feature was not considered to contain any archaeological potential and was not included in the dive survey. |
| 2 | <p>This is an angular contact 1.5 metres height 2 metres length consistent with a concrete block or similar and likely associated with what appears to be pylons from an adjacent derelict wharf immediately north of the South Grafton Rail Precinct (CZB37) and Grafton Bridge construction area (CZB36) and west of the entrance to Alipou Creek. There is a high concentration of debris in this area.</p> <p>The proximity to a former wharf site (CZB36) makes this an area with potential for deposition of wharf infrastructure remains and equipment associated with the transfer of goods and services across the river.</p> | This feature was considered suitable for inclusion in the dive survey to confirm the nature of the object and of the adjacent debris. |
| 3 | This 1 metre x 1 metre angular contact is located adjacent to the former wharves (CZB36) east of Alipou Creek. It is consistent with a concrete block or similar sighted along the shoreline of south bank. | This feature was considered suitable for inclusion in the dive survey due to confirm its identity and relationship to the original wharf structure. |
| 4 | This is an area associated with the wreck of the <i>SS Induna</i> (FMW29). The debris field could include structural remains of the ship and/or remains of an associated wharf (FMW28). | If these objects are associated with the <i>SS Induna</i> they share that ship's listing status on the SHR. This area was included in the visual inspection to determine the nature and extent of the objects and their relationship to the <i>SS Induna</i> (FMW29). An inspection and assessment of the condition of the submerged section of the ship's hull. |
| 5 | This is a linear contact, 1 metres in length, at the entrance to Alipou Creek. It is consistent with metal rod or similar. | Due to its proximity to the former wharves (CZB36) it was included in a survey of the south bank area east of the bridge in order to assess its archaeological potential. |
| 6 | This linear contact is 30 metres in length and consistent with cable, chain, rope or similar. It may be associated with a communication cable or with the construction of the bridge. | This feature was not considered to contain any archaeological potential and was not included in the dive survey |
| 7 | This linear contact is the only feature identified on the northern side of the river. It is 9 metres length and consistent with rope. It is believed to be discarded anchor or mooring line from recreational boats in the area. | This feature was not considered to contain any archaeological potential and was not included in the dive survey. |

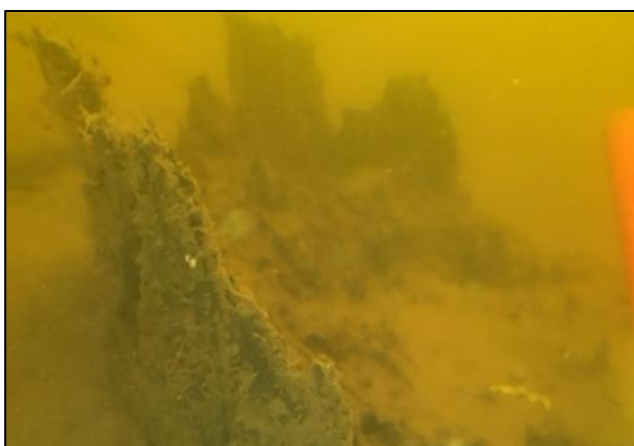
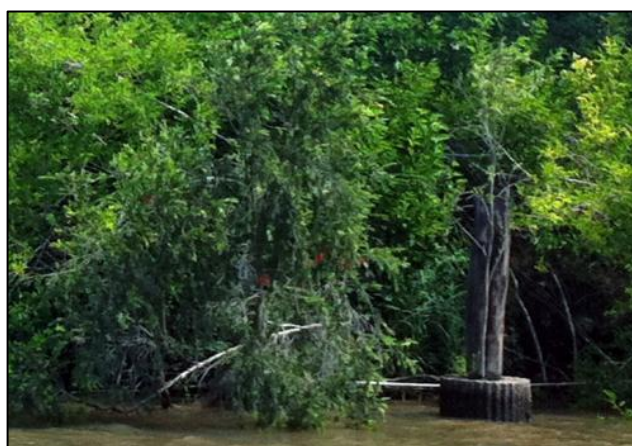
This feature lies between the existing bridge and the entrance to Alipou Creek. It consists of an extensive debris field, in up to 5 metres of water, comprising of wharf remains as well as a quantity of mattocks and picks. The debris field is about 6 to 20 metres from the river bank.

The wharf remains include two hollow concrete pylon sleeves with a corrugated outer surface lying end to end. Half of a third concrete sleeve, split open longitudinally, was also observed. Each concrete sleeve is about 3.15 metres in length. They are identical in construction to the pylons that are visible above water at the edge of the river. The concrete formed a sleeve around a central timber pole, however the timber has rotted away leaving the hollow centre. An upright piece of one timber post of similar dimension (0.3 m) was visible on the riverbed (see Plate 54).

**Plate 54: Remains of a timber post (left) and (right) Exposed remains of timber post with concrete sleeve at base near river bank – showing corrugated outer surface of the sleeve (Source: Comber Consultants)**

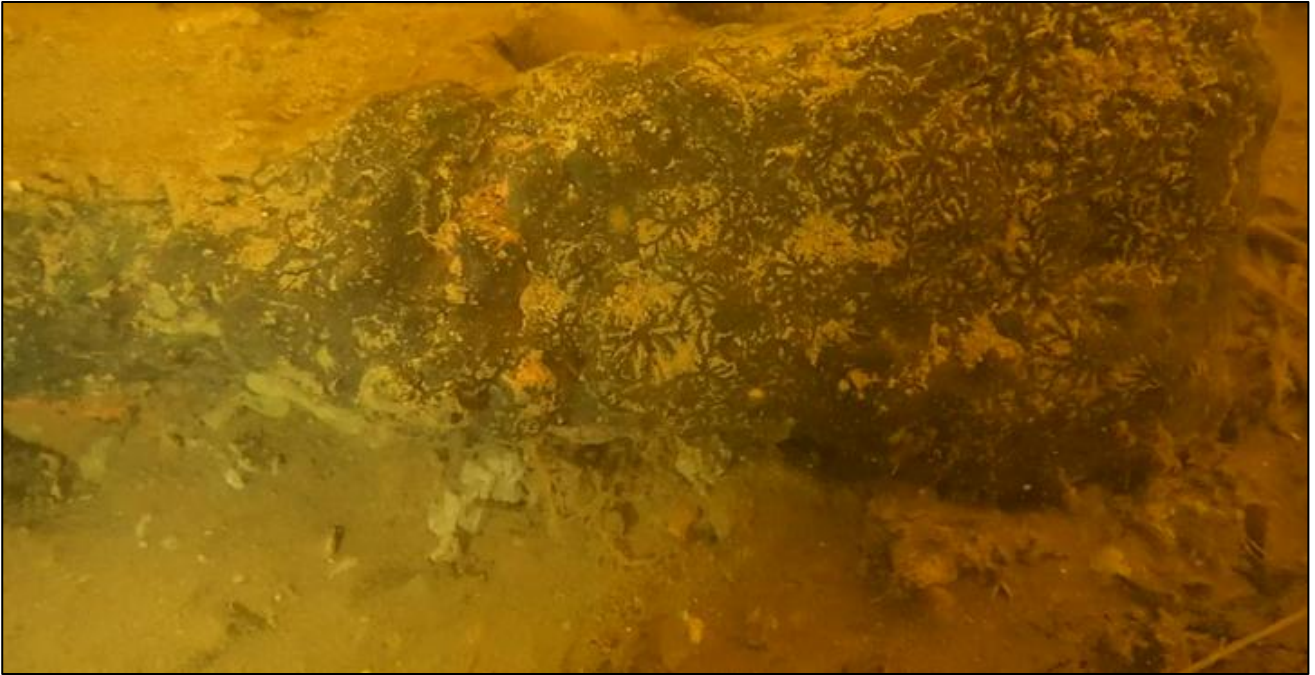
Mattocks and picks lie west of the concrete pylons and are massed together in heaps of six or more. The timber handles were occasionally present (see Plate 55). The tools appeared to have been dumped as a group. Elsewhere, also in about 5 metres of water, are a number of timber beams with metal fastenings or bolt holes which appear to be the remains of the wharf. These timbers run parallel to the shore line (see Plate 56). The items encountered at Feature 2 are common in nature and therefore have been assessed as not being a relics or heritage items.

**Plate 55: Mattock blade at remote sensing Feature 2 (Source: Comber Associates)**

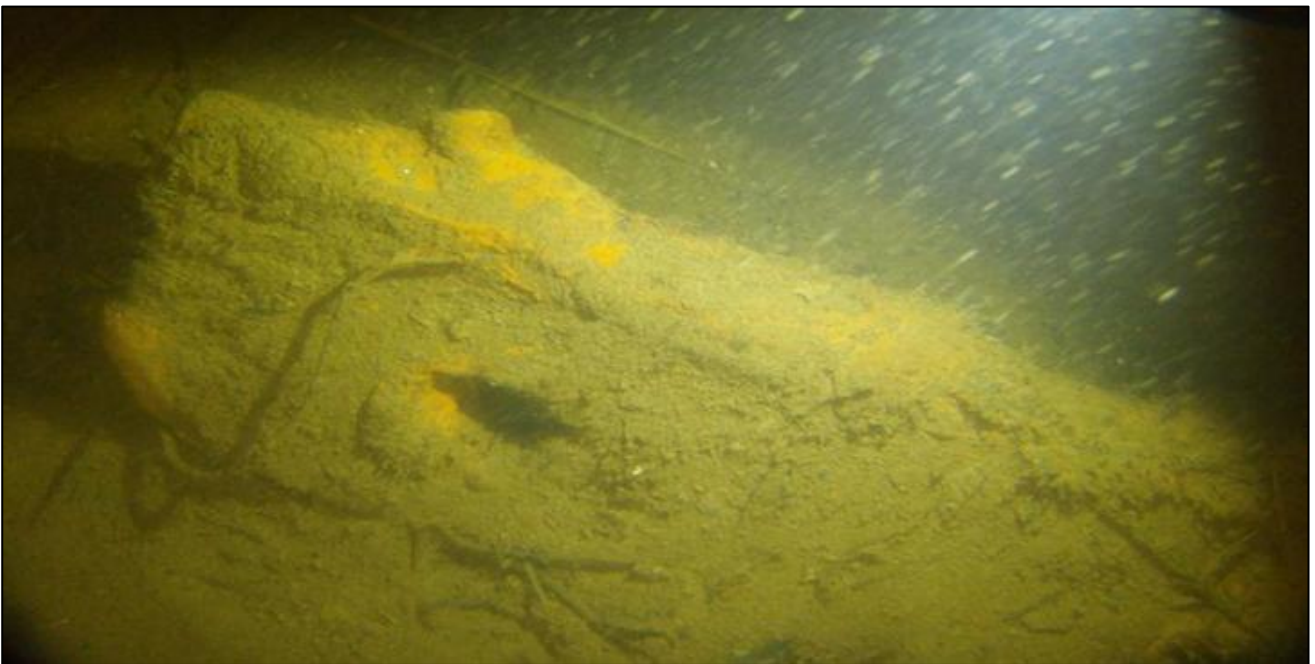
**Plate 56: Wharf timber at remote sensing Feature 2 (Source: Comber Associates)**

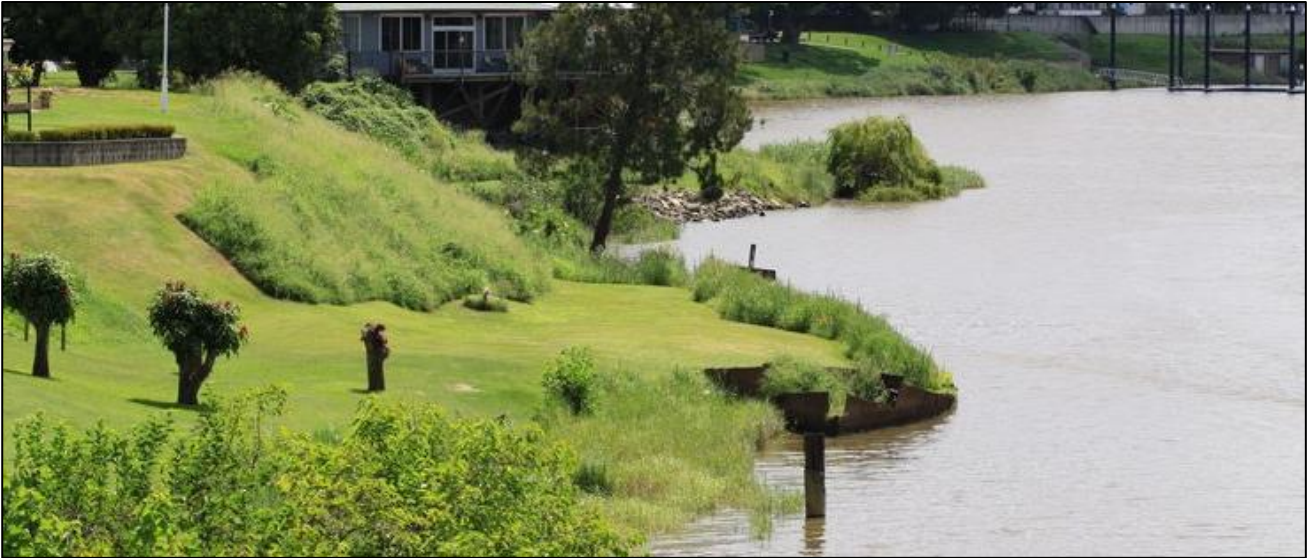
Underwater, the debris field is restricted to the length of the ship (about 58 metres) and about 6 metres northwards from the port side of the hull (see Plate 57). Most of the debris was within 3 metres of the hull. With the exception of one and a half house bricks the debris field consisted entirely of ferrous metal associated with the *SS Induna* which appears to have fallen into the river prior to or during the removal of the ship's superstructure in 1972. This included rectangular sections of iron plate, one of these was 3 metres in length and about 1 metres in width. A five metres section of frame was located near the stern of the *SS Induna* (FMW29) and frame sections as well as a couple of 1.5 metres sections of 40-50 millimetres diameter ferrous pipe. A 1 metres long, 0.3 metres diameter ferrous cylinder with a 50 millimetres diameter pipe running through the centre of the cylinder was also located in this area. A 0.4 x 0.3 metres moulded, oval ferrous cover, possibly off a pressure vessel, was located about 3 metres north of the stern. The site also included a single ferrous bolt of about 160 millimetres in length.

**Plate 57: Western facing photograph of the SS *Induna* (FMW29) which clearly shows the embankment extending over SS *Induna* hull and the proximity of the existing levee (Source: Comber Consultants).**

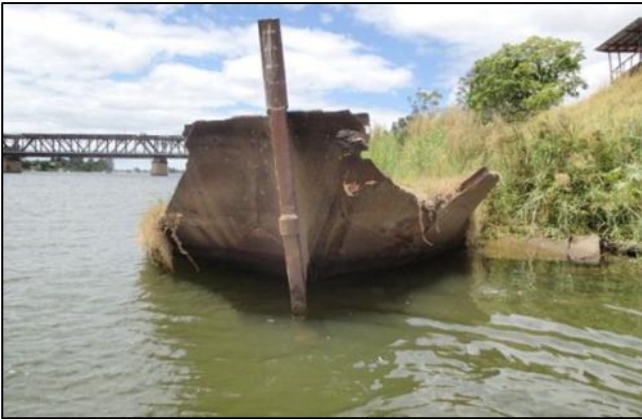
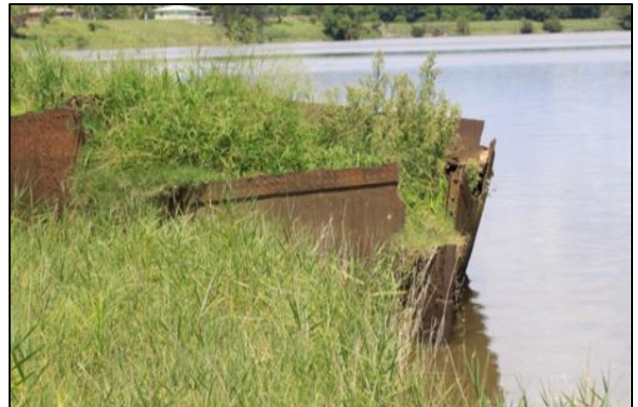
**Plate 58: East facing photograph of the stern of SS *Induna* (FMW29) (left) and (right) bow area where bow was removed for nearby memorial (Source: Comber Consultants).**

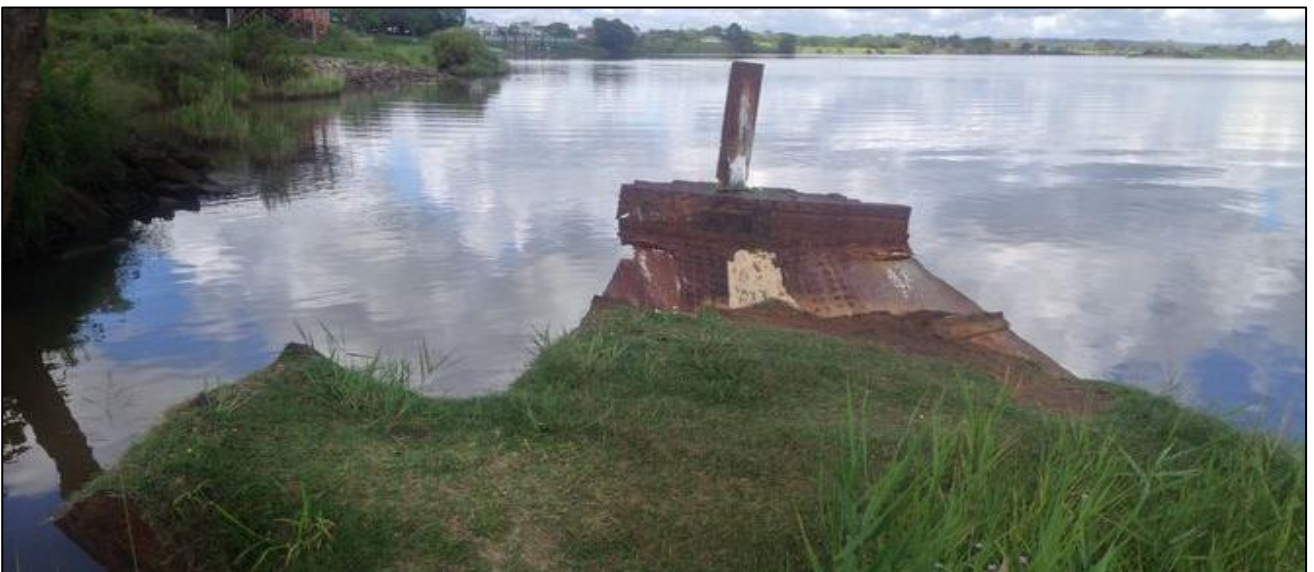
**Plate 59: West facing photograph of the stern of the SS *Induna* (FMW29) (Source: Comber Consultants)**

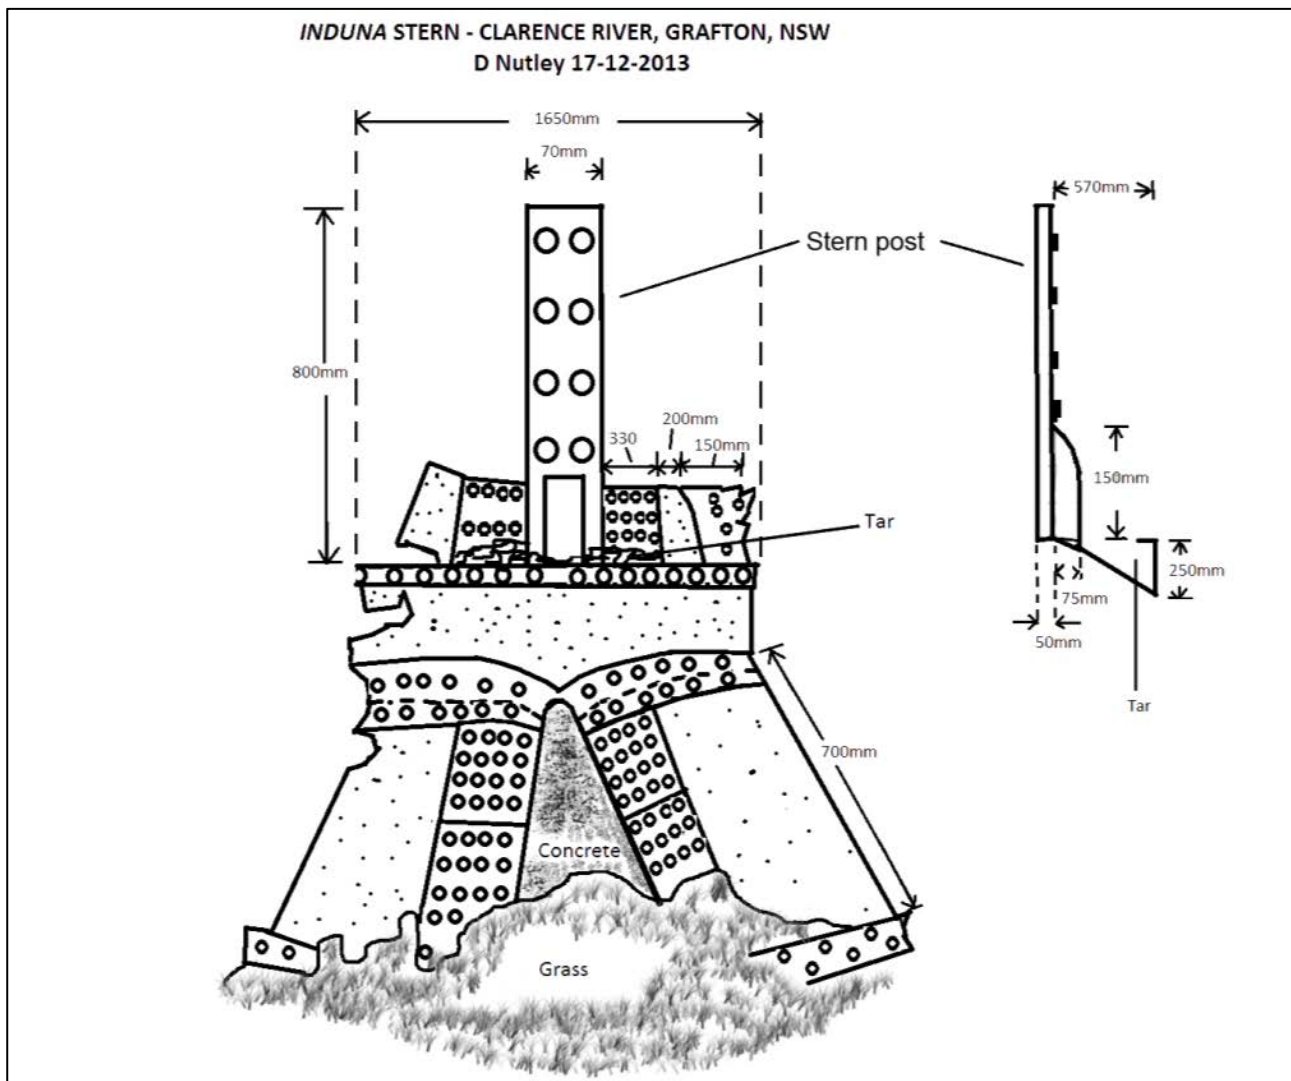
The lower hull of the *SS Induna* is clear of the seabed. Due to the confined space, safety concerns and limited visibility, the full extent of the hull clearance could not be established but, based on observations at the bow and stern and the limit of torch light penetration at mid-ships, the clearance appears to be about at least as far as the keel (see Plate 58 and Plate 61). The submerged bow and stern sections of the port hull were in good condition. Amidships, however, there were six large openings between the hull frames and above the turn of the bilge. Each opening is about 1 metres in height and 0.7 metres in width. This appears to be the result of natural corrosion of the hull plating in an oxygenated area that is periodically exposed to wetting and drying.

Immediately in front of the stern post is remnant tar/pitch which lies between the stern post and a 1650 millimetres frame. In front of this frame can be seen the rear extremity of the concrete ballast that was introduced for the vessel's rail ferry work. The wreckage itself has survived the regular flooding of the river and appears relatively stable. The submerged hull plates and frames remain relatively sound and there are no signs of loose plating or frames that could indicate potential for imminent collapse. At water level, the hull plating and longitudinal frames just forward of the stern assembly are no longer present but the lower frames and keel appear to be intact and the stern remains in alignment with the bow. The underwater survey revealed that almost the entire port side of the hull is supported by water rather than the river bed sediment.

Plate 61: Raised and exposed stern section of the SS *Induna* (FMW29). View to the west from inside the hull (Source: Comber Consultants).
