# **The Northern Road – Mersey Road, Bringelly to Glenmore Parkway, Glenmore Park**

## **Environmental Representative Monthly Report**

**October 2020**

**Doc no. 18008-RP-MR-028-TNR 4,5,6 Monthly Report\_October 2020 \_0**

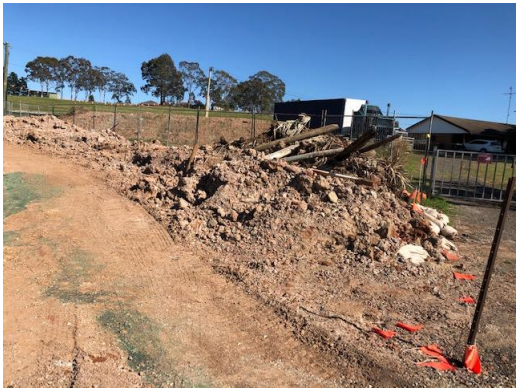
1	General – Bradley Street as an example	<p>Housekeeping across the site need some attention. Bradley Street site is a good example of where housekeeping needs some attention.</p>

L	Housekeeping across the site needs some attention to just generally clean up the site of construction waste and rubbish.	Ongoing	<p>Rubbish removed – refer photo below.</p>

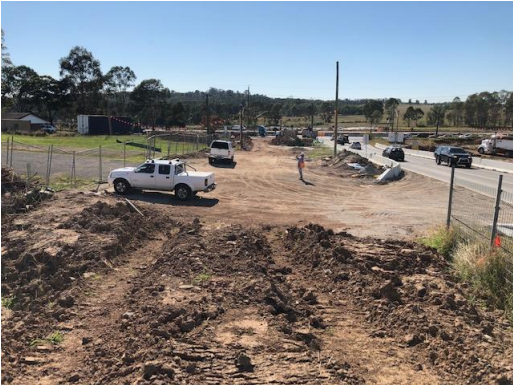
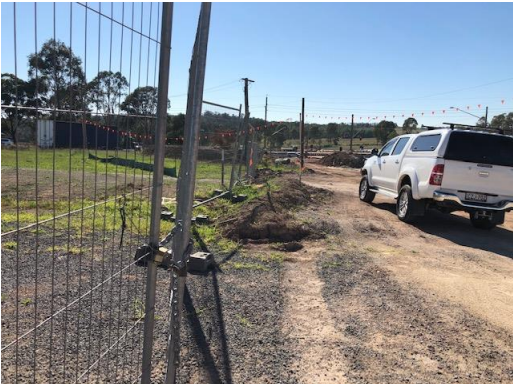
2	Bradley Street	<p>The north side of the Bradley Street site does not currently have good 'clean water' separation.</p>

M	<p>Install earth bund (or amend the existing earth bund) to ensure the clean water coming from the north of the site is separated and being directed to the existing TNR roadside vegetated swale.</p> <p>Water may need to be piped under the driveway.</p> <p>Water to be directed to a stabilised batter chute to get into the vegetated swale.</p>	16/10/20	<p>A continuous earth bund has been installed. Refer photo for 1 above and from photo below:</p>

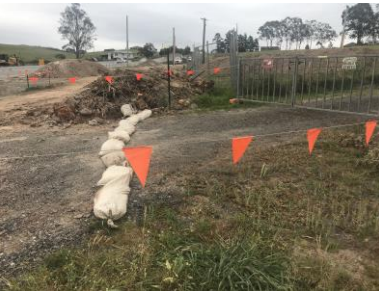
<p>Sandbags have also been placed across tenants driveway to help direct concentrated clean water flows over into grassed area</p>

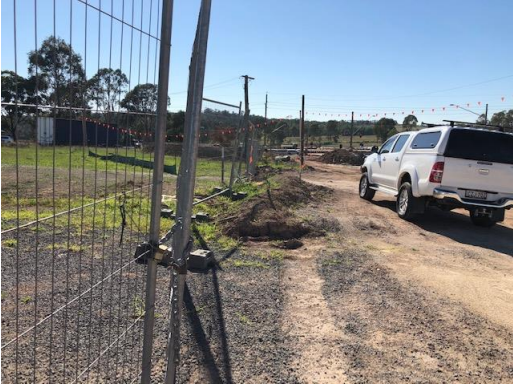
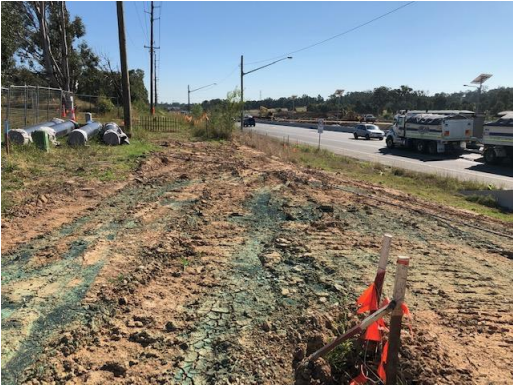
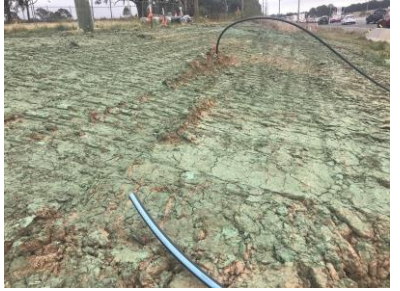
<p>Stockpiled material has been compacted and sprayed with soil binder. The lower section has had a good dose of soil binder applied to it. Refer photo below:</p>
---	----------------	------------------------------------------------------------------------------------------------------------------------------------------------------------------------------------------------------------------------------------------------------------------------------	---	--------------------------------------------------------------------------------------------------------------------------------------------------------------------------------------------------------------------------------------------------------------------------------------------------------------------------------------------------------	----------	---------------------------------------------------------------------------------------------------------------------------------------------------------------------------------------------------------------------------------------------------------------------------------------------------------------------------------------------------------------------------------------------------------------------------------------------------------------------------------------------------------------------------------------------------------------------------------

<p>Sand bag checks have also been installed against jersey kerbs to slow concentrated flows along asphalted edge and assist with sediment retention from top of site, down to bottom.</p>
3	P12 – northern fill area	Northern fill area is currently boxed out so that if it were to rain water would pond on the fill.	M	Recommend to cut a drain in the verge material to drain the fill area in the event of a rain event. Also, strengthen controls in drain by adding sand bags to strengthen and raise the bund.	16/10/20	This action has been communicated for completion over dayshift this weekend.

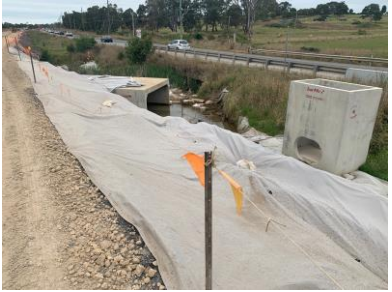
5	South of P12 Gate	<p>Outlet of main culvert – fill has been built up around this area, however, the sediment controls have not kept up.</p>  	M	<p>Recommend pulling batters around the culvert outlet and covering with geofabric on the north and south sides of the culvert.</p>	16/10/20	<p>Geofabric refreshed in this area. Refer photo below:</p>

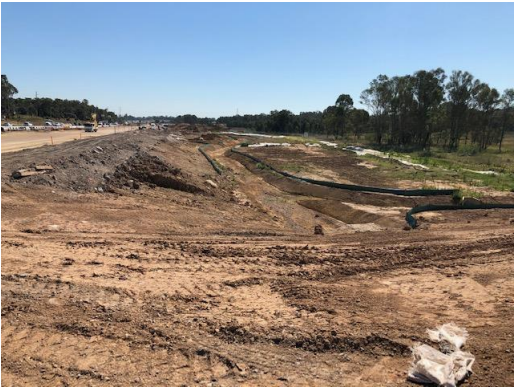
6	P12 – main retention dam	<p>Works in progress - Drain from the outlet of the retention dam is currently being constructed.</p>

M	Continue to make this drain construction a priority to get finished prior to rainfall. Where it cannot be finished prior to rainfall, install temporary controls to minimise the amount of potential dirty water being discharged into the vegetated drain downstream.	16/10/20	Noted. Progress has been made this week to dig the fish passage. Further work to install temporary controls has been communicated with the site Foreman.

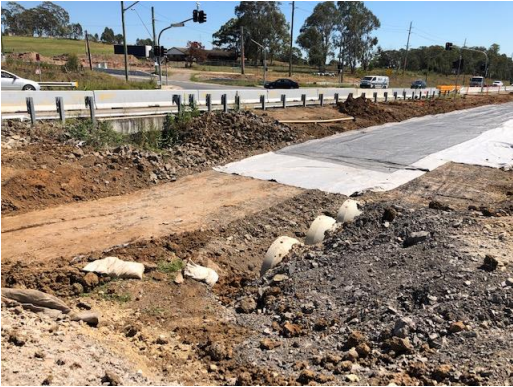
7	Median inlet of triple cell pipe culvert	<p>Works in progress – currently filling median at inlet of pipes to create a stable base. Once complete, the clean water path needs to be reinstated prior to the weekend.</p>

M	Reinstate clean water path from the existing culvert through the new triple cell pipe culvert.	16/10/20	The construction team has shaped the inlet and will be finalising to design soon. Water from Bradley street has the ability to be slowed in this area prior to entering the triple cell culvert.
8	N3 Box Culvert	<p>General observation - Southbound side of culvert is currently being constructed. Formwork for base slab currently being installed and being prepared for concrete pour in near future. It is noted that the clean water from this culvert is being accepted in this</p>	N/A	N/A	N/A	Concrete slab has been poured. An outlet to join the water from the culvert to the existing clean water diversion will occur in due course.

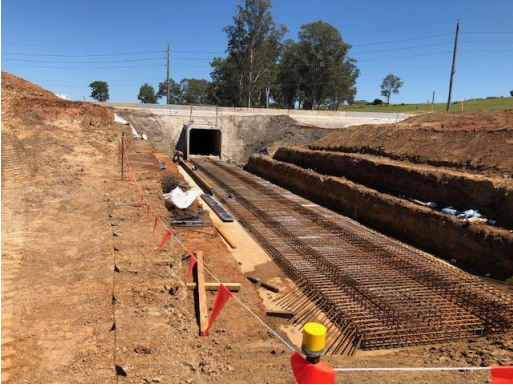
<p>excavation, and it is recommended that the construction of the slab continue to be a priority to get constructed prior to the next significant rainfall to minimise the impact on the culvert construction program, which will allow the outlet to be completed soon after and the clean water be able to pass all the way through the transverse drainage system.</p>

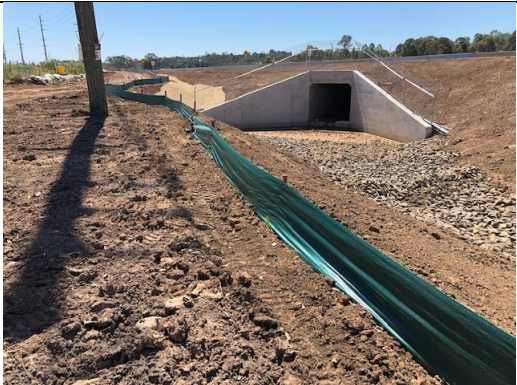
9	N3 Box culvert – inlet	<p>The inlet side of the culvert largely complete, however there are a few critical items that need to be completed to protect the area to minimise the potential of erosion and subsequently re-work.</p>	M	<p>As a minimum jute mesh should be installed between the sediment fence and rock.</p> <p>Recommend that a bund or similar is installed from the power pole to where the photo is taken to slow water down and direct the water to enter this drain at a single point which can be strengthened. This single point should also have a low batter height to minimise the velocity the water will flow down the batter.</p>	16/10/20	<p>At this point a temporary fix using soil binder will ensure the surface is stabilised. Hydro mulching is currently occurring on the South bound in preparation for the main traffic switch and will then move over to the N3 side in due course.</p> <p>RFI has been put into the system for enhancing water quality flows into N3 Box culvert on the inlet side.</p>

<p>Hydro-mulch all of the areas that have not been hyrdo-mulched yet (ie above the culvert headwall and drain to the north of the inlet.</p> <p>Inlet apron should be cleaned off while dry to minimise the risk of this sediment remobilising in a rain event.</p> <p>Further discussion should be had with RMS about the areas that have been specified to be “naturally regenerated”. Natural regeneration will not occur in this corridor, but rather weeds will grow and take over these areas instead.</p>	an update.	
--	--	-----------------------------------------------------------------------------------	------------------------------------------------------------------------------------------------------------------------------------------------------------------------------------------------------------------------------------------------------------------------------------------------------------------------------------------------------------------------------------------------------------------------------------------------------------------------------------------------------------------	------------	--

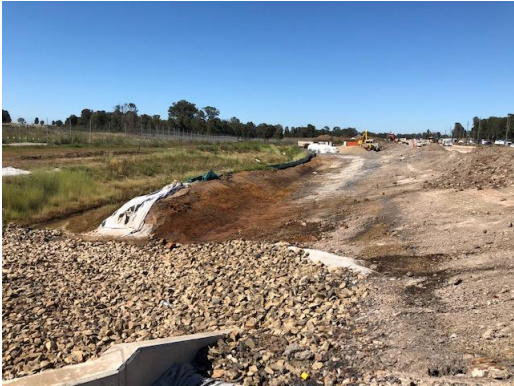
No	LOCATION (Chainage/ Description)	ISSUE/COMMENT	PRIORITY/ RISK (I, H, M, L)	ACTION	Agreed Close out date	Response
1	South of P12 gate	<p>Works in progress - New table drain has been cut to lead into the inlet of the main culvert. Drain needs to be lined and complete, or an earth bund installed to hold water back as a matter of priority.</p>

M	Complete drain lining or install bund to hold water back by the end of the week.	23/10/20 or prior to rainfall.	<p>Geotextile has been laid down to reduce erosion and sedimentation into the creek.</p>

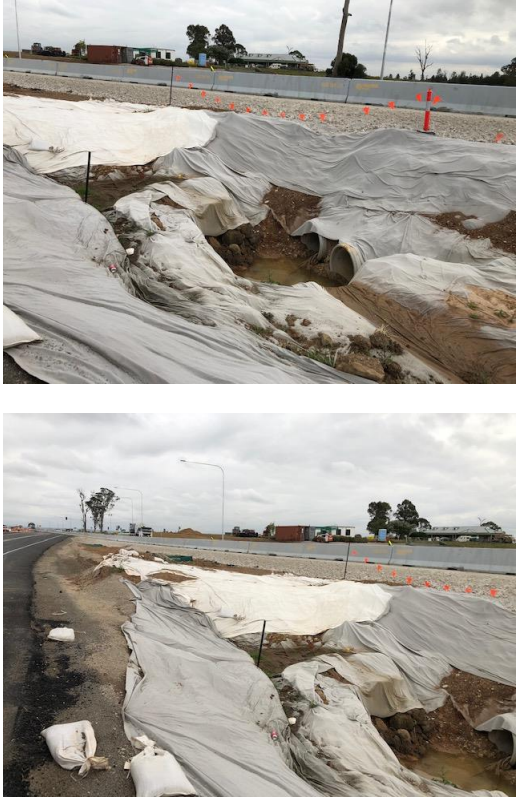
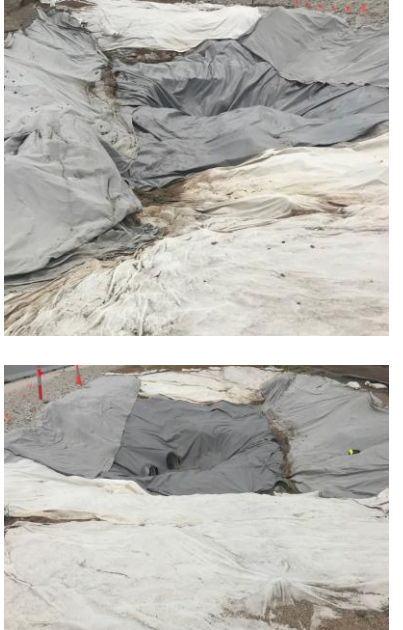
2	Basin near small compound north of Gate N2	Water in this area is not currently maximised to the basin.	M	Install an earth bund between batter and stockpile area to direct as much water to the basin as possible.	23/10/20 or prior to rainfall.	<p>Toe-of-batter berms added to push water across at grade with spillways upgraded into and out of Basin 17, as shown below:</p>

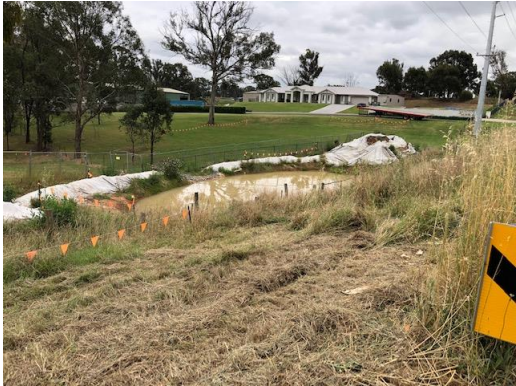
3	Basin near GRS Towing	Basin appears to be nearly at capacity

M	Empty basin prior to forecast rainfall	23/10/20 or prior to rainfall.	Basin flocced 21/10 and emptied 22/10.

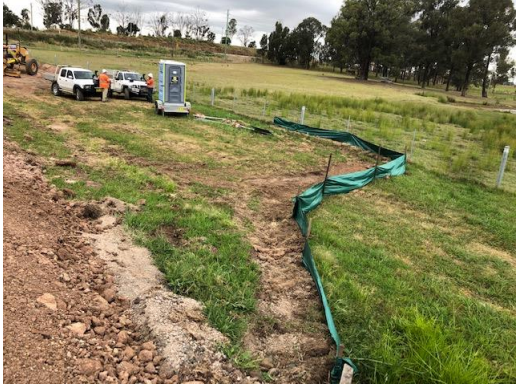
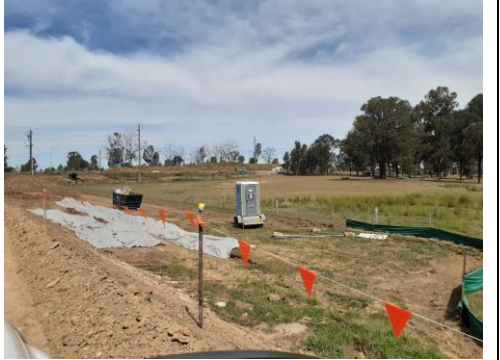
4	Kings Hill Road	Clean and dirty water separation needs some additional controls	M	Install some additional sediment fence or an earth bund along the edge of the site to better separate clean and dirty water.	23/10/20 or prior to rainfall.	An earth bund has been installed along the fence line to divert rainwater from the

paddock into the clean water channel.

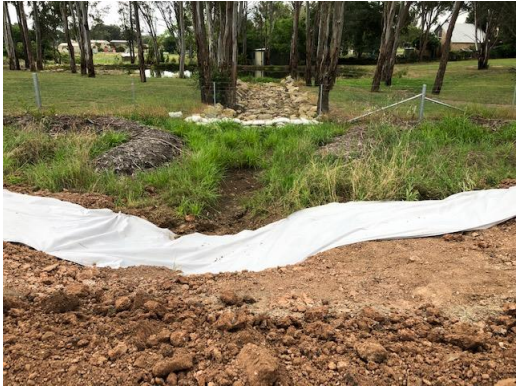
5	Kings Hill Road	<p>Additional work required to not allow dirty water to go directly into the clean water area of the culvert outlet.</p>

M	<p>Install bund across the top of the culvert outlet to hold water on the formation. And install additional geofabric to protect the exposed material on the clean water side of the bund.</p>	23/10/20 or prior to rainfall.	<p>Bund has been installed at end of shift 22/10.</p> <p>Due to the volume of material brought in since the inspection date, water now travels past this point to a location further west of here.</p> <p>Short of a 150mm of rain event, there is very little chance forecast rainfall would bank up from the new low point to the west and overtop at this culvert location.</p>

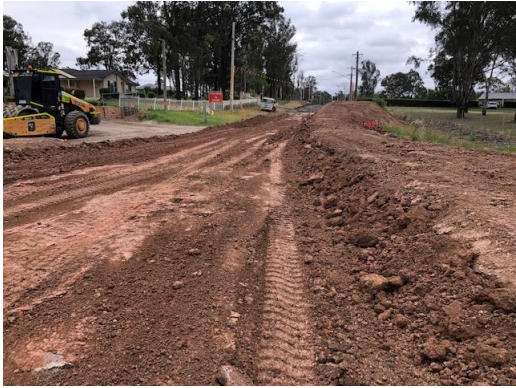
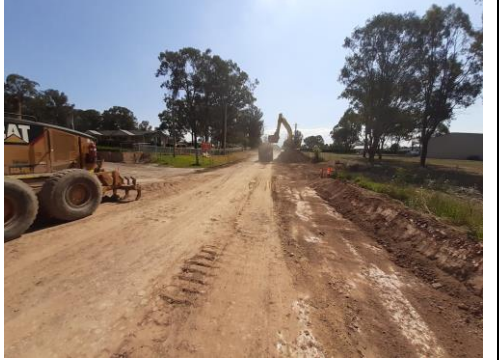
6	Kings Hill Road	<p>Dirty water from the formation is currently not directed into the correct locations.</p>

<p>Direct water from the formation to the pad foot in the photo. Then ensure the water passes through controls prior to making its way in the clean water area.</p>	<p>23/10/20 or prior to rainfall.</p>

<p>Excavator at Kings Hill will construct a bund to send water down towards silt fence and ensure it is in place prior to forecast rainfall.</p>
7	Kings Hill Road.	<p>Gaps in the controls observed (ie mulch bund does not meet the geofabric) and gaps should be filled to ensure clean and dirty water is separated.</p>

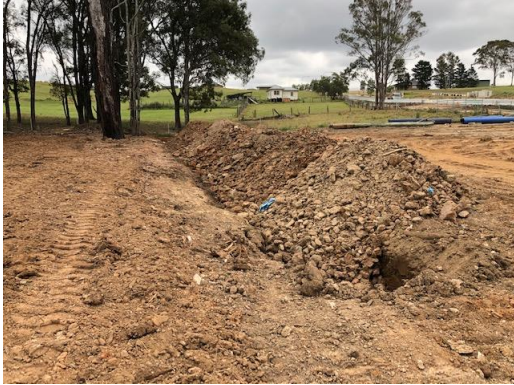
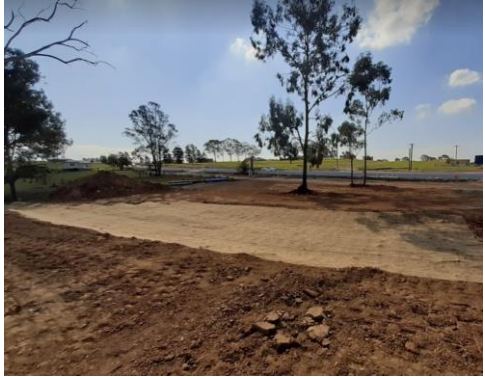
8	Bradley Street	<p>Work is progressing to in area where old farm dam was filled in. Once drainage channel has</p>	M	<p>Once drainage channel has been shaped final controls/treatment should be</p>	<p>23/10/20 or prior</p>	<p>Work has progressed this week to shape the channel. Jute mesh has been laid down</p>

<p>been shaped final controls/treatment should be installed as soon as possible. Where final treatments can't be installed prior to the rain, temporary erosion controls should be installed.</p>

<p>installed as soon as possible. Where final treatments can't be installed prior to the rain, temporary erosion controls should be installed prior to the forecast rain. Erosion controls could include earth bunds, sandbags or similar to slow water flow through the site. End of line controls should also be reviewed and strengthened if required,</p>	<p>to rainfall.</p>	<p>to reduce water flow. A robust mulch bund is in place to assist with filtration of site water prior to it entering P12.</p>
