# **The Northern Road – Mersey Road, Bringelly to Glenmore Parkway, Glenmore Park**

## **Environmental Representative Monthly Report**

**November 2020**

**Doc no. 18008-RP-MR-029-TNR 4,5,6 Monthly Report\_November 2020 \_0**

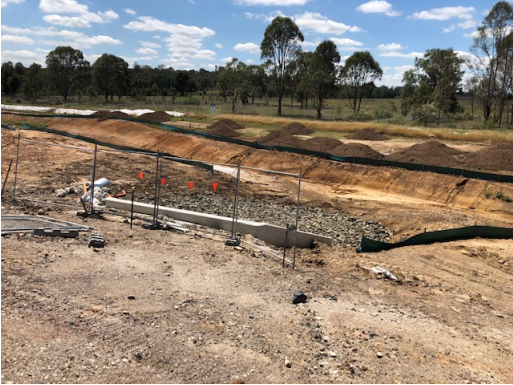
No	LOCATION (Chainage/ Description)	ISSUE/COMMENT	PRIORITY/ RISK (I, H, M, L)	ACTION	Agreed Close out date	Response
1	P12 – main retention dam and open drainage lines either side of this dam	<p>Works in progress - Drain from the outlet of the retention dam is currently being constructed.</p>

M	<p>Continue to make this drain construction a priority to get finished as quickly as possible. Where it cannot be finished prior to rainfall, install/re-install temporary controls to minimise the amount of potential dirty water being discharged into the vegetated drain downstream. Topsoil has started to be delivered, which is good to see. (Note that this is a large construction element and is expected to take a number of weeks to complete.)</p>	Please provide update by 13/11/20	Significant paving adjacent to this area. Spreading of topsoil has commenced. Ongoing focus to finish this area.

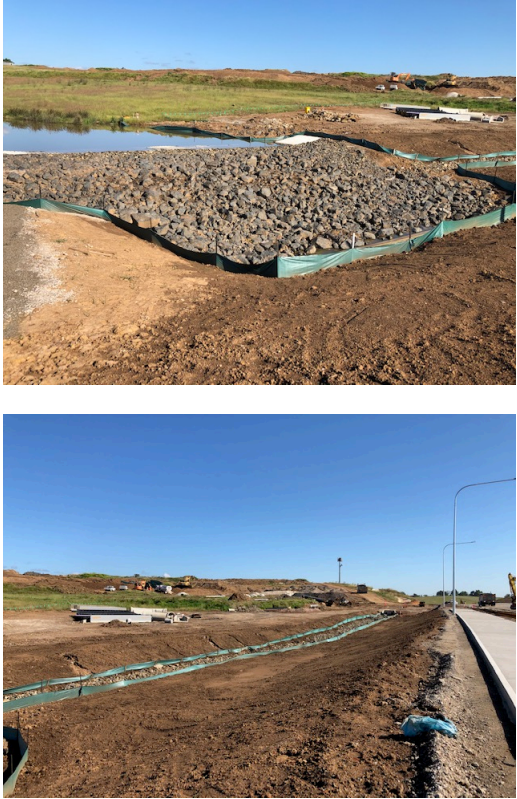
1	Dam 3 area	<p>Laydown area is planned to be removed by the end of the week and area is going to commence being rehabilitated and landscaped.</p>

L	<p>Continue with current plan of remediating this area and completing the landscaping as quickly as possible.</p> <p>Install a lined temporary drain/bund to direct the water from the basin spillway to the rock lined drain.</p>	11/11/20	<p>Foreman has been advised of the need to connect Basin 13 spillway to the northern end of the rock-lined drain but has pointed out that there is still landscaping work to be done where materials and plant were being removed from the laydown area and he can't put a connecting trench in place until the landscaping work is complete.</p> <p>In the interim, he is ensuring Basin 13 is flocced and emptied, to provide capacity for dirty water flow off Telstra Hill which lessens the need for the lined temp drain.</p>

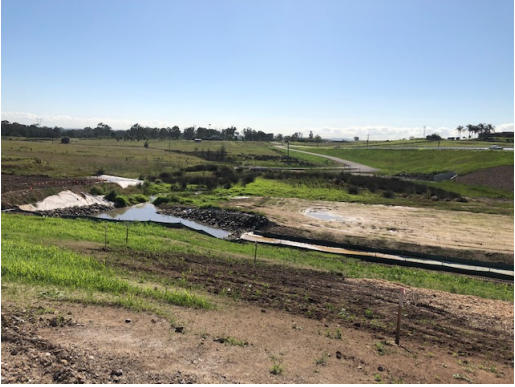
2	Outlet of culvert in Dam 3 area	<p>General observation – ground cover grass appears to be growing well and landscaping has commenced.</p>	L	<p>Continue to complete the landscaping and finishing works prior to opening. Focus on areas that will be difficult to get</p>	Please provide progress	Refer remarks above

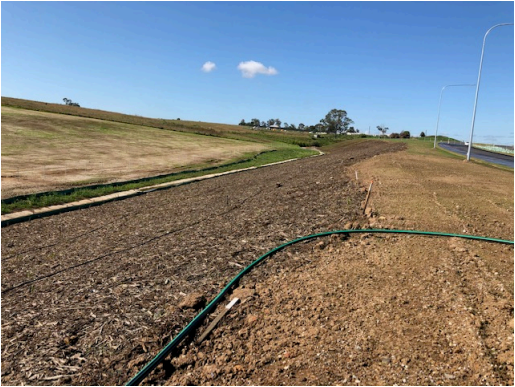
into after opening and areas that are adjacent to the drainage line.	update by the 13/11/20	
3	Area to the south of Adams Road.	<p>Positive observation – grass is growing well on the old stockpile area. Landscaping along the road formation batter also looks great, plants seem to be growing, and there was no major damage done during the recent large rainfall event. Some mulch has been displaced from the invert of the median channel, which may need to be reinstated once it has dried out.</p>

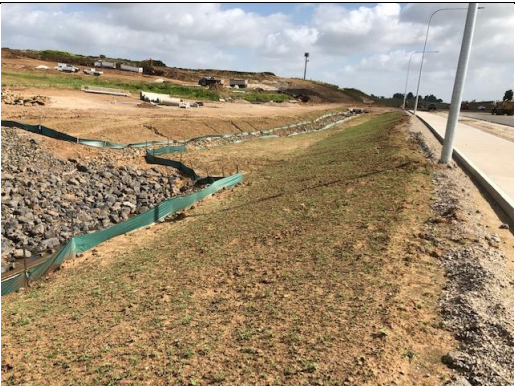
1	Dam 3 area	Some sediment fence observed to require some maintenance after the recent rainfall event. Also, some minor rilling on batter observed to the north of the Dam 3 culvert inlet.	L	Undertake maintenance on sediment fence and tidy batter prior to next rainfall event.	20/11/20	Sediment fencing across the TNR6 area is being tidied up.
---	------------	--	---	---	----------	---

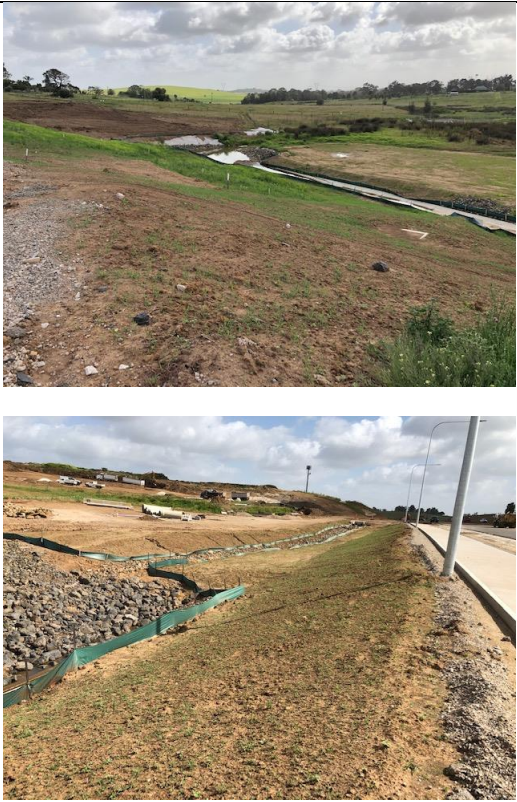
2	N2	Positive observation – water was maximised to the basin from previous storm event. Basin water has been flocked and ready for discharge, however, water is being used for dust suppression throughout this week and will be discharged only when required.	N/A	N/A	N/A	N/A

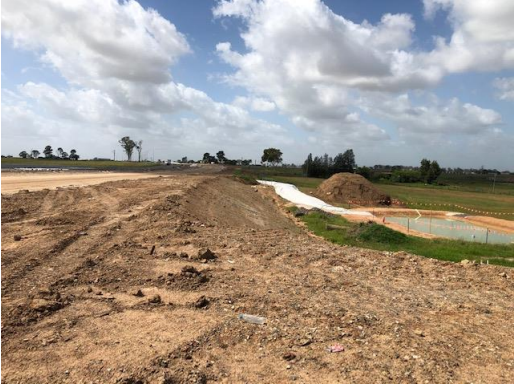
3	Kings Hill Road	<p>Works in progress – new culverts are currently being installed across Kings Hill Road.</p>

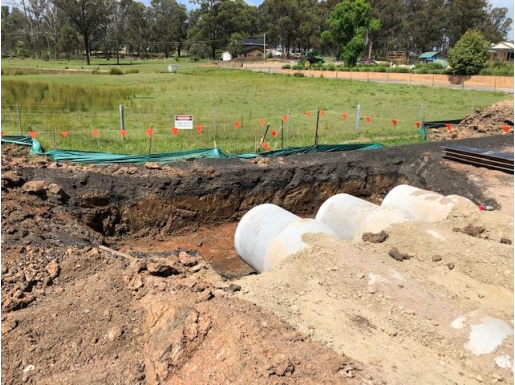
N/A	N/A	N/A	N/A
4	Kings Hill Road	<p>Works in progress – new culverts are currently being installed across Kings Hill Road.</p> <p>Material stockpiled around culvert as part of the culvert installation has been temporarily stockpiled prior to removal.</p>	L	Where material cannot be removed from the site prior to the weekend, it is recommended the material is moved away from the culvert into the unsuitable material stockpile closer to the Northern Road to reduce risk around the culvert.		Concrete apron and headwalls will be complete by first week of December and if rain is expected geofabric will be placed upstream to give water a clean path through this area.

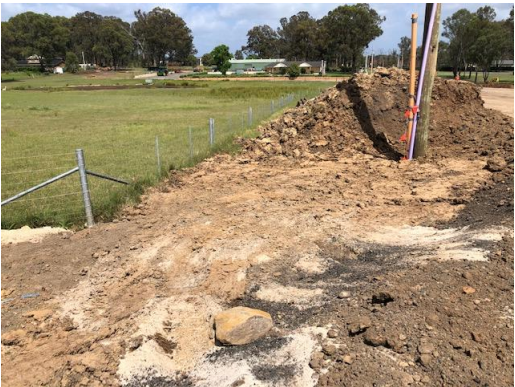
5	Kings Hill Road	<p>Works in progress – As part of the recent electricity cut-over, a bund and part of a sediment fence were removed and have not yet been replaced.</p>

L	Reinstate bund along the edge of the site to ensure clean water is separated from the site. Clean water should be directed through a clean water path through the new culvert once complete.	20/11/20	Refer comments above. This area has had excess materials removed and surfaces compacted.
6	P12	<p>Positive observation – lean mix paving was underway in this section of the site during the inspection. With the lean mix pavement down, a significant proportion of the area of the site will have 100% cover, and therefore focus can move onto completing the landscaping in the</p>	N/A	N/A	N/A	N/A

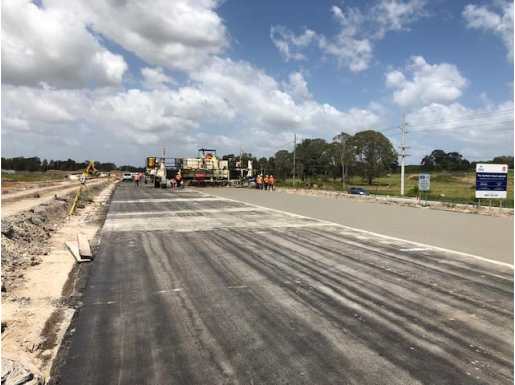
<p>area prior to the section of road opening to traffic prior to Christmas.</p> <p>It was generally observed that the paving operation was being undertaken in a clean and tidy manner.</p>
