The Northern Road – Mersey Road, Bringelly to Glenmore Parkway, Glenmore Park

Environmental Representative Monthly Report

March 2021

Doc no. 18008-RP-MR-033-TNR 4,5,6 Monthly Report_March 2021_0

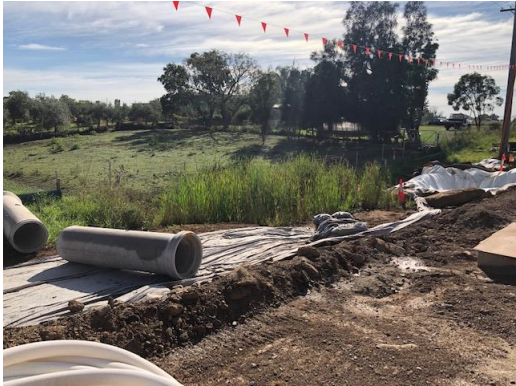
1	Chain-of-Ponds Road	<p>Extension of sediment fence around the stockpiled pipes and along the toe of the disturbed area is recommended to further protect the drainage line.</p>

M	Install sediment fence in location discussed on site prior to forecast rainfall.	11/03/21	<p>Silt fence has been installed on the 11th March 2021 prior to expected rainfall this week.</p>

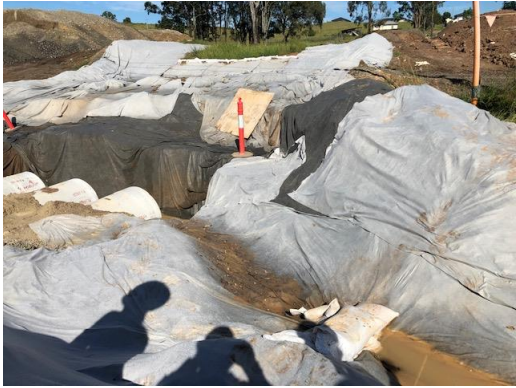
2	Bradley Street	<p>Sandbags installed in spillway could have been higher to retain more water.</p>

M	<p>Install additional sandbags to increase the amount of water that is retained behind the sandbags.</p>	11/03/21

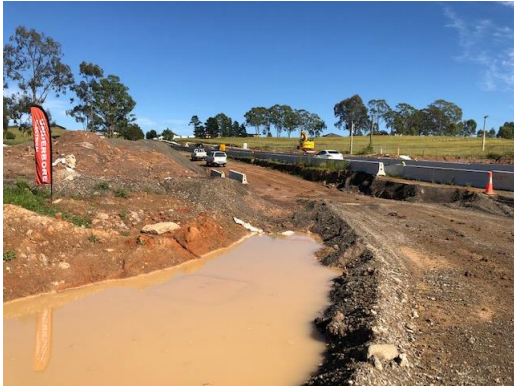
4	Bradley Street	<p>Water ponding in formation on both the south and north sides of Bradley Street should be pumped out and into a water cart prior to the next rainfall event.</p>

L	<p>Water ponding in formation on both the south and north sides of Bradley Street should be pumped out and into a water cart prior to the next rainfall event.</p>	11/03/21

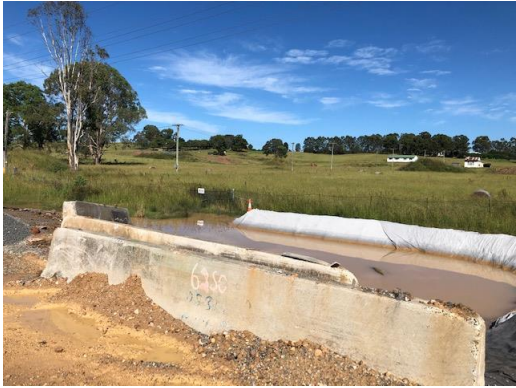
5	Surveyors Creek culvert	<p>Water captured behind bund/sump should be removed prior to the next forecast rainfall.</p>

L	<p>Water captured behind bund should be removed prior to the next forecast rainfall.</p>	11/03/21

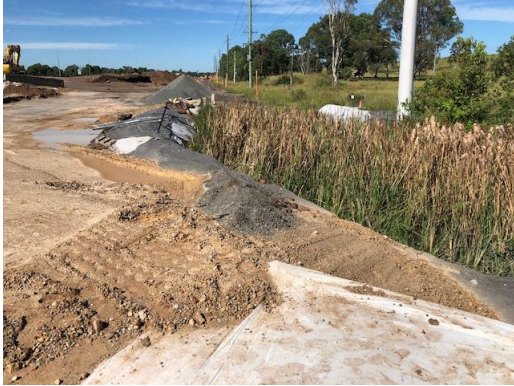
6	Surveyors Creek culvert	<p>Install bund over the top of culvert box cells to direct water to bund/sump to the south of the culvert.</p> <p>Also, there are areas of exposed dirt adjacent to the culvert outlet.</p>

L	<p>Install bund over the top of culvert box cells to direct water to bund/sump to the south of the culvert.</p> <p>Cover exposed dirt with geofabric on the clean water side of the new bund.</p>	11/03/21	<p>A bund covered in geotextile has been installed to maximise the diversion of stormwater runoff to a dedicated sump approximately 10m South of the 45-degree bend culvert at area N10. Completed on the 10th March 2021.</p>

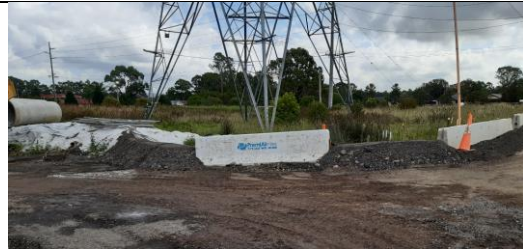
7	P12 Flood overflow culvert	<p>Section of the access road into the compound was observed to be a potential low point where water could escape from access road</p>	L	<p>Install rock bund along the edge of the access track into the compound to provide a sediment control.</p>	11/03/21

<p>Robust knee-high bunds made from millings have been placed between the concrete barriers to assist with the control and capture</p>

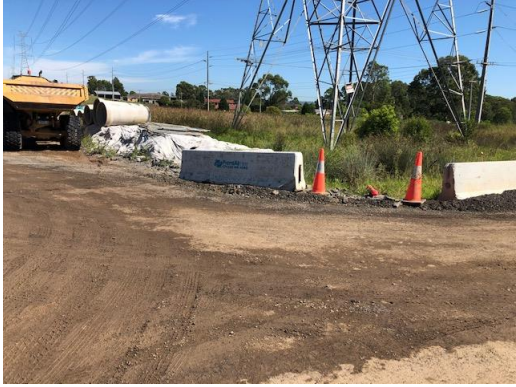
of site water. Completed on the 9 th March 2021.
8	Area to north of DEOH gate/Gate S3	<p>Positive to see the progress in this area. As a short term temporary measure for forecast rain prior to the final landscaping treatment, install sediment fence along the top of the channel and over the top of the culvert to protect drainage line.</p>

L	Install sediment fence along the top of the channel as discussed on site.	11/03/21

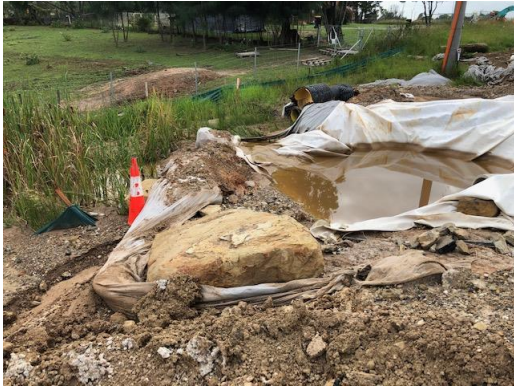
1	Chain-of-Ponds Road	<p>Area around outlet of culvert has been too wet to amend after the rainfall, however, the area should be able to be access prior to the weekend and maintenance of controls should be able to be completed.</p>

M	<p>If access is possible, reinstatement and maintain erosion and sediment controls around the outlet of the culvert.</p> <p>Clean off the top of the inlet pit and reinstate controls.</p>	1/04/21

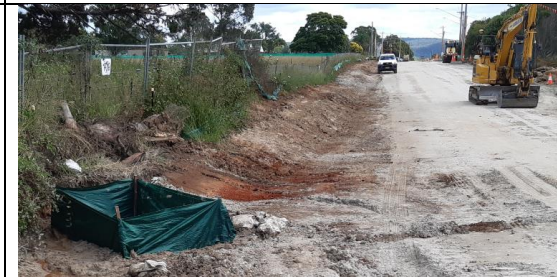
2	Chain-of-ponds Road	Section above the culvert inlet pit has been exposed by the extreme weather event and revealed that there is a pretty large step from the adjacent property that will need to be stabilised.	L	Review design and propose a solution to stabilise this area around the boundary.	09/04/21

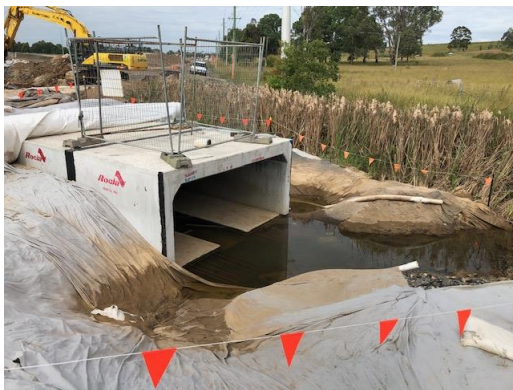
Surveyors Creek
tributary culvert

Positive observation – clean water was observed to be flowing through the Surveyors Creek tributary culvert. Some damage has been caused around the culvert outlet and can be maintained and reinstated once the water stops flowing.

Maintain and reinstate controls around the culvert outlet when it can be accessed without risking causing more damage or dirty water.

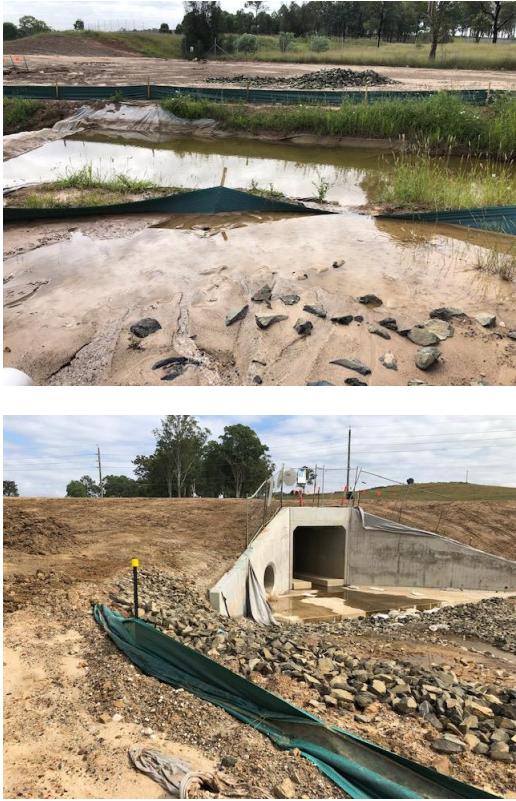
5	Area to north of DEOH gate/Gate S3	<p>Some areas in this area are still very wet and controls have not yet been reinstated or maintained yet.</p>

M	<p>Reinstate controls that have been damaged around the culvert and clean water drain.</p> <p>Where sediment fence has been removed to trim batter around the headwall of the culvert, either reinstate the sediment fence or install a berm to divert water away from headwall to an area that is protected.</p>	01/04/21
