The Northern Road – Mersey Road, Bringelly to Glenmore Parkway, Glenmore Park

Environmental Representative Monthly Report

May 2021

Doc no. 18008-RP-MR-035-TNR 4,5,6 Monthly Report_May 2021_0

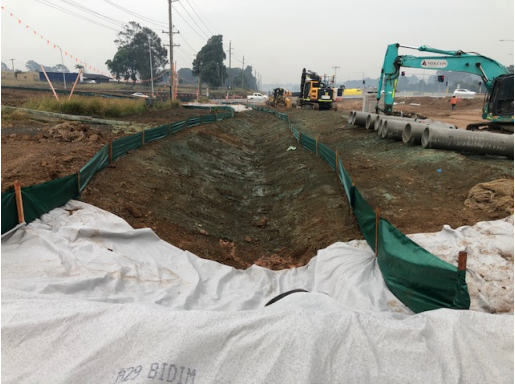
1	Bradley Street	<p>General observation – work has progressed since last inspection. Where required incomplete clean water flow paths have been temporarily covered with either geofabric, or sprayed with soil binder. Headwall and wingwalls were cast in-situ and the formwork is currently blocking the culvert, which allows water to pond in front of the culvert apron.</p>

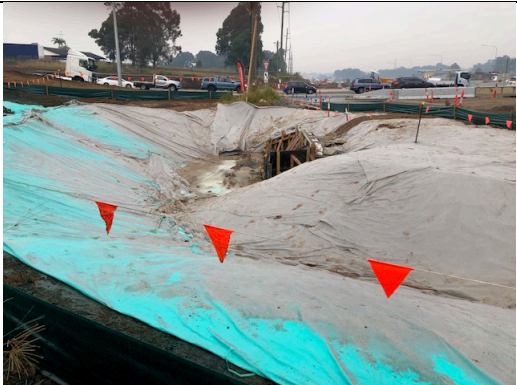
2	Bradley Street	<p>Observed that some of the scour protection rock being placing in the drain has a relatively high content of fines.</p> <p>Rock being placed in clean water areas should be clean and free of fines.</p>	L	Ensure the remainder of the rock being placed in this clean water area is clean and free of fines to minimise the risk of sediment being eroded and transported downstream.	14/05/21	Scour protection rock placement put on hold due to supply issues. Rock will be inspected as it is delivered and/or placed with a shaker bucket.
3	Bradley Street	Positive observation – drainage depression has been topsoiled, lined with jute-mesh, straw bails installed as checks, and sprayed with hydro-mulch. Sediment fence has also been installed on either side of the channel.	N/A	N/A	N/A	N/A

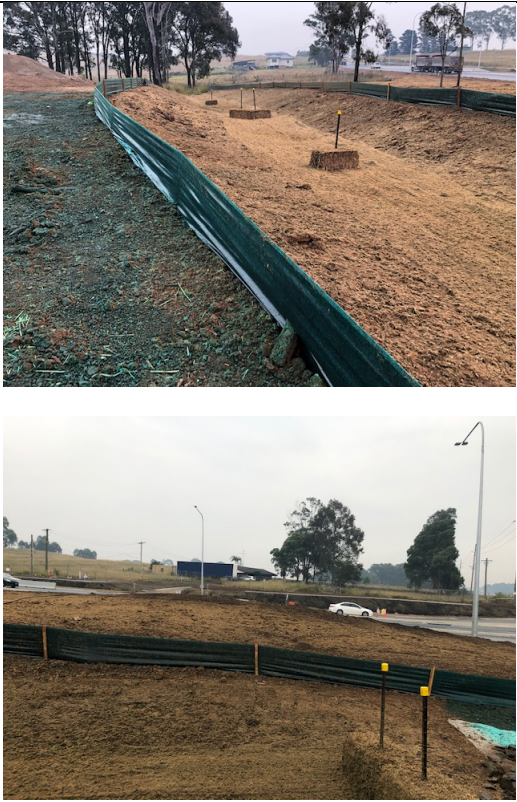
3	Bradley Street	Observed that the trees at the west of the property did not have exclusion fencing installed around them to protect encroachments into the tree protection zone.	L	Re-instate exclusion fencing around trees to protect tree protection zone.	06/05/21	Reinstated.
4	Tributary of Surveyors Creek	Positive observation – rainfall had only recently commenced, however, very positive to see that water flowing through the culvert was very clean.	N/A	N/A	N/A	N/A

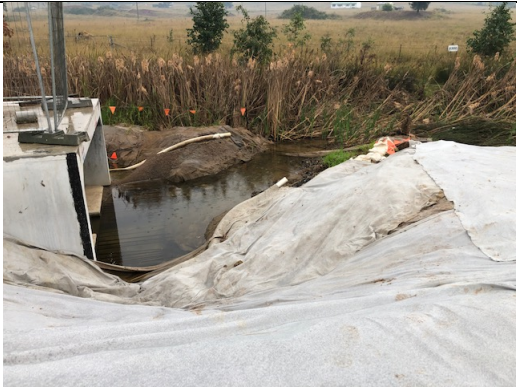
5	South of the tributary of Surveyors Creek	General observation – it was noted that the vast majority of water from this area of the site would flow towards excavation in road formation and therefore this area currently poses a low risk from an ERSER perspective. Project team should however start planning how the area would be set up prior to rainfall as this excavation is filled in and the road formation increases in height. May need to look at augmenting and/or re-aligning the sediment trap adjacent to the culvert or similar; and reviewing how the clean and dirty water interact in this area.	N/A	N/A	N/A	N/A

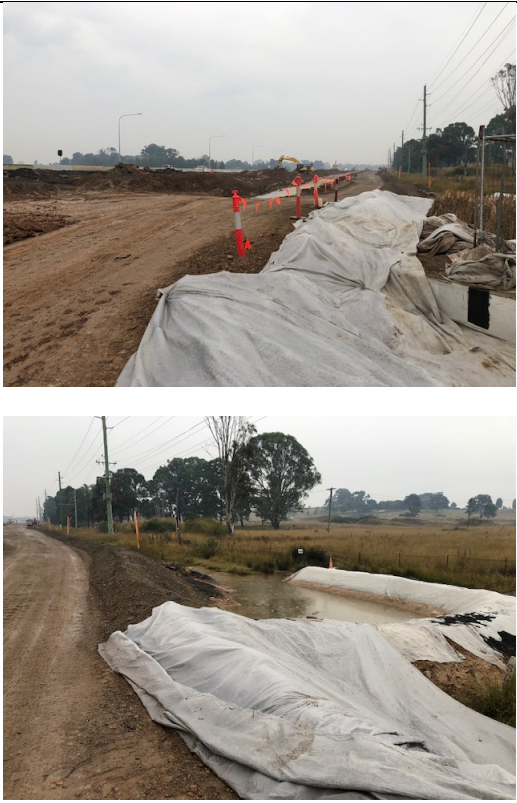
6	Chain-of-Ponds Road	Positive observation – open drains and inlet and out of the culvert on Chai-of-Ponds Road have been finished very well. Looks great!	N/A	N/A	N/A	N/A

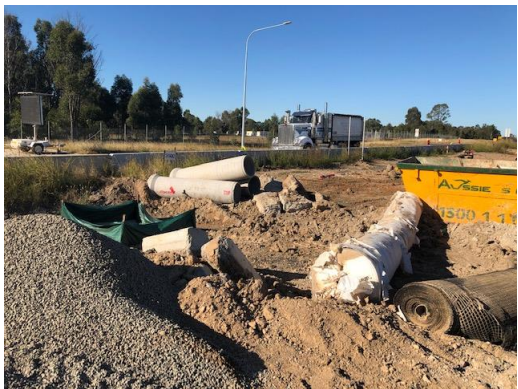
1	Chain-of-Ponds Road	Housekeeping in the vicinity of the intersections needs some attention.

L	Tidy area to minimise the safety and enviro risk from poor housekeeping.	27/05/21	The area surrounding the Chain-O-Ponds intersection has been cleaned up and unwanted materials removed in time for the scheduled opening of Chain-O-Ponds Road starting 4 th June 2021.
2	South of N3 stockpile area	Stockpile area has been reworked over the last few months and requires some additional erosion controls to minimise sedimentation in downstream areas.	L	Install erosion controls as discussed at the along the bottom of the stockpile area. Consider a mulch bund if there an excess of mulch. Or the material near the fence could be reshaped to form a bund along	25/05/21	A mulch bund has been placed. Stockpiles close to the fenceline (where mulch could not be placed at this point) need to remain joined in order to prevent water from sheeting down to the silt fence and drainage below closer to the roadway. The CPB CPESC (Andrew Macleod of SEEC) noted this in his inspection report 27 th

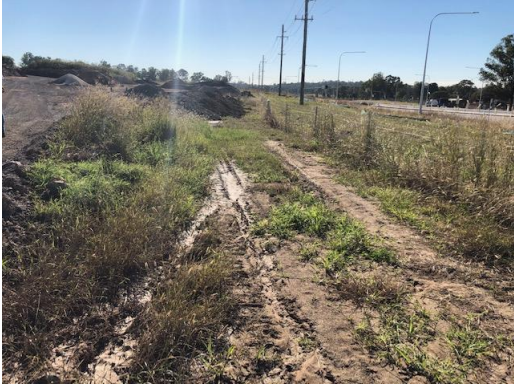
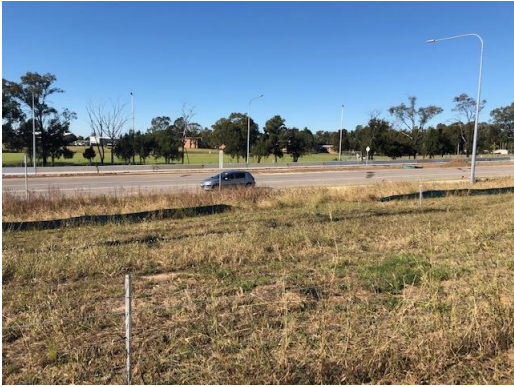
<p>the fence line in the lower portion of the stockpile area to slow water and catch sediment in the stockpile area before the catch drain.</p> <p>Also, amend sediment fence adjacent to the clean water drain.</p>		<p>May 2021 and discussed this with the Site Foreman the same day.</p> <p>The silt fence is no longer required if the bunds are installed and the grass cover here is maintained.</p> <p>The silt fence is causing water to concentrate to one location (which has scoured). Removal of the silt fence has been discussed and actioned with the Site Foreman 27th May 2021.</p>
3	Bradley Street – south	Works in progress - Clean water drain is currently being constructed and area around the inlet of the culvert. This should continue to be a priority in this area.	L	Continue to complete the clean water drain and tidy clean water areas as a priority in this area.	Please provide an update by 28/05/21	The swale will continue to be progressed next week commencing 31 st May 2021. The remaining 20-30m connecting to the N3 culvert is yet to be constructed.

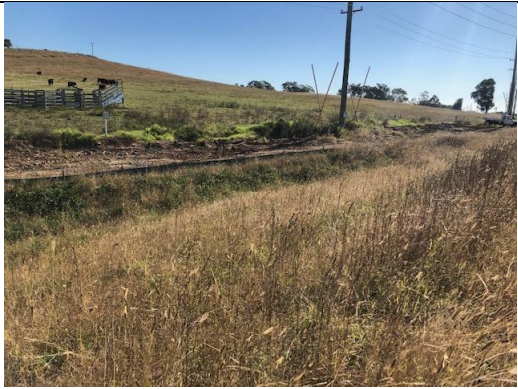
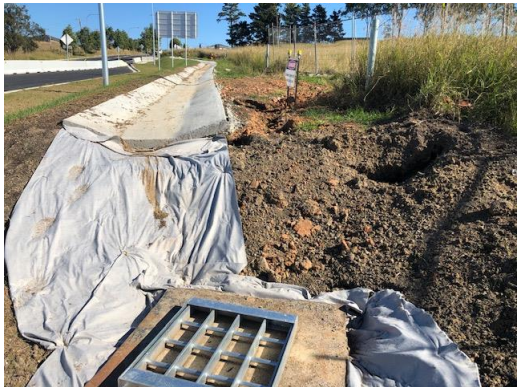
3	Bradley Street – north	<p>Works in progress – drain inlet incomplete and should try to be completed prior to next rainfall event. If this can't occur ensure water is directed into the pit rather than bypassing.</p>

L	Complete drain inlet prior to next rainfall event. If this can't occur ensure water is directed into the pit rather than bypassing.	25/05/21	The swale will continue to be progressed next week commencing 31 st May 2021 and will include additional concreting to extend the swale and a grate above the pit.

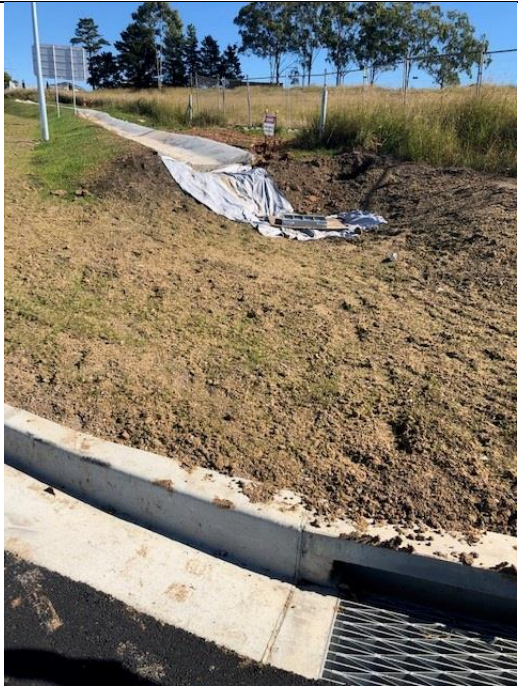
4	Bradley Street – south	Sediment fence is observed to not extend around the whole disturbed area.	L	Extent sediment fence around the back of the stockpile.	25/05/21	A mulch bund has been installed Monday 24 th May 2021 and extends all the way to the fenced property boundary.

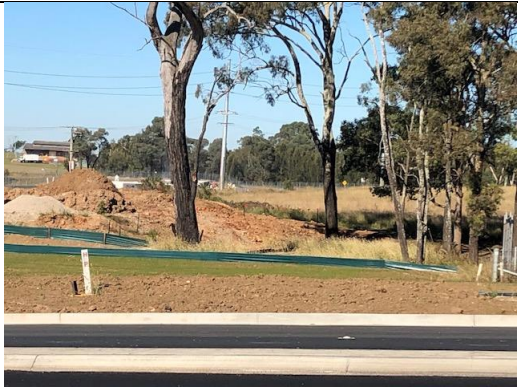
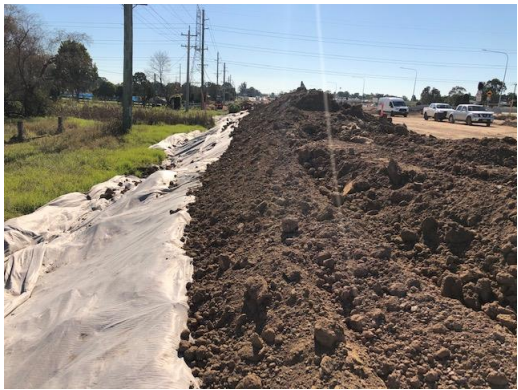
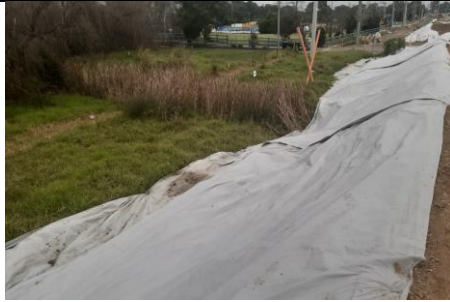
5	Tributary of Surveyors Creek	<p>Area around the culvert outlet has changed in the recent weeks to change the risk profile.</p>

M	<p>Recommend the following in the short term:</p> <ul style="list-style-type: none"> recently established batters should be pulled and compacted progressively. If rainfall is forecast prior to being completed the batters should be covered. Continue to direct water to low areas in the formation during construction. Utilise sediment traps where water can't be ponded in the formation.

<p>The batter has been pulled and covered temporarily. The Progressive ERSED Plan endorsed by the CPB Soil Con (Andrew Macleod of SEEC) 27th May 2021 details how site water can be managed.</p>

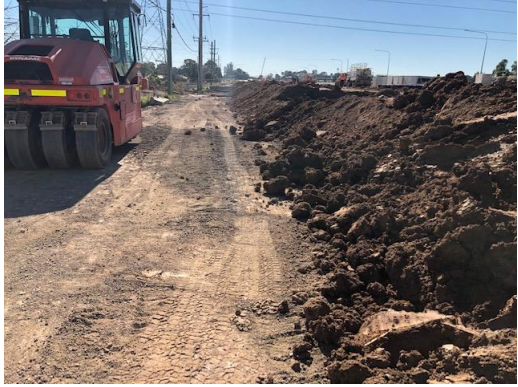
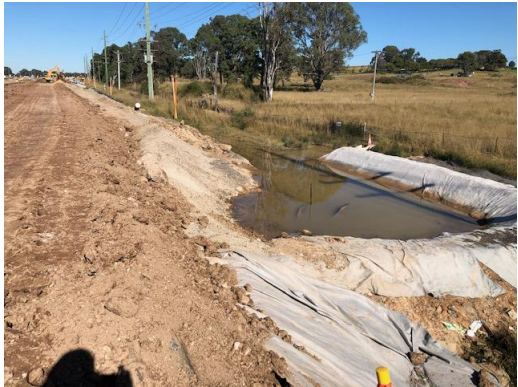
6	Tributary of Surveyors Creek	<p>Area around the culvert outlet has changed in the recent weeks to change the risk profile.</p> <p>Prior to commencing any work in the outlet of culvert a workshop is recommended to be carried out to review of work required to complete the design and the methodology of the work.</p>

M	<p>Carry out a workshop to review of work required to complete the design and the methodology of the work. Document workshop and ensure the methodology is documented in a work method statement and the PESCP.</p> <p>Things to be discussed but not limited to:</p> <ul style="list-style-type: none"> • How will standing water be managed? • How will the old water main be removed? • How will unsuitable be treated? • Consider the potential for PFAS contamination. • How will new water main be installed? • How will clean water be diverted from upstream of the culvert and from the upstream area to the west. 	21/05/21	<p>How will standing water be managed? Ground water can be either pumped into water carts for reuse or discharged in accordance with EPL requirements.</p> <p>How will the old water main be removed? The old watermain can be grouted in the near vicinity of the culvert. However, a small will need to be section removed below the culvert outlet.</p> <p>How will unsuitable be treated? Material spoil will be taken to area P12 (SB side of TNR) and spread and incorporated into landscaping rehab for the area.</p> <p>How will the new water main be installed? Through the shared path away from the batter and above the culvert.</p>

<ul style="list-style-type: none"> Consider the length of time it will take for each element to complete (ie removal of old water main, installation of new water main, prep of foundation, blinding, reo, base slab and curing, FRP of wing walls and apron and curing time. How will dissipater be constructed? Materials and equipment that will be required to construct these elements. 		<p>How will clean water be diverted from upstream of the culvert and from the upstream area to the west.</p> <p>A progressive ERSED plan has been developed and implementation has commenced on site.</p> <p>How will dissipater be constructed?</p> <p>The PESCP endorsed by the CPB CPESC on the 27/5/2021 indicates how the works will be timed and control types to be installed prior and during construction. A Workshop with CPB and TfNSW to discuss the plan has been set for 1st June 2021.</p> <p>Materials and equipment that will be required to construct these elements.</p> <p>Materials will not be installed in the flow path or within the creek line.</p>

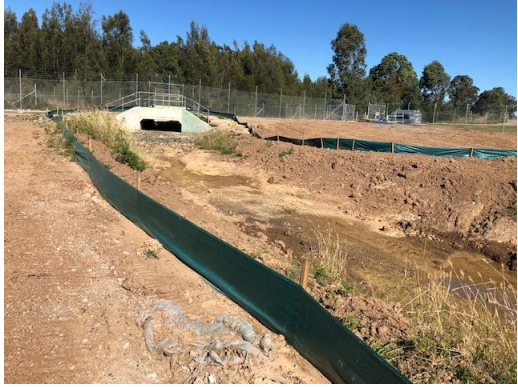
7	Gate S3 area	<p>Works in progress – whole area to the north of Gate S3 is being progressively completed and prepared for landscaping.</p>

L	<p>Continue to complete this area as planned.</p> <p>Rocking of the clean water drain should be treated as one of the priorities.</p>	Provide update by 29/05/21	<p>Works have re-commenced 24th May to install rock checks in the channel to dissipate flows and armour the batters consistent with Blue Book standards. Rock has been placed at the wingwalls of the large fauna culvert to prevent scour and erosion and to provide an aesthetically pleasing feature to the area that is over and above the original design.</p>
