Barangaroo Metro Station

Tree Report

Arboricultural Impact Assessment

**Barangaroo Metro Station
Barangaroo NSW 2000**

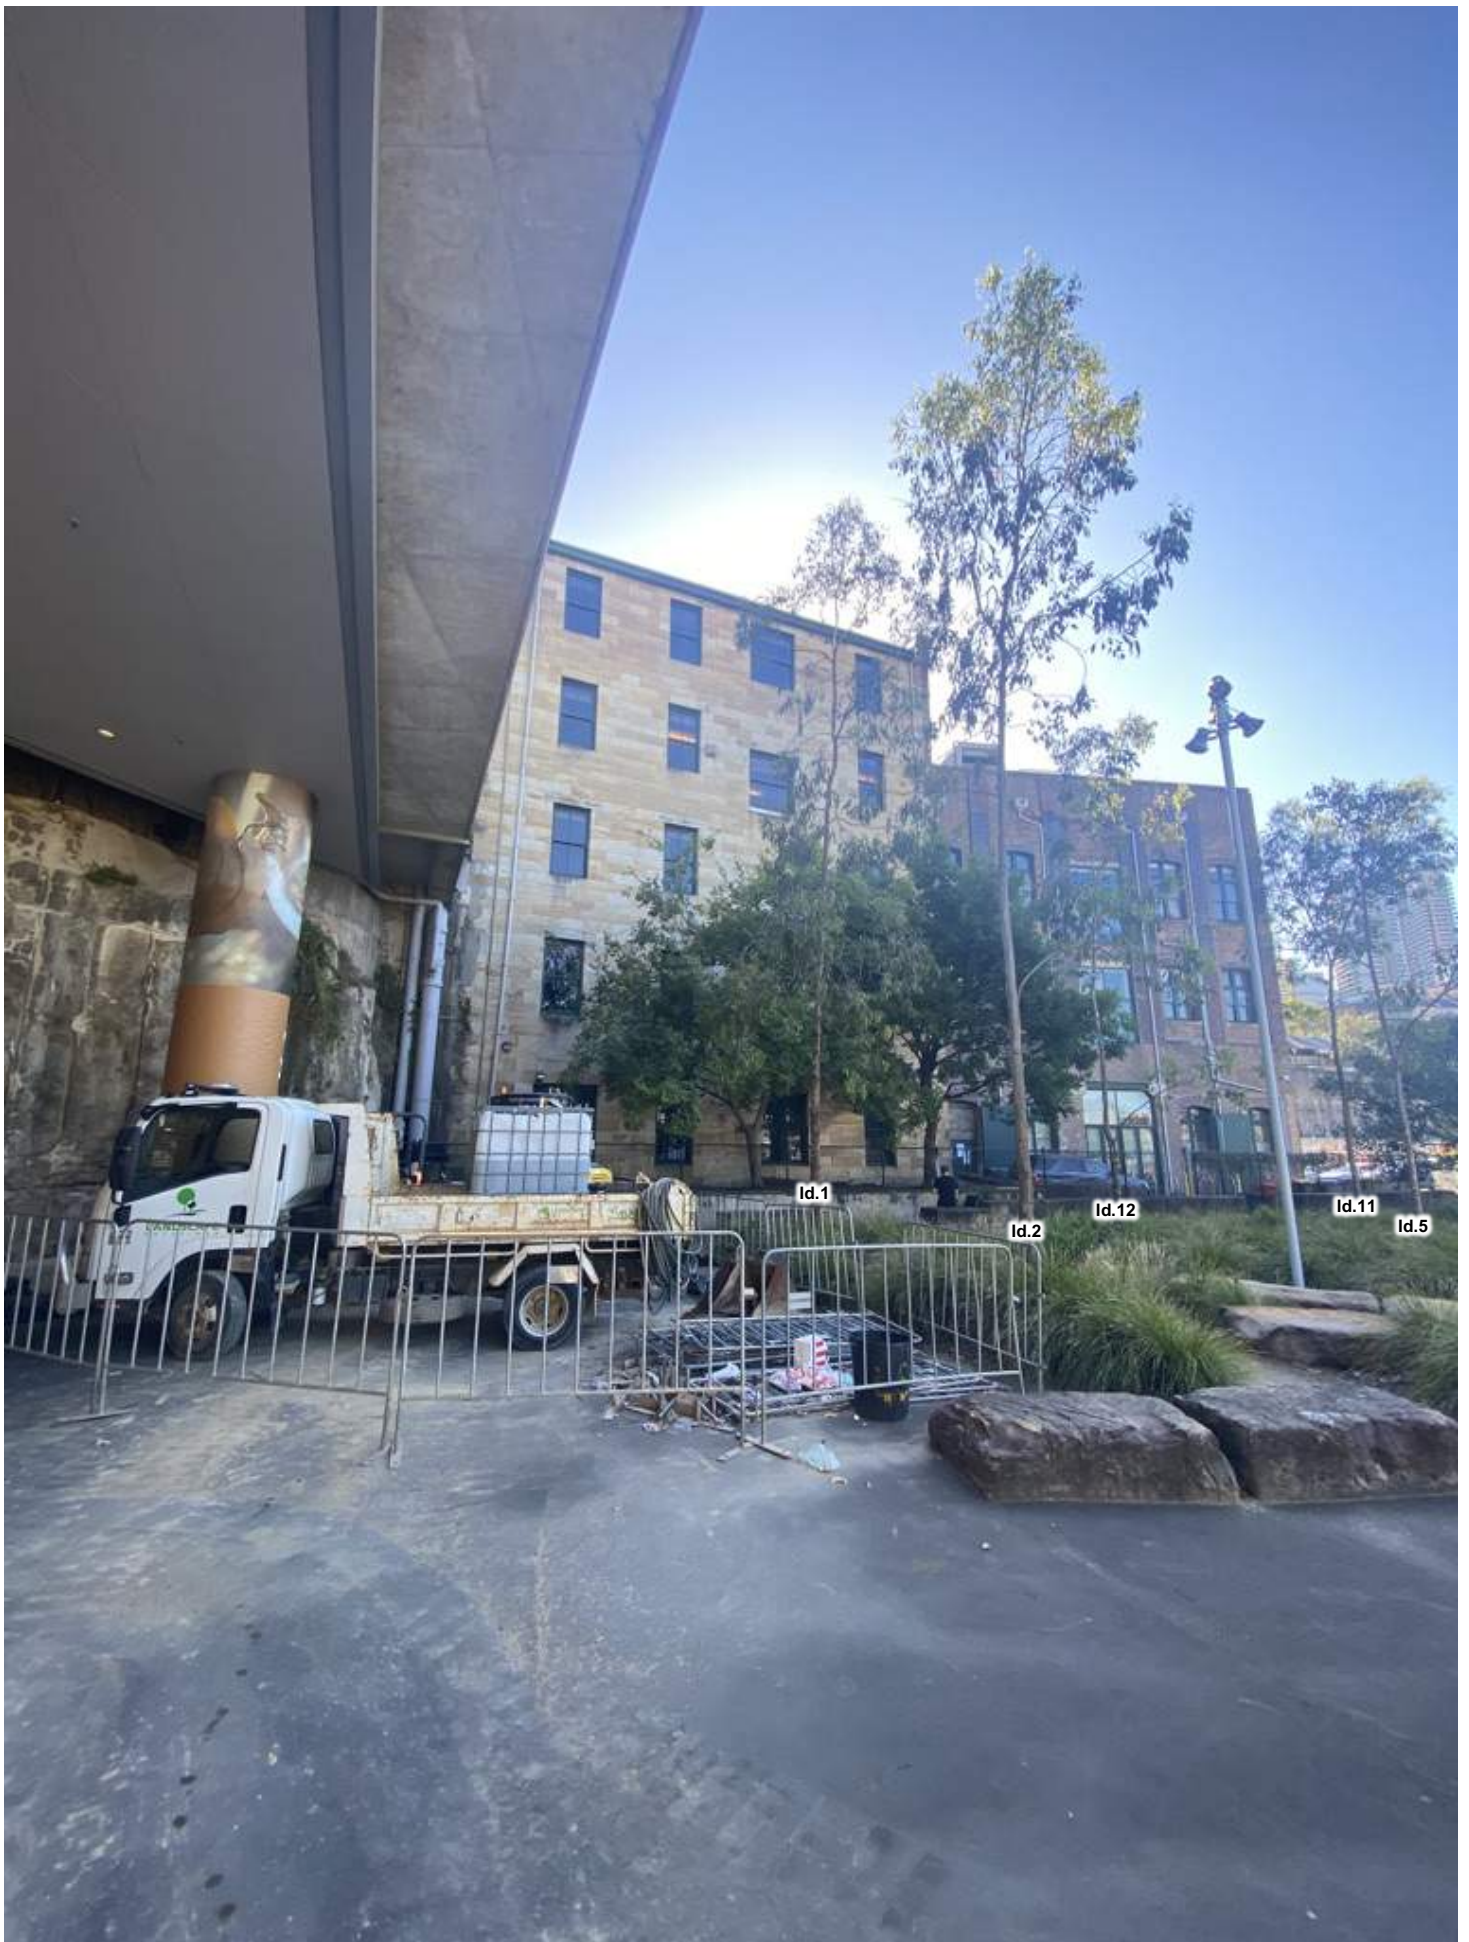
Total Impact: Subject Trees **id. 2, 5 & 8-12** are located wholly within the construction footprint and are recommended for removal as part of the proposed development.

Image 1: Subject Trees 1, 2, 5, 11 & 12

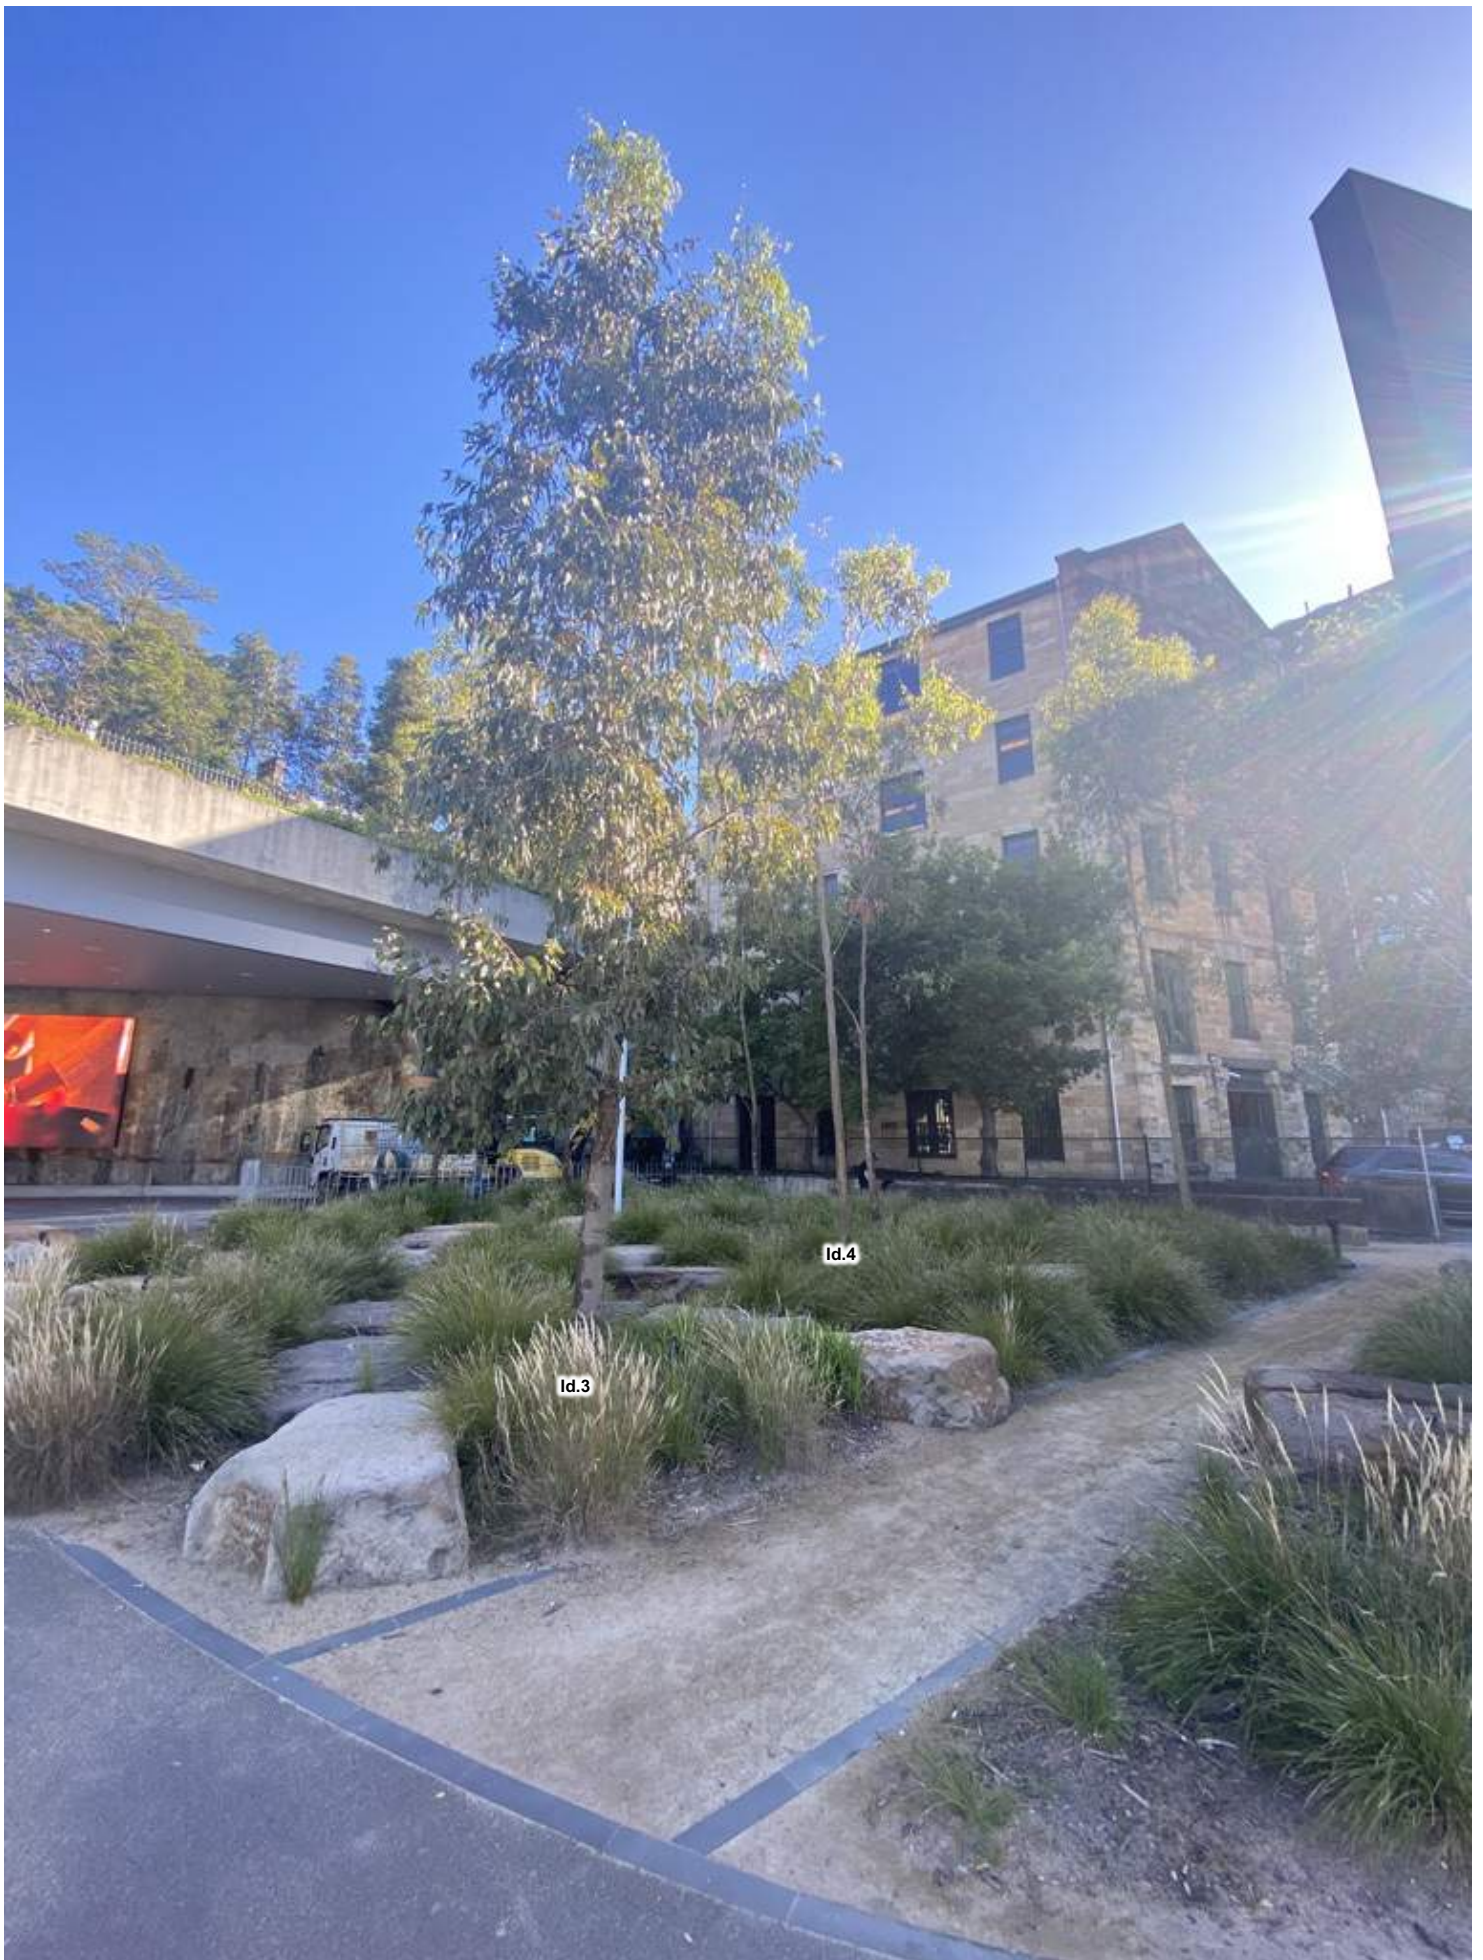
Image 2: Subject Trees 3 & 4

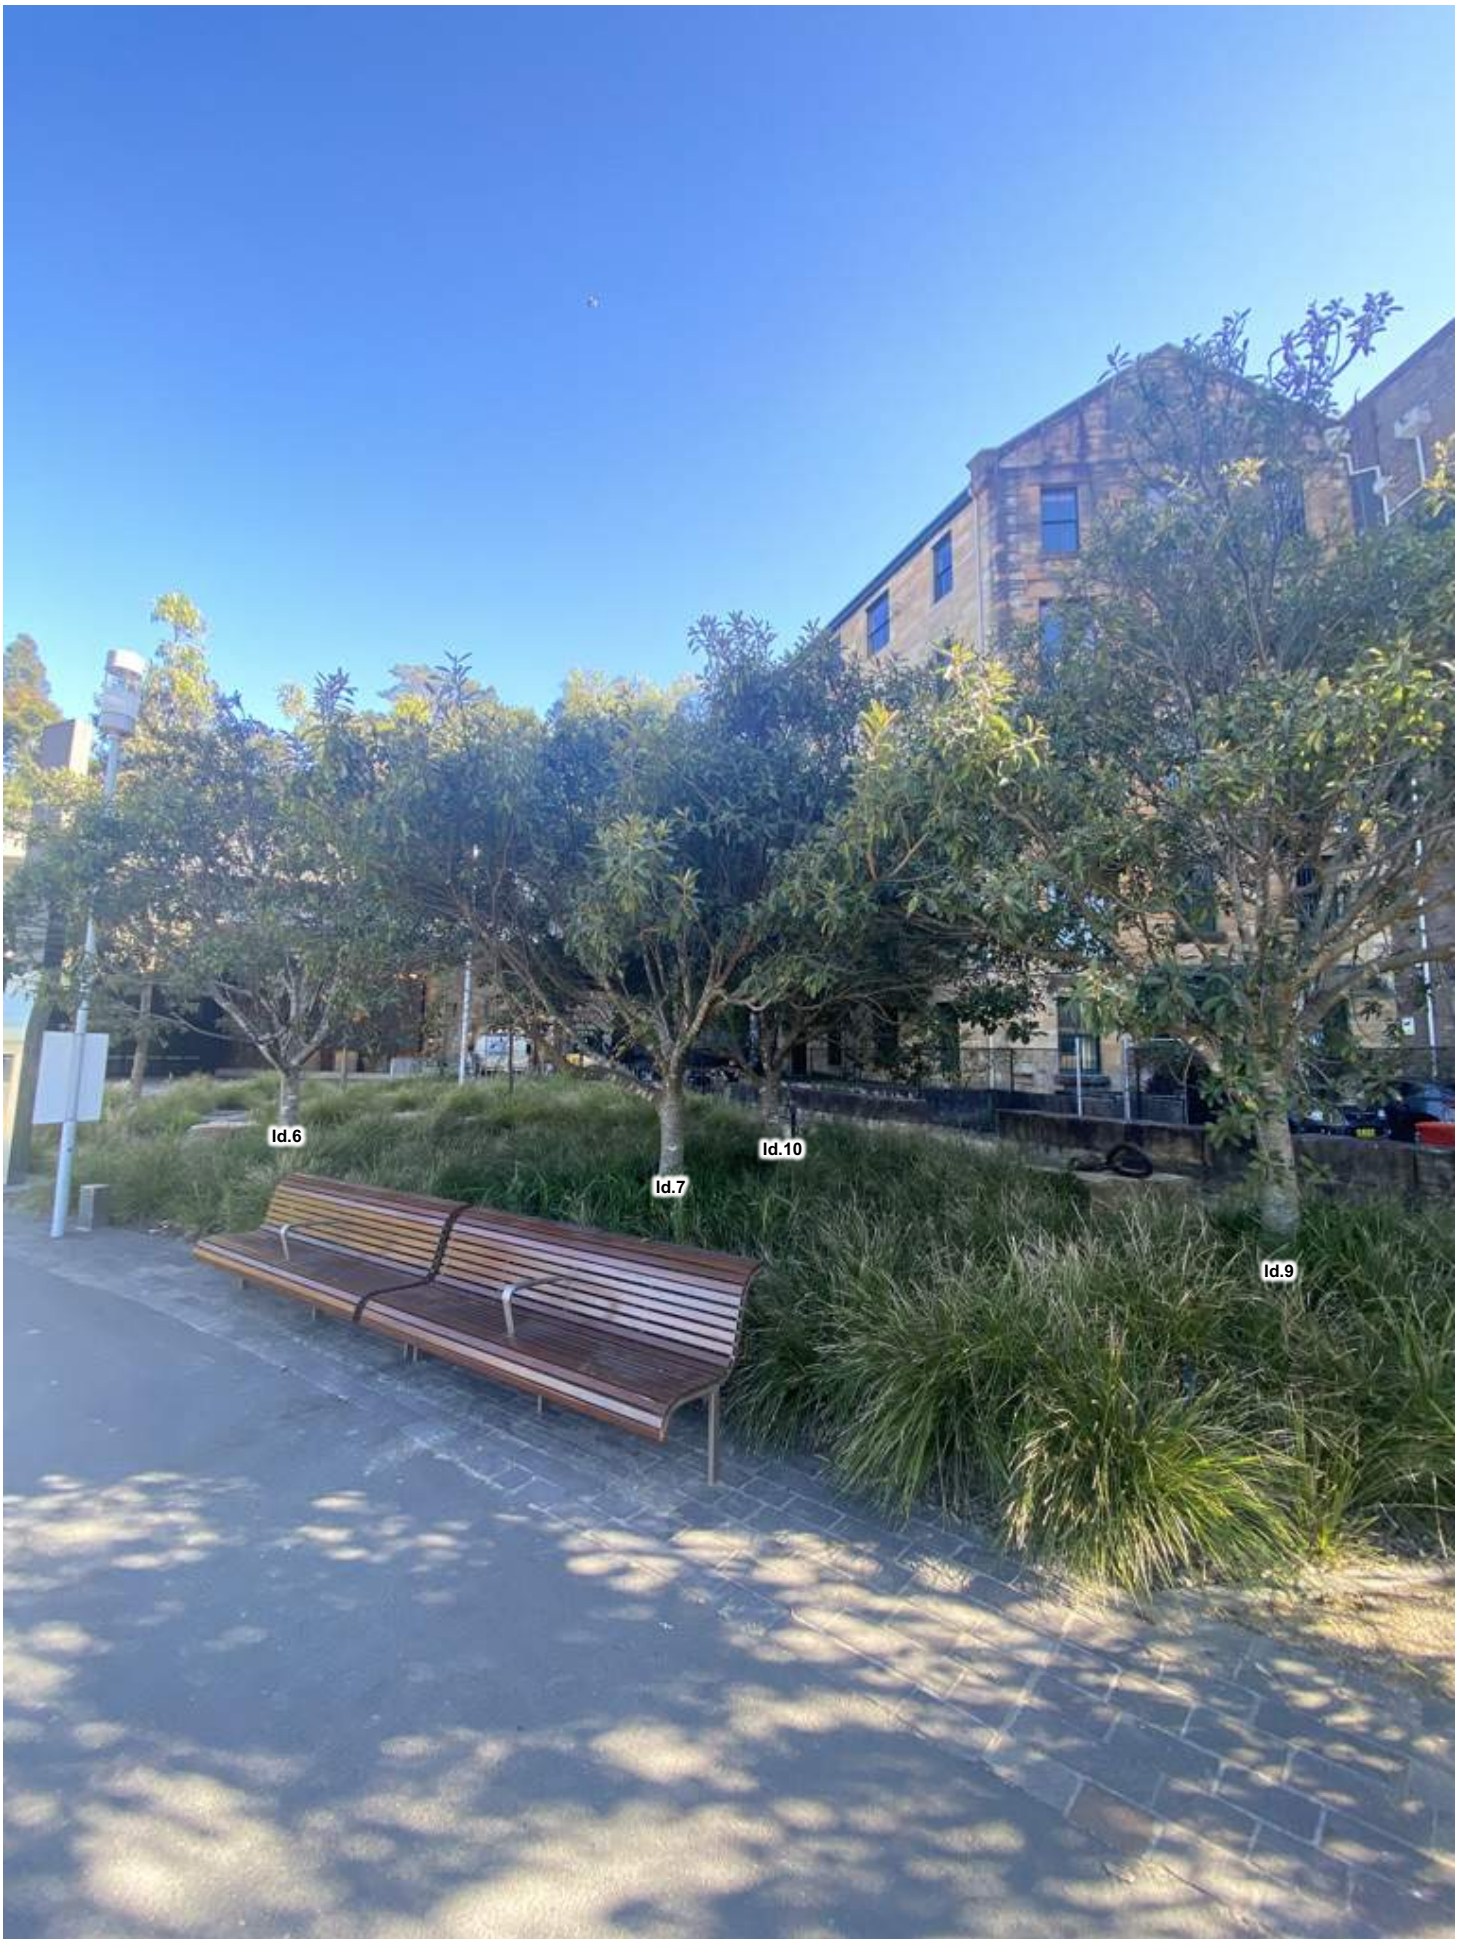
A total of **two** Subject Trees (**id. 1 & 7**) will require excavation activities <20% of total TPZ and are unlikely to have a significant impact on the Subject Tree's ability to store carbohydrates, use stored carbohydrates in times of stress and are unlikely to have a significant impact on the health, condition and/or stability of the subject trees long term and are only to be removed as a contingency if the construction activities taking place necessitate this, or if required for safety reasons, ie. If the construction activities can take place without these trees being removed, then they are to be retained.

Image 3: Subject Trees 6, 7, 9 & 10

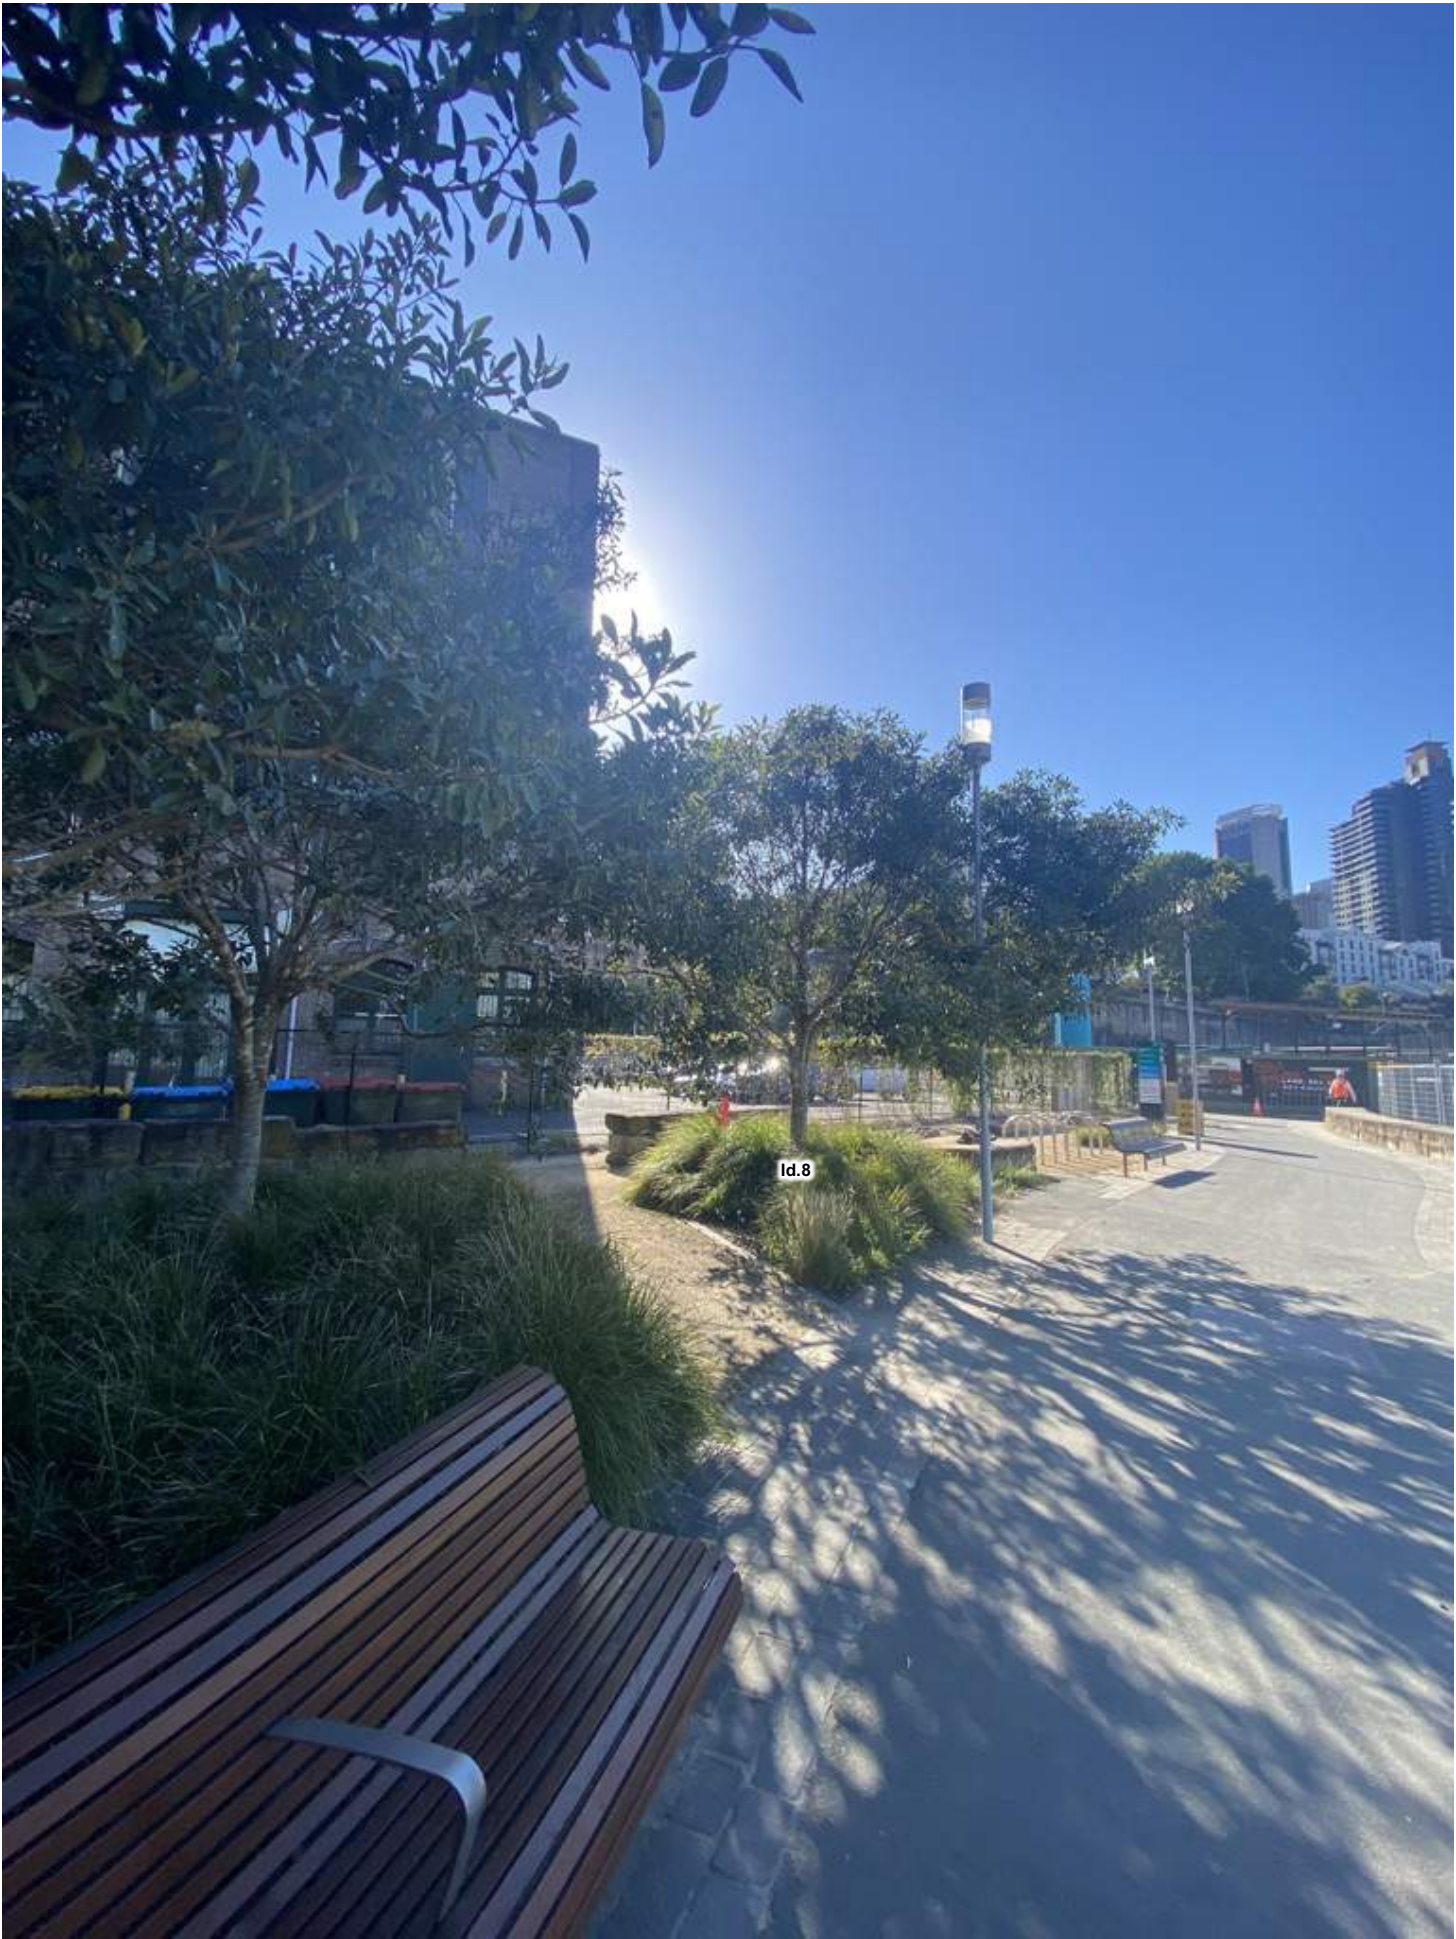
Image 4: Subject Tree 8
