Construction Monitoring Report September 2021 – February 2022

Sydney Metro City & Southwest – Line-wide Works

Contract Number:	C600
Systems Connect Number	N21063
Document number:	SMCSWLWC-SYC-CSW-EM-REP-011744
Revision date:	24/03/2022
Revision:	0

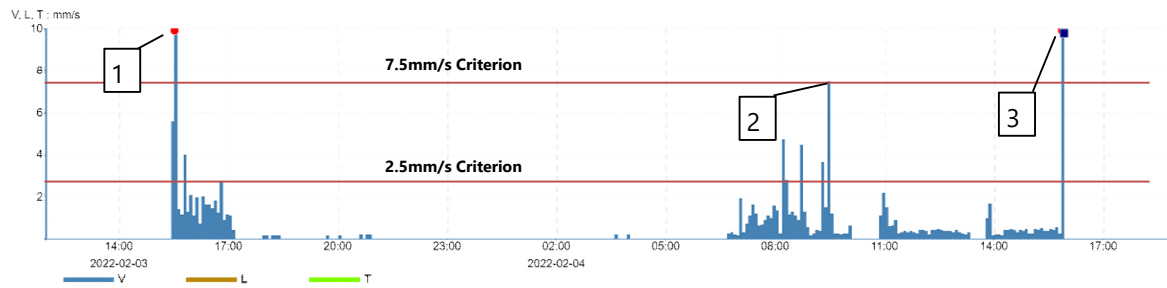
Figure 4-1 – Unattended vibration monitoring results

Where the vibration from rockhammering activity initially exceeded the 2.5 mm/s criterion, the works were paused and the heritage seawall was inspected for any signs of cosmetic damage. When no signs were found, the works proceeded with caution. Where the vibration from rockhammering activity initially exceeded the 7.5 mm/s criterion, the works were paused until the source of the exceedance was identified. Where it was confirmed that this was not due to rockhammering activity, the works continued.

Exceedance ID	Date and Time	Cause of exceedance
1	03.02.2022 03:30pm	At this time, the vibration monitor was mounted on the ground spike to commence monitoring. Exceedance was not caused by the nearby rockhammering activity.
2	04.02.2022 09:26am	At this time, the site engineer confirmed that the instantaneous exceedance was caused by the impact of the walls of the concrete platform being knocked over on site and falling to the ground. Exceedance was not caused by the nearby rockhammering activity.
3	04.02.2022 03:50pm	At this time, the vibration monitor was removed from the ground spike to complete the monitoring. Exceedance was not caused by the nearby rockhammering activity.

It can be seen in Figure 4-1 that the vibration levels produced from the nearby rockhammering activity is generally below 7.5 mm/s. Note that there were events that resulted in an instantaneous vibration level of above 7.5 mm/s. However, these were not caused by the nearby rockhammering activity, as justified in Table 4-4.

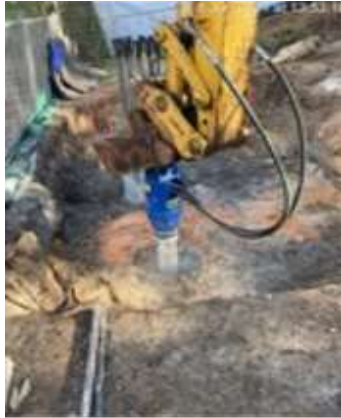
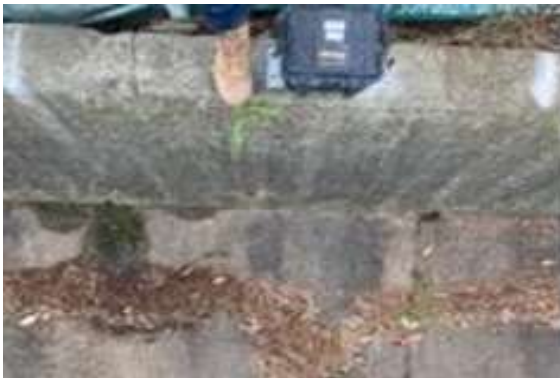
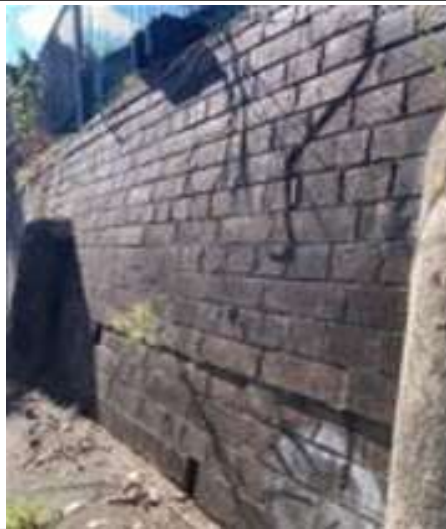
20/09/2021	3:27:00 PM	6.77	0.34	0.76	Auger piling through hard rock at depth
COMPLIANT WITH VIBRATION CRITERIA:			Yes		
MONITORING COMMENTS OR ACTIONS TAKEN TO ADDRESS EXCEEDENCES OF VIBRATION CRITERIA					
No vibration exceedance above the criteria of 10 mm/s during piling works
