# INLAND RAIL – NARRABRI TO NORTH STAR – SSI 7474

## ER MONTHLY REPORT

September | 2022

**Report Name:** Inland Rail N2NS – SSI 7474 – ER Monthly Report – September 2022  
**Project No.:** 136

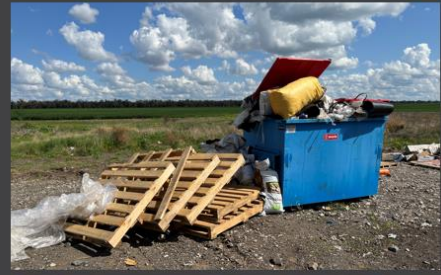
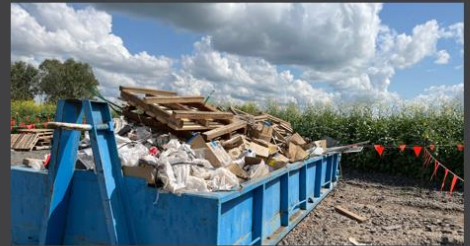
Waste management issues in Stage 3

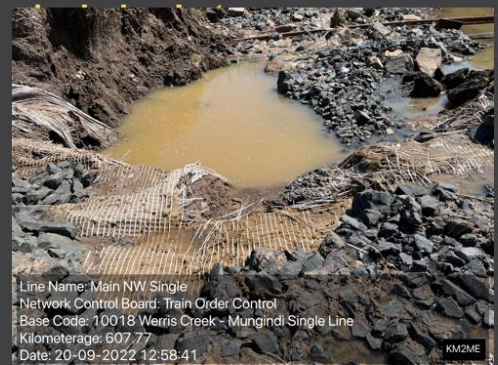
Downstream damage at Boggy Creek requires stabilisation

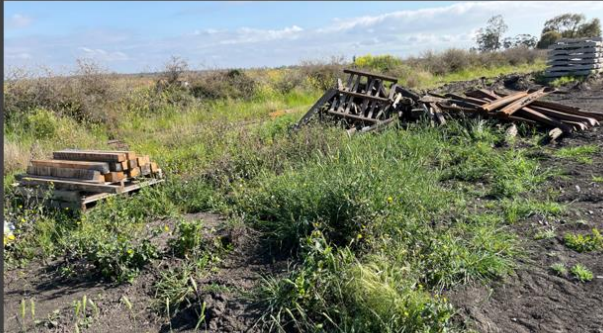
Stage 3 - Weed and waste management  
require attention

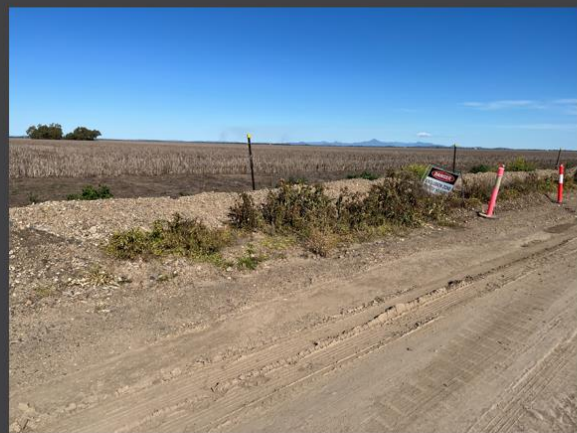
Weed control at Pad 2

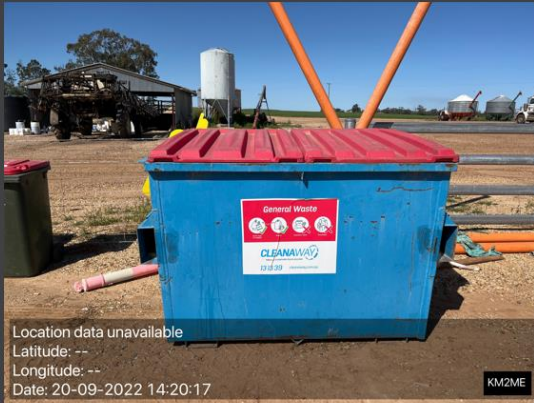
Skip bin at Pad 6 noted as overfull during previous inspection has subsequently been emptied

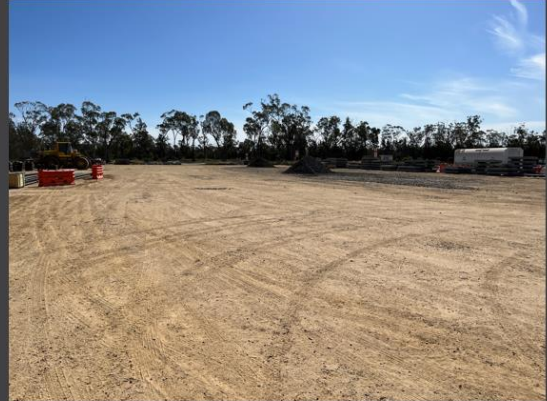
Pad 6 adjacent to occupied house site of dust generation by travelling vehicles. Dust control required

Notwithstanding the above average rainfall, dust generation by vehicles travelling along access tracks and at Pad 6 was observed during the ER inspection on 20/09. It was recommended that the contractor implement dust mitigation measures, particularly at Pad 6 where an occupied house is located close to the southern boundary of the pad.

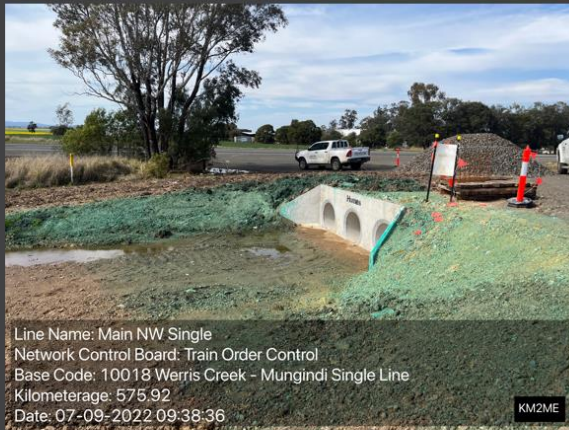
Soil binder application at Gate 1

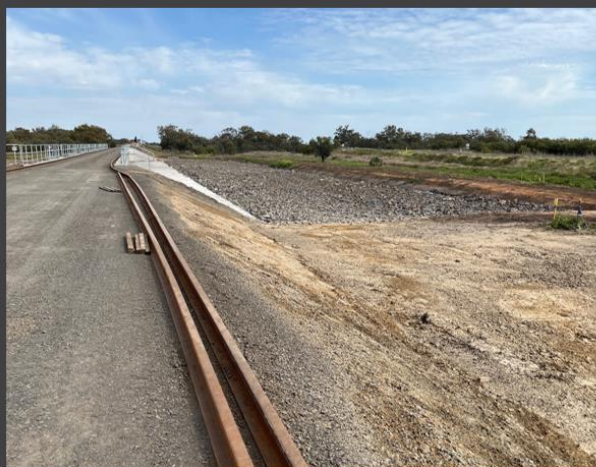
Final profile in Stage 2 – Awaiting Application of hydro mulch

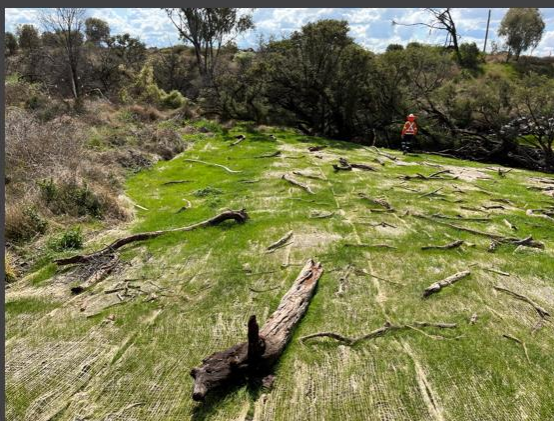
Croppa Creek – Woody debris disburshed throughout riparian zone as part of Creekside rehabilitation works – Note potential for augmentation of riparian zone function by planting trees and tall shrubs close to the creek line

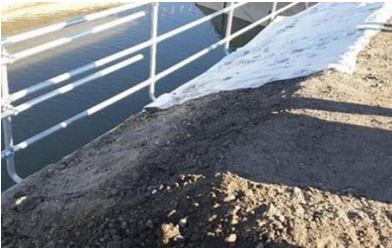
| Unique ID | Document / requirement reference | Requirement | Finding | Action proposed / implemented | Status |
|---|---|---|---|---|---|
| 20210908-119<br><br>Lon:149.819<br><br>Lat: -29.636<br><br>Tycannah Creek Tributary | NA | <br><br>In September 2021 it was noted there was a risk of embankment fill material washing over edge of bridge prior to the embankment being cut back to final shape. Recent inspections have confirmed material has been stabilised with soil binder and hydroseeding. | Design process to be reviewed to understand how constructability factored in (or not) & any lessons learned arising | Wing walls on upstream and downstream top edges of culvert being redesigned to better contain rail embankment material. It is planned to retrofit these during the next Stage 2 possession from April to October 2022<br><br>11/07/22 ARTC advised:<br><br>Following on from the Event Summary Report attached, ARTC has been investigating mitigation measures to prevent material spill in the short and long term.<br><br><b>Short Term:</b><br><br>1. On all culverts to be constructed with earth fill the Contractor will be required to provide temporary edge support.<br><br>2. Edges support to be hungry boards, silt fencing or similar to retain all material spill form the culvert.<br><br>3. Temporary batter protection with geofabric required to limit scour due to rainfall events<br><br><b>Long Term:</b><br><br>1. Resolve batter scour on culverts.<br><br>2. Consider access, refuge and maintenance activities.<br><br>3. Permanent batter slope product will be a fabric and/or concrete solution..<br><br>4. Permanent hungry board will likely be a large, galvanized steel equal angle the is anchored to the top face of the in-situ headwall. | Progressing.<br><br>27/07/22 ARTC advises that works are yet to commence.<br><br>Remains open pending inspection of close out works<br><br>10/8 – No change<br><br>07/09 – No change |

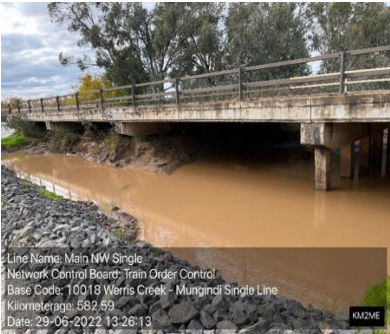
| Unique ID | Document / requirement reference | Requirement | Finding | Action proposed / implemented | Status |
|---|---|---|---|---|---|
| 220629_3<br><br>Stage 1-<br>Spring<br>Creek | NA | <br><small>Line Name: Main NW Single<br/>Network Control Board: Train Order Control<br/>Base Code: 10018 Werri Creek - Mungindi Single Line<br/>Kilometrage: 582.59<br/>Date: 29-06-2022 13:26:13</small> | Upstream ponding of highly turbid water<br><br>Update 07/09 –<br>Several high flow level events have occurred subsequent to 29/06.<br>Action can be closed | <br><br>To be pumped out and used on on-site before final site clean-up | Closed |

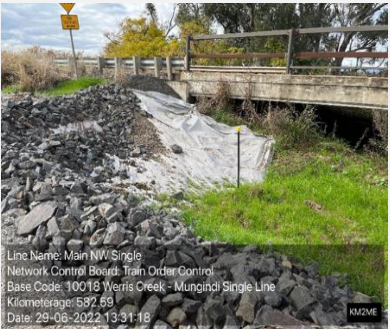
| Unique ID | Document / requirement reference | Requirement | Finding | Action proposed / implemented | Status |
|---|---|---|---|---|---|
| 220629_4<br><br>Spring<br>Creek | NA | <br><small>Line Name: Main NW Single<br/>Network Control Board: Train Order Control<br/>Base Code: 10018 Werri Creek - Mungindi Single Line<br/>Kilometrage: 582.59<br/>Date: 29-06-2022 13:31:18</small> | Temporary stabilisation works | <br><br>To be replaced by permanent works as part of final site stabilisation works | Open |

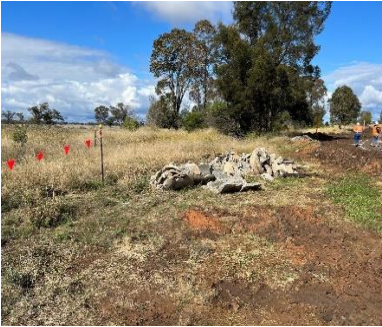
| Unique ID | Document / requirement reference | Requirement | Finding | Action proposed / implemented | Status |
|---|---|---|---|---|---|
| 2206713_5<br><br>Stage 1 -<br>Culvert<br>578.730 | NA | | Concrete waste disposal. | On-going discussions with EPA regarding on-farm disposal of concrete waste materials<br><b>Update 27/0722</b><br>Contractor advises that discussions are now ongoing with Moree Plains Shire Council for the waste materials to be transported to licensed waste disposal site for crushing and re-use at other locations<br><b>Update 10/08</b><br>Contractor advises that small stockpiles will go to Moree. Larger stockpiles will be backloaded to Gunnedah quarry site<br><b>Update 07/09</b><br>Concrete waste disposal mechanisms operational | Open<br>pending application of updated action<br><br>Closed |

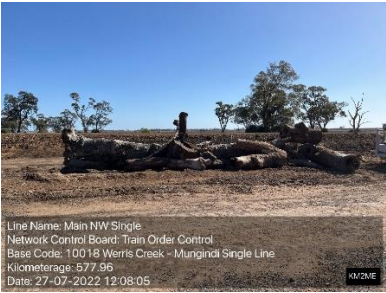
| Unique ID | Document / requirement reference | Requirement | Finding | Action proposed / implemented | Status |
|---|---|---|---|---|---|
| 220727_2<br><br>Kms 577.96 | NA | <br><small>Line Name: Main NW Single<br/>Network Control Board: Train Order Control<br/>Base Code: 10018 Werris Creek - Mungindi Single Line<br/>Kilometrage: 577.96<br/>Date: 27-07-2022 12:08:05</small> | Large woody debris (LWD) – Red Gum salvaged from clearing operations<br><br>To be dispersed across the corridor following completion of construction | <div>Low</div><br><br>For dispersal across site at ecologically strategic locations | Open |

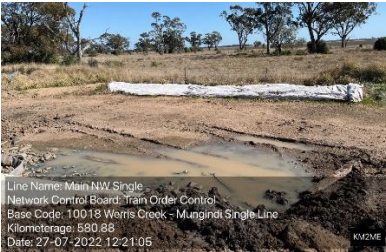
| Unique ID | Document / requirement reference | Requirement | Finding | Action proposed / implemented | Status |
|---|---|---|---|---|---|
| 220727_4<br><br>Km 580.88 | NA | <br><small>Line Name: Main NW Single<br/>Network Control Board: Train Order Control<br/>Base Code: 10018 Werris Creek - Mungindi Single Line<br/>Kilometrage: 580.88<br/>Date: 27-07-2022 12:21:05</small> | Downstream apron gravel bed to be extended to boundary fence.<br><br>Geotextile folded bund to be removed | <div>Low</div><br><br>Works to be undertaken as works progress | Open |

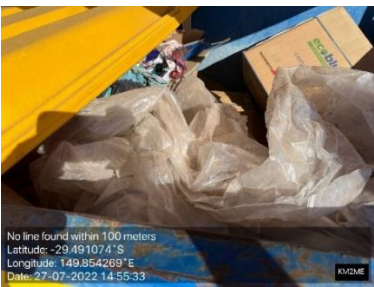
| Unique ID | Document / requirement reference | Requirement | Finding | Action proposed / implemented | Status |
|---|---|---|---|---|---|
| 220727_9 | NA | <br><small>No line found within 100 meters<br/>Latitude: -29.4910741 S<br/>Longitude: 149.854269 E<br/>Date: 27-07-2022 14:55:33</small> | Plastic waste in comingles recycling bin | <div>Low</div><br><br>Storage of plastic material in comingled recyng bin not permitted | Open |

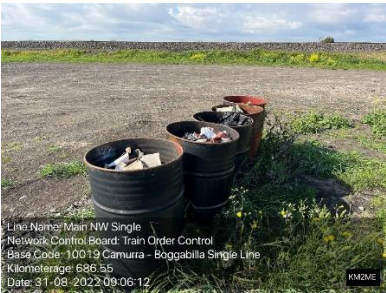
| Unique ID | Document / requirement reference | Requirement | Finding | Action proposed / implemented | Status |
|---|---|---|---|---|---|
| 220831_3<br><br>Km 686.55<br><br>Milguy Laydown | NA | <br><small>Line Name: Main NW Single<br/>Network Control Board: Train Order Control<br/>Base Code: 10019 Camurra - Boggabilla Single Line<br/>Kilometrage: 686.55<br/>Date: 31-08-2022 09:06:12</small> | Drums for storage of sleeper jewelry<br><br>Note weed growth adjacent to drums | <div>o</div><br><br>Consider covering drums with lids to prevent entry of water and vermin | Open |

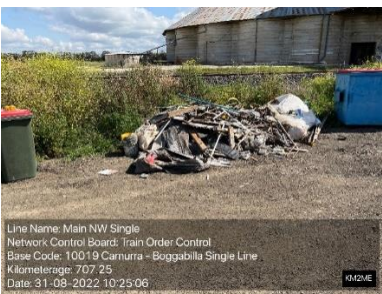
| 220831_7<br>Km 707.25 | NA | <br><small>Line Name: Main NW Single<br/>Network Control Board: Train Order Control<br/>Base Code: 10019 Canungra - Boggabilla Single Line<br/>Kilometrage: 707.25<br/>Date: 31-08-2022 10:25:06</small> | Non-segregation of waste material stockpile<br><br>Waste segregation should occur as soon as possible<br><br>Note weed growth behind waste stockpile | Medium | Open |

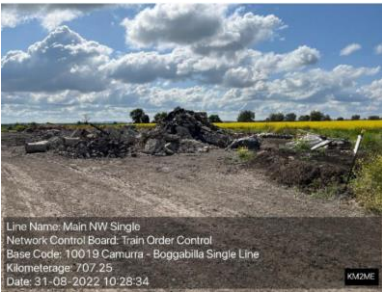
| 220831_8<br>Km 707.25 | NA | <br><small>Line Name: Main NW Single<br/>Network Control Board: Train Order Control<br/>Base Code: 10019 Canungra - Boggabilla Single Line<br/>Kilometrage: 707.25<br/>Date: 31-08-2022 10:28:34</small> | Waste concrete awaiting transport to Moree licensed waste disposal facility<br><br>Noted that the stockpiles will require separation of non-concrete materials from the stockpiles prior to transportation to the land fill | Medium | Open |

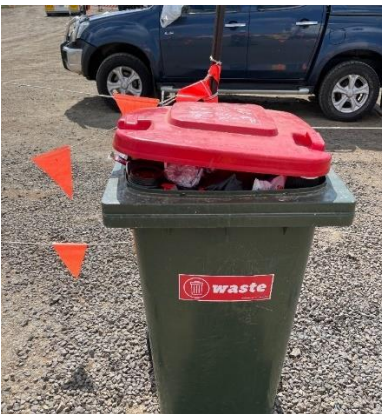
| 220831_8<br>Km 707.24 | NA | | Waste bins overfull | High<br>To be emptied ASAP | Open |

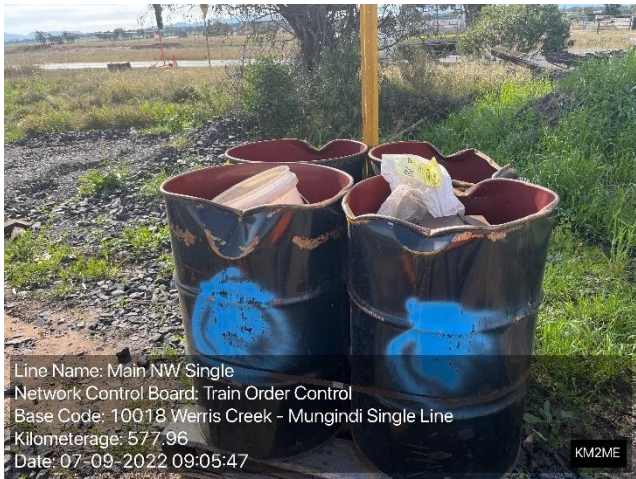
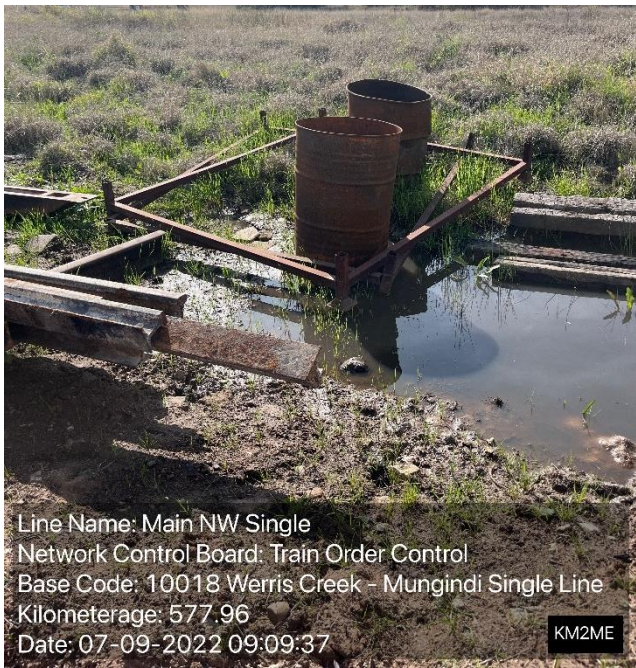
| Unique ID | Photo | Finding | Priority | Status |
|---|---|---|---|---|
| 220907_1<br>Km 577.96<br>Gate 2 | <div><p>Line Name: Main NW Single<br/>Network Control Board: Train Order Control<br/>Base Code: 10018 Werris Creek - Mungindi Single Line<br/>Kilometrage: 577.96<br/>Date: 07-09-2022 09:05:47</p><p>KM2ME</p></div> <div><p>Line Name: Main NW Single<br/>Network Control Board: Train Order Control<br/>Base Code: 10018 Werris Creek - Mungindi Single Line<br/>Kilometrage: 577.96<br/>Date: 07-09-2022 09:09:37</p><p>KM2ME</p></div> | 200 litres drums without lids – exposed to the elements.<br><br>Contractor is encouraged to cover the bins to exclude rain and access by vermin | Low | Open |

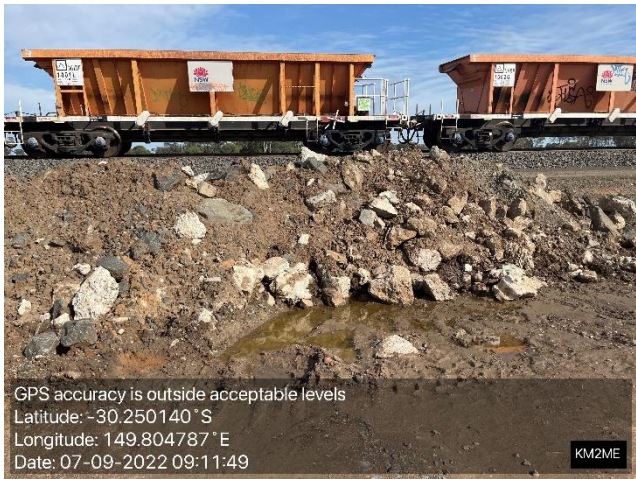
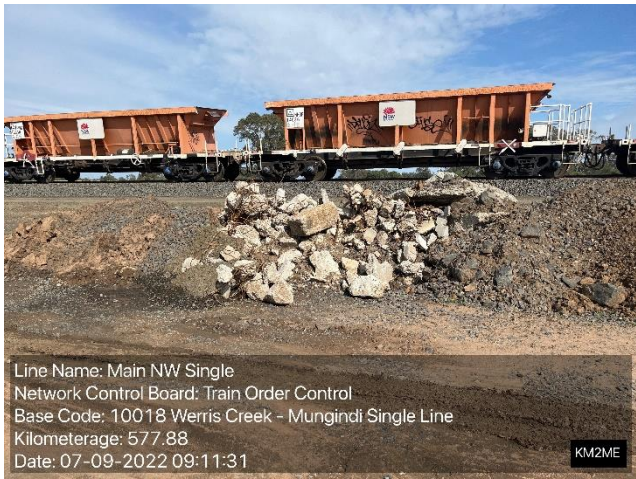
| Unique ID | Photo | Finding | Priority | Status |
|---|---|---|---|---|
| 220907_2<br>Km 577.88 | | Waste concrete requires segregating prior to transport to recycling facility | Low | Open |

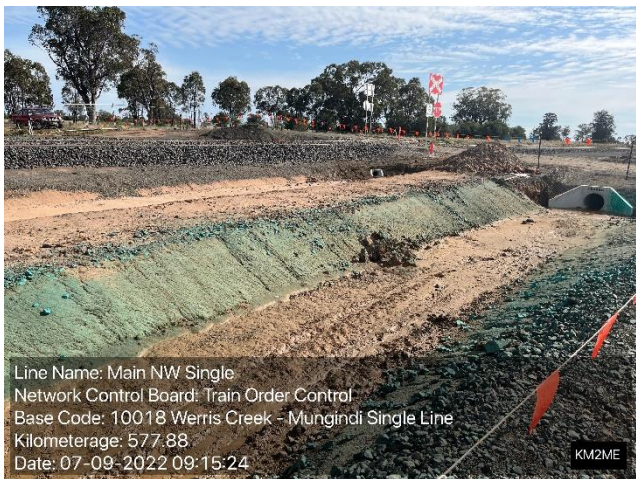
| Unique ID | Photo | Finding | Priority | Status |
|---|---|---|---|---|
| 220907_3<br>Km 577.88 | | Recently applied polymer to cut surfaces for stabilisation | <br>Example of good practice | No further action required |

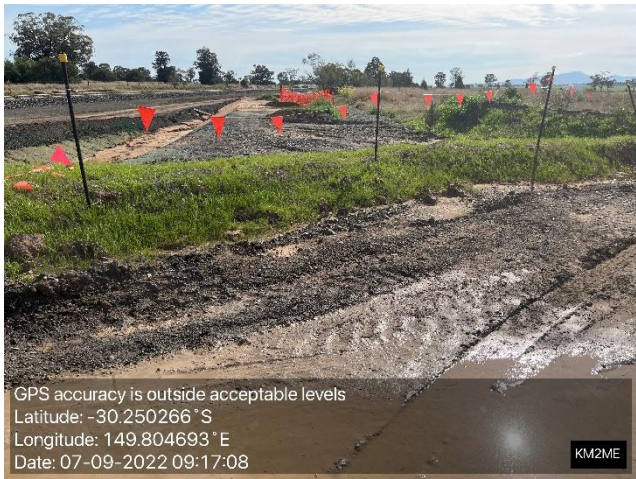
| Unique ID | Photo | Finding | Priority | Status |
|---|---|---|---|---|
| 220907_4<br>Gate 2B | | Seeding of stockpiles and bunds taking effect | <br>Example of good practice | No further action required |

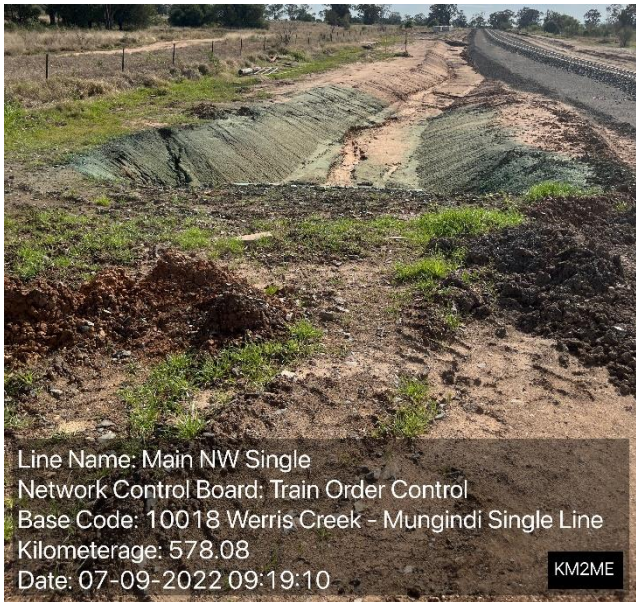
| Unique ID | Photo | Finding | Priority | Status |
|---|---|---|---|---|
| 220907_5<br>Km 578.08<br>Gate 2B | | Erosion rill beginning to develop in the bed of the cutting.<br><br>Recommended that invert of cutting is hardened to reduce erosion risk | <div>Low</div> | Open |

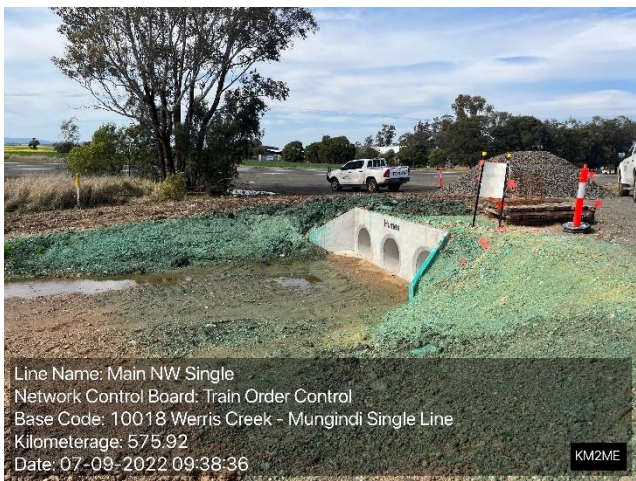
| Unique ID | Photo | Finding | Priority | Status |
|---|---|---|---|---|
| 220907_6<br>Gate 1<br>Km 575.92 | | Recently applied polymer for site stabilisation | <br>Example of good practice | No further action required |

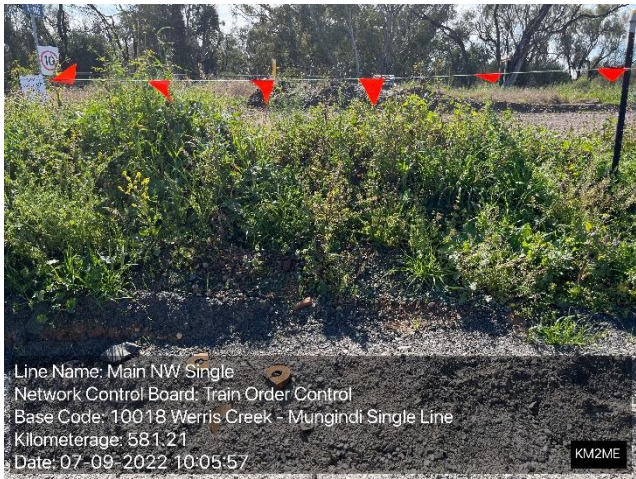
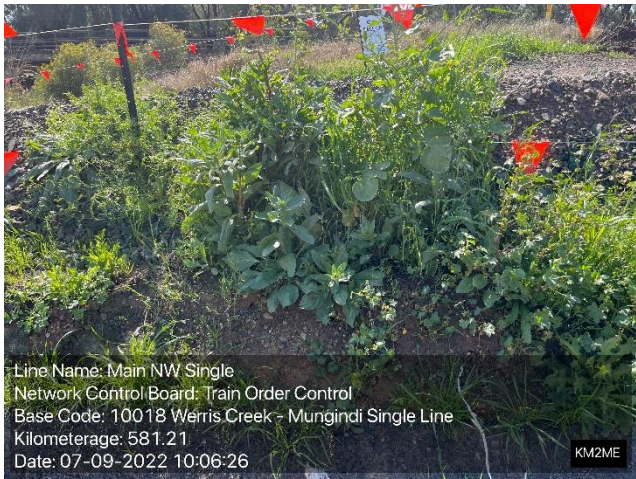
| Unique ID | Photo | Finding | Priority | Status |
|---|---|---|---|---|
| 220907_7<br>Km 581.21 | <p>Line Name: Main NW Single<br/>Network Control Board: Train Order Control<br/>Base Code: 10018 Werris Creek - Mungindi Single Line<br/>Kilometerage: 581.21<br/>Date: 07-09-2022 10:05:57</p> | Evidence of recent weed spraying beginning to take effect | <p>Example of good practice</p> | No further action required |

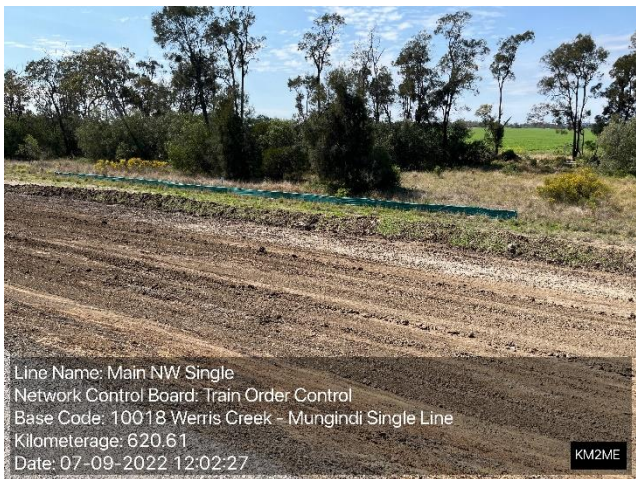
| Unique ID | Photo | Finding | Priority | Status |
|---|---|---|---|---|
| 220907_7<br>Km 620.61<br>North of Penneys Rd | <p>Line Name: Main NW Single<br/>Network Control Board: Train Order Control<br/>Base Code: 10018 Werris Creek - Mungindi Single Line<br/>Kilometerage: 620.61<br/>Date: 07-09-2022 12:02:27</p> | <p>Skink hotel – One of three in the general location.</p> <p>To be inspected and consideration given to removal if no longer serving a purpose</p> | | Open pending inspection and decision re removal or retention |

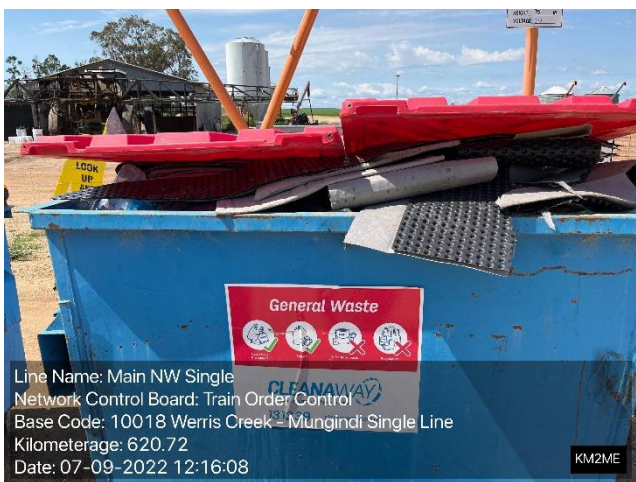
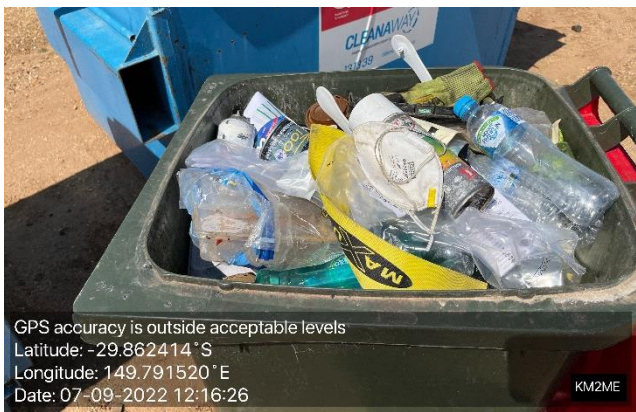
| Unique ID | Photo | Finding | Priority | Status |
|---|---|---|---|---|
| 220907_8<br>Km 620.72<br>Pad 6 | <p>Line Name: Main NW Single<br/>Network Control Board: Train Order Control<br/>Base Code: 10018 Werris Creek - Mungindi Single Line<br/>Kilometerage: 620.72<br/>Date: 07-09-2022 12:16:08</p> | Waste bins overfull – to be emptied as soon as possible | High | Open pending removal of waste |

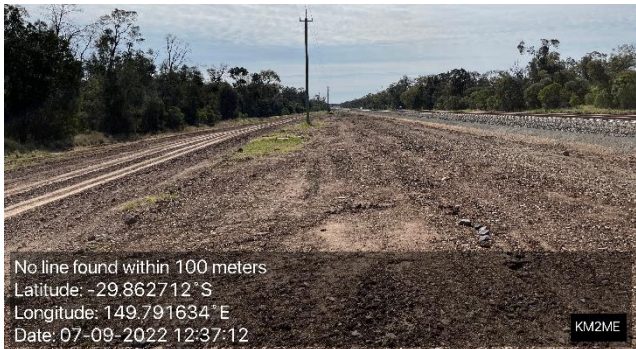
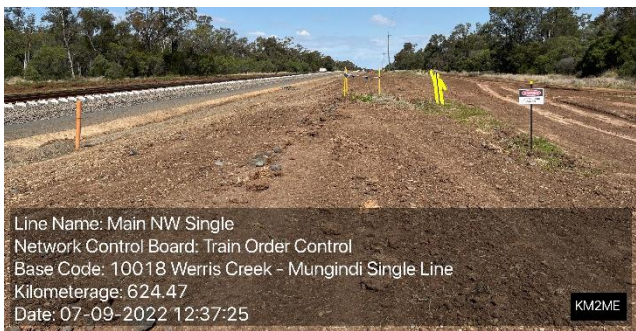
| Unique ID | Photo | Finding | Priority | Status |
|---|---|---|---|---|
| 220907_9<br>Km 624.47 | <p>No line found within 100 meters<br/>Latitude: -29.862712°S<br/>Longitude: 149.791634°E<br/>Date: 07-09-2022 12:37:12</p> | Batters and adjoining areas awaiting application of hydro mulch | On | Open pending application of hydro mulch |

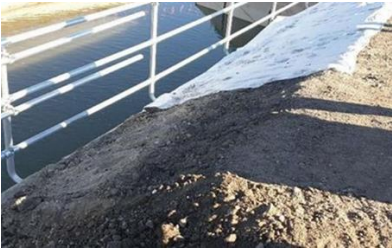
| Unique ID | Document / requirement reference | Requirement | Finding | Action proposed / implemented | Status |
|---|---|---|---|---|---|
| 20210908-119<br><br>Lon:149.819<br><br>Lat: -29.636<br><br>Tycannah Creek Tributary | NA | <p>In September 2021 it was noted there was a risk of embankment fill material washing over edge of bridge prior to the embankment being cut back to final shape. Recent inspections have confirmed material has been stabilised with soil binder and hydroseeding.</p> | Design process to be reviewed to understand how constructability factored in (or not) & any lessons learned arising | <p>Wing walls on upstream and downstream top edges of culvert being redesigned to better contain rail embankment material. It is planned to retrofit these during the next Stage 2 possession from April to October 2022</p> <p>11/07/22 ARTC advised:</p> <p>Following on from the Event Summary Report attached, ARTC has been investigating mitigation measures to prevent material spill in the short and long term.</p> <p><b>Short Term:</b></p> <ol style="list-style-type: none"> <li>On all culverts to be constructed with earth fill the Contractor will be required to provide temporary edge support.</li> <li>Edges support to be hungry boards, silt fencing or similar to retain all material spill form the culvert.</li> <li>Temporary batter protection with geofabric required to limit scour due to rainfall events</li> </ol> <p><b>Long Term:</b></p> <ol style="list-style-type: none"> <li>Resolve batter scour on culverts.</li> <li>Consider access, refuge and maintenance activities.</li> <li>Permanent batter slope product will be a fabric and/or concrete solution..</li> <li>Permanent hungry board will likely be a large, galvanized steel equal angle the is anchored to the top face of the in-situ headwall.</li> </ol> | <p>Progressing.</p> <p>27/07/22 ARTC advises that works are yet to commence.</p> <p>Remains open pending inspection of close out works</p> <p>10/8 – No change</p> <p>07/09 – No change</p> <p>23/09/22 – Revised design issued for information approved 23/09/22</p> |

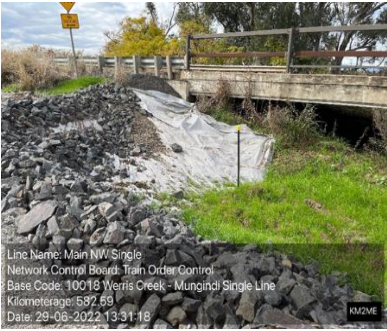
| Unique ID | Document / requirement reference | Requirement | Finding | Action proposed / implemented | Status |
|---|---|---|---|---|---|
| 220629_4<br>Spring Creek | NA | <br><small>Line Name: Main NW Single<br/>Network Control Board: Train Order Control<br/>Base Code: 10018 Werris Creek - Mungindi Single Line<br/>Kilometrage: 582.69<br/>Date: 29-08-2022 13:31:18</small> | Temporary stabilisation works | <br><br>To be replaced by permanent works as part of final site stabilisation works | Open |

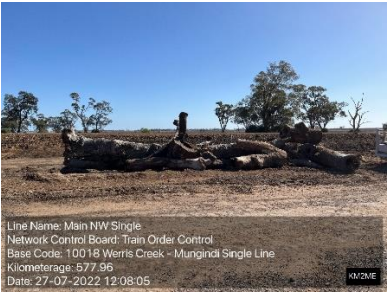
| Unique ID | Document / requirement reference | Requirement | Finding | Action proposed / implemented | Status |
|---|---|---|---|---|---|
| 220727_2<br>Kms 577.96 | NA | <br><small>Line Name: Main NW Single<br/>Network Control Board: Train Order Control<br/>Base Code: 10018 Werris Creek - Mungindi Single Line<br/>Kilometrage: 577.96<br/>Date: 27-07-2022 12:08:05</small> | Large woody debris (LWD) – Red Gum salvaged from clearing operations<br><br>To be dispersed across the corridor following completion of construction | <br><br>For dispersal across site at ecologically strategic locations | Open |

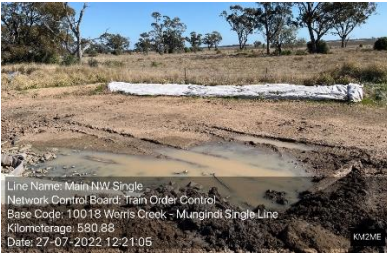
| Unique ID | Document / requirement reference | Requirement | Finding | Action proposed / implemented | Status |
|---|---|---|---|---|---|
| 220727_4<br>Km 580.88 | NA | <br><small>Line Name: Main NW Single<br/>Network Control Board: Train Order Control<br/>Base Code: 10018 Werris Creek - Mungindi Single Line<br/>Kilometrage: 580.88<br/>Date: 27-07-2022 12:21:05</small> | Downstream apron gravel bed to be extended to boundary fence.<br><br>Geotextile folded bund to be removed | <br><br>Works to be undertaken as works progress | Open |

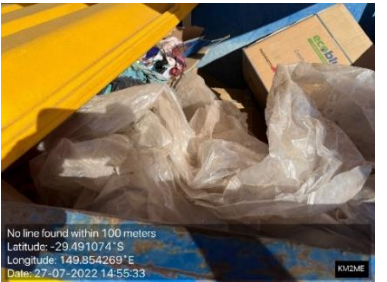
| Unique ID | Document / requirement reference | Requirement | Finding | Action proposed / implemented | Status |
|---|---|---|---|---|---|
| 220727_9 | NA | <br><small>No line found within 100 meters<br/>Latitude: -29.491074°S<br/>Longitude: 149.854269°E<br/>Date: 27-07-2022 14:55:33</small> | Plastic waste in comingles recycling bin | <br><br>Storage of plastic material in comingled recyng bin not permited | Open |

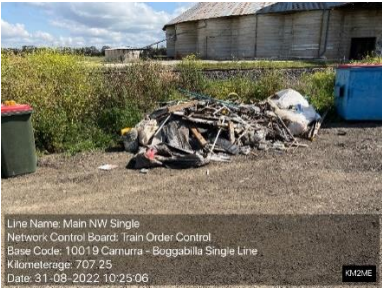
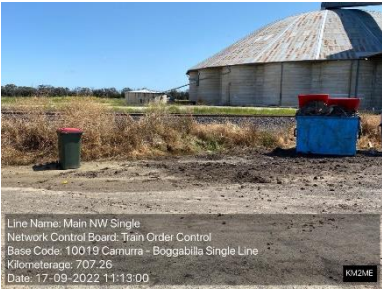
| Unique ID | Document / requirement reference | Requirement | Finding | Action proposed / implemented | Status |
|---|---|---|---|---|---|
| 220831_7<br><br>Km 707.25 | NA | <br><small>Line Name: Main NW Single<br/>Network Control Board: Train Order Control<br/>Base Code: 10019 Camurra - Boggabilla Single Line<br/>Kilometerage: 707.25<br/>Date: 31-08-2022 10:25:06</small> | Non-segregation of waste material stockpile<br><br>Waste segregation should occur as soon as possible<br><br>Note weed growth behind waste stockpile | <b>Medium</b> | Open |
| | | <br><small>Line Name: Main NW Single<br/>Network Control Board: Train Order Control<br/>Base Code: 10019 Camurra - Boggabilla Single Line<br/>Kilometerage: 707.25<br/>Date: 17-09-2022 11:13:08</small> | Update 23/09/22<br><br>Waste stockpile removed and weed spraying undertaken | | Closed |

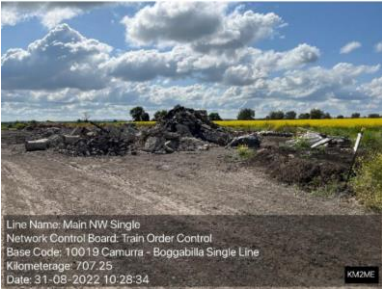
| Unique ID | Document / requirement reference | Requirement | Finding | Action proposed / implemented | Status |
|---|---|---|---|---|---|
| 220831_8<br><br>Km 707.25 | NA | <br><small>Line Name: Main NW Single<br/>Network Control Board: Train Order Control<br/>Base Code: 10019 Camurra - Boggabilla Single Line<br/>Kilometerage: 707.25<br/>Date: 31-08-2022 10:28:34</small> | Waste concrete awaiting transport to Moree licensed waste disposal facility<br><br>Noted that the stockpiles will require separation of non-concrete materials from the stockpiles prior to transportation to the land fill | <b>Medium</b> | Open |

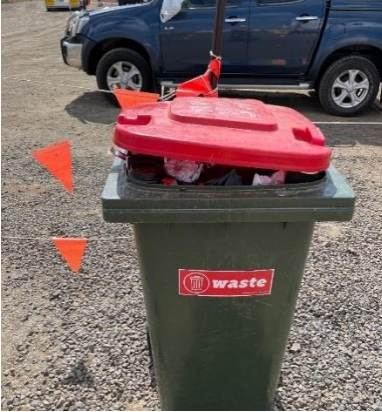
| Unique ID | Document / requirement reference | Requirement | Finding | Action proposed / implemented | Status |
|---|---|---|---|---|---|
| 220831_8<br><br>Km 707.24 | NA | | Waste bins overfull | <b>High</b><br><br>To be emptied ASAP | Open |

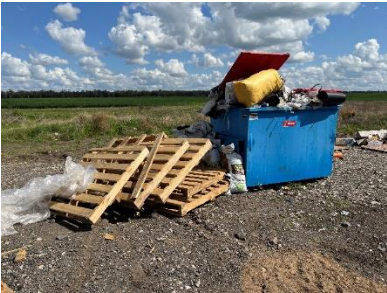
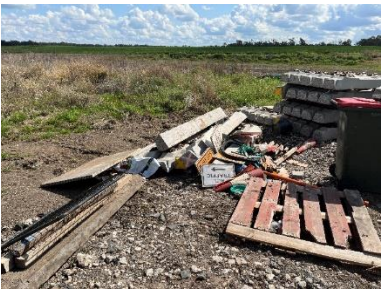
| Unique ID | Document / requirement reference | Requirement | Finding | Action proposed / implemented | Status |
|---|---|---|---|---|---|
| 220831 -15<br><br>Croppa Creek Laydown Area | NA | | <p>Waste bin overfull – waste material windblown across neighbouring land</p> <p>Waste needs to be collected ASAP</p> | <div>High</div> | Open |

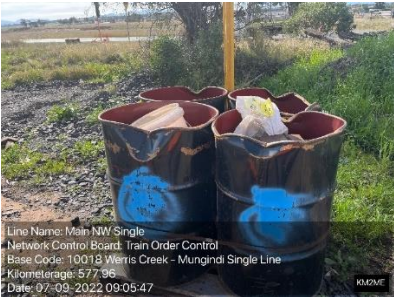
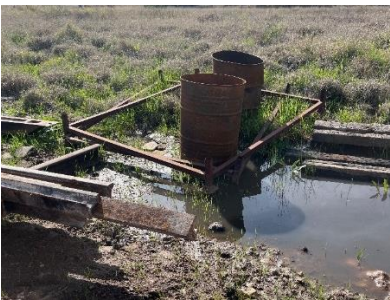
| Unique ID | Document / requirement reference | Requirement | Finding | Action proposed / implemented | Status |
|---|---|---|---|---|---|
| 220907_1<br><br>Km 577.96<br><br>Gate 2 | NA | | <p>200 litres drums without lids – exposed to the elements.</p> <p>Contractor is encouraged to cover the bins to exclude rain and access by vermin</p> | <div>Low</div> | Open |

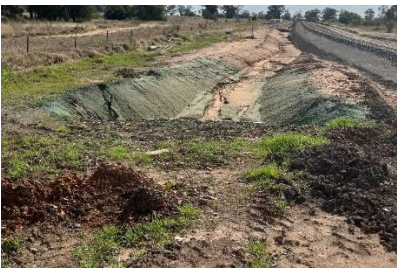
| Unique ID | Document / requirement reference | Requirement | Finding | Action proposed / implemented | Status |
|---|---|---|---|---|---|
| 220907_5<br><br>Km 578.08<br><br>Gate 2B | NA | | <p>Erosion rill beginning to develop in the bed of the cutting.</p> <p>Recommended that invert of cutting is hardened to reduce erosion risk</p> | <div>Low</div> | Open |

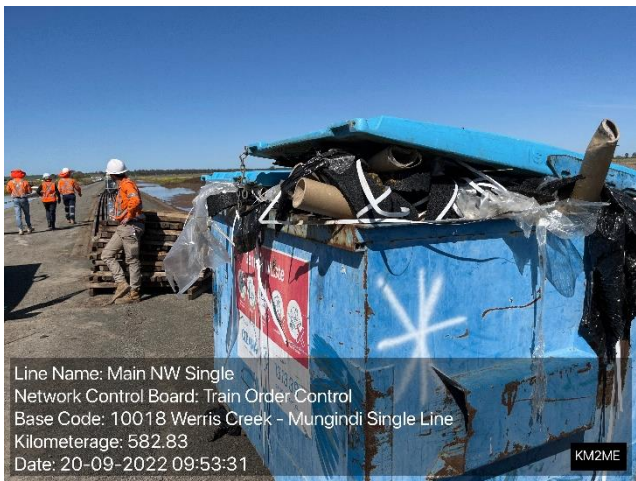
| Unique ID | Photo | Finding | Priority | Status |
|---|---|---|---|---|
| 220920_1<br>Km 582.83<br>Gate 2b | | Waste bin overfull | Low<br><br>Arrange for bin to be emptied when possible | Open |

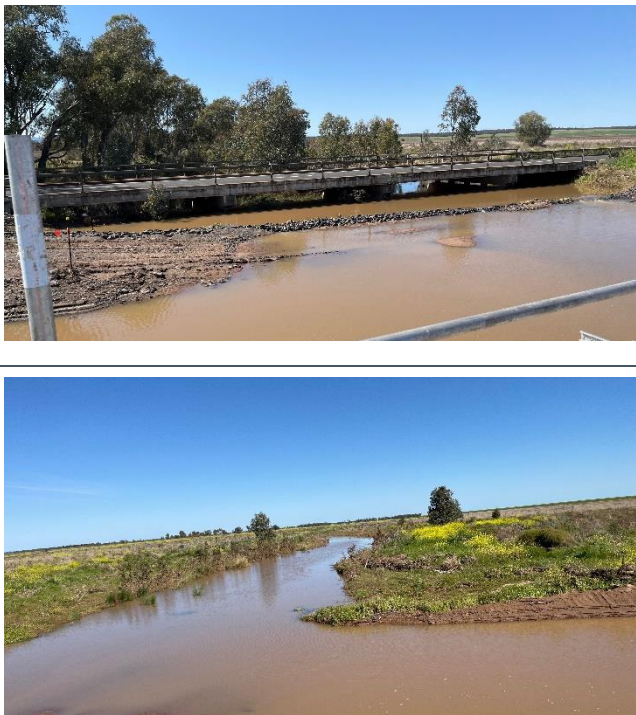
| Unique ID | Photo | Finding | Priority | Status |
|---|---|---|---|---|
| 220920_2<br>Km 582.83<br>Spring Creek | | Spring Creek highly turbid flows upstream and downstream of construction site | O | To be monitored |

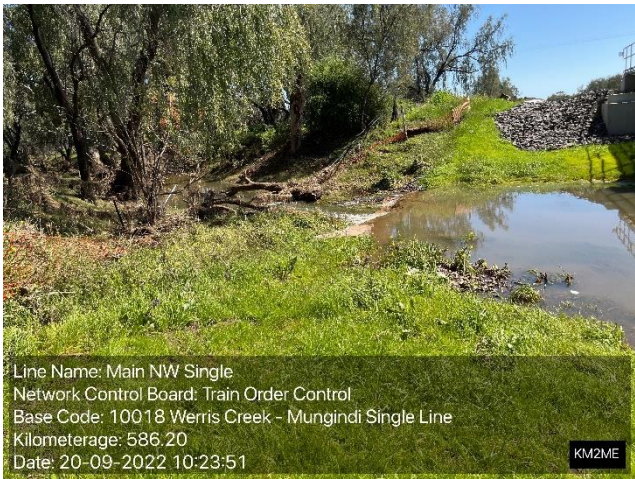
| Unique ID | Photo | Finding | Priority | Status |
|---|---|---|---|---|
| 220920_3<br>Km 586,20<br>Bobbiwaa Creek | | Bobbiwaa Creek – Erosion and sediment controls in place | <br>Example of good practice | No further action required |

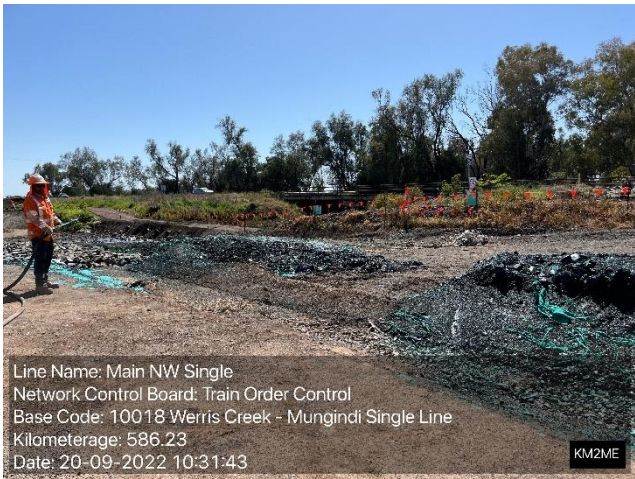
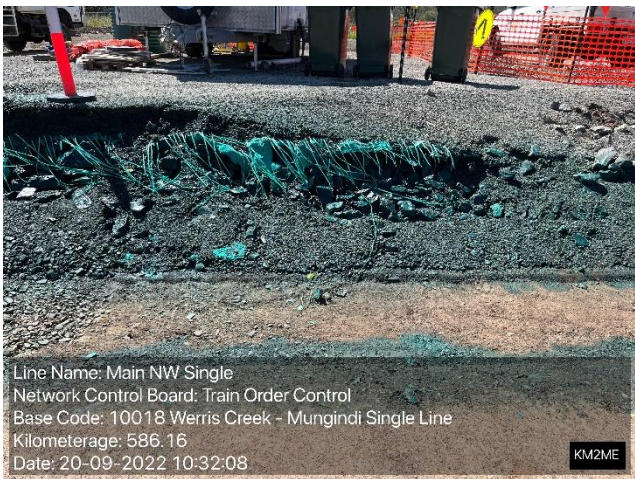
| Unique ID | Photo | Finding | Priority | Status |
|---|---|---|---|---|
| 220920_4<br>586,23<br>Bobbiwaa Creek | <br> | Application of polymer stabiliser to temporary stockpile | <br>Example of good practice | No further action required |

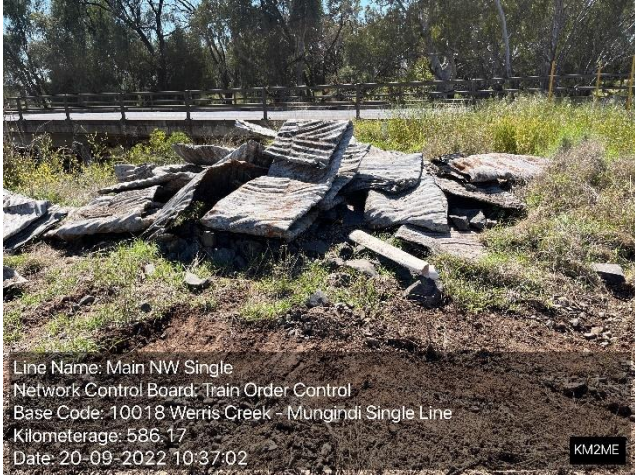
| Unique ID | Photo | Finding | Priority | Status |
|---|---|---|---|---|
| 220920_5<br>Bobbiwaa Creek<br>Km 586.17 | <br>Line Name: Main NW Single<br>Network Control Board: Train Order Control<br>Base Code: 10018 Werris Creek - Mungindi Single Line<br>Kilometerage: 586.17<br>Date: 20-09-2022 10:37:02<br>KM2ME | Remnant of pre-existing culvert structures<br><br>To be removed and transported to reprocessing facility | <br><br>Example of good practice | No further action required |

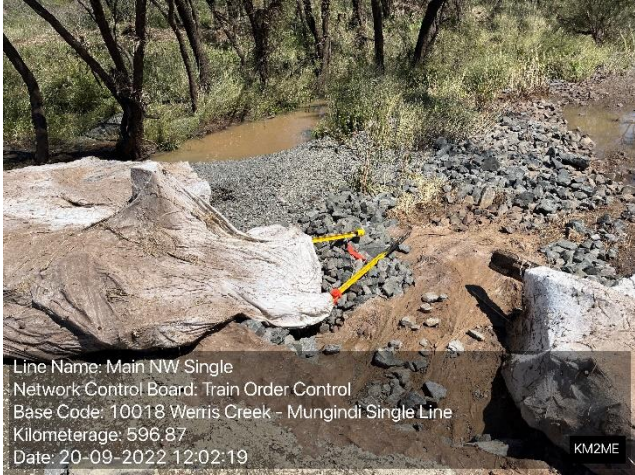
| Unique ID | Photo | Finding | Priority | Status |
|---|---|---|---|---|
| 220920_7<br>Km 596.87<br>Ten Mile Creek | <br>Line Name: Main NW Single<br>Network Control Board: Train Order Control<br>Base Code: 10018 Werris Creek - Mungindi Single Line<br>Kilometerage: 596.87<br>Date: 20-09-2022 12:02:19<br>KM2ME | Silt and gravel material washed down stream of work site by flood waters | <b>Low</b> | Open<br><br>Material to be retrieved when flood and work permit |

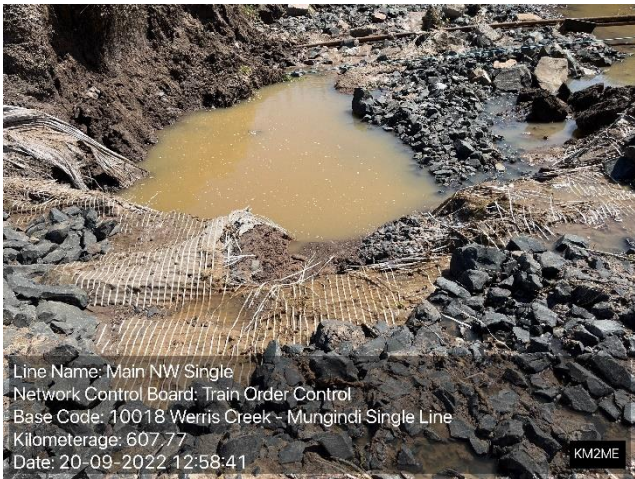
| Unique ID | Photo | Finding | Priority | Status |
|---|---|---|---|---|
| 220920_8<br>Km 607.77<br>Boggy Creek | | <p>Incising downstream of work site has resulted in development of potentially unstable creek bed and banks.</p> <p>Requires development and implementation of long term post construction final design for stabilised land / creek form</p> | Medium | Open |

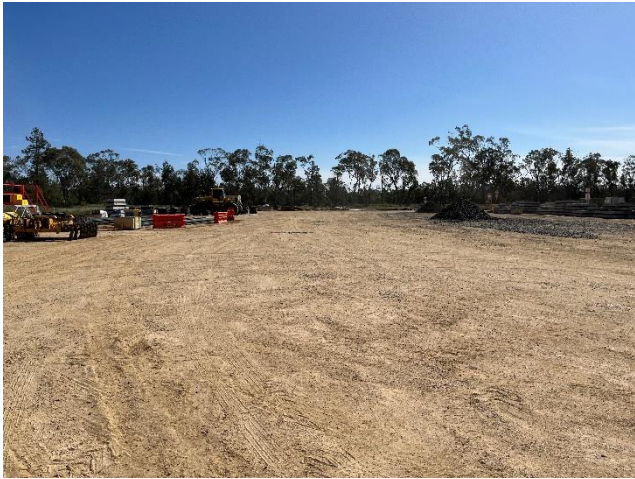
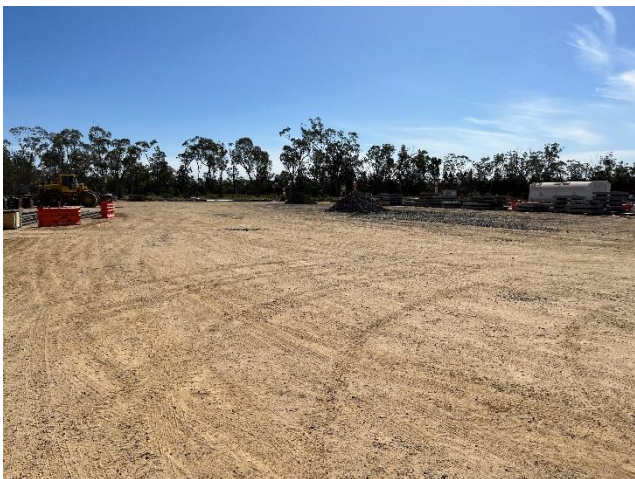
| Unique ID | Photo | Finding | Priority | Status |
|---|---|---|---|---|
| 220920_9<br>Pad 6 | | <p>Exposed surface susceptible to dust generation as vehicles travel through the site.</p> <p>Neighbouring land holder resides in nearby house which can be impacted by dust during windy conditions</p> <p>Recommended that dust control measures are implemented when there is a risk of dust generation impacting the neighbouring house</p> | Medium | Open pending adoption of mitigation measures |

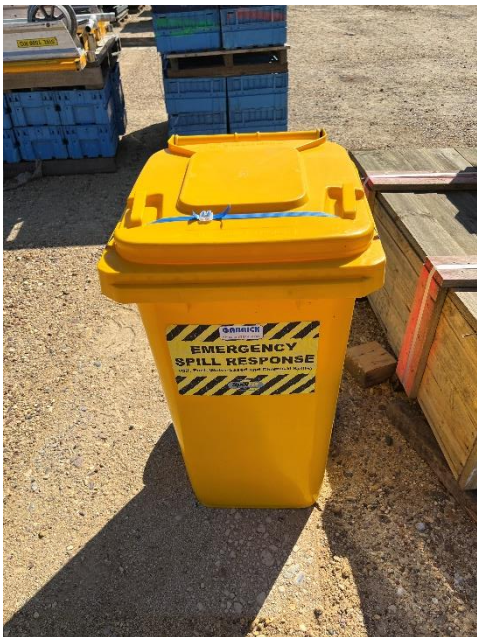
| Unique ID | Photo | Finding | Priority | Status |
|---|---|---|---|---|
| 220920_10<br>Pad 6 | | Emergency spill kit with tie down straps to prevent random access<br><br>Trans4m is maintain9ng emergency spill kits across the site to a very high standard | <br><br>Example of best practice | No further action required - Continue current practice |

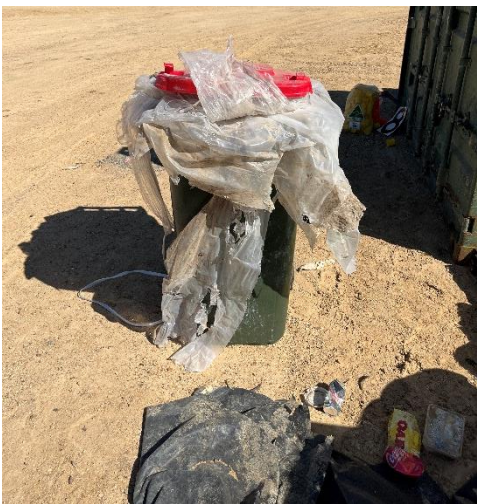
| Unique ID | Photo | Finding | Priority | Status |
|---|---|---|---|---|
| 220920_11<br>Pad 6 | <br> | Waste bin overflowing with sub-standard house keeping | Medium | Open pending clean up and emptying of bin |

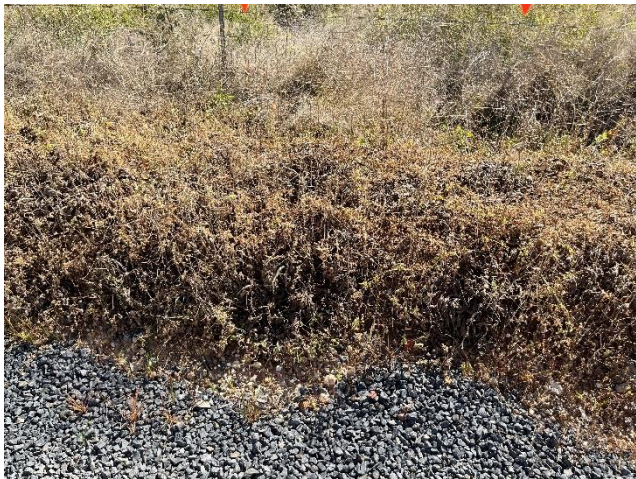
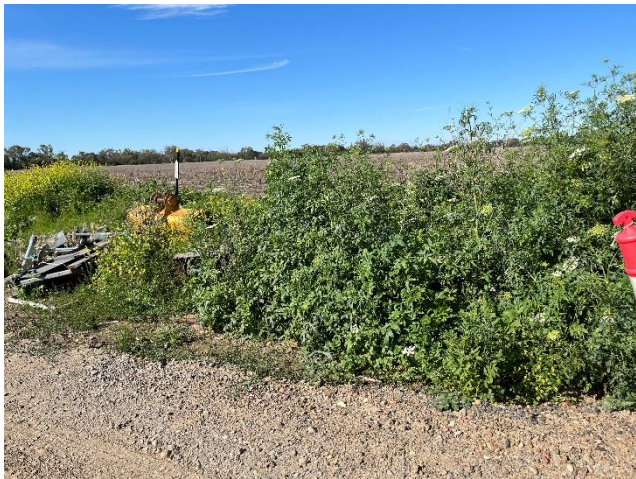
| Unique ID | Photo | Finding | Priority | Status |
|---|---|---|---|---|
| 220920_12<br>Pad 6 | | Effective implementation of weed control programs<br><br>Weed control measures should be applied to complete program on the site | Medium | Open pending adoption of weed |

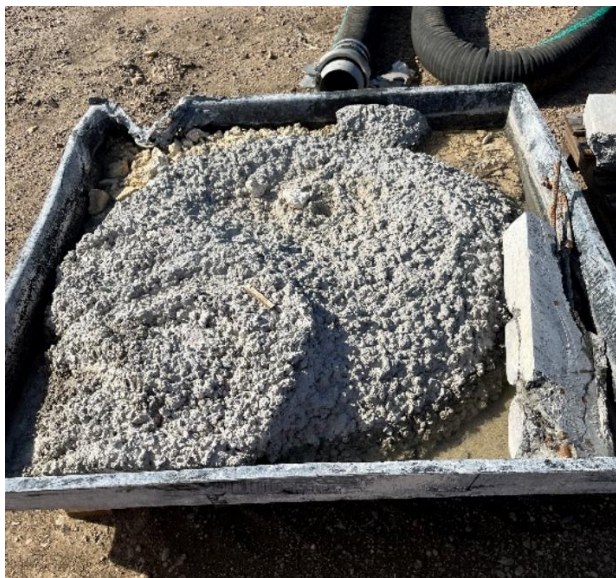
| Unique ID | Photo | Finding | Priority | Status |
|---|---|---|---|---|
| 220920_13<br>Pad 2 | | Correct use of concrete washout disposal bin | <br>Example of best practice | No further action required |
