Tree Impact Assessment Report

City and Southwest Metro Station Upgrade Works Package 5 & 6

P5 Document No. SMCSWSW5-DEW-WEC-EM-REP-000542

P6 Document No. SMCSWSW6-DEW-WEC-EM-REP-000632

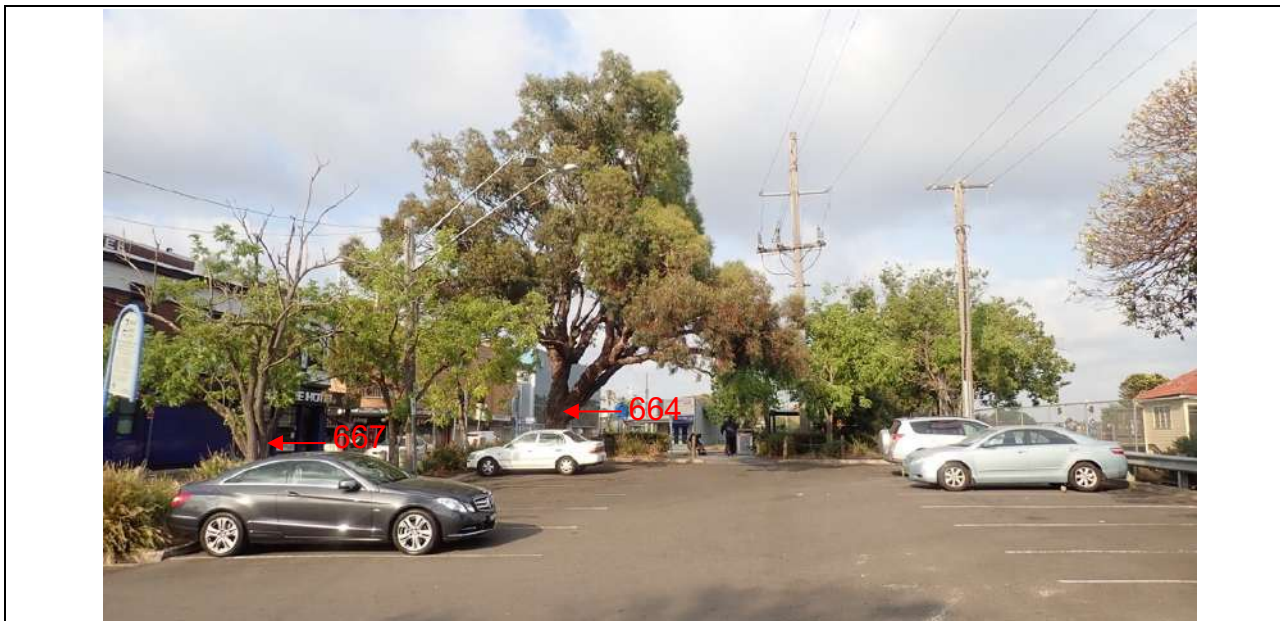
Image 1: Looking West towards tree 664 and 667. The proposed construction must be completed in accordance with section 9.2 to ensure tree 664 is not significantly impacted by the proposed works. Tree 667 is in poor health/advanced stages of decline and is recommended for removal due to its current condition and impacts from the proposed development.

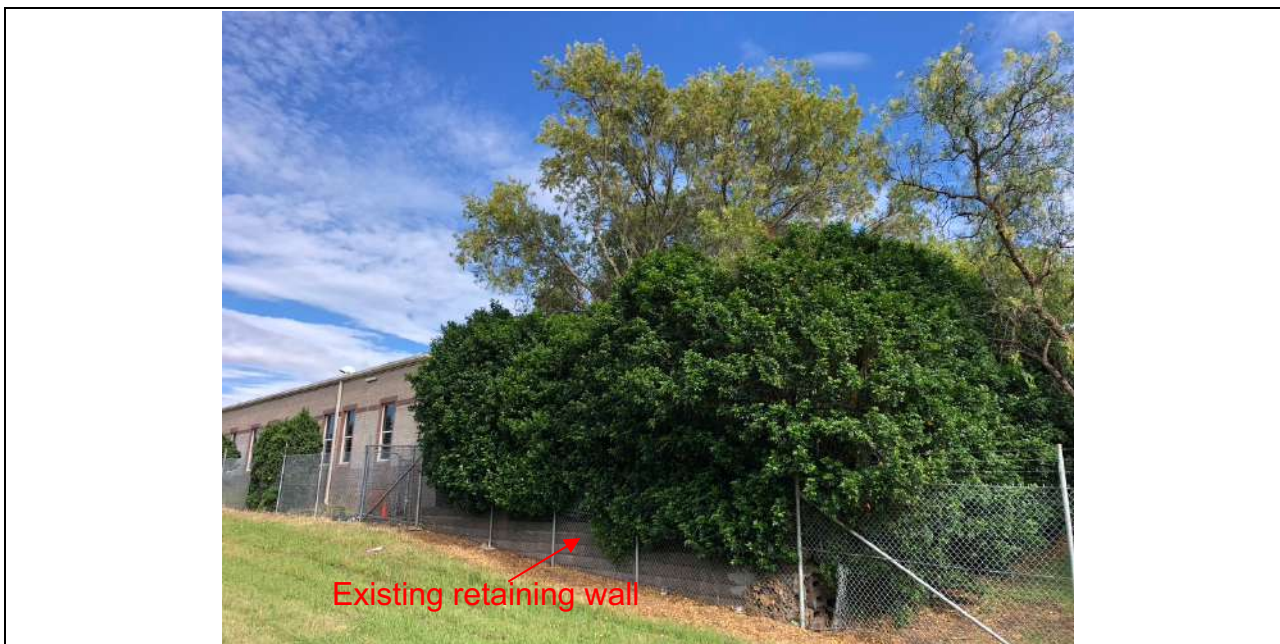
Image 2: Looking towards tree 3316, 3317, 3318, 3319 and 3320, showing the existing boundary retaining wall. The existing boundary retaining wall appears to be restricting root growth into the corridor, therefore, the proposed works within the corridor will not impact the trees. Minor canopy pruning may be required for tree 3316, 3317, 3319 and 3320. The proposed canopy pruning will result in the removal of less than 10% of the live foliage area of the trees and will not significantly impact the trees.

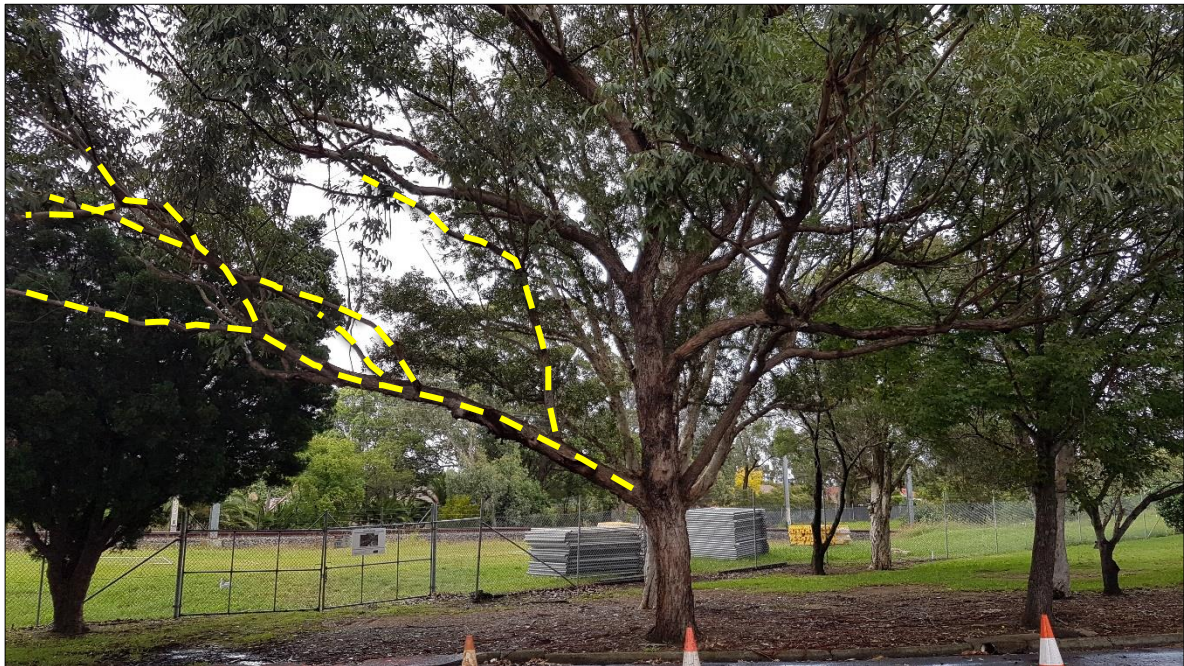
Tree 14 *Eucalyptus robusta* (Swamp Mahogany) identified pruning involves the removal of one first order branch at 2m height. The branch is approximately 300mm in diameter and constitutes 30% of the total canopy volume of the tree. A reduction in tree growth and physiological function can be expected as a result of the pruning works. Exposure of internal woody tissues at the site of the final pruning cut shall be susceptible to infection by decay causing fungi. The removal of the branch is not considered to significantly affect vocal amenity.

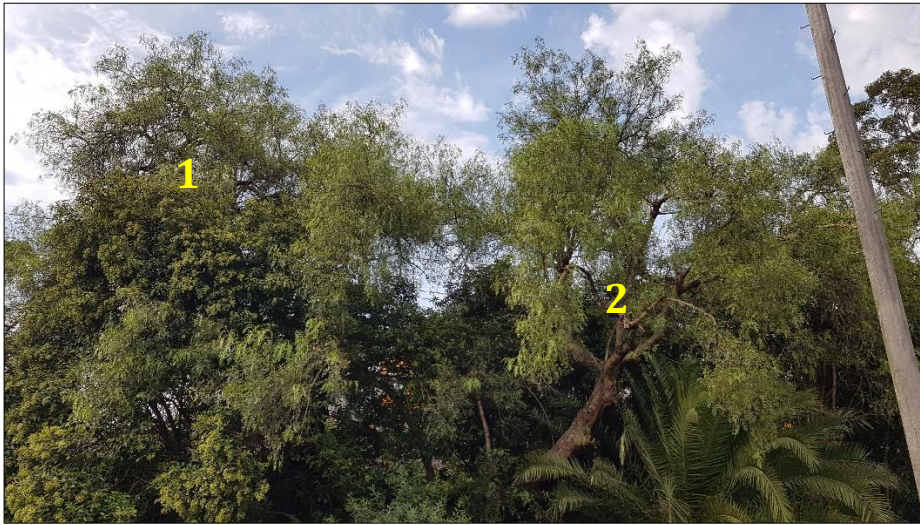
Photograph 1: Trees 1 and 2 *Schinus molle* (Peppercorn Tree) to be removed.

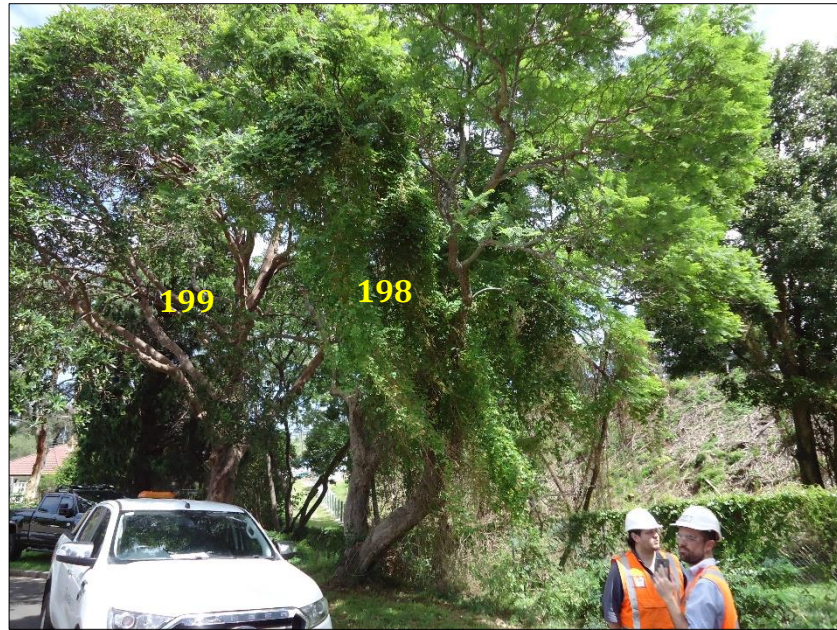
Image 5: Trees 198 and 199 as identified within the AIA report shall require removal for the Metro Services Building access road.

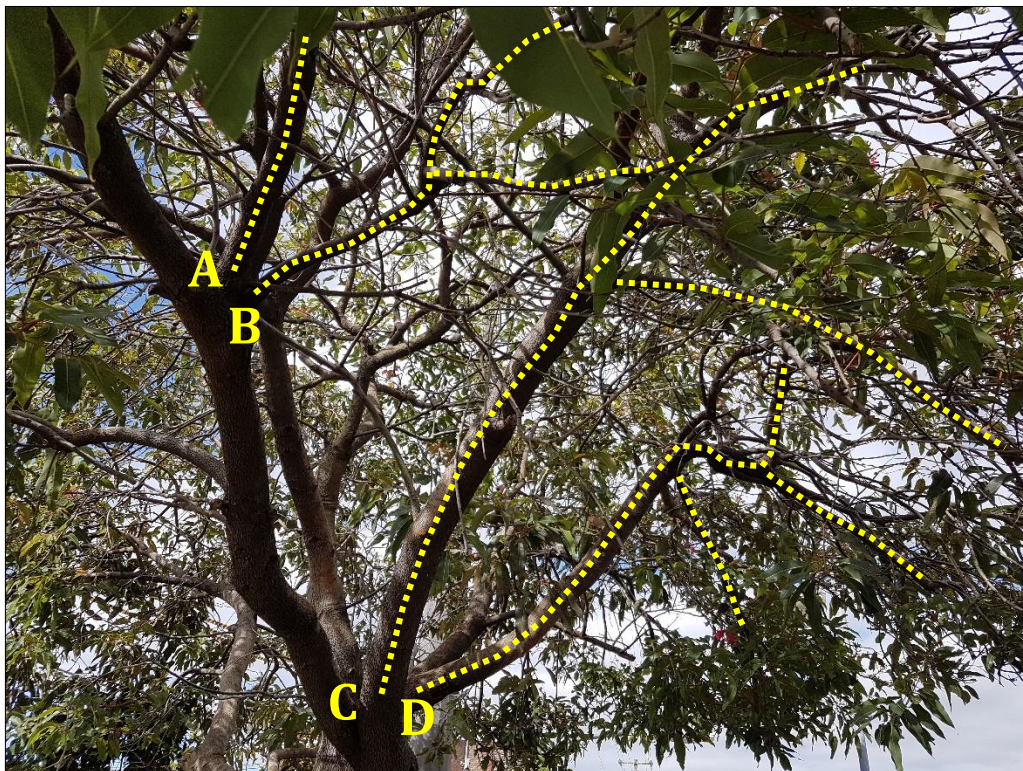
Photograph 3: Branches identified for removal from tree 591 to provide clearance for the proposed concourse roof structure. Branch A is 40mm in diameter at 2.7m height, branch B is 20mm in diameter at 2.7m height, branch C is 120mm in diameter at 2.1m height, branch D is 120mm in diameter at 2.2m height. The removal of identified branches constitutes approximately 35% of the total live canopy volume of the tree.

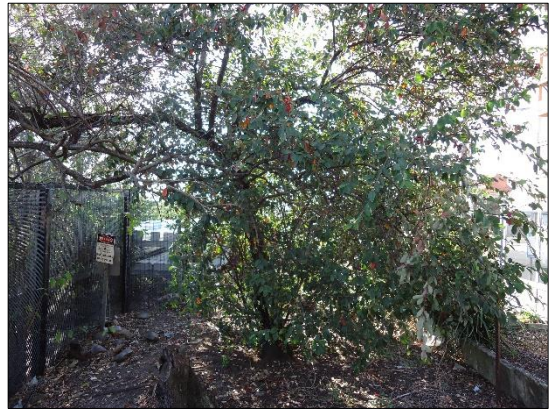
Photograph 2: Tree 516 *Leptospermum petersonii* (Lemon-scented Teatree) was found to be dead.

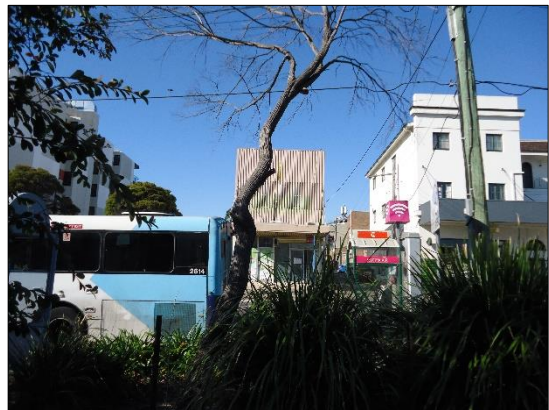
Photograph 3: Tree 517 *Pittosporum undulatum* (Sweet Pittosporum) was found to be dead.

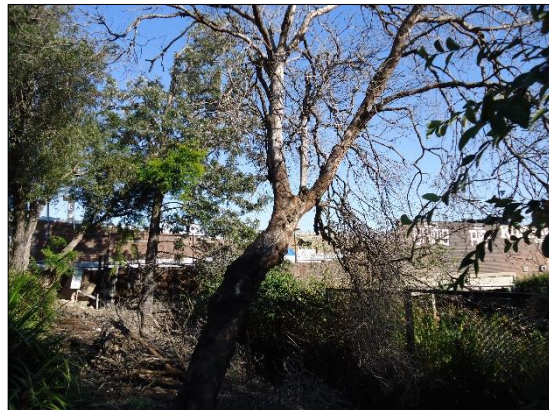
Photograph 4: Tree 519 *Callistemon viminalis* (Weeping Bottlebrush) located adjacent the northern side of South Parade.

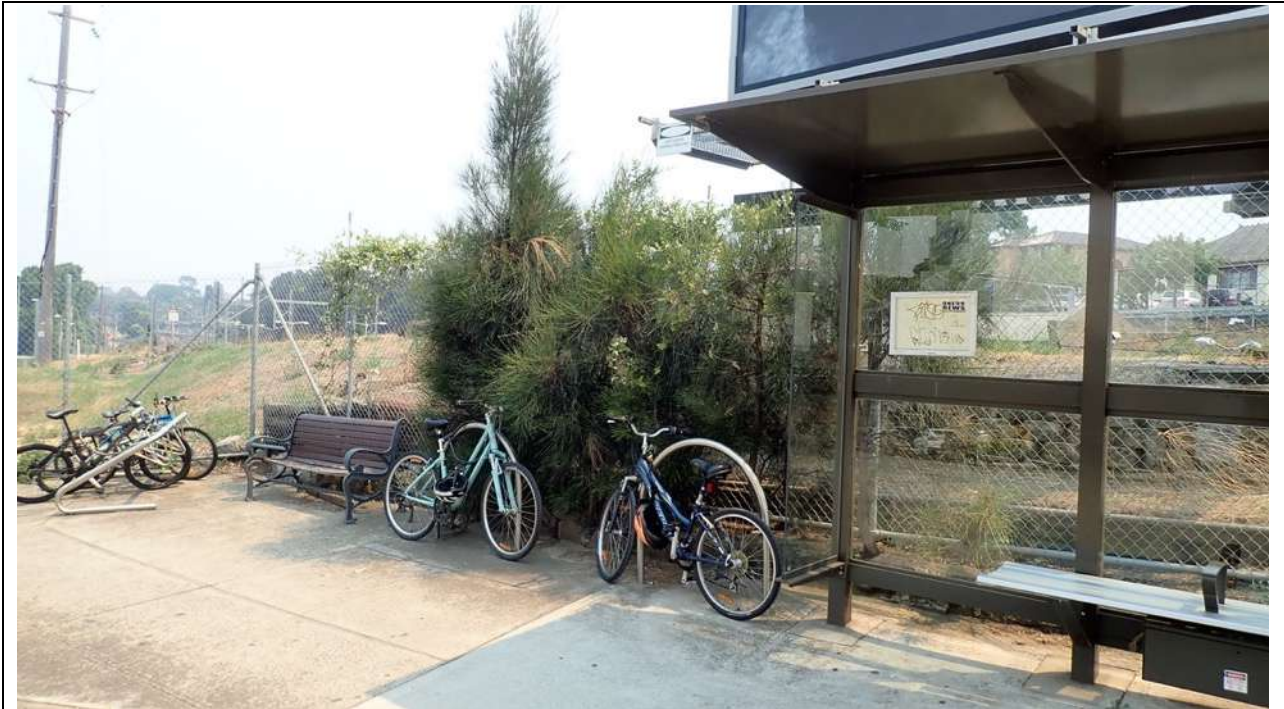
Image 1: Looking North towards trees 586, 587, 588, 589 and 590. The trees have been recommended for removal due to impacts from the proposed hard surfacing excavations.
