## Tree Impact Assessment Report

### City and Southwest Metro Station Upgrade Works Package 5 & 6

**Project wide: Hurlstone Park, Wiley Park, Belmore,  
Campsie, Dulwich Hill and Punchbowl**

**P5 Document No. SMCSWSW5-DEW-WEC-EM-REP-000542**

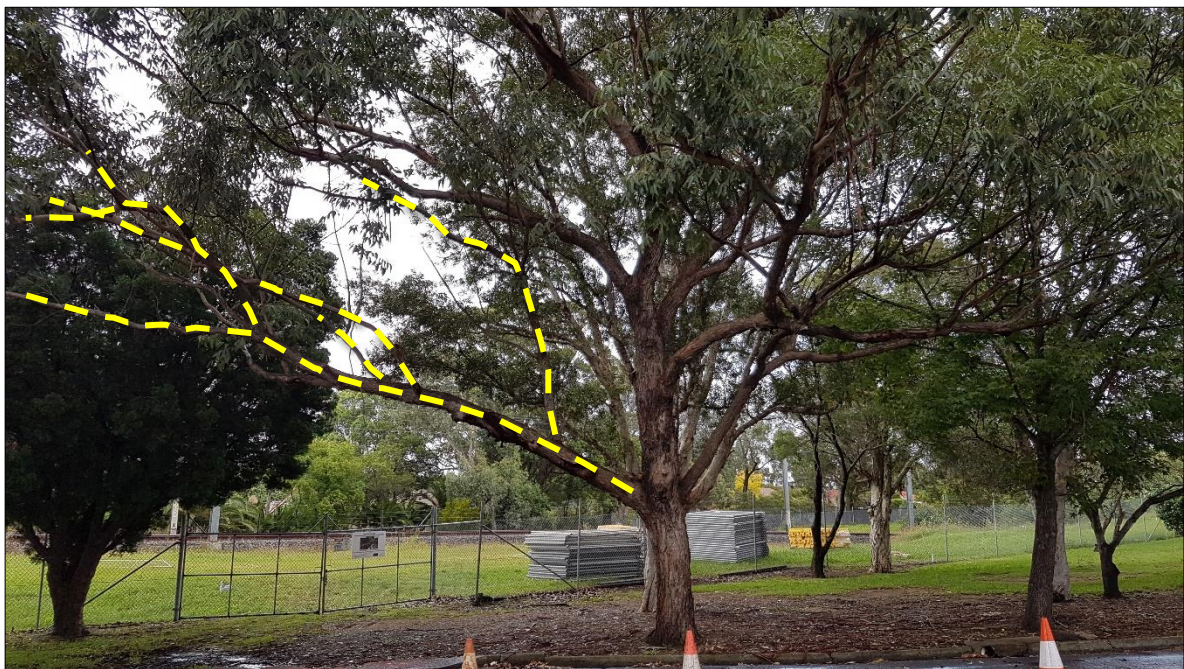
Tree 14 *Eucalyptus robusta* (Swamp Mahogany) identified pruning involves the removal of one first order branch at 2m height. The branch is approximately 300mm in diameter and constitutes 30% of the total canopy volume of the tree. A reduction in tree growth and physiological function can be expected as a result of the pruning works. Exposure of internal woody tissues at the site of the final pruning cut shall be susceptible to infection by decay causing fungi. The removal of the branch is not considered to significantly affect vocal amenity.

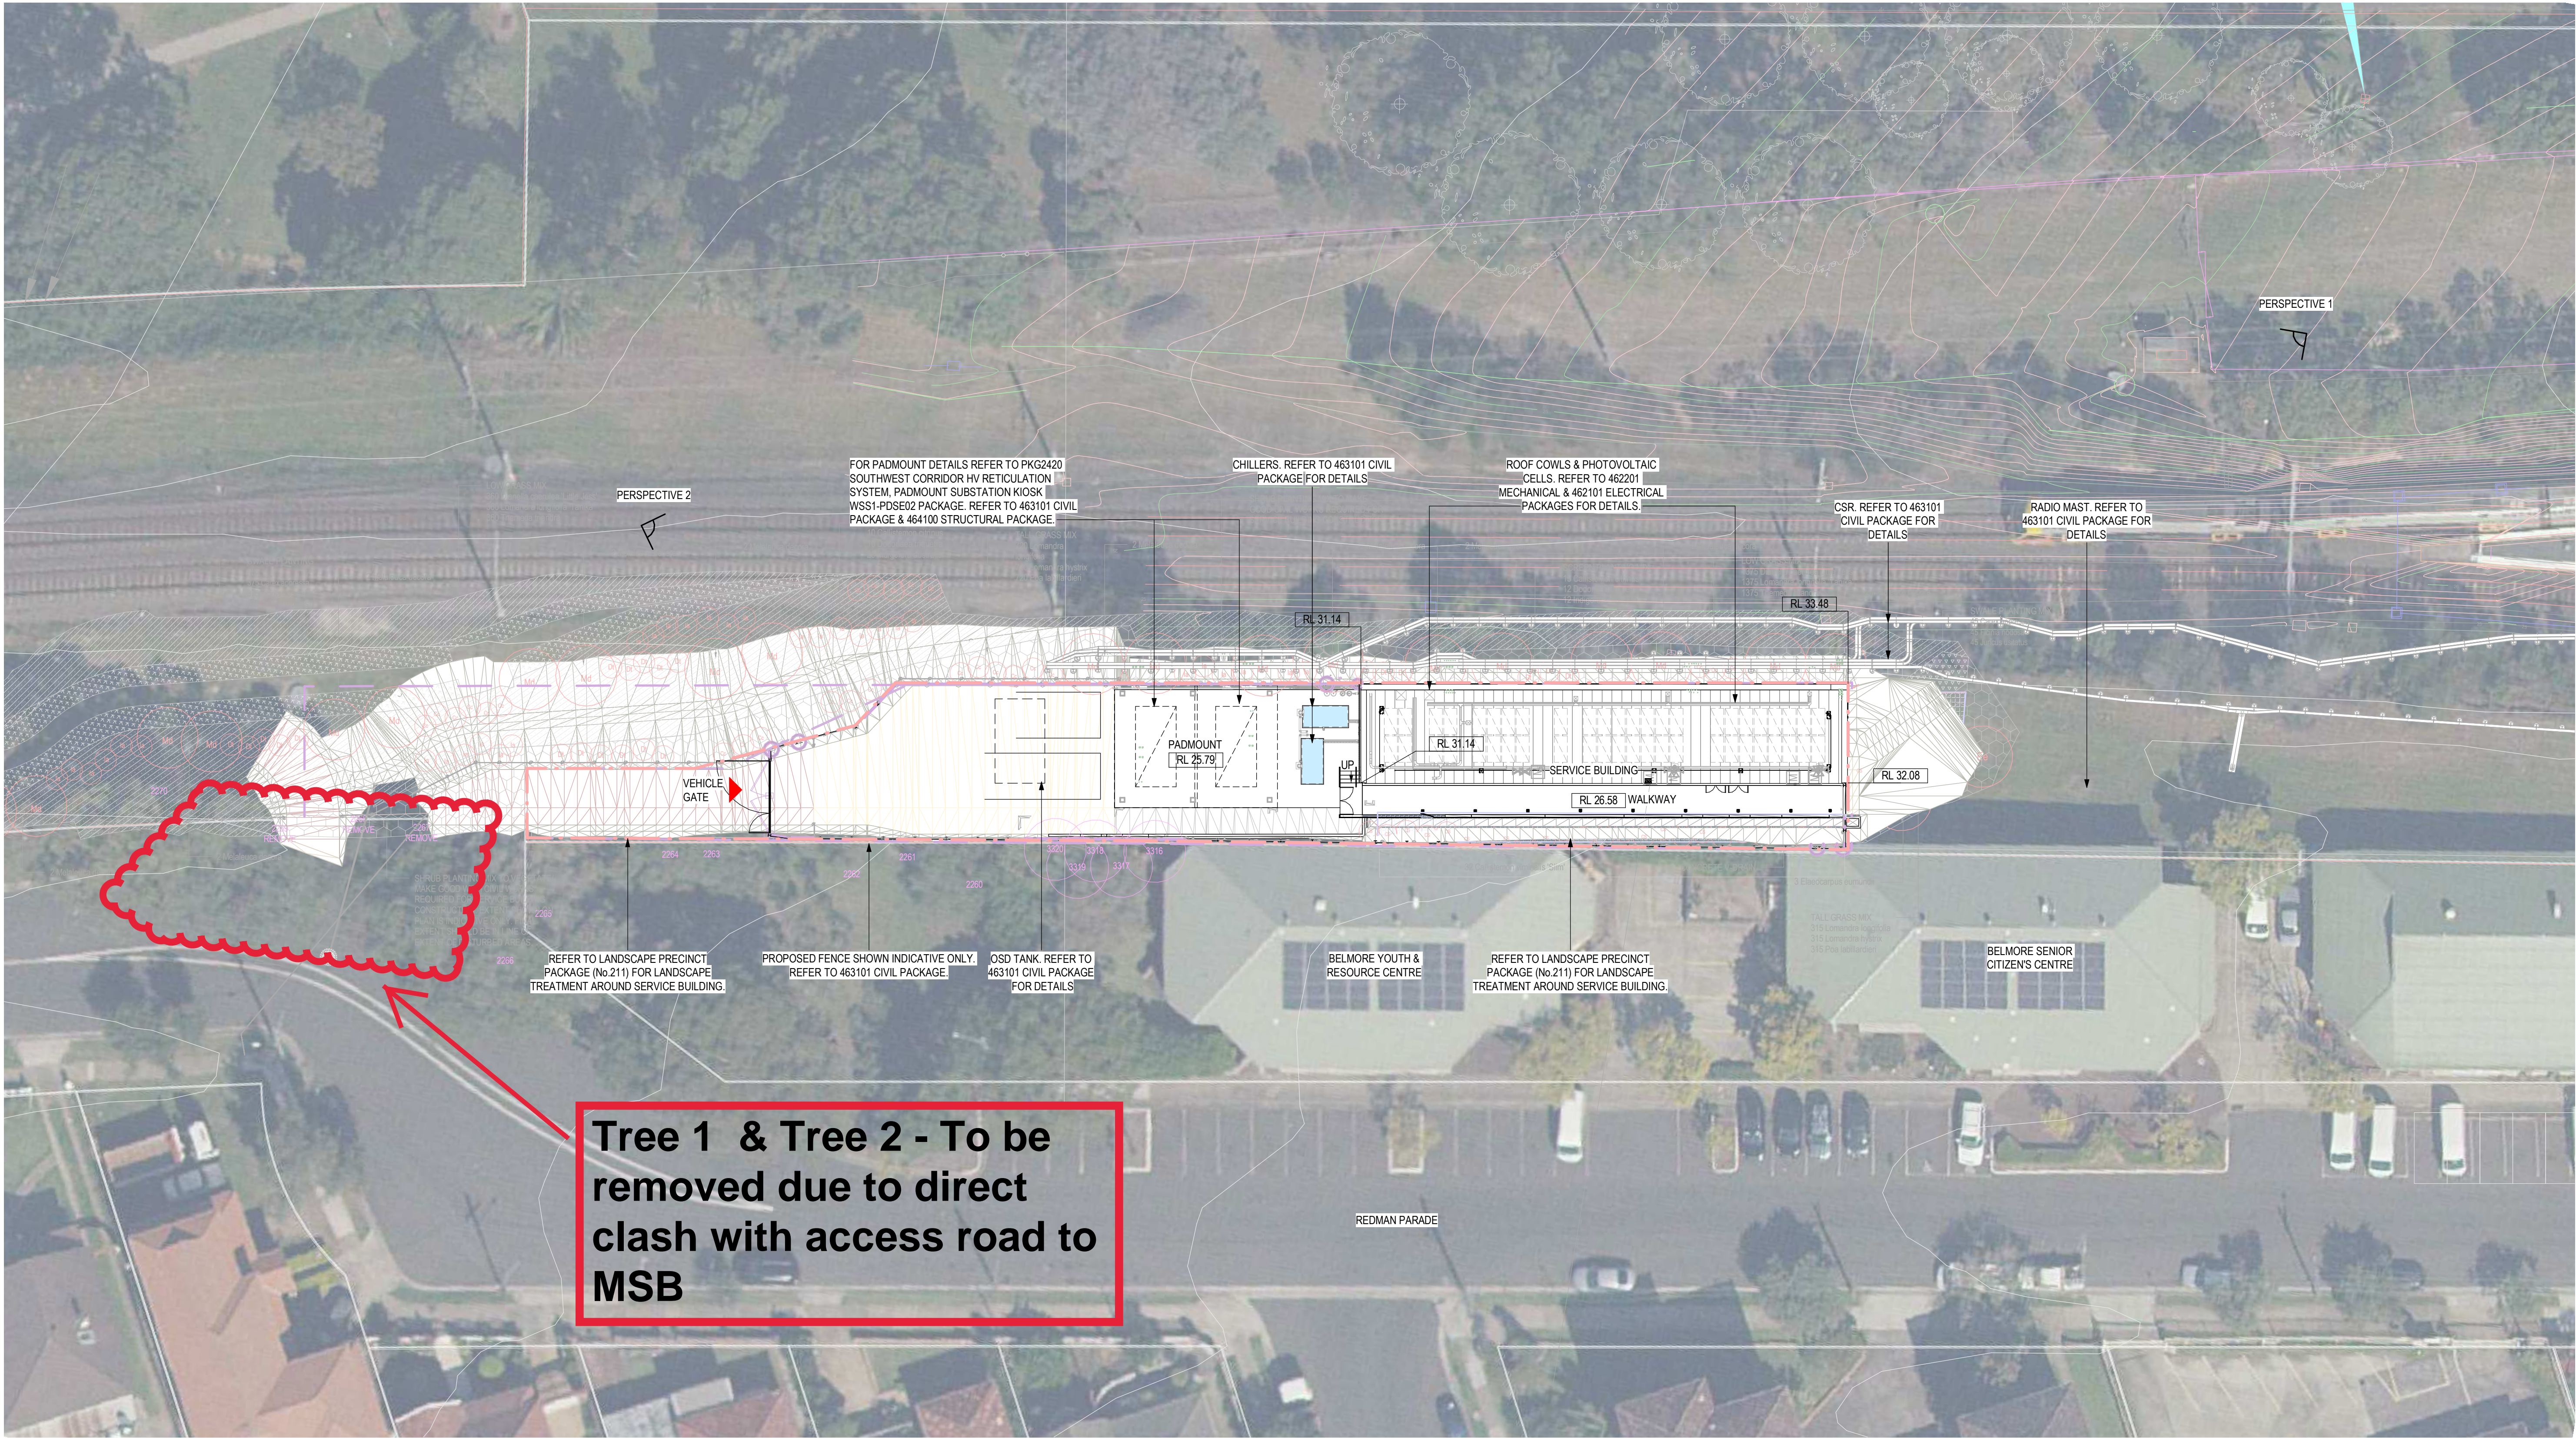
Tree 1 & Tree 2 - To be removed due to direct clash with access road to MSB

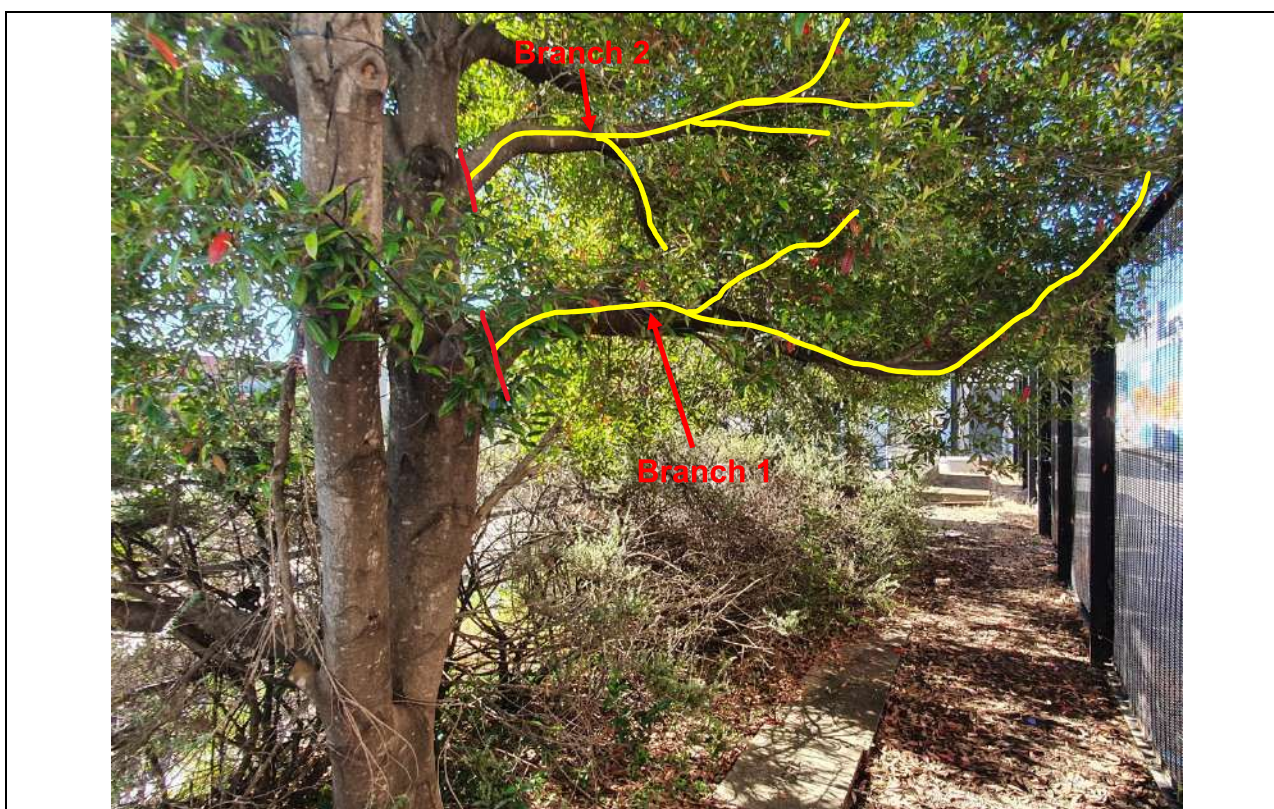
**Image 1:** Looking East from within the site towards tree 612, showing branch 1 and 2. The yellow lines indicate the branches to be removed, the red lines indicated the approximate location of the final pruning cuts.

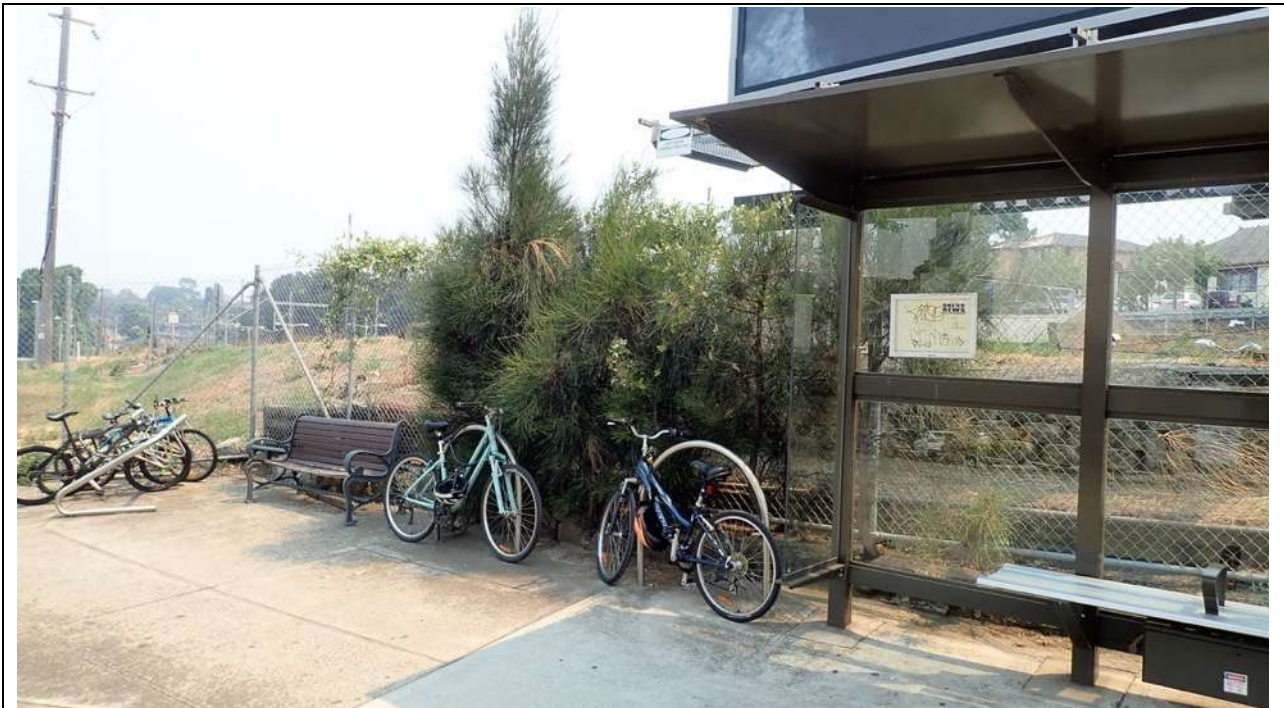
**Image 1:** Looking North towards trees 586, 587, 588, 589 and 590. The trees have been recommended for removal due to impacts from the proposed hard surfacing excavations.

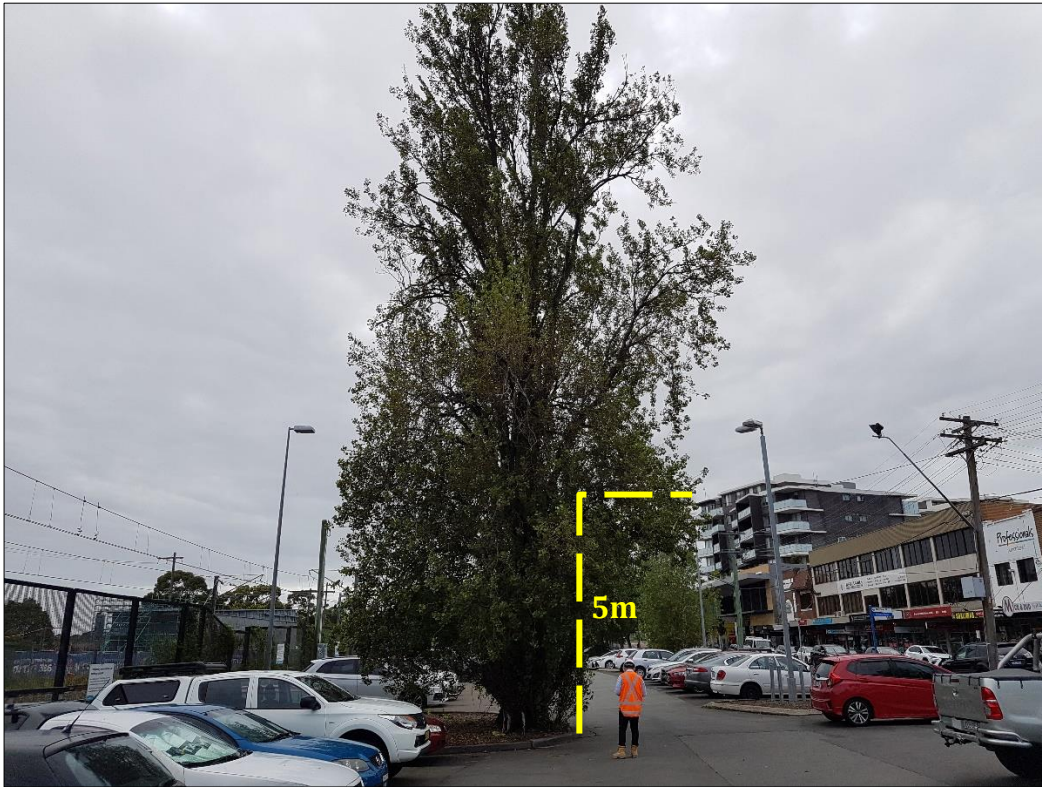
**Photograph 1:** Tree 1 *Populus nigra* 'Italica' (Lombardy Poplar as seen from the carpark area adjacent The Boulevard. 5m of vertical clearance is required from the outside edge of kerb adjacent the base of the tree.
