# Arboricultural Report: BAC Tree Report

**Site Location:** Southwest Metro -  
Marrickville, Belmore, Wiley Park,  
Punchbowl and Bankstown, NSW

**Prepared for:**  
John Holland Laing O'Rourke

**Prepared by:** Bryce Claassens  
Urban Arbor Pty Ltd  
**Date prepared:** 23 September 2022  
**Ref:** 220923-BAC-AIA  
**Rev:** 1

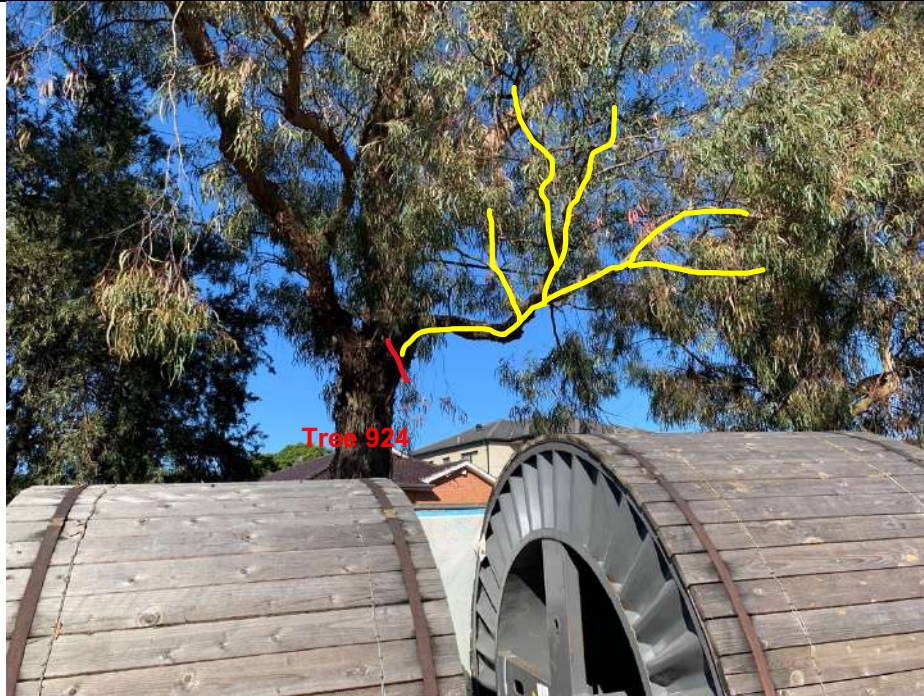
**Image 4:** Looking towards tree 924, showing required canopy pruning. The 150mm primary branch to the North at 3.5m above ground is to be removed. The branch has been marked yellow and the final pruning cut has been marked red. The pruning will result in the removal of less than 10% of the overall live canopy.

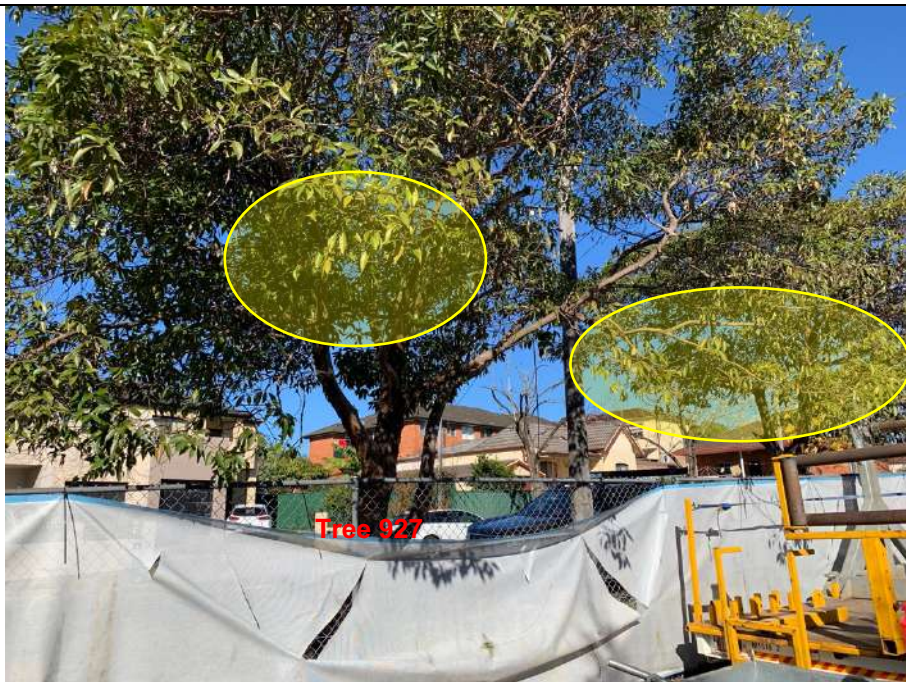
**Image 5:** Looking towards tree 927, showing required canopy pruning (hatched yellow). The North side of the crown is to be raised by 4m to allow for the works. Final pruning cuts should not exceed 50mm in diameter. The pruning will result in the removal of less than 10% of the overall live canopy.

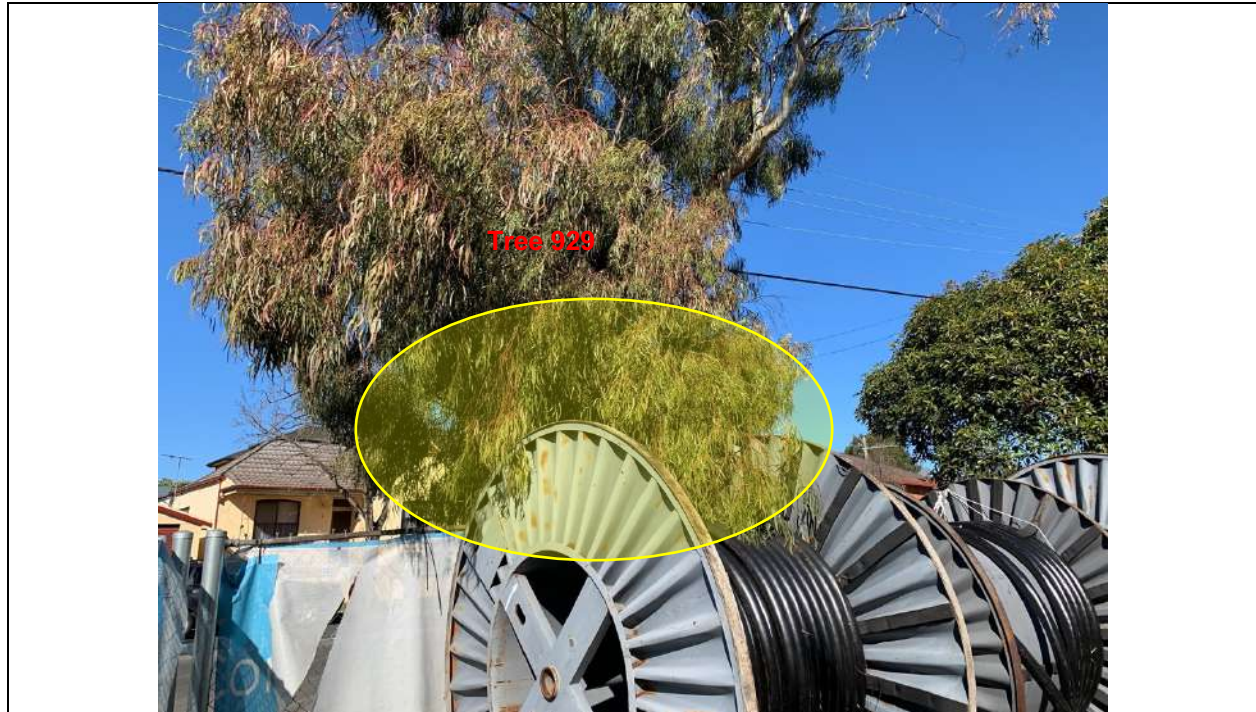
**Image 6:** Looking towards tree 929, showing required canopy pruning (hatched yellow). The North side of the crown is to be raised by 4m to allow for the works. Final pruning cuts should not exceed 50mm in diameter. The pruning will result in the removal of less than 10% of the overall live canopy.

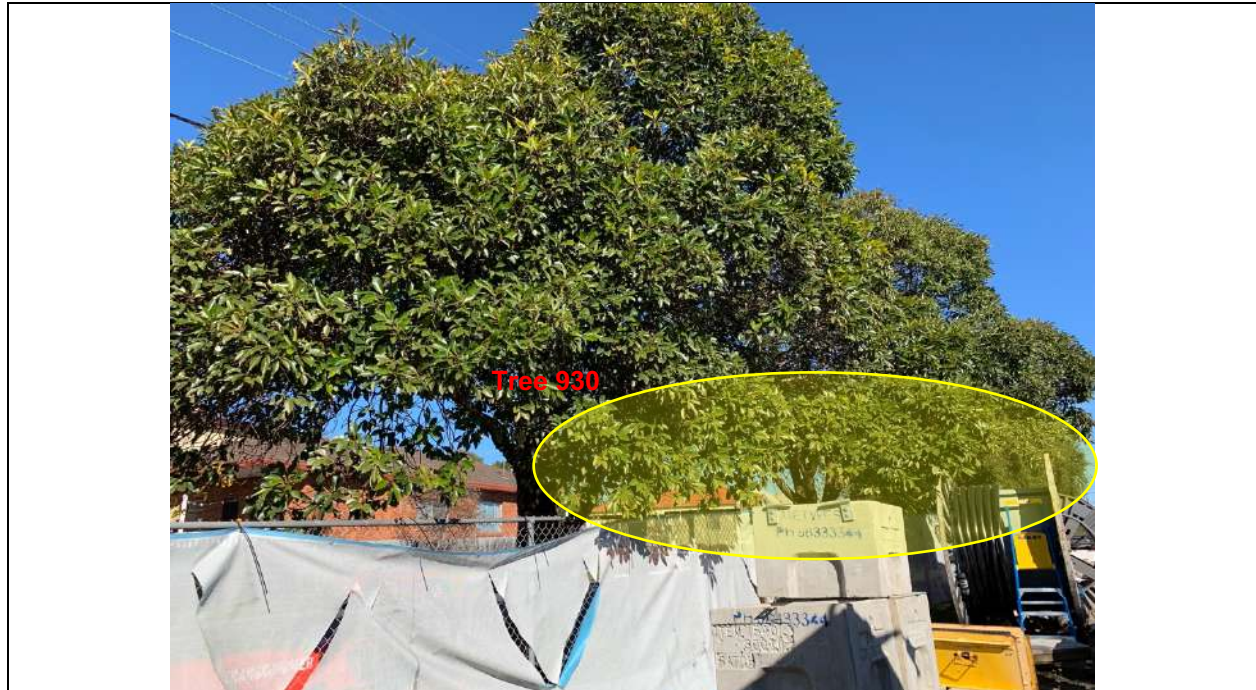
**Image 7:** Looking towards tree 930, showing required canopy pruning (hatched yellow). The North side of the crown is to be raised by 4m to allow for the works. Final pruning cuts should not exceed 50mm in diameter. The pruning will result in the removal of less than 10% of the overall live canopy.

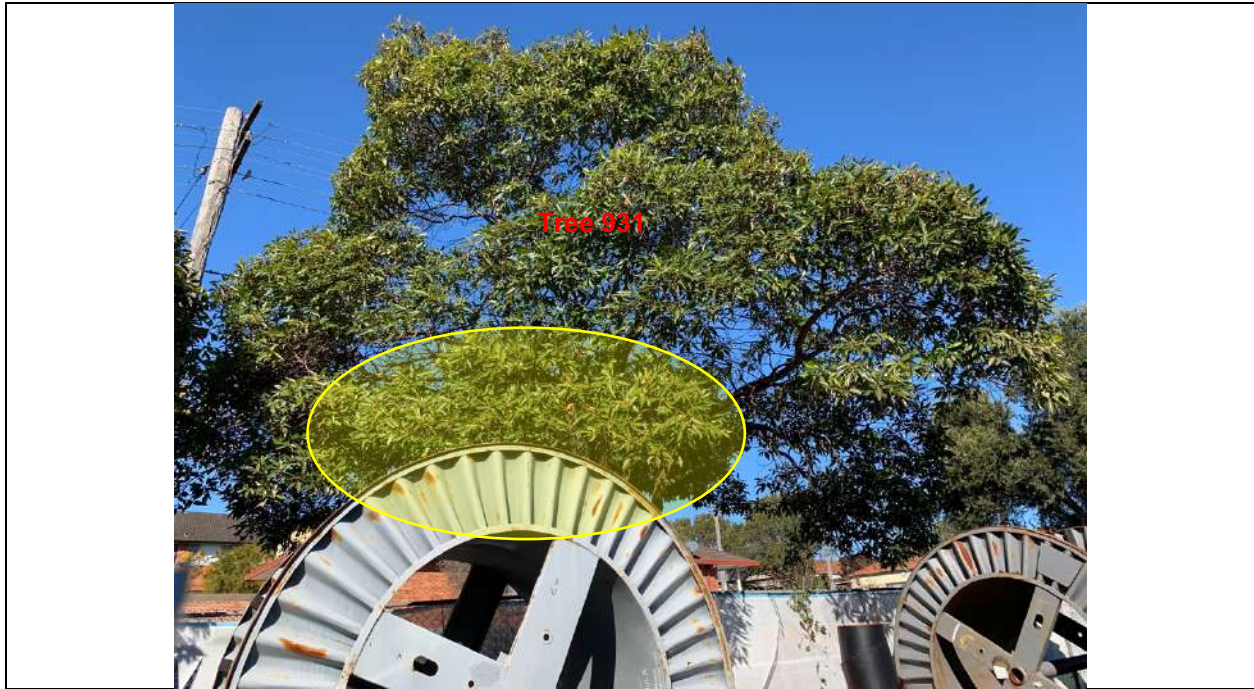
**Image 8:** Looking towards tree 931, showing required canopy pruning (hatched yellow). The North side of the crown is to be raised by 4m to allow for the works. Final pruning cuts should not exceed 50mm in diameter. The pruning will result in the removal of less than 10% of the overall live canopy.

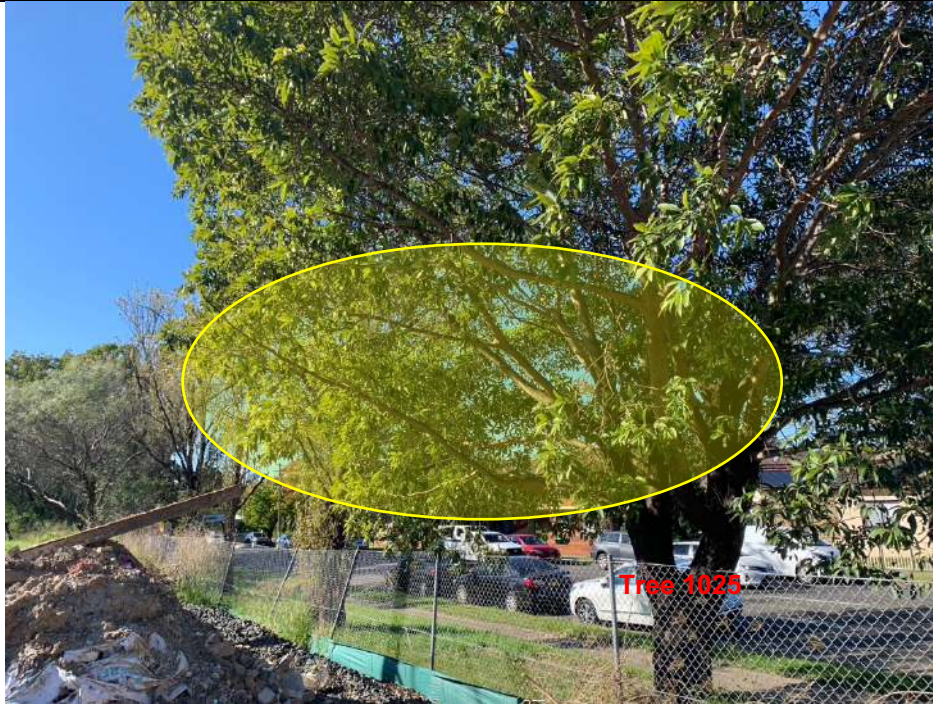
**Image 11:** Looking towards tree 1025, showing required canopy pruning (hatched yellow). The North side of the crown is to be raised by 4m to allow for the works. Final pruning cuts should not exceed 70mm in diameter. The pruning will result in the removal of less than 10% of the overall live canopy.

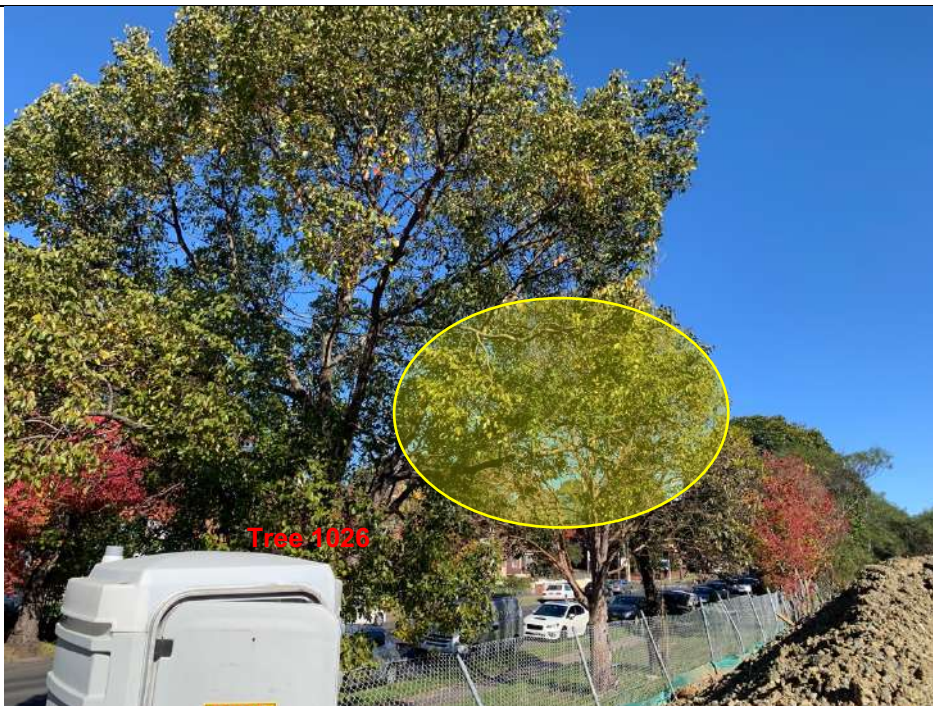
**Image 12:** Looking towards tree 1026, showing required canopy pruning (hatched yellow). The North side of the crown is to be raised by 4m to allow for the works. Final pruning cuts should not exceed 50mm in diameter. The pruning will result in the removal of less than 10% of the overall live canopy.

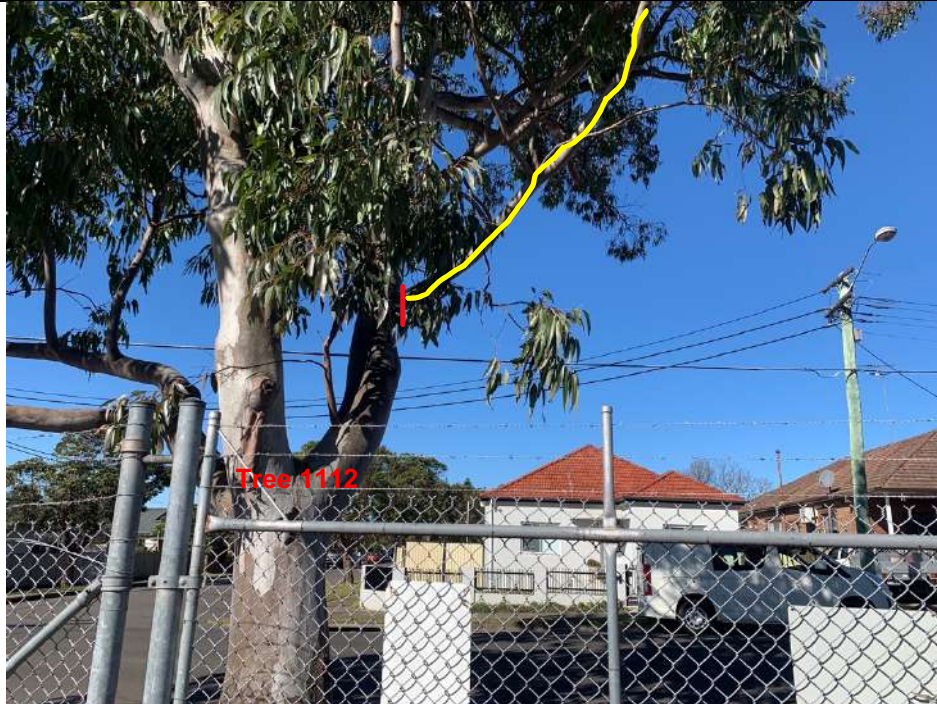
**Image 14:** Looking towards tree 1112, showing required canopy pruning. The 120mm second order branch to the West at 3m above ground is to be removed. The branch has been marked yellow and the final pruning cut has been marked red. The pruning will result in the removal of less than 5% of the overall live canopy.

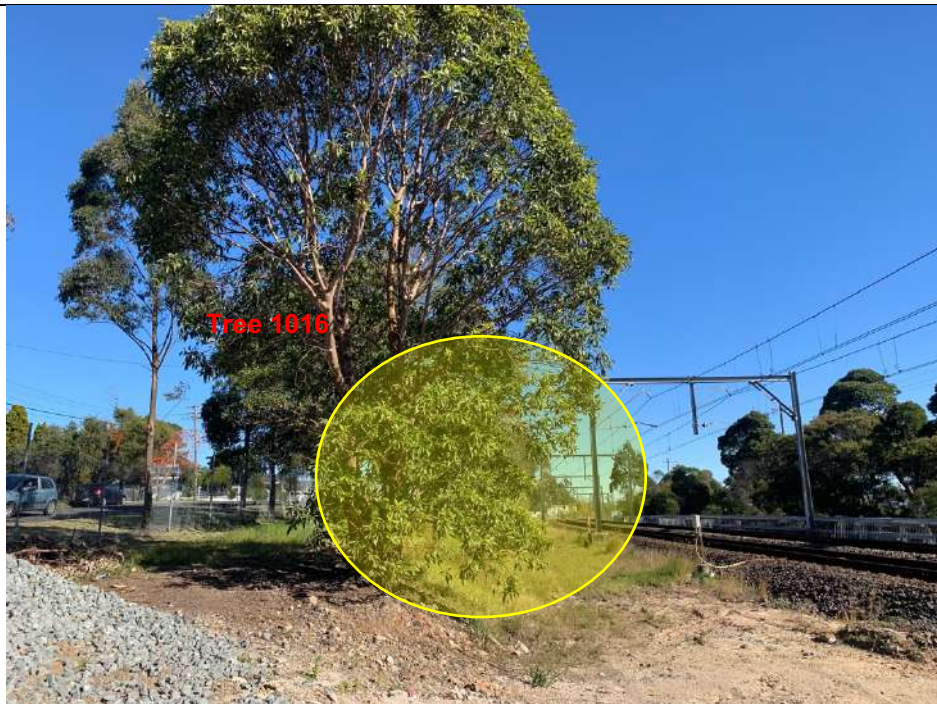
**Image 15:** Looking towards tree 1016, showing required canopy pruning (hatched yellow). The North side of the crown is to be raised by 4m to allow for the works. Final pruning cuts should not exceed 50mm in diameter. The pruning will result in the removal of less than 10% of the overall live canopy.

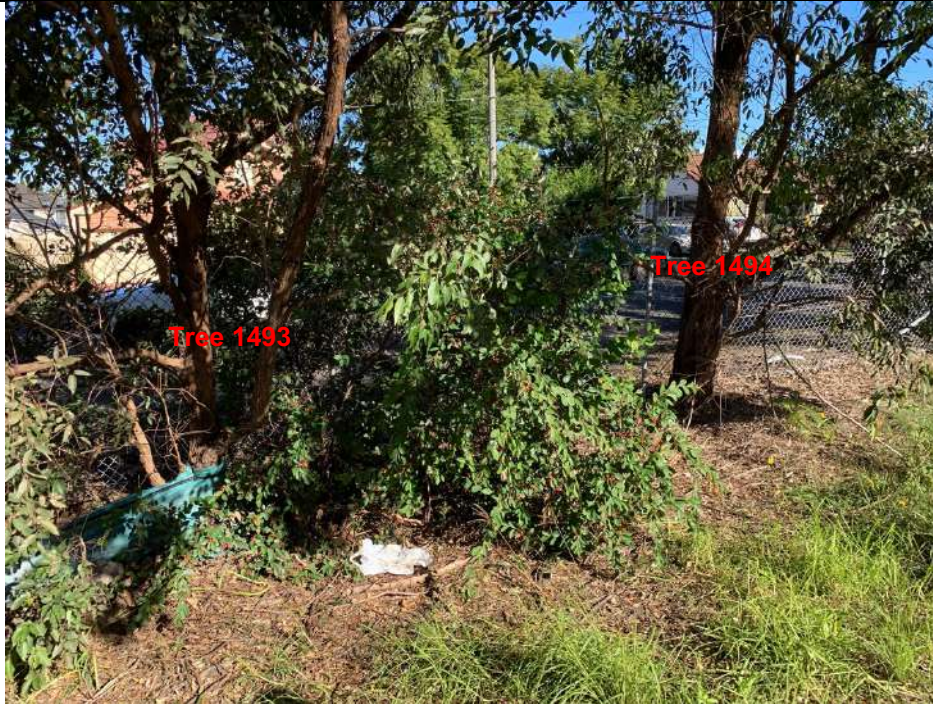
**Image 18:** Showing tree 1493 and 1494, recommended for removal due to development impacts from the proposed works area.

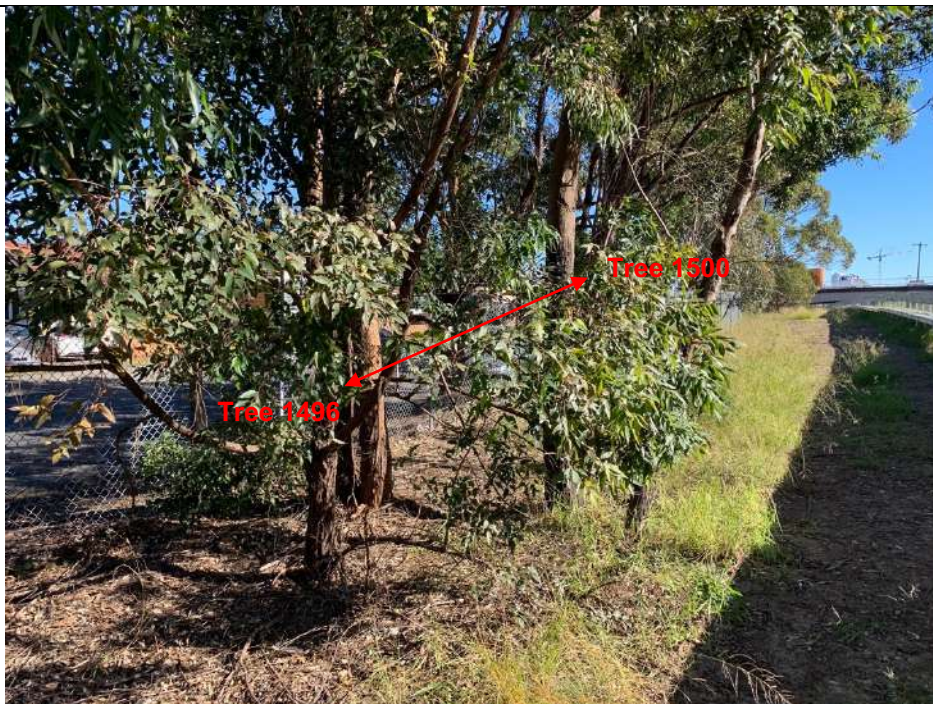
**Image 19:** Showing tree 1496, 1497, 1498, 1499 and 1500, recommended for removal due to development impacts from the proposed works area.

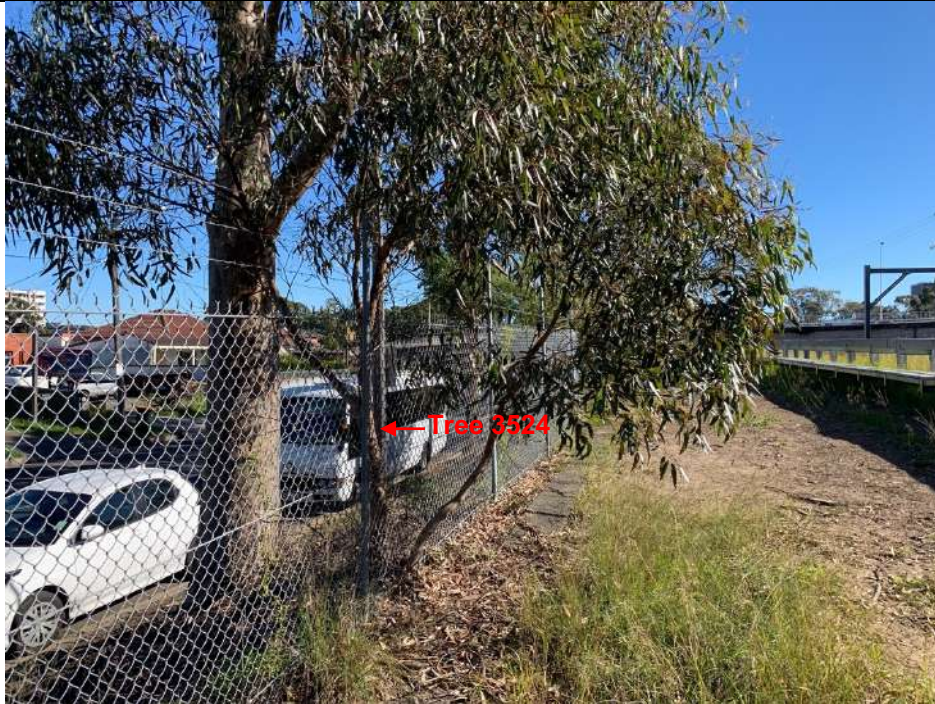
**Image 20:** Showing tree 3524, recommended for removal due to development impacts from the proposed works area.

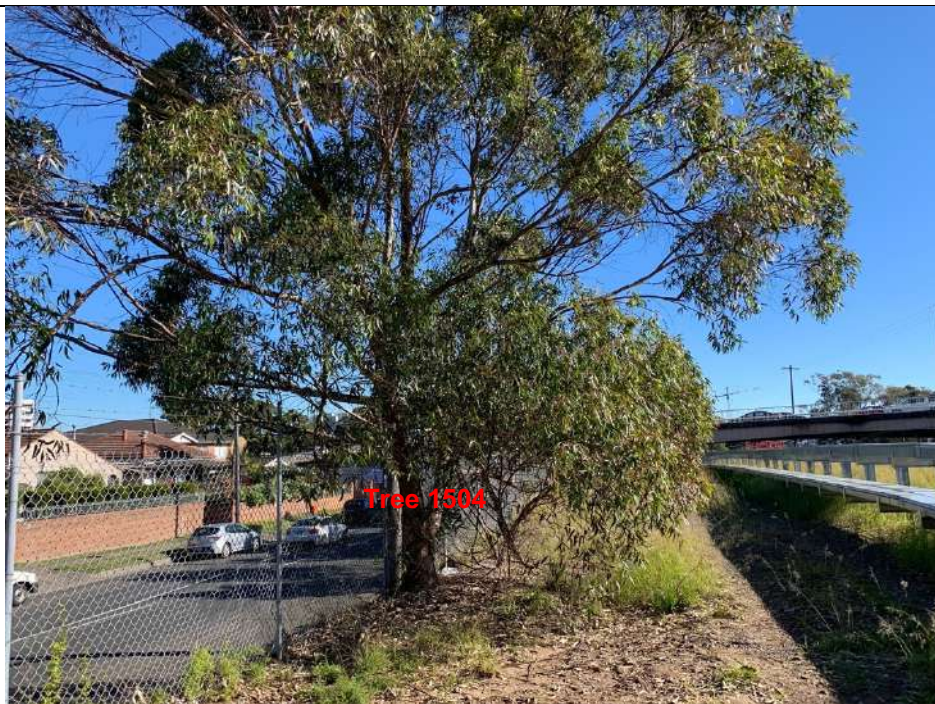
**Image 21:** Showing tree 1504, recommended for removal due to development impacts from the proposed works area.

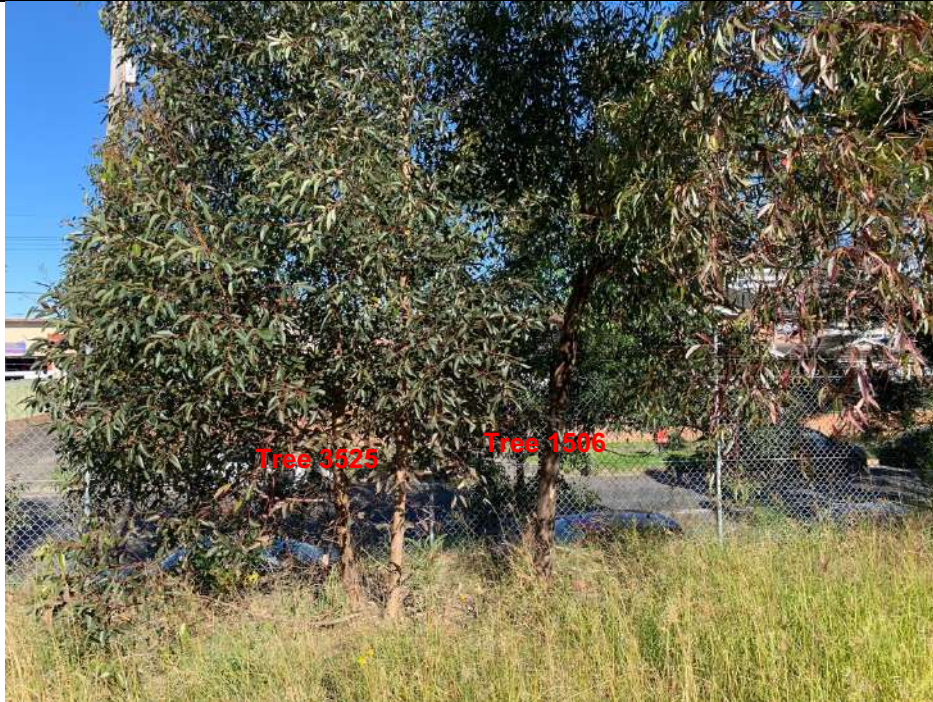
**Image 22:** Showing tree 1506 and 3525, recommended for removal due to development impacts from the proposed works area.

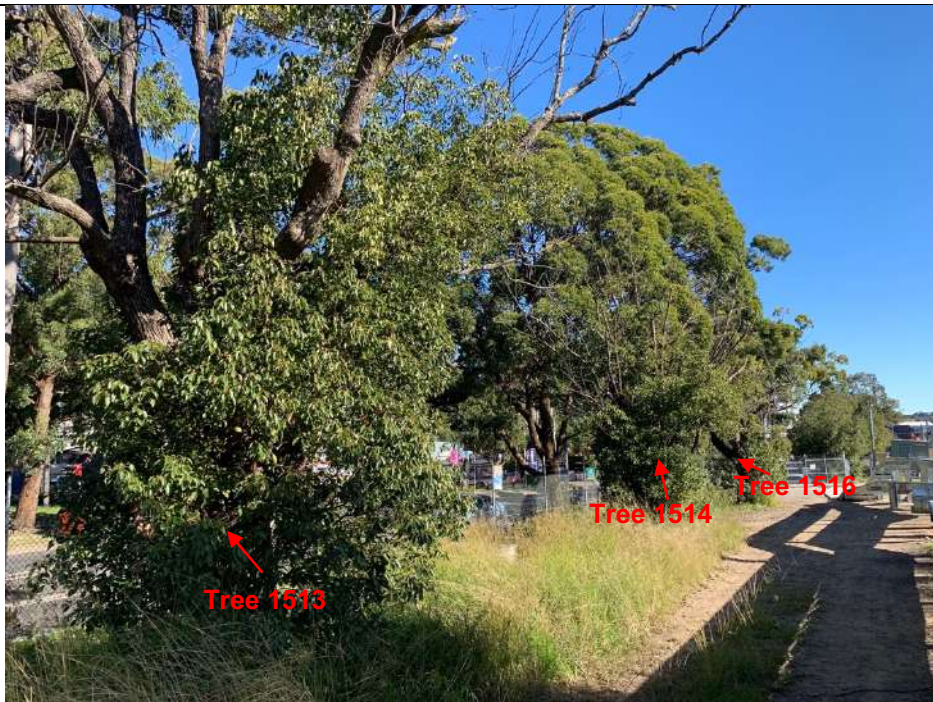
**Image 23:** Showing tree 1513, 1514 and 1516, recommended for removal due to development impacts from the proposed works area.

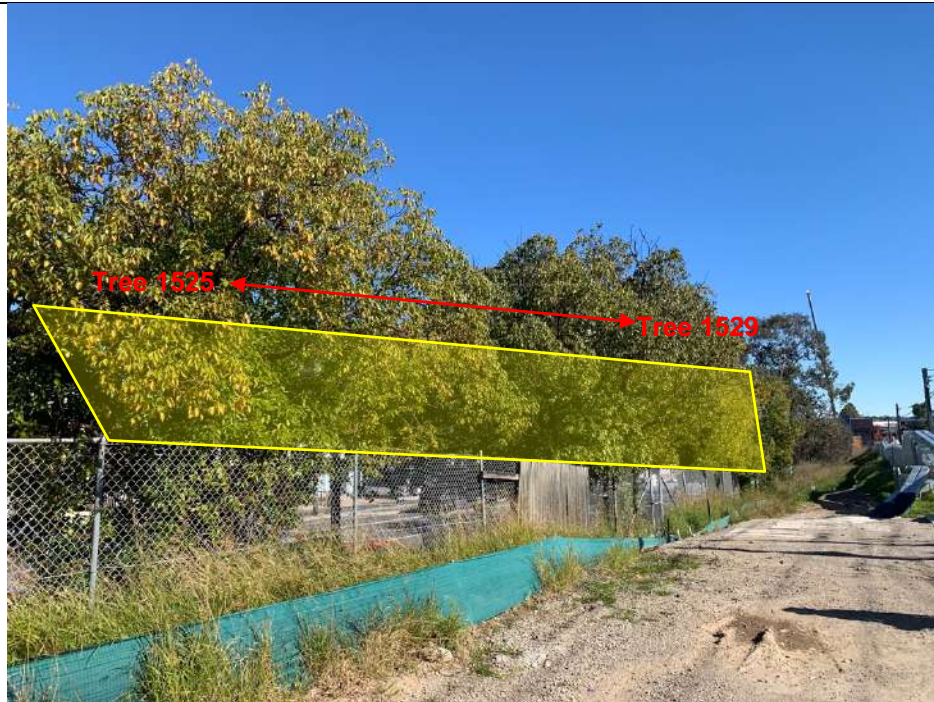
**Image 24:** Looking towards tree 1525, 1526, 1527, 1528 and 1529, showing required canopy pruning (hatched yellow). The North side of the crown of each tree is to be reduced by 1m to allow for the works. Final pruning cuts should not exceed 100mm in diameter. The pruning will result in the removal of less than 10% of the overall live canopy.

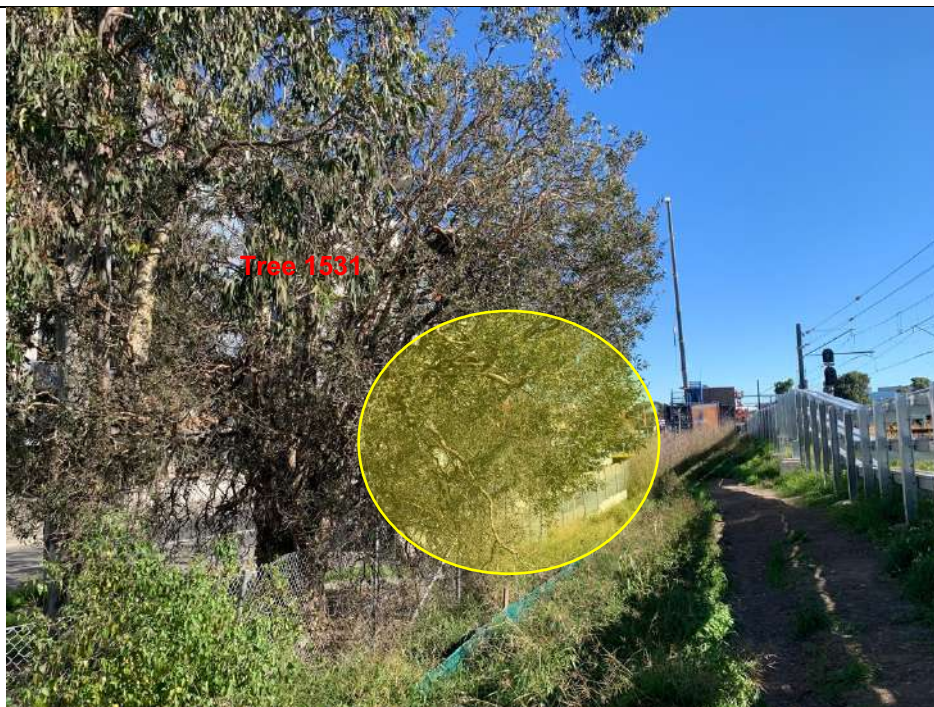
**Image 25:** Looking towards tree 1531, showing required canopy pruning (hatched yellow). The North side of the crown is to be raised by 4m to allow for the works. Final pruning cuts should not exceed 100mm in diameter. The pruning will result in the removal of 15% of the overall live canopy.

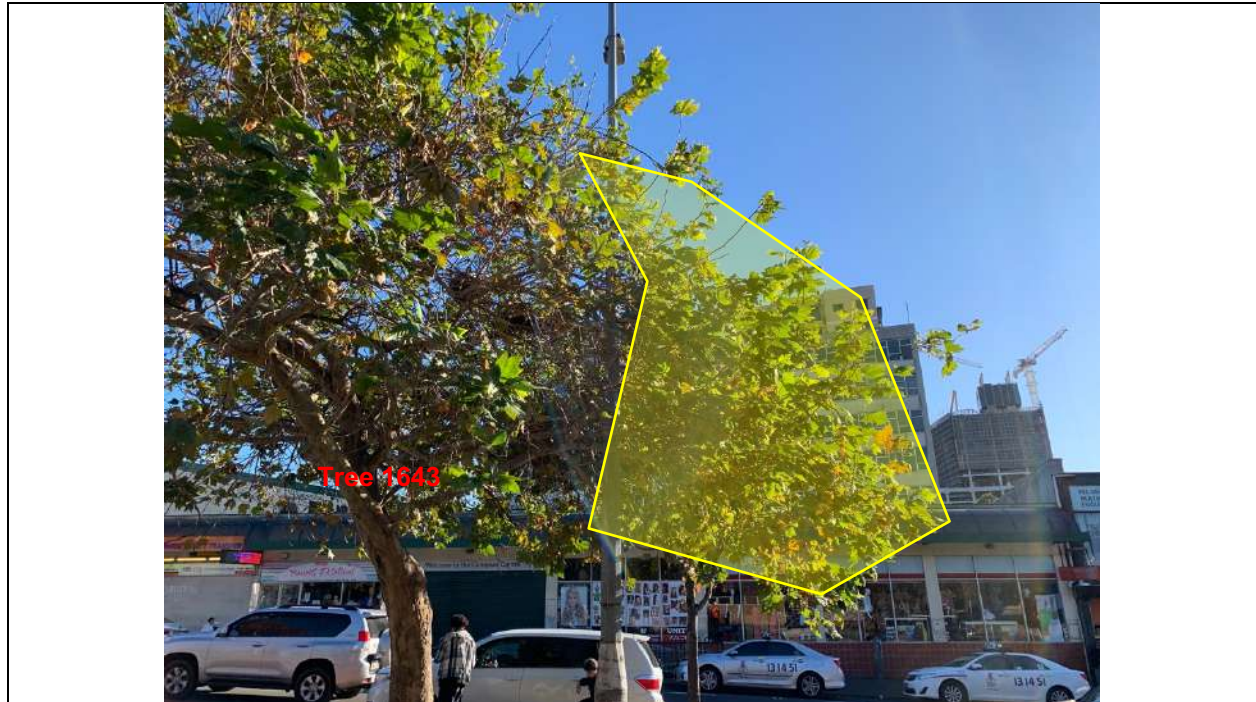
**Image 28:** Looking towards tree 1643, showing required canopy pruning (hatched yellow). The North side of the crown is to be reduced by 2m to allow for the works. Final pruning cuts should not exceed 50mm in diameter. The pruning will result in the removal of 15% of the overall live canopy.

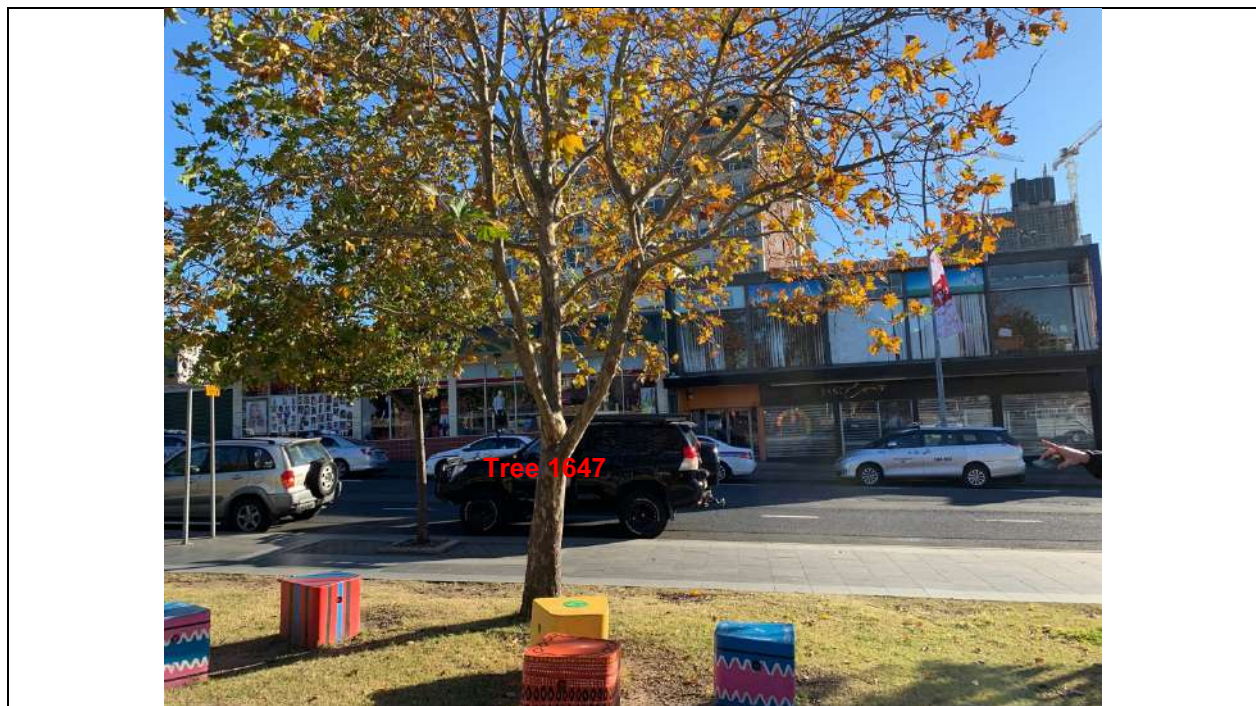
**Image 29:** Showing tree 1647, recommended for removal due to development impacts from the proposed works area.

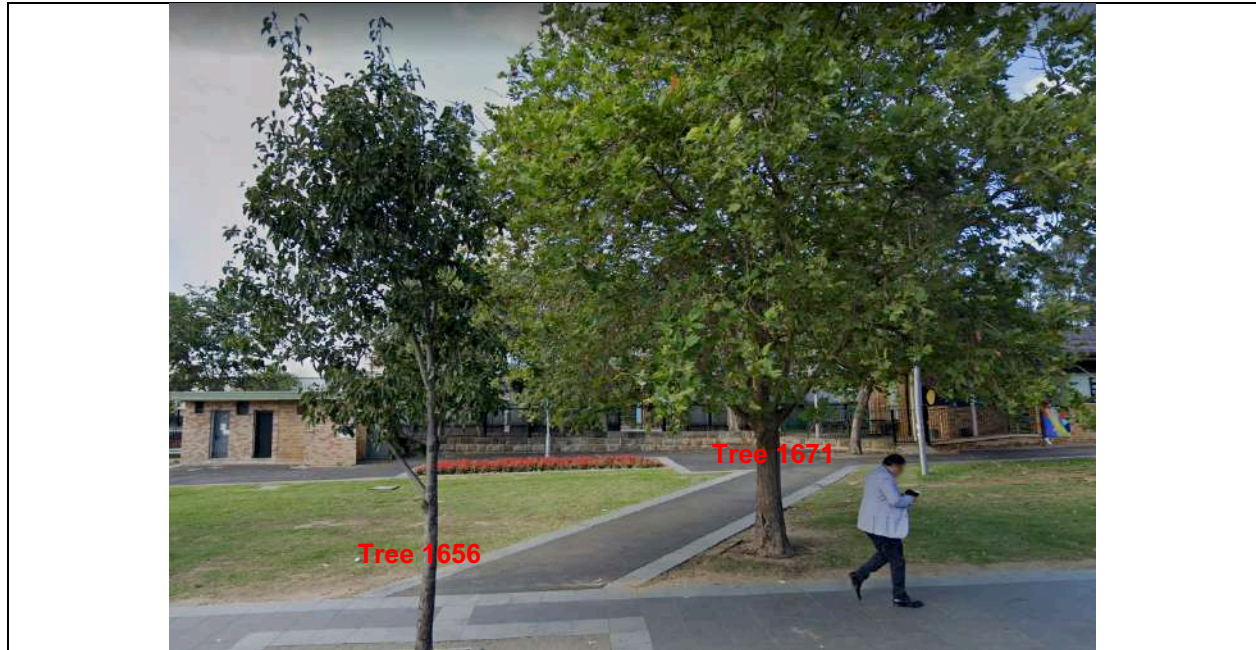
**Image 30:** Showing tree 1656 and 1671, recommended for removal due to development impacts from the proposed works area.

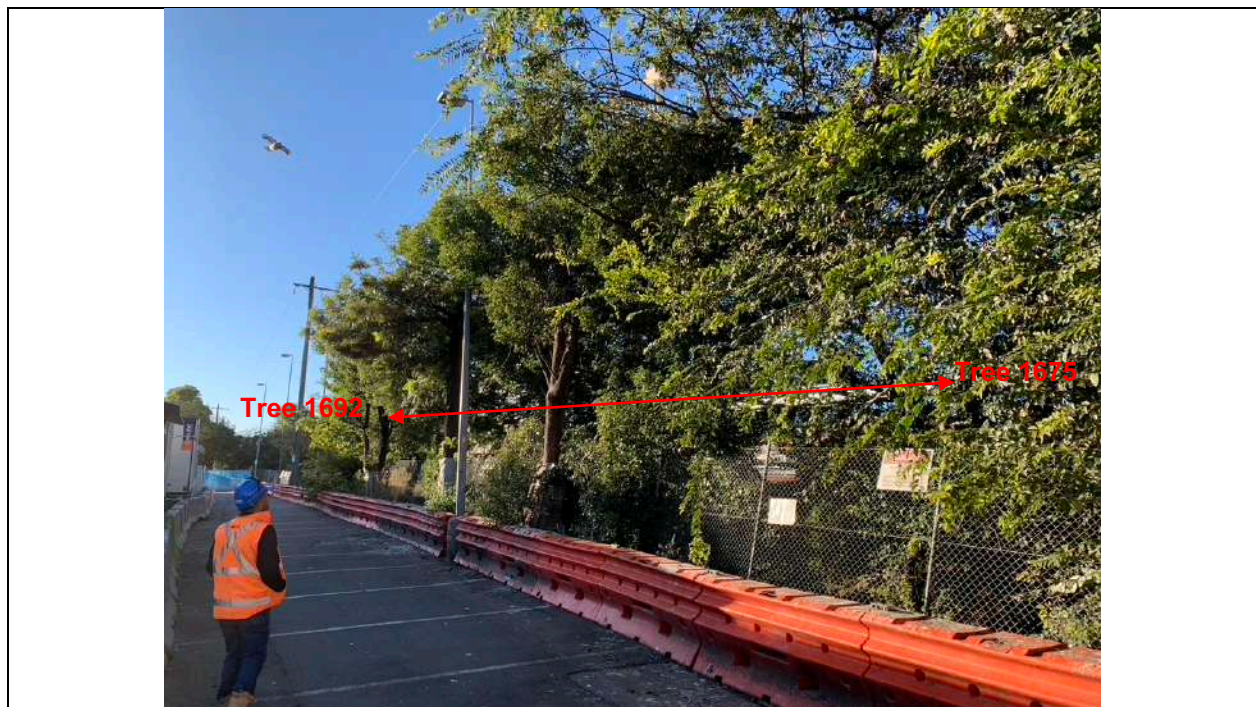
**Image 31:** Showing tree 1675, 1677, 1678, 1679, 1685, 1686, 1687, 1688, 1689, 1690, 1691 and 1692, recommended for removal due to development impacts from the proposed works area.

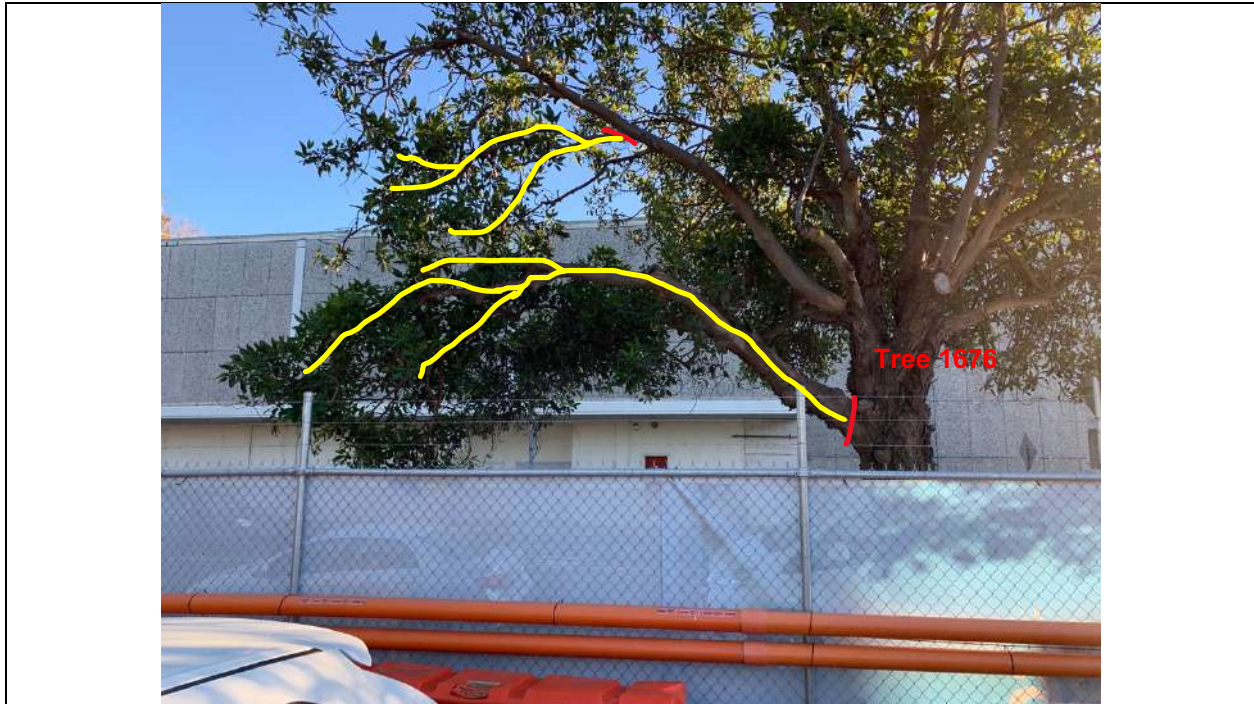
**Image 32:** Looking towards tree 1676, showing required canopy pruning. The first order 200mm branch to the West at 2m is to be removed. The second order 30mm branch to the East at 4m is to be removed. The pruning will result in the removal of 15% of the overall live canopy.

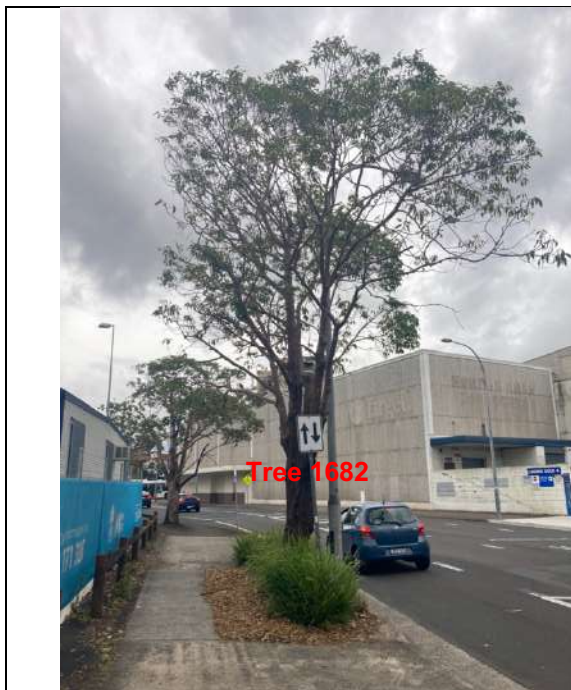
**Image 33:** Showing tree 1682, recommended for removal due to development impacts from the proposed works area.

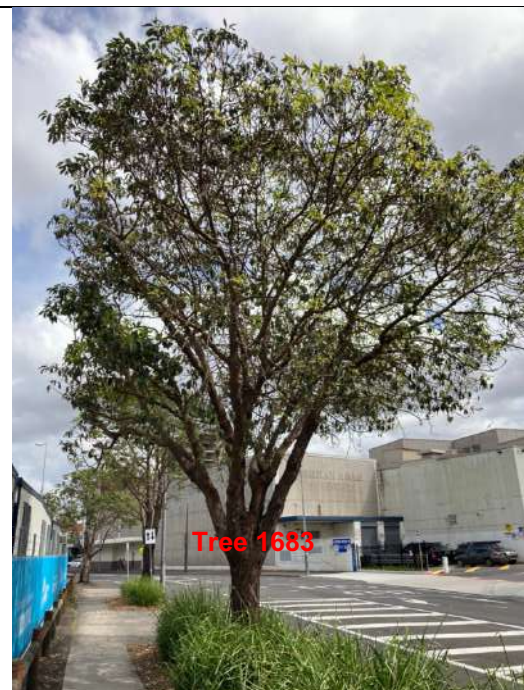
**Image 34:** Showing tree 1683, recommended for removal due to development impacts from the proposed works area.

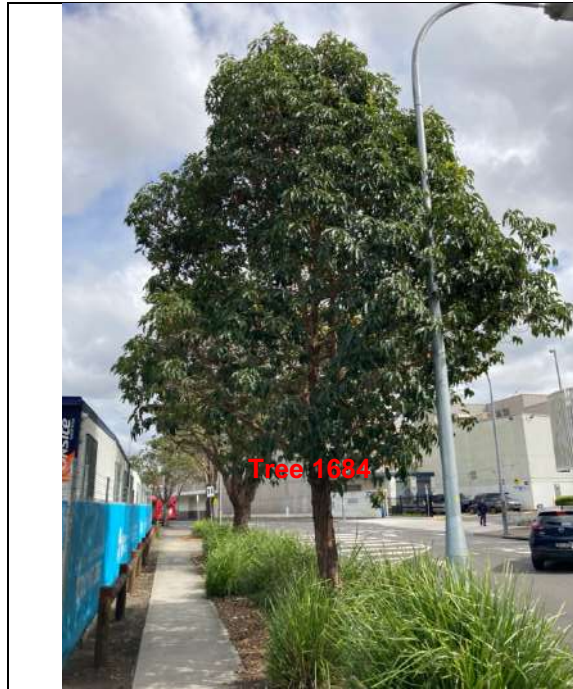
**Image 35:** Showing tree 1684, recommended for removal due to development impacts from the proposed works area.

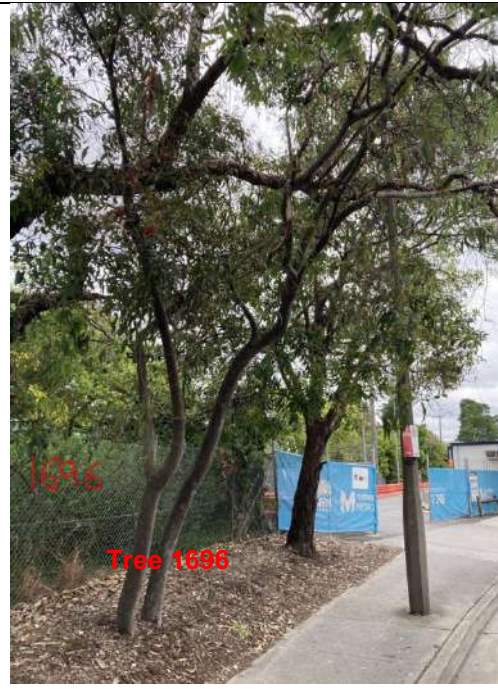
**Image 36:** Showing tree 1696, recommended for removal due to development impacts from the proposed works area.

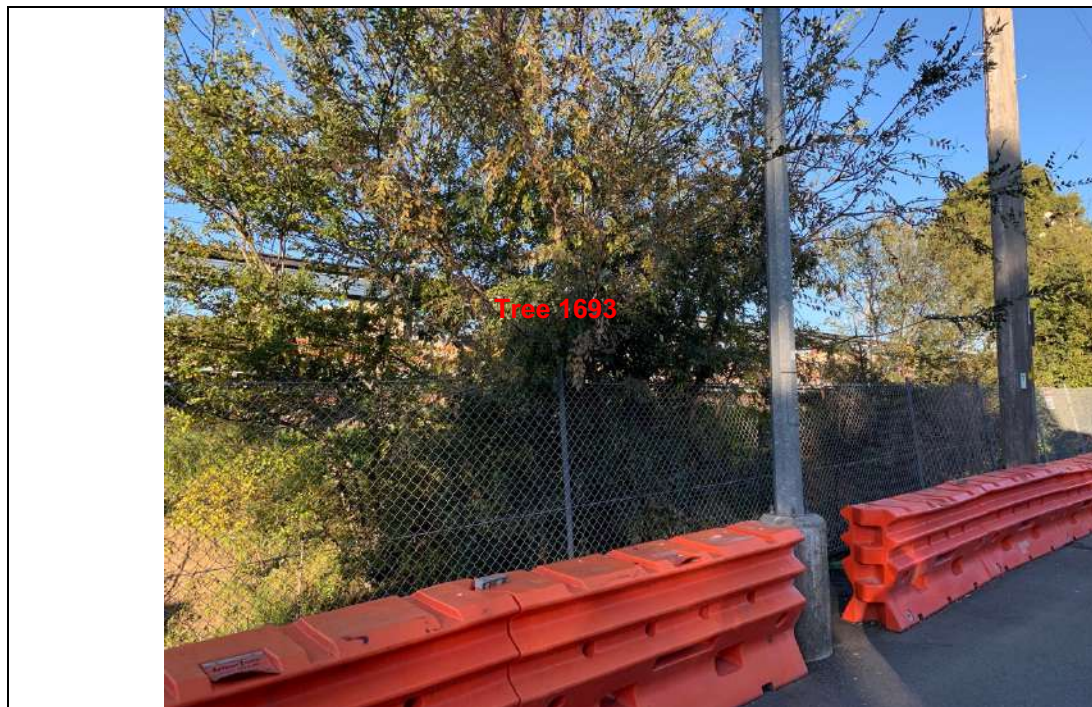
**Image 37:** Showing tree 1693, recommended for removal due to development impacts from the proposed works area.

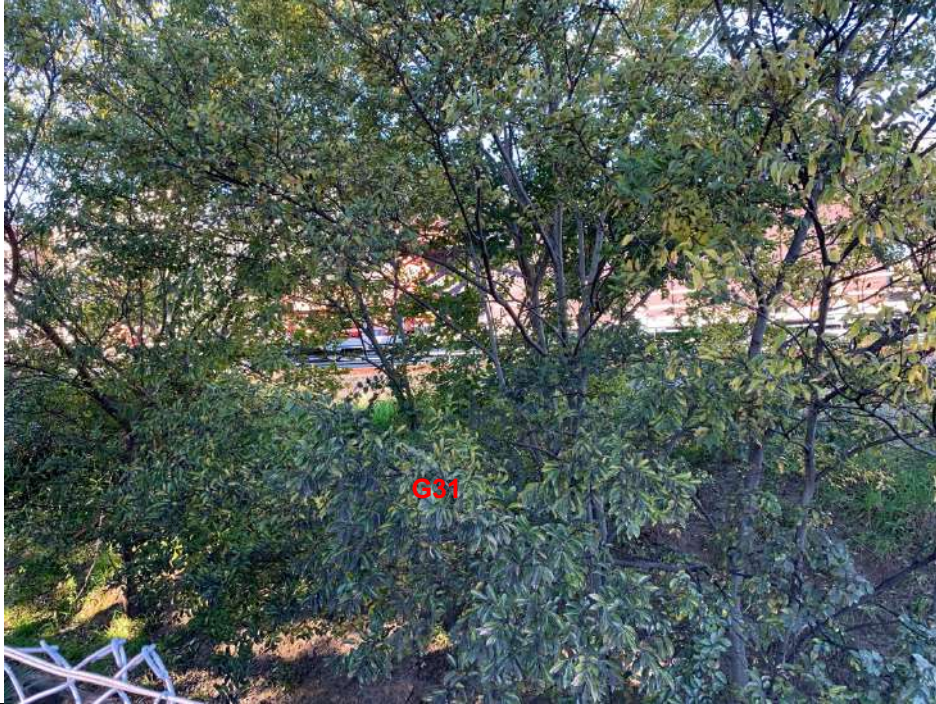
**Image 38:** Showing tree G31, recommended for removal due to development impacts from the proposed works area. G31 consists of 4 x *Celtis sinensis* and 1 x *Acacia saligna*.

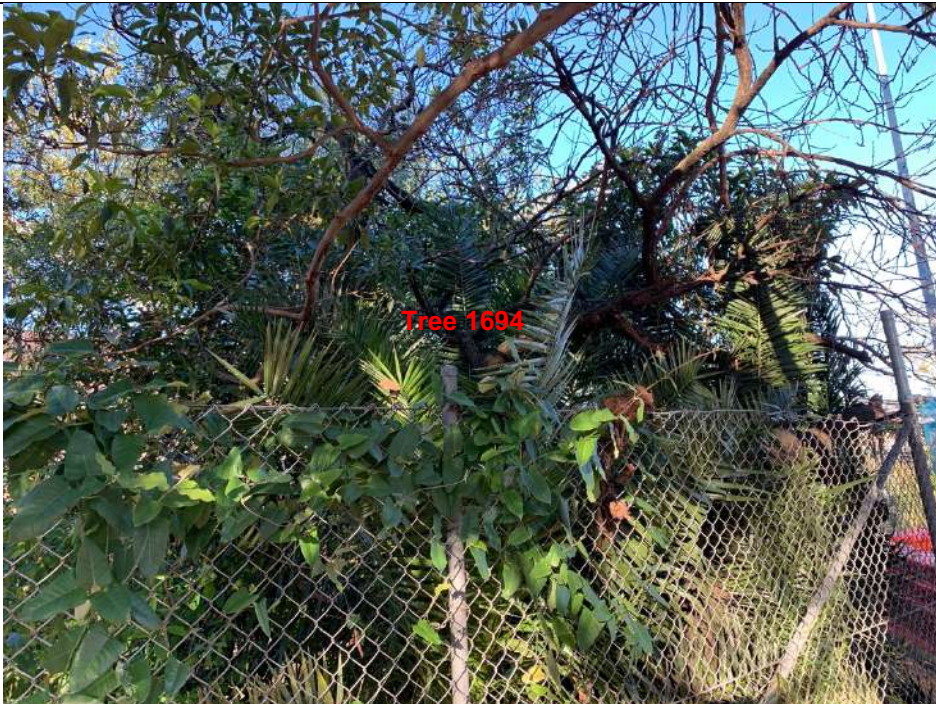
**Image 39:** Showing tree 1694, recommended for removal due to development impacts from the proposed works area.

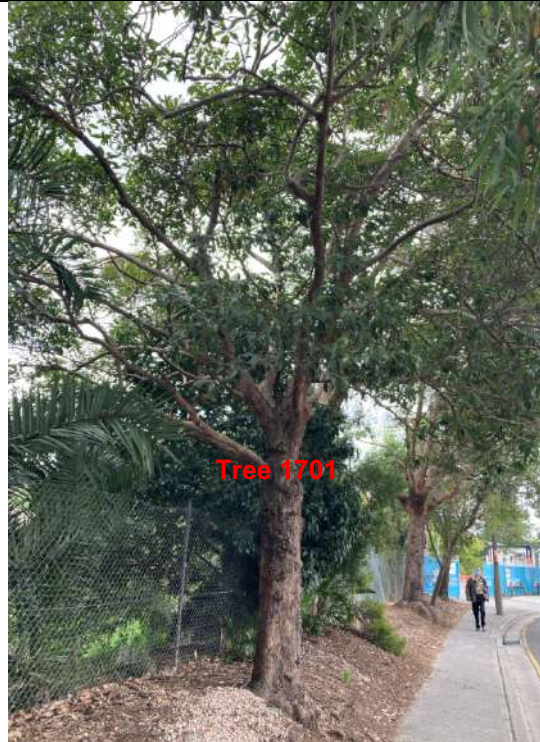
**Image 43:** Showing tree 1701, recommended for removal due to development impacts from the proposed works area.

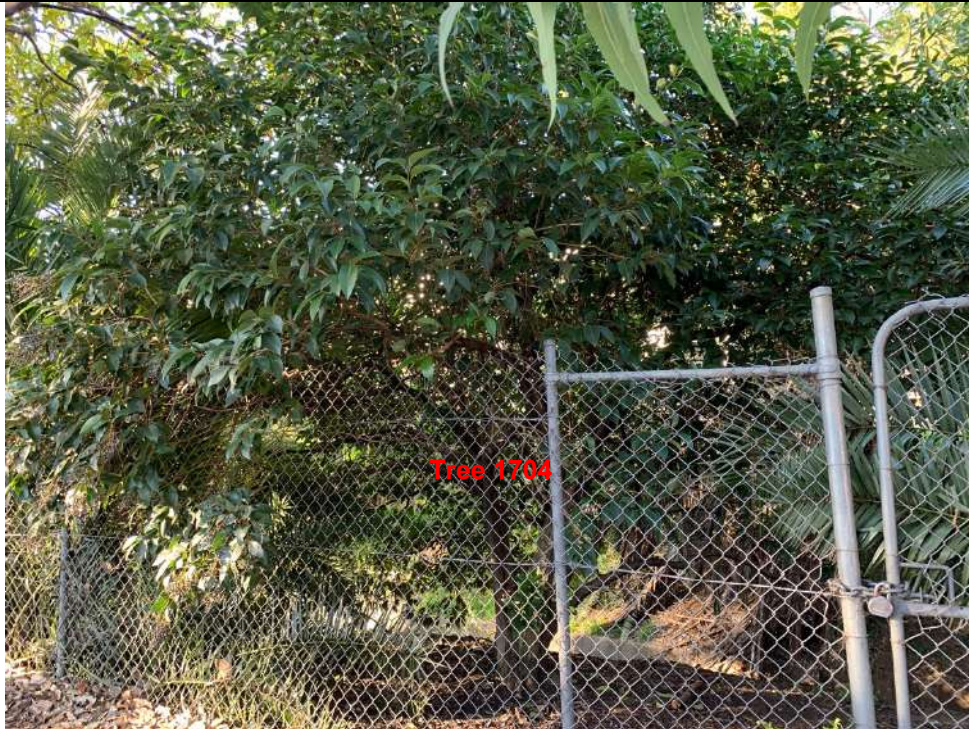
**Image 44:** Showing tree 1704, recommended for removal due to development impacts from the proposed works area.

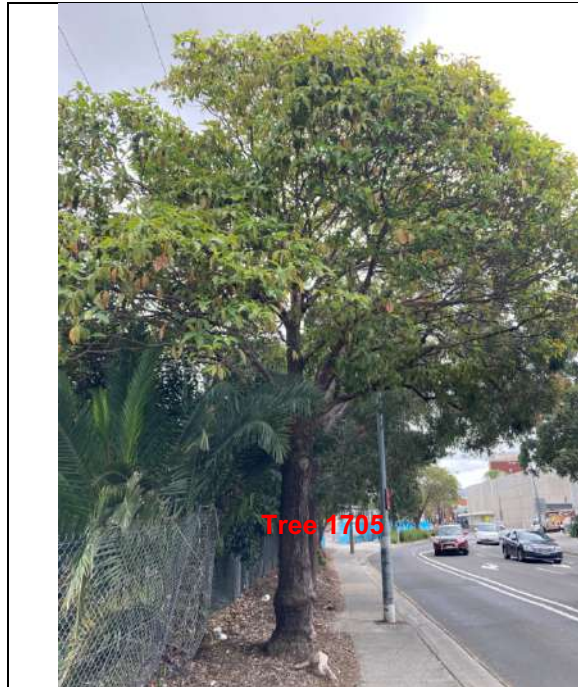
**Image 45:** Showing tree 1705, recommended for removal due to development impacts from the proposed works area.
