# Arboricultural Report: BAC Tree Report

**Site Location:** Southwest Metro -  
Marrickville, Belmore, Wiley Park,  
Punchbowl and Bankstown, NSW

**Prepared for:**  
John Holland Laing O'Rourke

**Prepared by:** Bryce Claassens  
Urban Arbor Pty Ltd  
**Date prepared:** 23 September 2022  
**Ref:** 220923-BAC-AIA  
**Rev:** 1

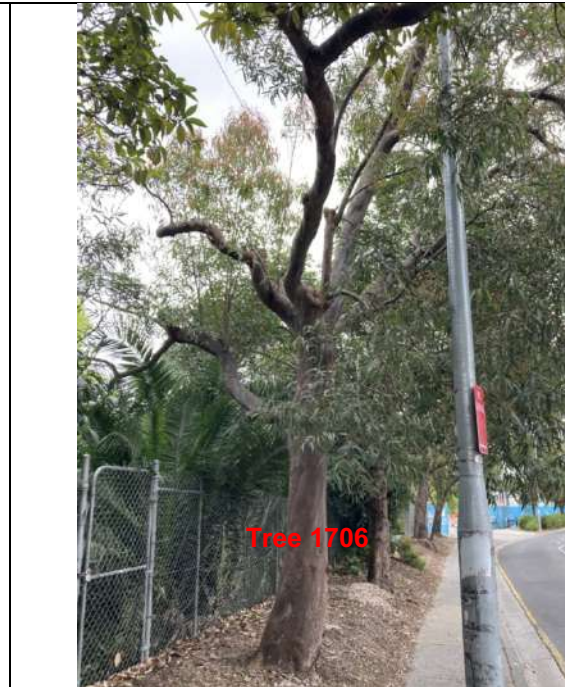
**Image 46:** Showing tree 1706, recommended for removal due to development impacts from the proposed works area.

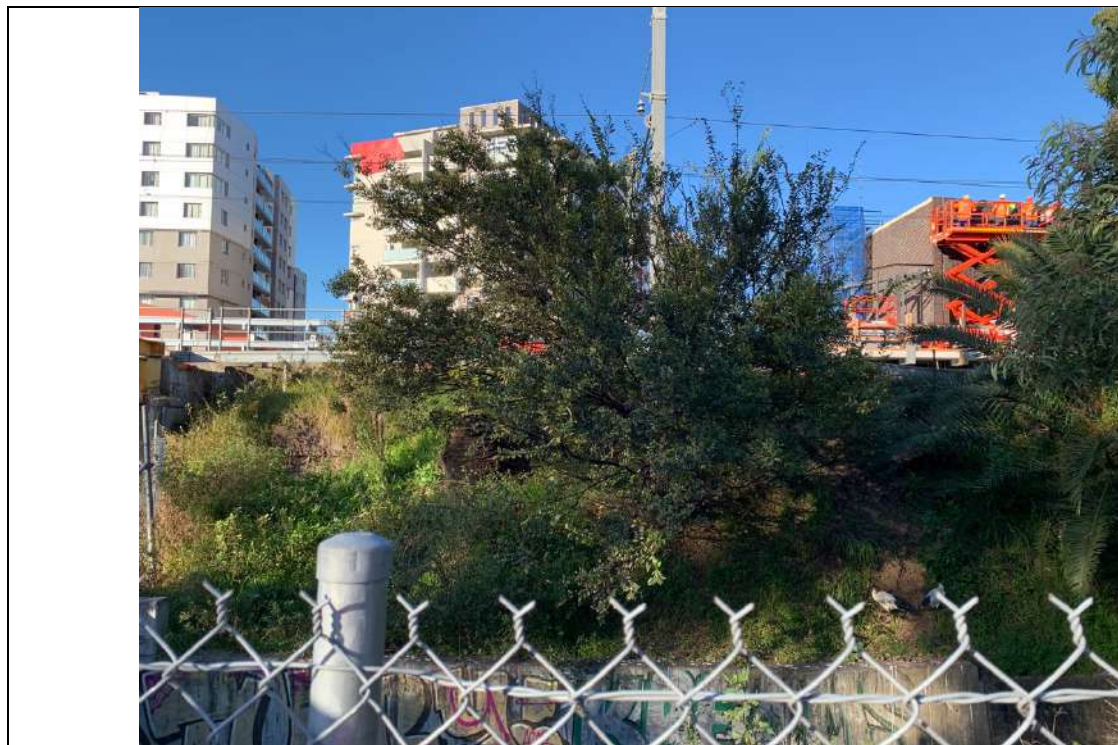
**Image 47:** Showing small weed species to be removed for the proposed works area.

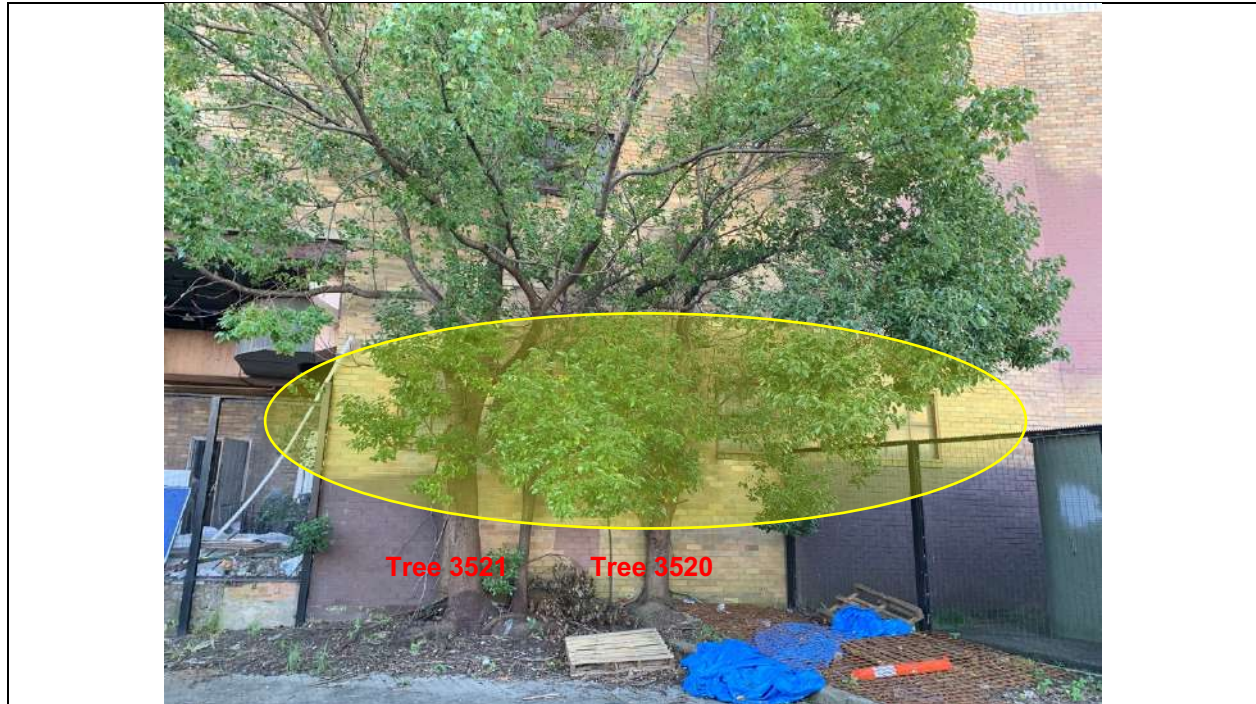
**Image 49:** Looking towards tree 3520 and 3521, showing required pruning (hatched yellow). The South side of the canopy of each tree is to be raised to 4m. The finished cut diameters must not exceed 50mm. The pruning will result in the removal of less than 5% of the overall live canopy of each tree.

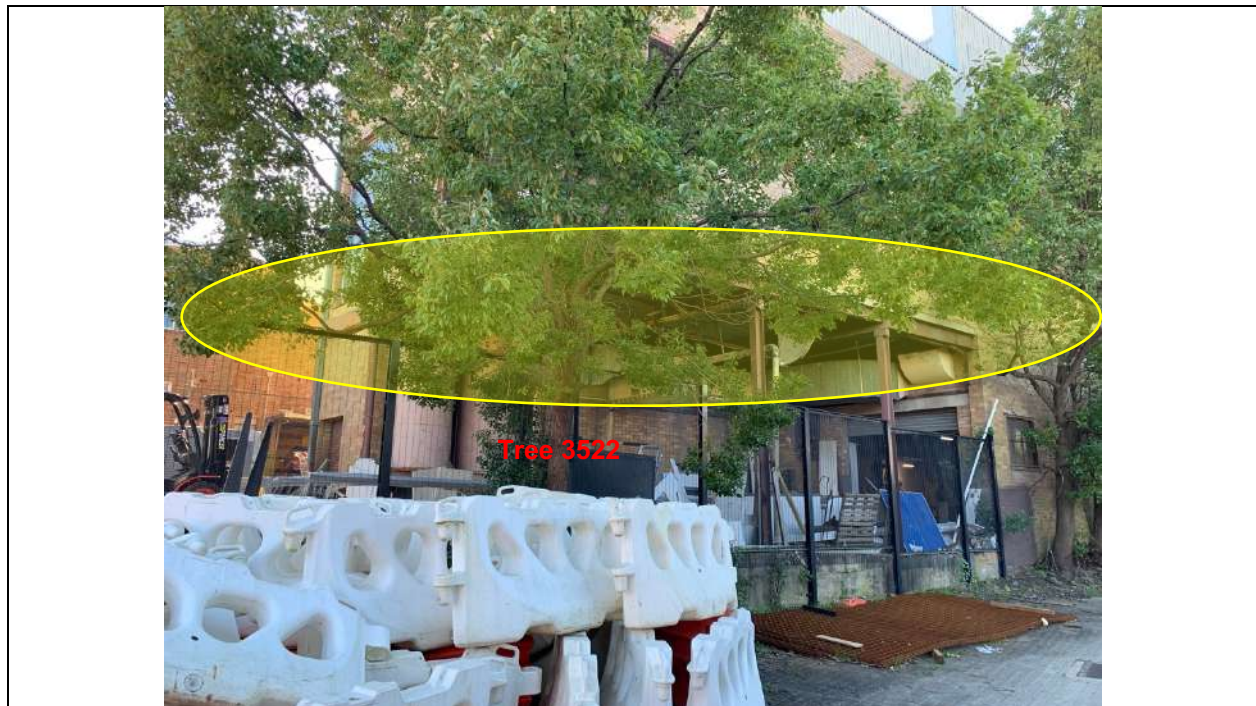
**Image 50:** Looking towards tree 3522, showing required pruning (hatched yellow). The South side of the canopy of each tree is to be raised to 4m. The finished cut diameters must not exceed 30mm. The pruning will result in the removal of less than 5% of the overall live canopy of each tree.

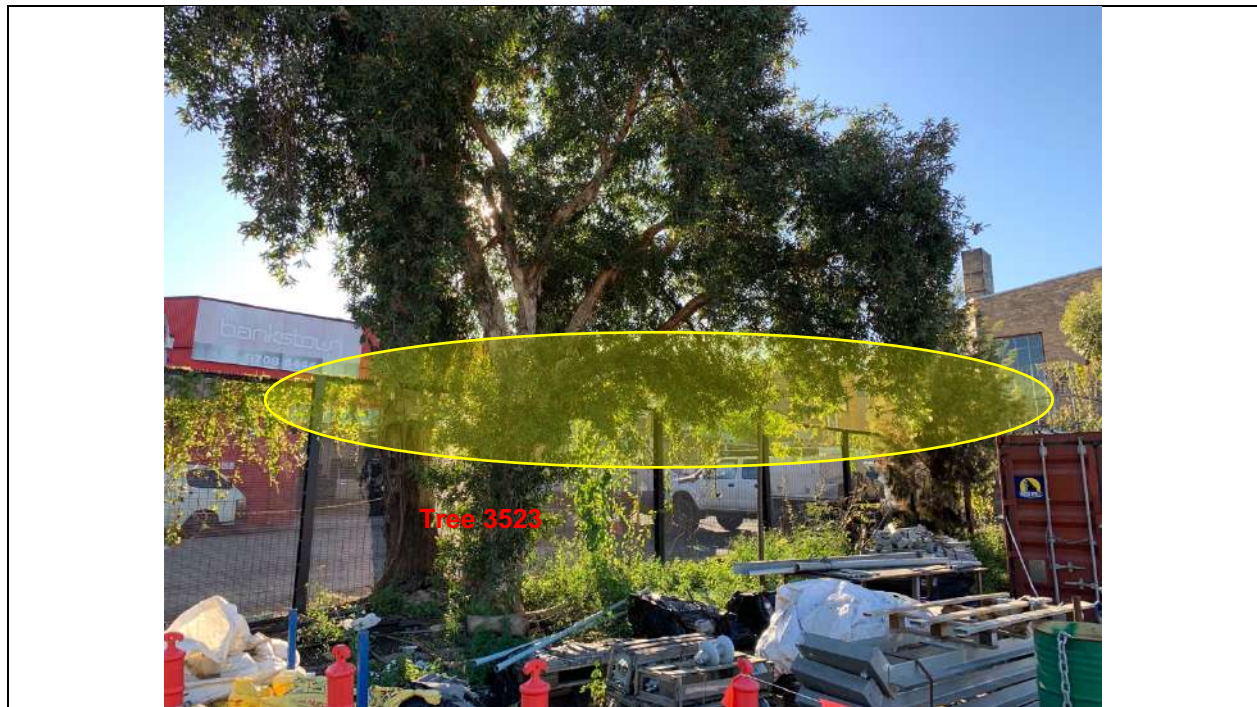
**Image 51:** Looking towards tree 3523, showing required pruning (hatched yellow). The South side of the canopy of each tree is to be raised to 4m. The finished cut diameters must not exceed 30mm. The pruning will result in the removal of less than 5% of the overall live canopy of each tree.
