Preliminary Site
Investigation

Warragamba Dam Raising - proposed construction disturbance areas

Client Reference No. 30013187
Prepared for: WaterNSW
15 July 2022

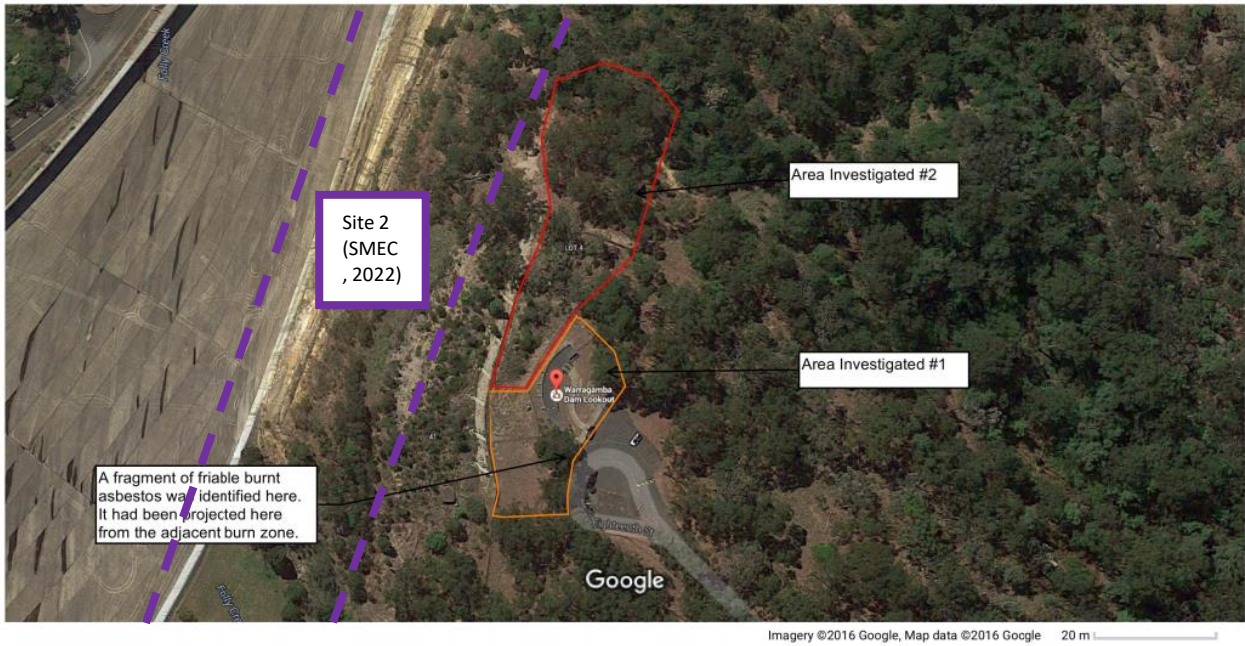
Figure 3-1 Figure extract from Integrated Environmental (2016), demonstrating the areas investigated over 19 and 20 May 2016 (Investigation Areas 1 and 2).

With reference to Figure 3-1 and Figure 3-2 below, 'Area investigated #1', 'Area investigated #2' and 'Area investigated #3' are located immediately outside of Site 2. The report states that areas outside of Area #1, #2 and #3 were not investigated. Approximately 500 fragments of cement sheeting were observed within Area #1 some of which was concluded to have been projected here from an adjacent burn zone. A representative fragment was analysed at a laboratory and shown to comprise chrysotile and amosite asbestos, the fragments were considered to be both non-friable and friable. Greater than 1,000 fragments of ACM (non-friable and friable) were estimated to be present at Area #2 and approximately 30 fragments (friable and non-friable) were observed in Area#3.

Burn Zone where friable asbestos containing material was identified

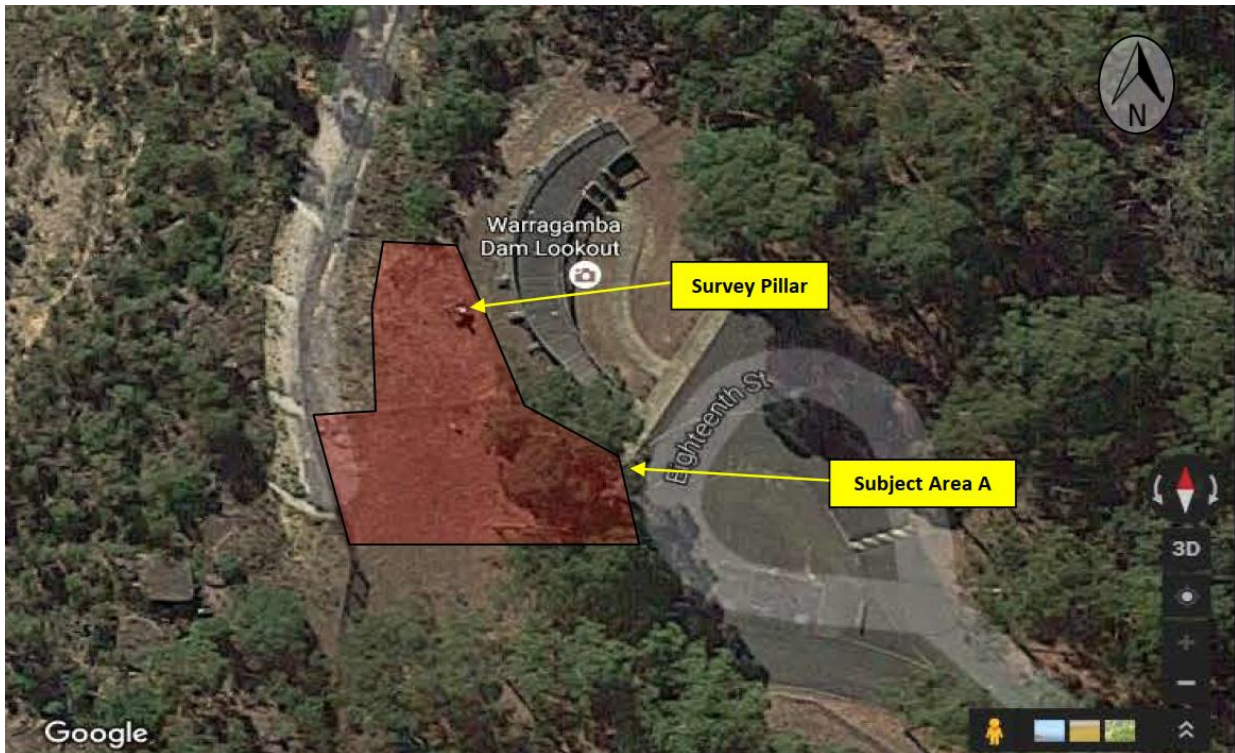
Figure 3-3 Figure extract from ADE 2016 report, demonstrating the areas investigated.

ADE consulting was commissioned by WaterNSW to undertake an Asbestos Materials Clearance Inspection at several areas located at Warragamba Dam, Warragamba. One of the areas was located adjacent to the viewing platform ('subject area A – refer to 3-3 below). The site inspection was carried out on 2 November 2016 and concluded that 'visual examination of the area revealed the asbestos containing material debris had been removed from the soil surface to a satisfactory standard; the subject area at the time of inspection was considered safe with regards to asbestos'. The cleared area (subject Area A) includes a portion (but not all of) 'Area Investigated # 1' as described in Section 3.4.2 above.

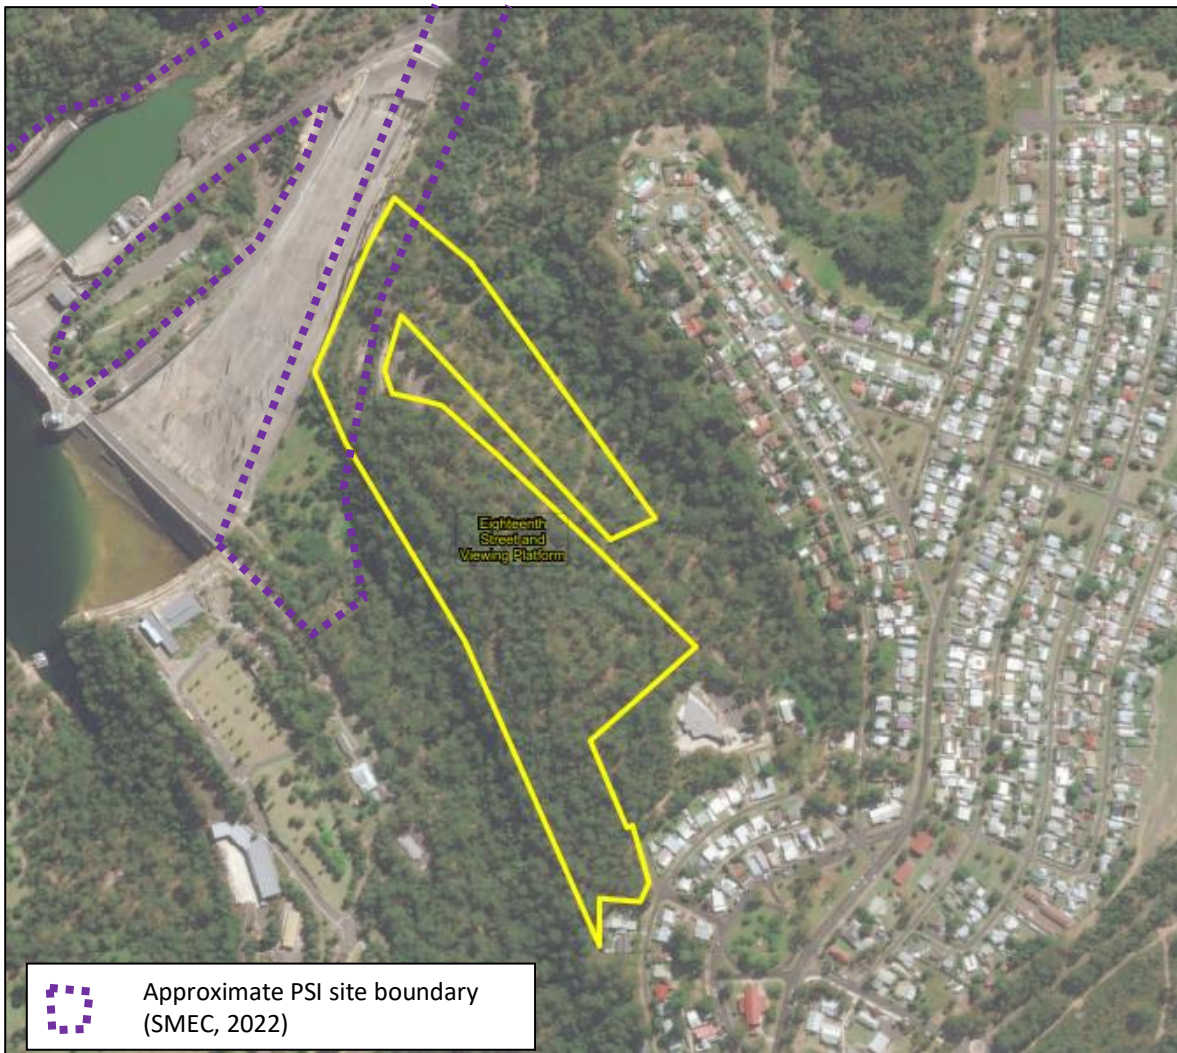
Figure 3-4 CH2M Hill (2018) assessment and remediation area

CH2M Hill were engaged by Sydney Water to prepare a CLMP for Sydney Water owned land near the Warragamba Dam viewing platform, this area had been fenced off due to identified asbestos contamination which was discovered during backburning in 2016, the source of the asbestos was from the demolition of temporary dwellings constructed for dam workers in the 1950's. The report references a previous investigation carried out by WSP (2016) which found widespread ACM contamination (including friable asbestos and asbestos fines) (generally limited to the top 0.2 below ground level. CH2M developed a remedial action plan (RAP) which recommended:

As part of the remediation works an emu pick was completed in December 2017 by Enviropacific.

Services at publicly accessible areas on and adjacent to the Site to remove visible asbestos. A clearance certificate was subsequently granted by a qualified hygienist at the completion of the emu pick.

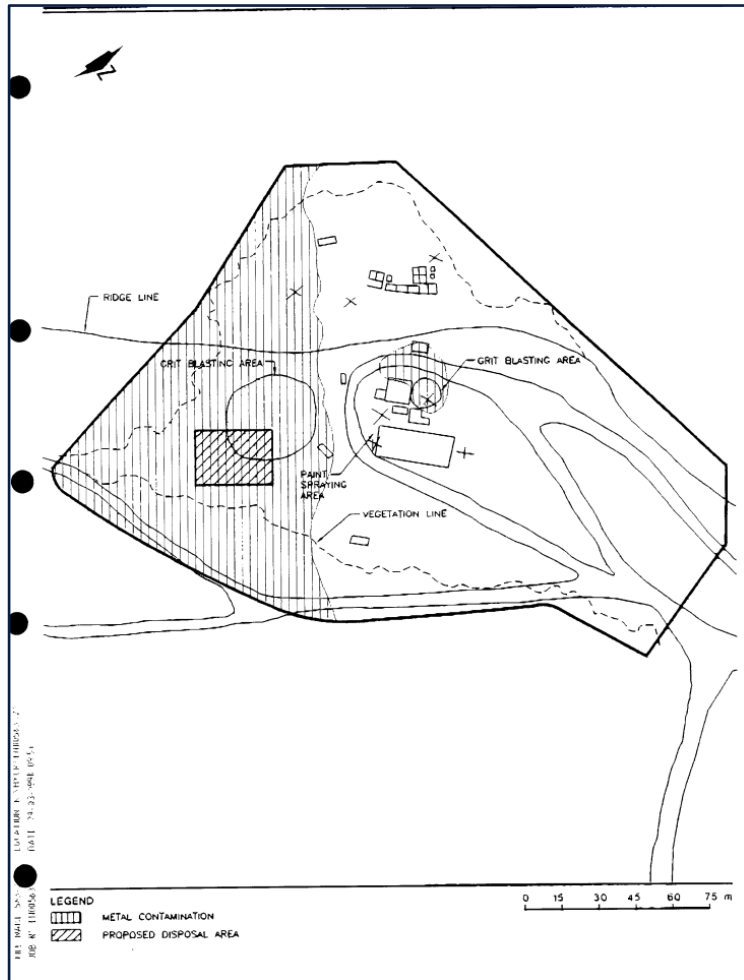
‘a contamination assessment of the site has confirmed that the site is contaminated by copper, lead and zinc as a result of grit blasting activities carried out on the site in the past. The material is mainly sandy topsoil mixed with black grit material. Contaminated material is distributed over approximately 1ha of the site extending into surrounding bushland and concentrated in drainage lines off-site. Contaminated material will be scraped up from around the site and secured into a cell, which is to be constructed on site. The cell will be strategically placed on-site to ensure that it is on the side of the ridge line which drains away from the water storage areas. From previous investigations it was estimated that approximately 1000m³ of material required securing on site’. The letter report also states that ‘a cell will be excavated to bedrock which was noted to be approximately 1m below the ground surface. The letter also states that the cell will be lined with geotextile fabric at the base and on the sides of the cell...the lining will extend over the edge of the excavated cell. It was then recommended that the cell, once full, be covered with multiple layers, including geo textile, HDPE, topsoil etc. The letter also included Figure 3-5 below which shows locations of metal contamination extent, grit blasting area and the proposed location of the cell.

Figure 3-5 Sketch from SKM (1998) letter report showing areas of metal contamination, grit blasting areas and proposed disposal area.

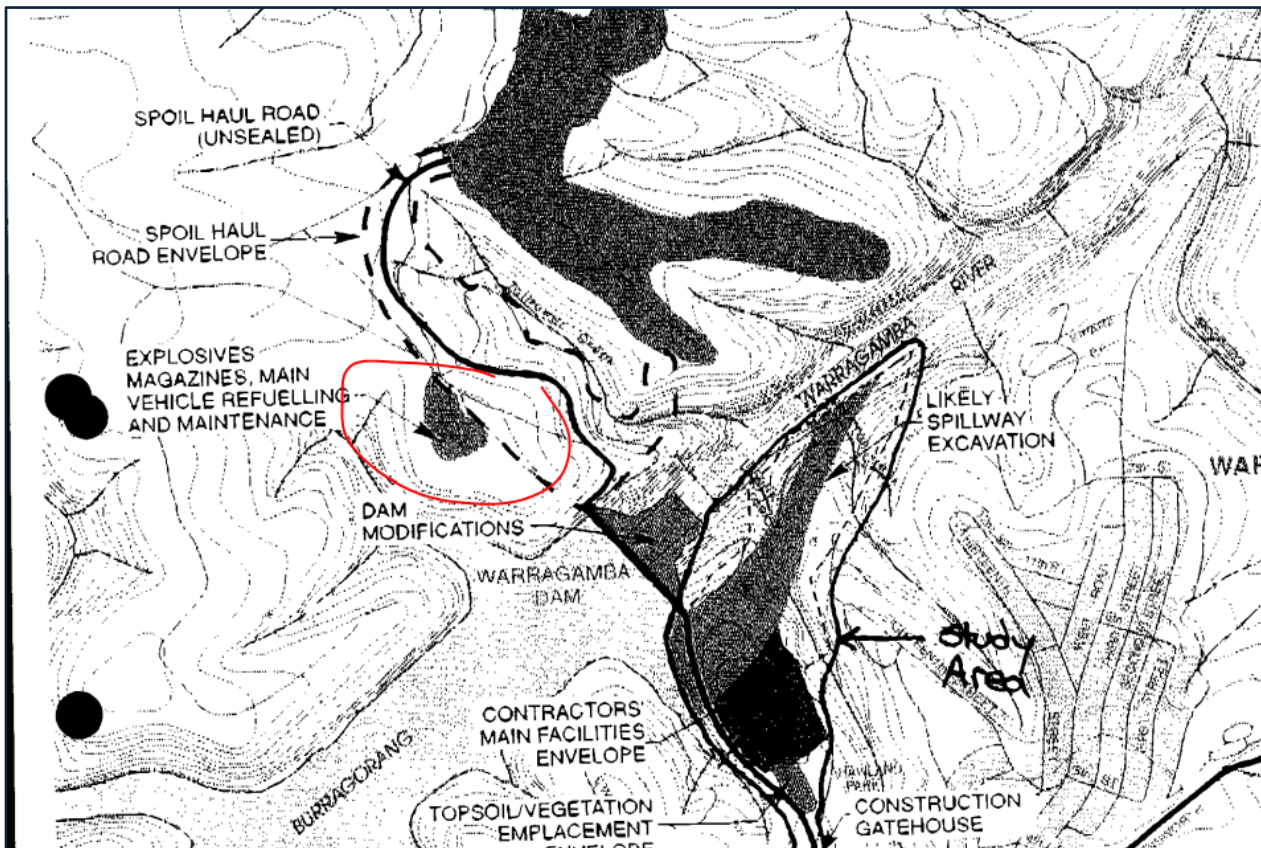
Figure 3-6 Map provided as part of tender briefing documents which describes Site 1 as 'Explosives magazines, main vehicle re-fuelling and maintenance'.

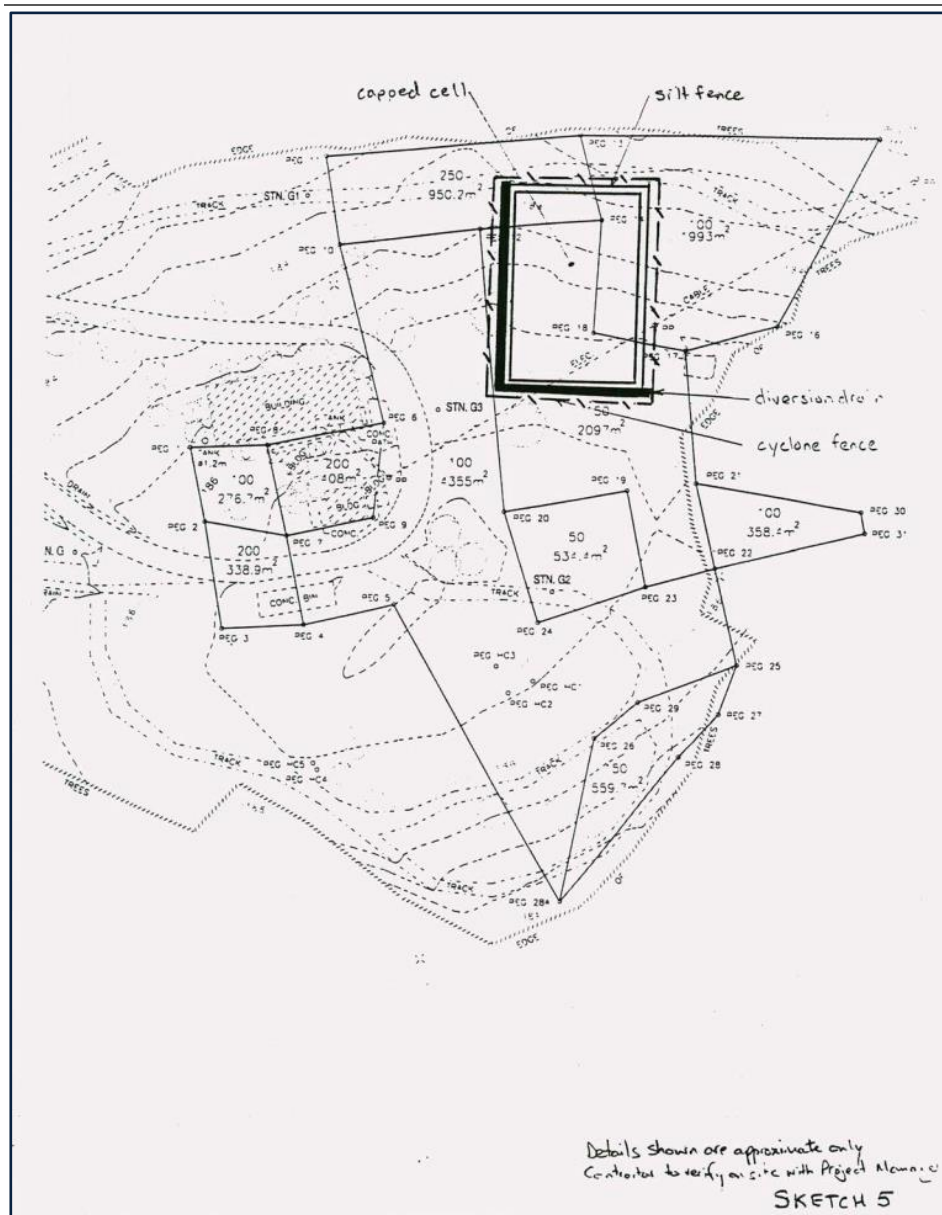
Figure 3-8 – shows proposed location for the contamination cell at Site 1

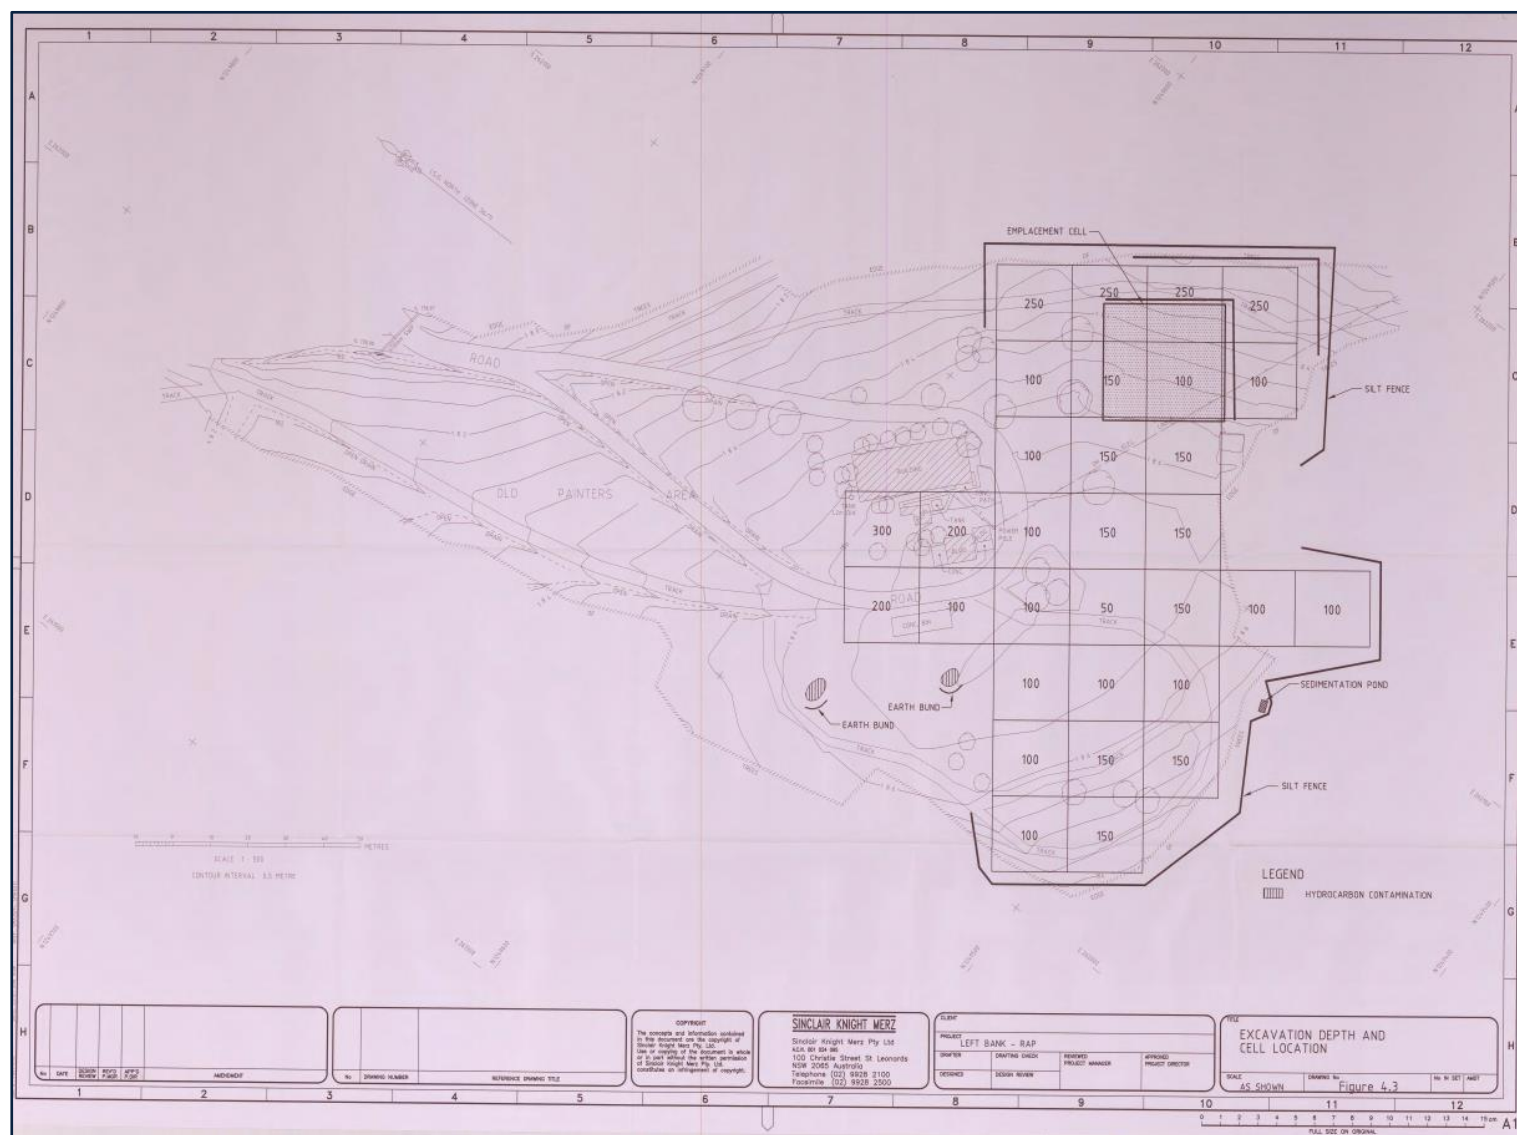
Figure 3-9 – 'excavation depth and cell location

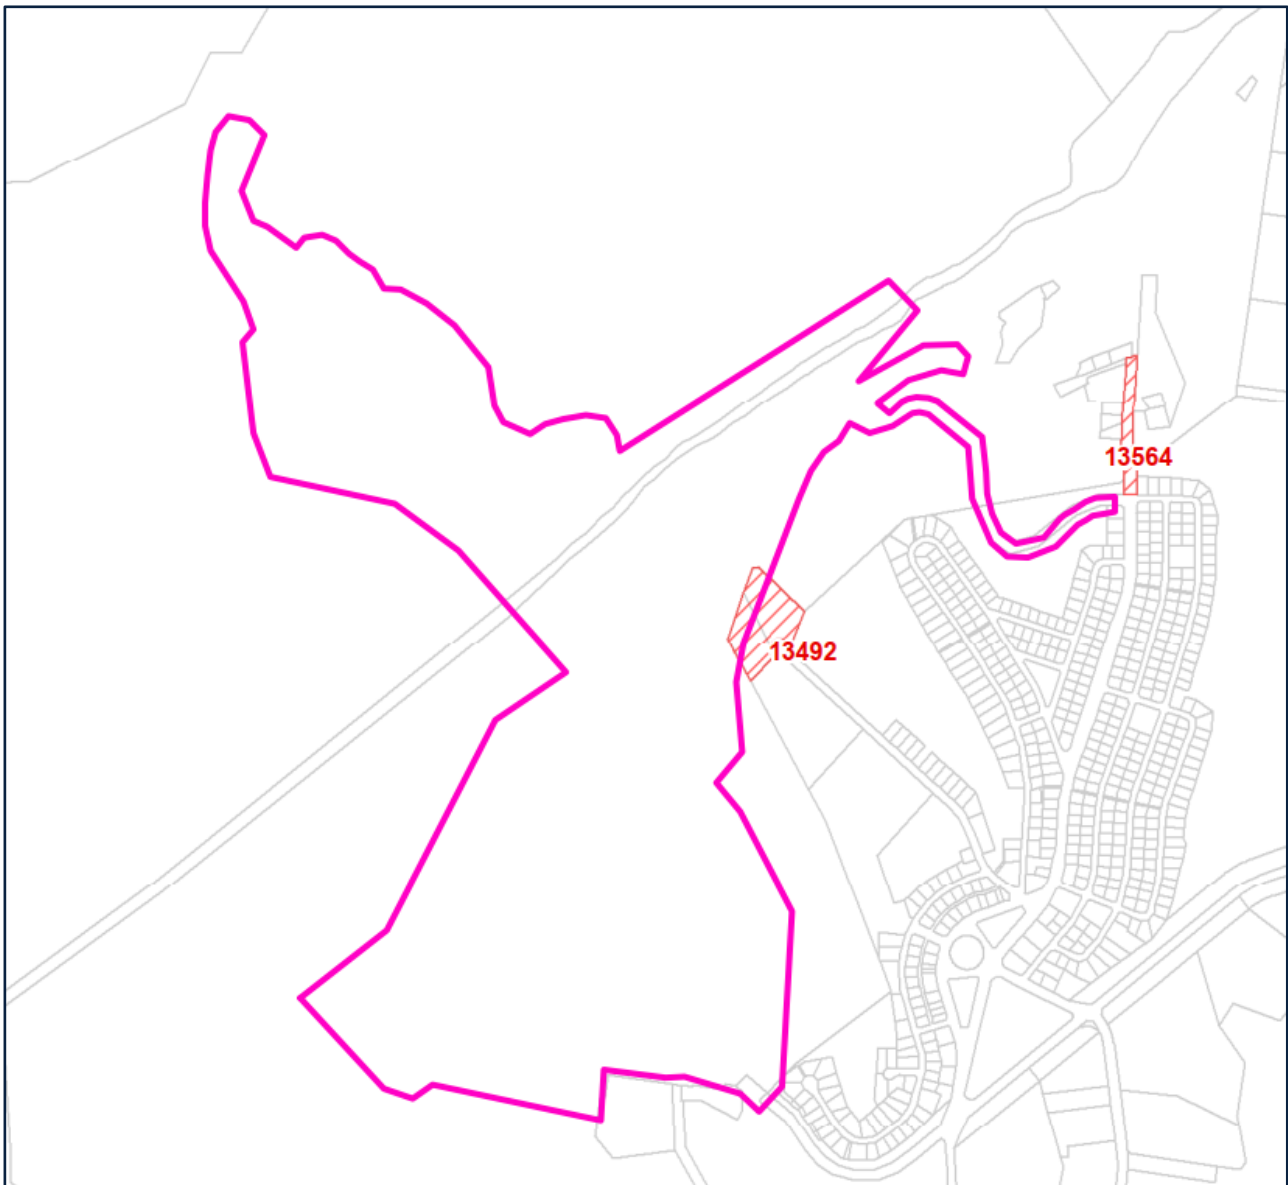
1 – The mapping provided within the Lotsearch report (Appendix B) indicates that the contamination associated with the Warragamba dam viewing platform extends across the eastern boundary of Site 2 into the site, however, discussions with WaterNSW indicate that this portion of the site will not be disturbed by the proposed construction works.

Figure 3-9 Location of NSW EPA contaminated sites relative to the Site
