Report on  
Geotechnical Investigation

Proposed New Maitland Hospital  
Metford Road, Metford

Prepared for  
Health Infrastructure

Project 81719.01  
May 2018

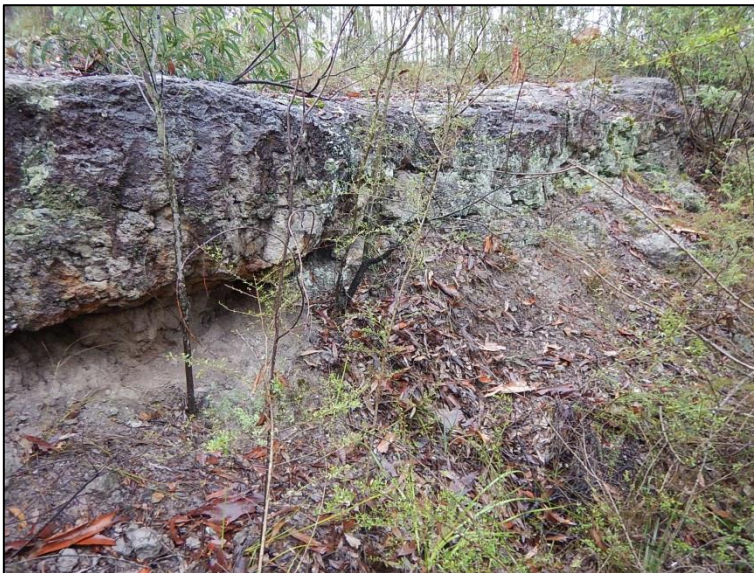
A natural drainage path was observed within the densely vegetated area in the south-western part of the site. As shown in Figure 2 below, the rock outcrop serves to facilitate the variation in surface level. This low cliff line defines the western boundary of a broad gully, within which overland flow passes roughly south-east to north-west through this area of the site. This drainage path is discussed further in Section 9.8.

**Figure 2: Natural drainage line in south-western part of the site (2015)**

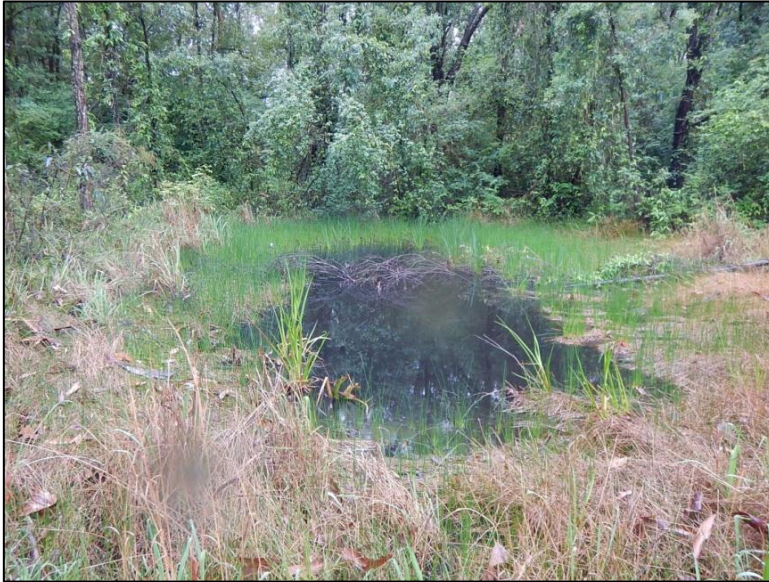
Several small ponds were present within the drainage path (refer Figure 3).

**Figure 3: A typical pond in the south-western area of the site (2015)**

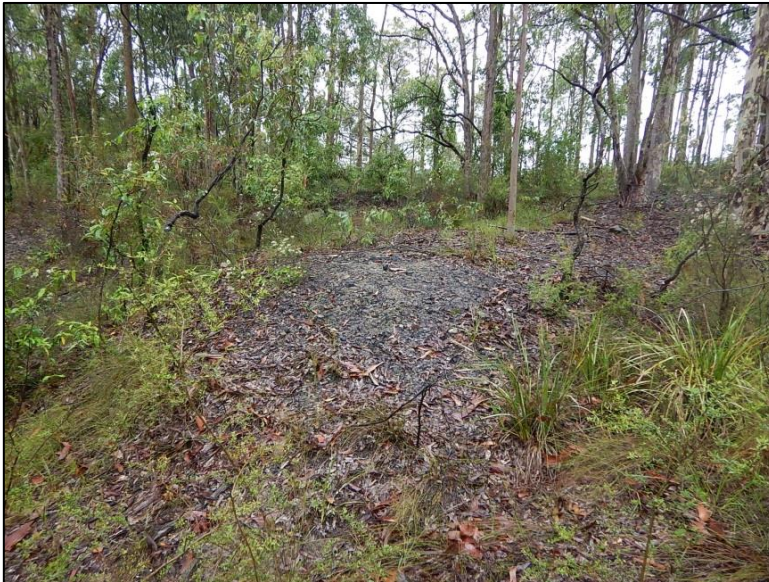
Fingers of fill material were observed to extend into this vegetated area from a constructed berm wall which segregates the disturbed central area of the site from the south-western area (refer Figure 4).

**Figure 4: Typical fill mound observed behind the berm wall (2015)**

The extent of these fingers of filling have not been fully characterised during the present investigation. An estimate of the affected area is shown on Drawing 2 in Appendix D.

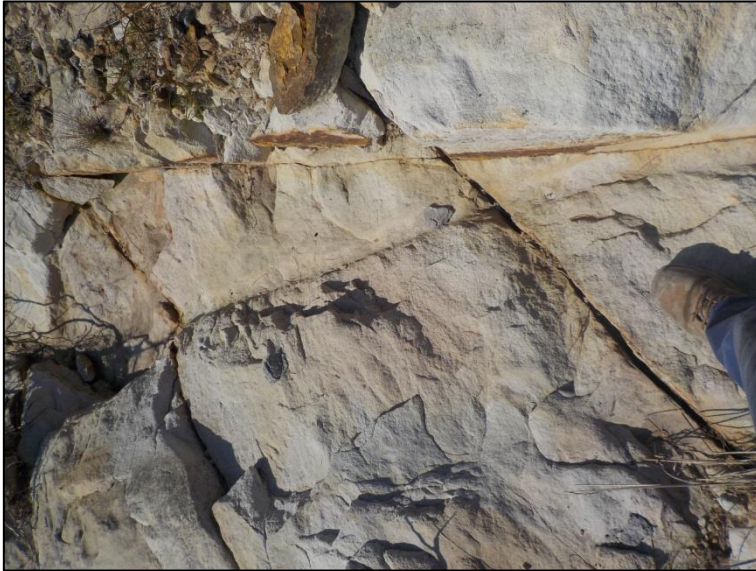
**Figure 5: Low to medium strength sandstone exposure in the southern part of the site (2015)**

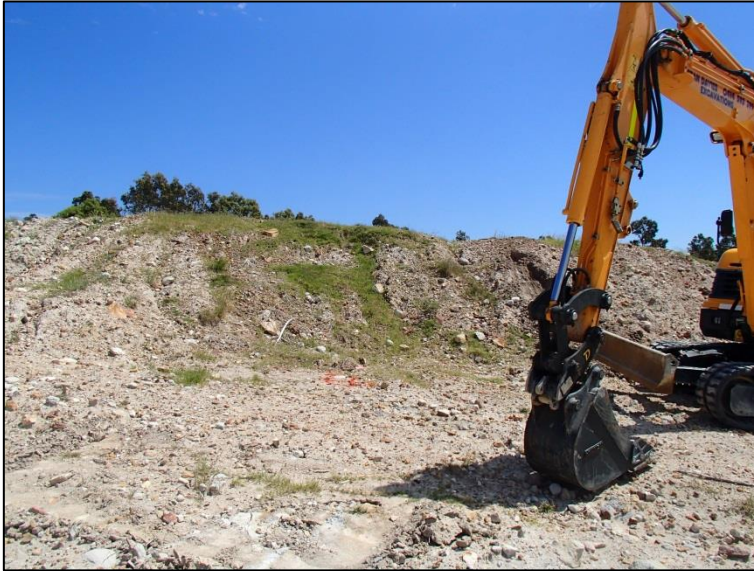
**Figure 7: Stockpile adjacent Pit 301, comprising cohesive soils and ripped bedrock (2015)**

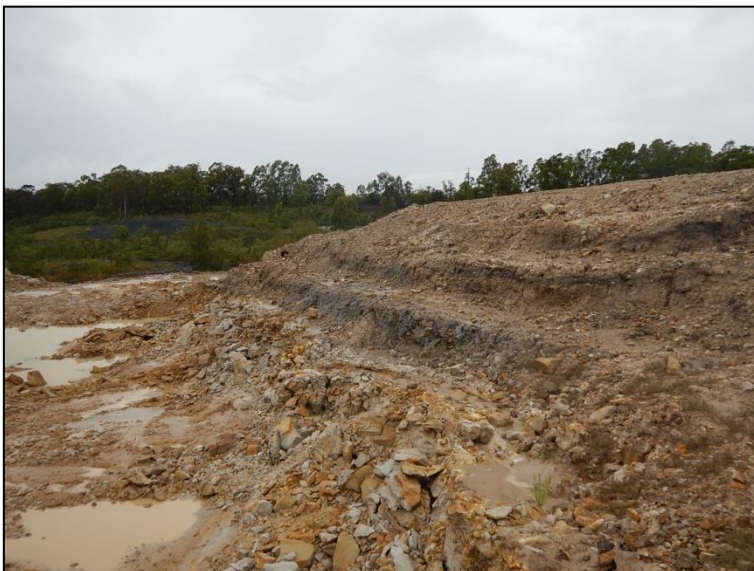
Several areas beyond the stockpiles exposed sandstone bedrock, particularly towards the eastern and south-eastern sides of this area (refer Figure 8). The sandstone was generally very low strength or stronger.

**Figure 8: Exposed sandstone bedrock in north-western area (2015)**

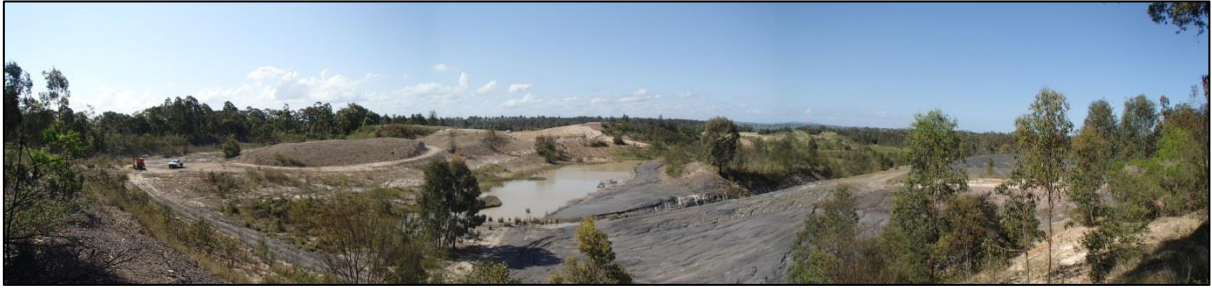
**Figure 9: Looking north across the site from Borehole 606 (2015)**

During the investigation in 2015, a large area of ponded water (Main Pond) was located in this area of the site (middle of Figure 9). The depth of the water was not known but based on probing around the edges it was anticipated to be greater than 1 m to 2 m. During the further investigation in July 2017, it was noted that the sediment in the base of the pond was in the process of being removed.

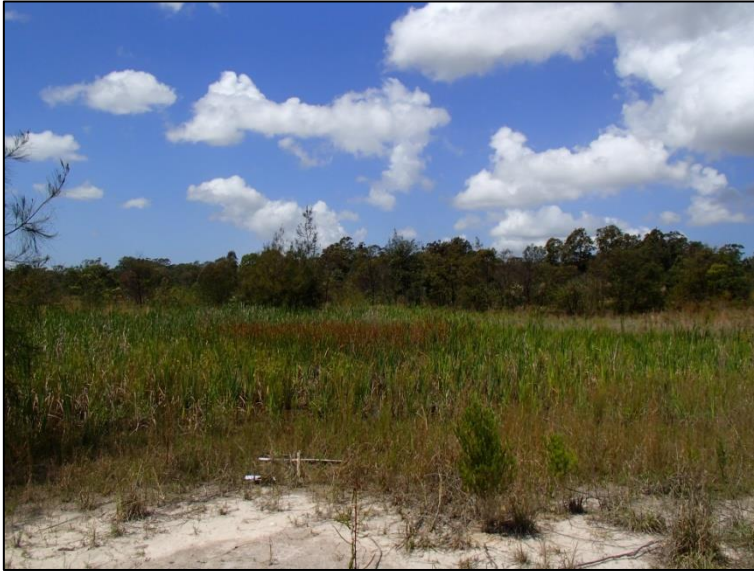
The remainder of this area is covered by accumulated sediments and low vegetation. Surface water is present in many parts of this area of the site (refer Figure 11).

**Figure 11: Typical view of eastern area (2015)**

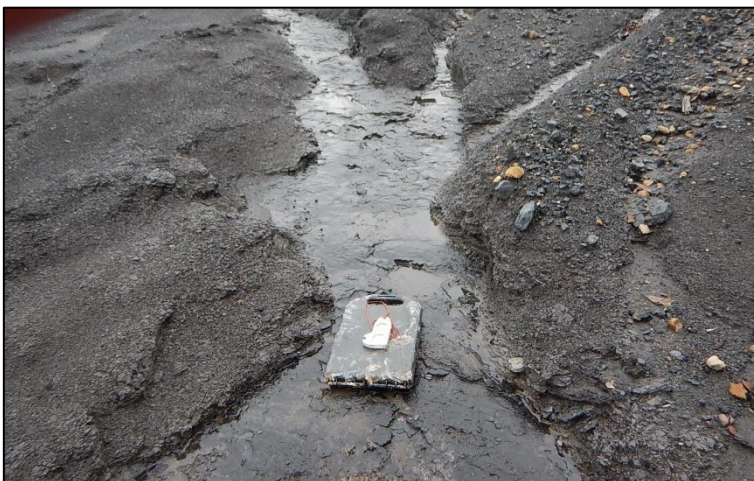
Within the southern part of this area of the site, a large stockpile of carbonaceous material was present. The height of the stockpile varied from less than 1 m to up to about 5 m. Erosion of the carbonaceous stockpiles, as shown in Figure 12, revealed coal below in some areas.

**Figure 12: In-situ coal exposed beneath edge of carbonaceous material stockpile in eastern area of the site (2015)**

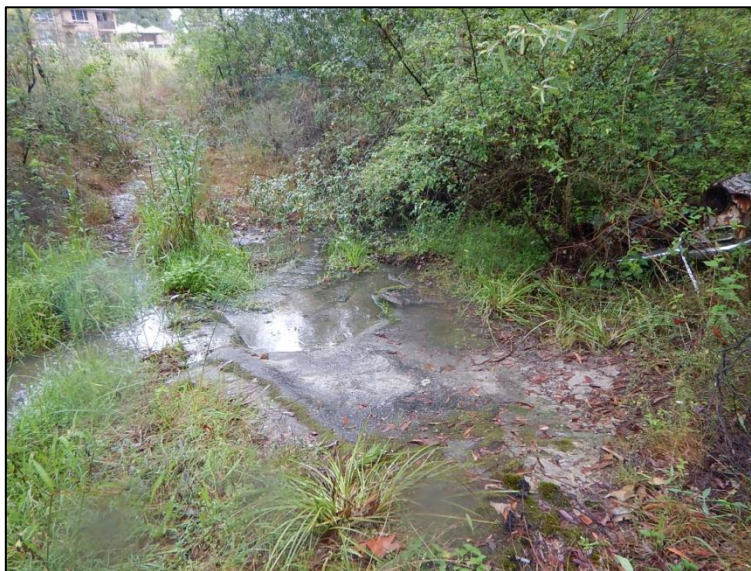
The drainage gully which traverses through the south-western area of the site, enters the site within the southern strip (refer Drawing 2). This gully is incised up to 3 m into the surrounding landscape, with sandstone bedrock of at least low strength exposed at its base (refer Figure 14).

**Figure 14: Sandstone bedrock exposed in crossing of gully (2015)**

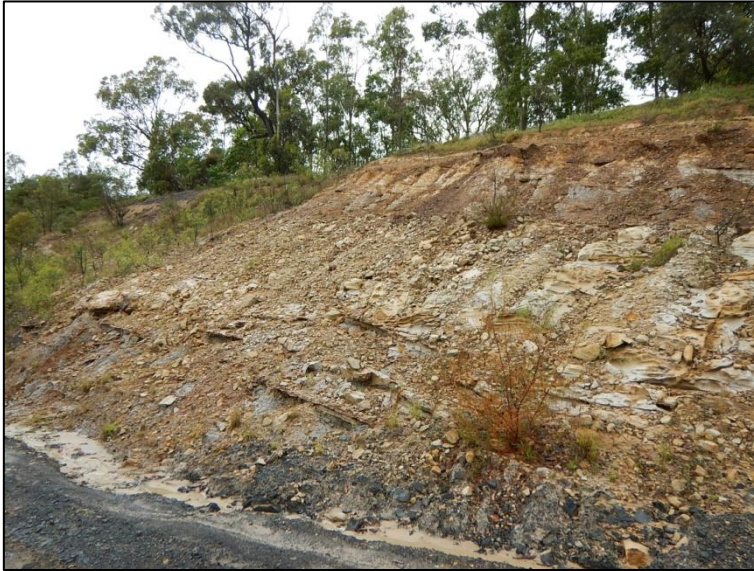
The eastern area and southern strip are separated by a rock batter of approximately 10 m in height (refer Figures 15 and 16).

**Figure 15: Rock batter between eastern area and southern strip (2015)**

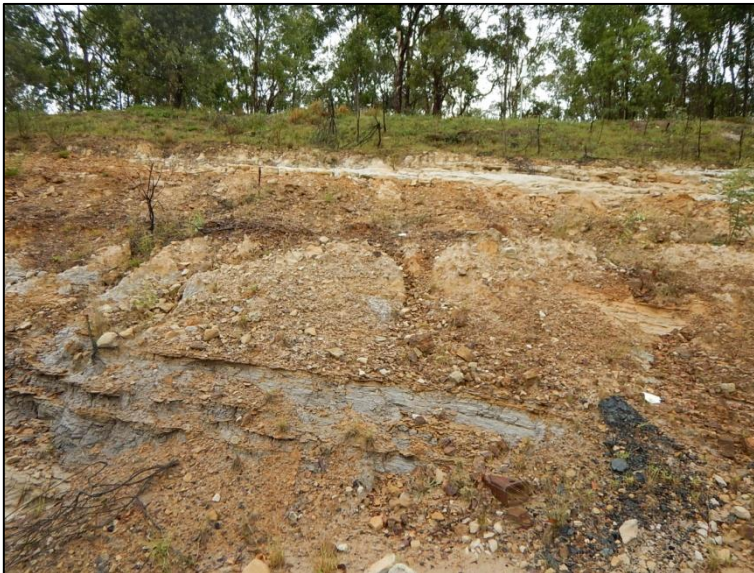
**Figure 16: Sandstone and siltstone exposed in batter (2015)**

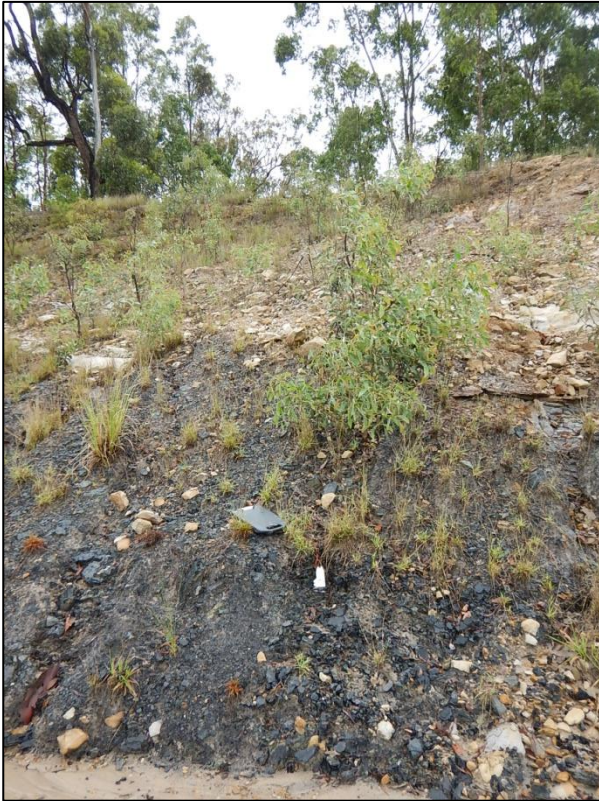
- The dominant joints were dipping at about 65° with a dip direction of around 060° M and a spacing ranging from 200 mm to 1000 mm;
- Coal was exposed within the lower approximately 1 m towards the eastern visible extent of the batter (refer Figures 20 and 21).

**Figure 20: Coal exposed in lower area of batter**

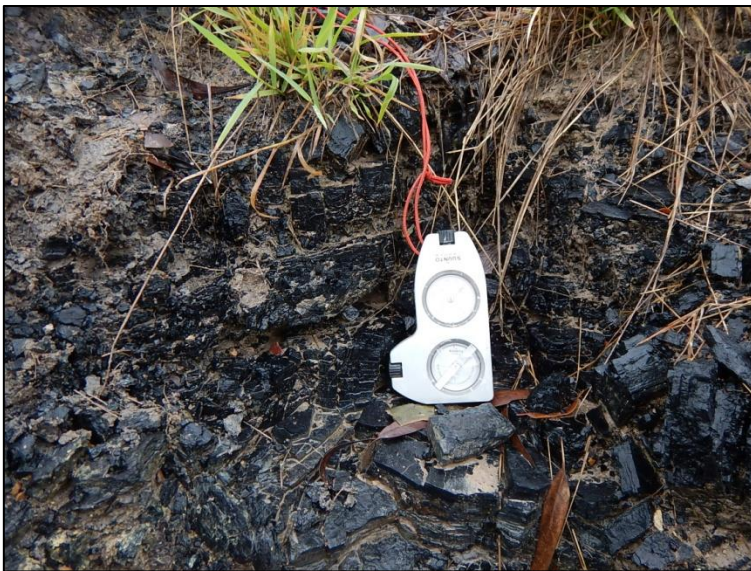
**Figure 21: Coal in exposed batter**

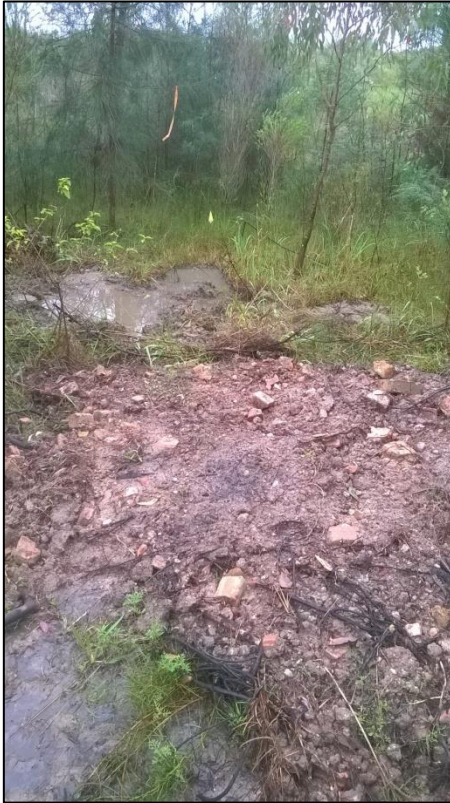
- Dewatering of main pond and other areas of ponded water;
- Given the low lying nature of this area of the site, a dewatering plan is anticipated to be required to allow earthworks;
- Removal of all accumulated sediments and filling, following appropriate assessment for disposal or reuse. In this regard, up to 0.8 m of filling, comprising soft silty clay with significant anthropogenic inclusions such as brick fragments were encountered in the pits undertaken in this area of the site (refer Figure 22). Penetrometer testing at Location 322 indicated that the sediments were less than 0.2 m thick at this location.

**Figure 22: Filling encountered in low lying area of the site**

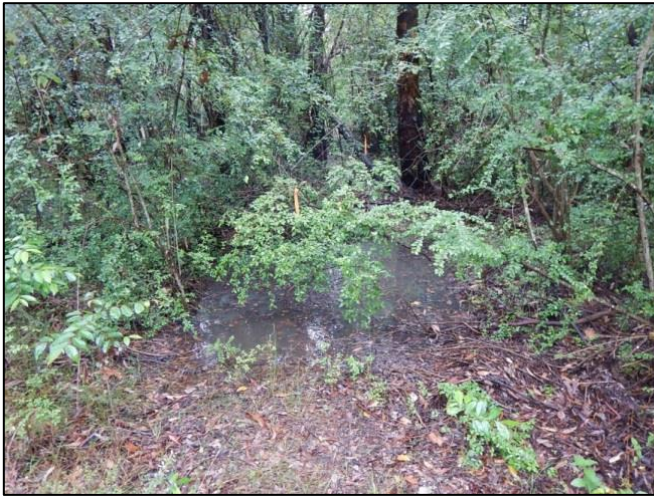
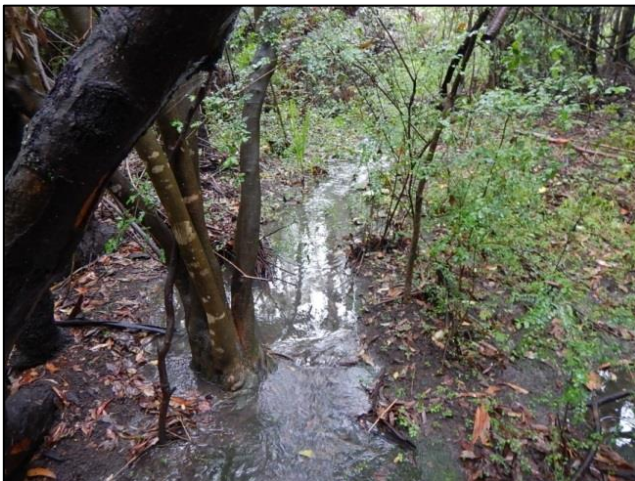
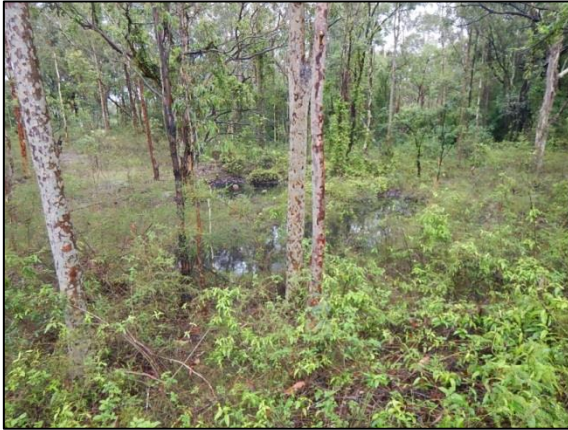
A site inspection was undertaken by a Principal Geotechnical Engineer from DP on 5 November 2015 after a rain event. Water ponding was observed within the densely vegetated area in the south-western portion of the site, adjacent the natural drainage path. Figures 25 to 27 show the area at the time of the inspection.

**Figure 25: Looking SSW at water ponding (co-ordinates: 369127, 6374429)**

**Figure 26: Looking SSE at overland flow (co-ordinates: 369112, 6374419)**

**Figure 27: Looking north at water ponding (co-ordinates: 369091, 6374344)**

It is understood that placement of up to 5 m of filling may be required in this area to raise the site to RL 18 m AHD. Consideration should be given to the design of earthworks to maintain flow of groundwater and surface water within this natural drainage path. Installation of an appropriately sized geotextile encapsulated gravel 'drainage blanket' or pipes would be appropriate prior to placing controlled fill in this area.

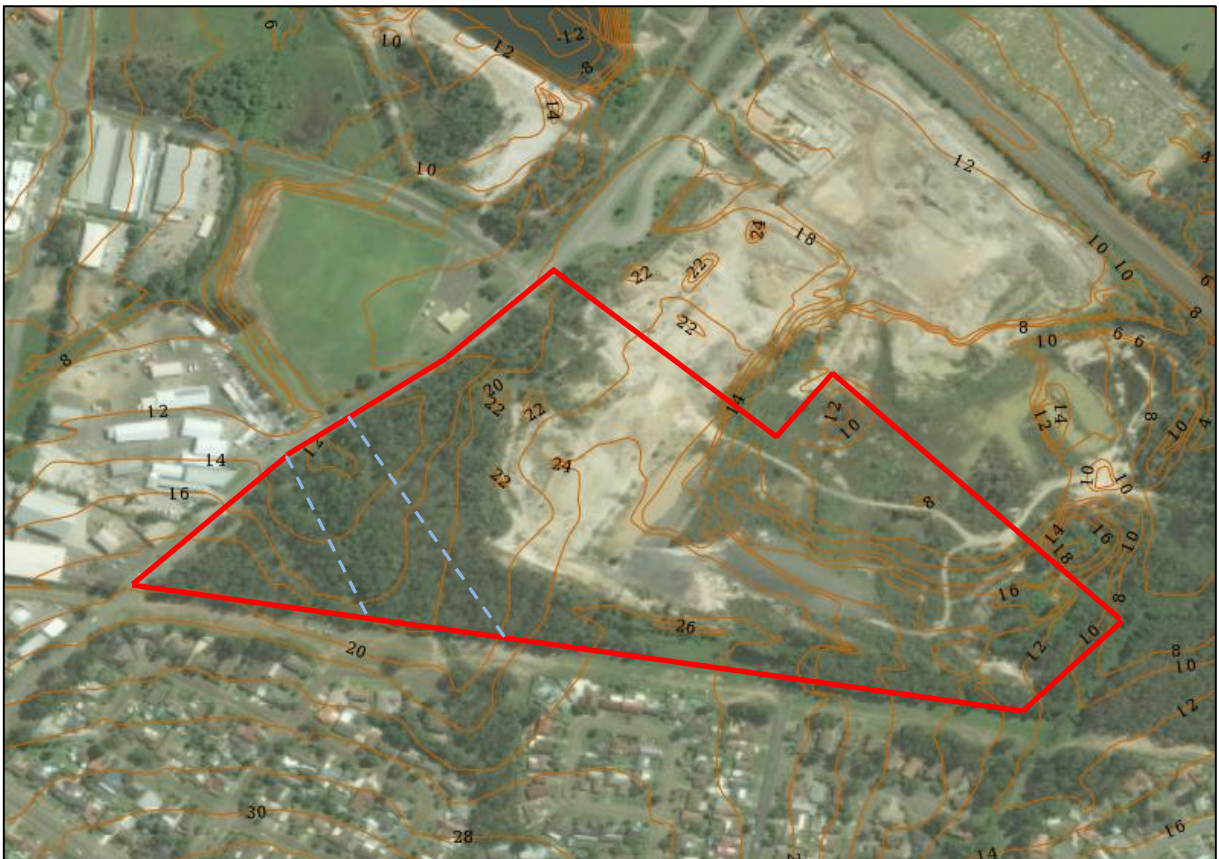
The area of overland flow / ponding observed is highlighted in Figure 28 below.

**Figure 28: Aerial with 2 m contours, site boundary (red), area of ponding / overland flow (blue)**

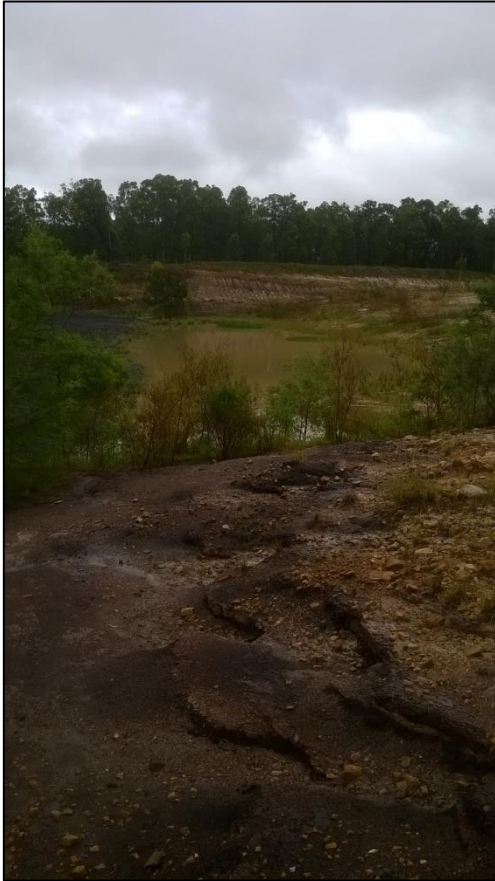
**Figure 30: View across former quarry batter and pond to principal former quarry batter**

No signs of gross instability were observed within either of these batters.

It is not anticipated that stabilisation measures, beyond removal of the existing filling and provision of erosion protection will be required for these batters.

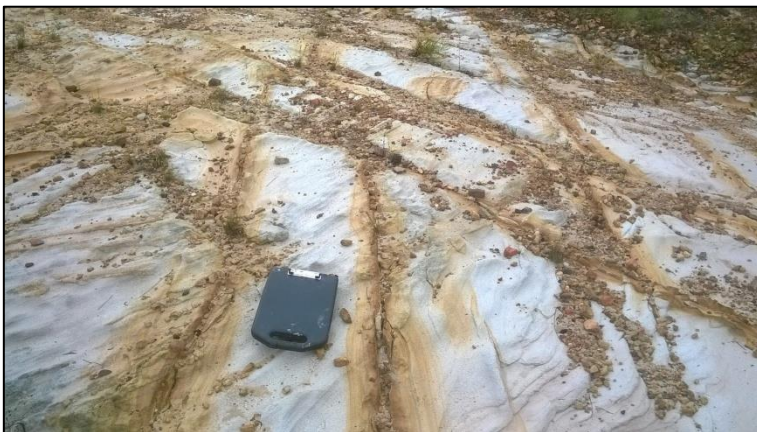
The western cut batter associated with the former quarry lies to the west of the main pond (refer Drawing 2). This batter has been formed at a range of slopes, generally less than about 2.5H:1V. Where clear of vegetation, the materials exposed within the batter included very low to low strength sandstone with some pebbly sandstone in parts (refer Figures 30 and 32).

**Figure 31: Exposed sandstone in former quarry excavation batter**

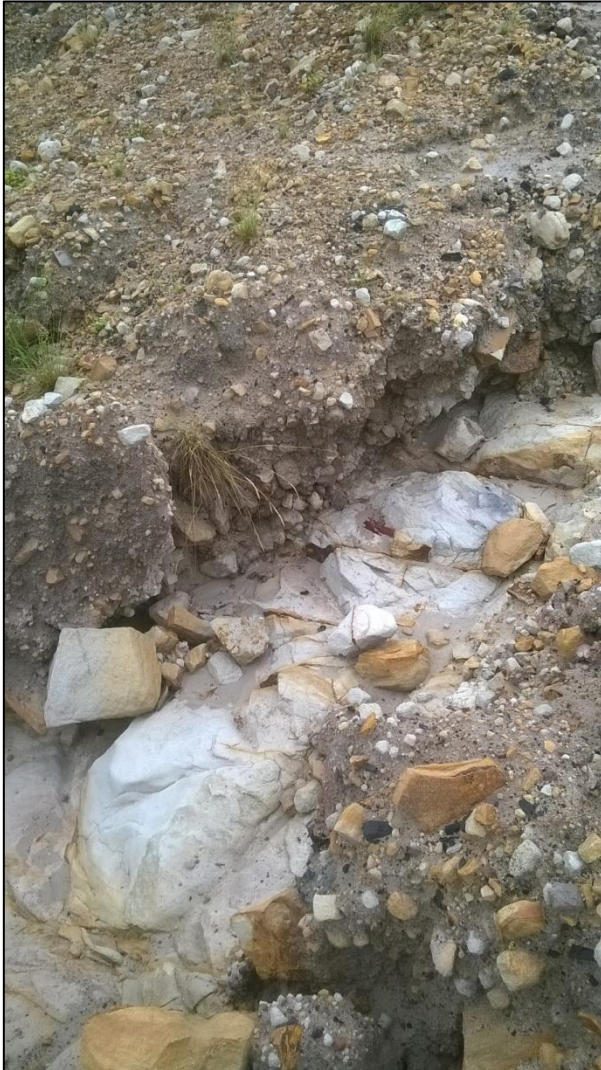
Towards the upper section of the former quarry excavation batter, filling has been placed. Inspection of local erosion indicates that the filling is generally shallow (less than about 1 m) and is underlain by sandstone bedrock (refer Figure 32).

**Figure 32: Localised filling underlain by sandstone in quarry batter**
