Conceptual site model and risk assessment

Snowy 2.0

Contamination Assessment

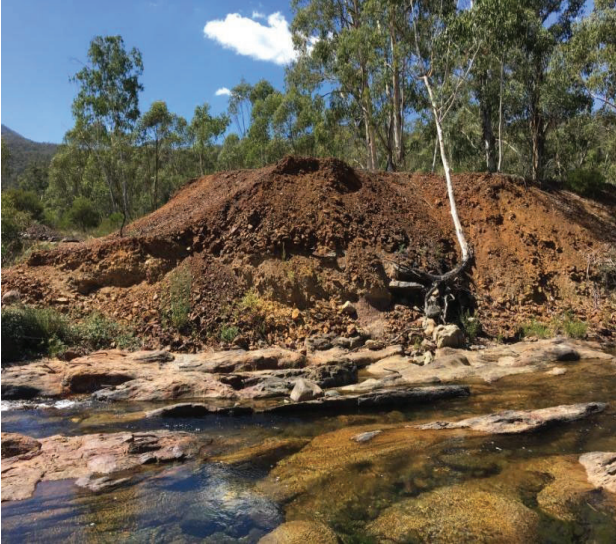
Historical mined waste at Lobs Hole

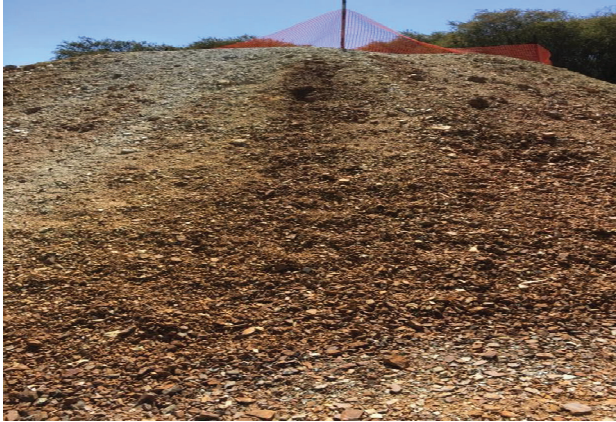
Historical shaft and processing area (facing east) at Lobs Hole

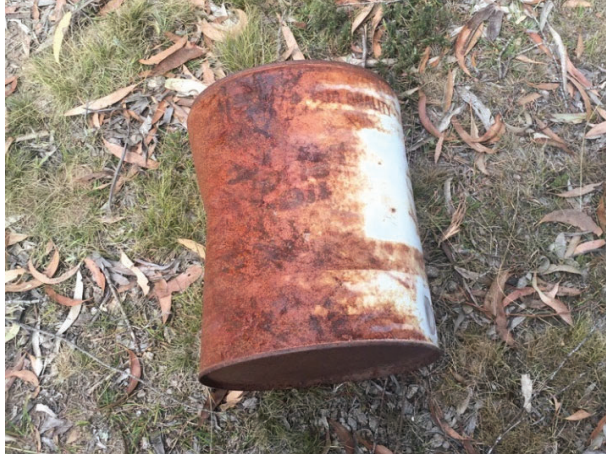
A single empty drum. No evidence of contamination to the underlying or surrounding ground surface was noted.

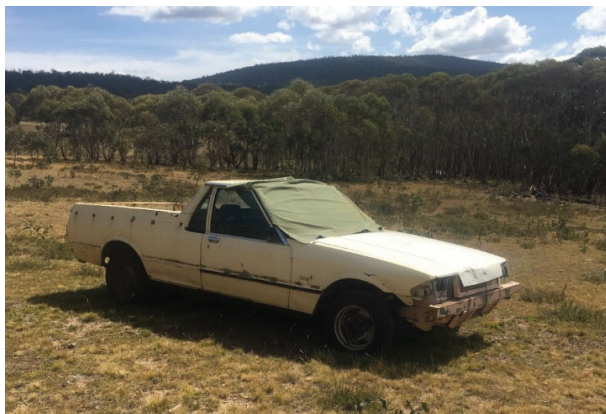
Abandoned ute.

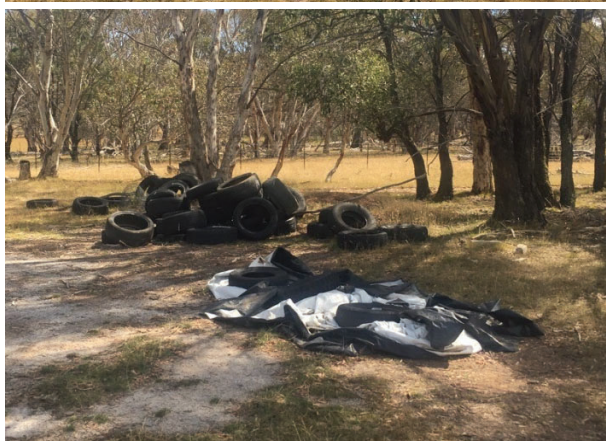
Used tyre storage area. Note covered fertiliser phosphate stockpile.

• Chemical storages / sheds (housing pesticides, fertilisers, agricultural chemicals)?	Phosphate fertiliser stockpiled every two or three years
• Tips / rubbish collections, including in dams or infilled pits?	Used tyres are used to hold down a tarpaulin to cover stockpiled fertiliser

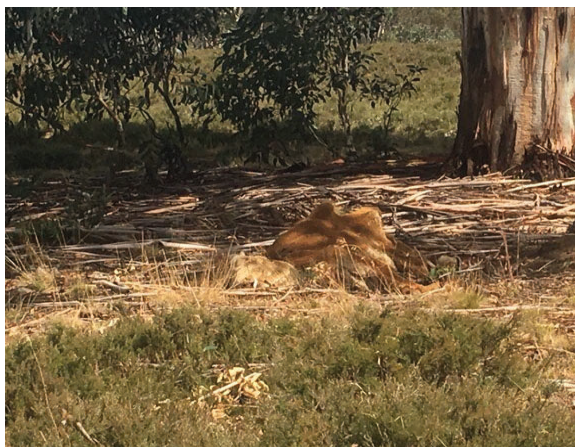
Dead cow

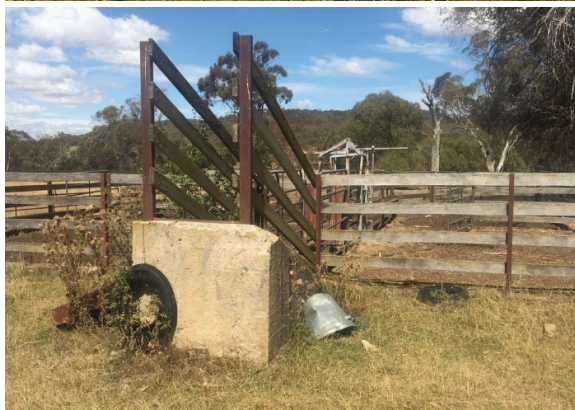
Rock Forest stockyard.

• Cattle / sheep dips at the stockyard?	No
• When was the stockyard built?	Late 1980's – these are the main stockyards
• Septic tanks?	No
• Properties (standing or demolished) build prior to the 1980's that may contain asbestos?	No
