## Snowy 2.0 External Agency Incident Notification Form

| Talbingo Wedgepit Material Placed in Pad 50 - SHL-ENV-INC-002 | |
| Site | Lobs Hole - Pad 50, Main Yard |

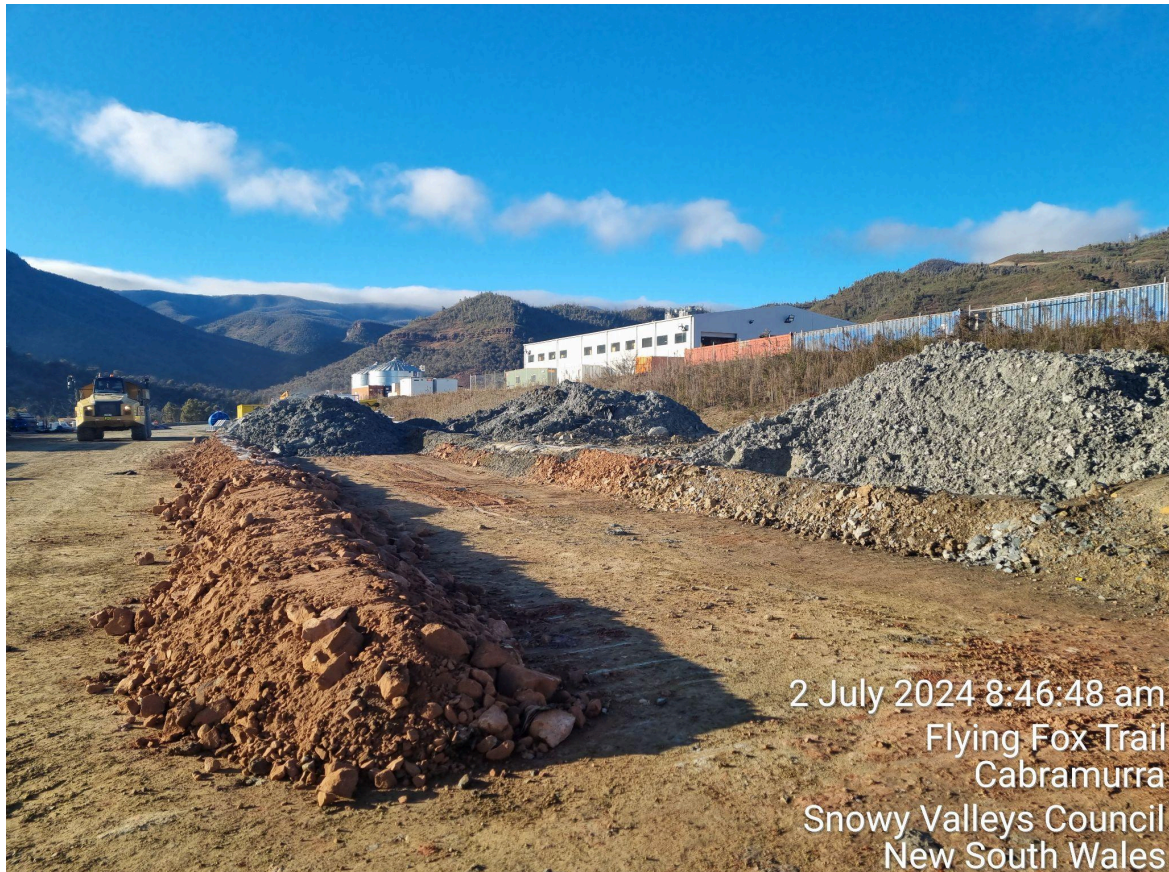
03/07/2024 - At the time of inspection, the FGJV Environment Team observed that solid spoil material blended with sludge was observed to be placed outside the bunded area.

- The earthen bunds featured above were constructed to control surface water flow

Remediation and Disposal: FGJV Construction Depart. to install/place adequate surface water controls to prevent potential runoff.

1. FGJV Spoil Manager followed up with ENM & GSW test results
2. FGJV Construction Depart. installed/placed adequate surface water controls to prevent potential runoff
3. FGJV Waste Superintendent organised waste evacuation receptacles for materials to be evacuated off-site.

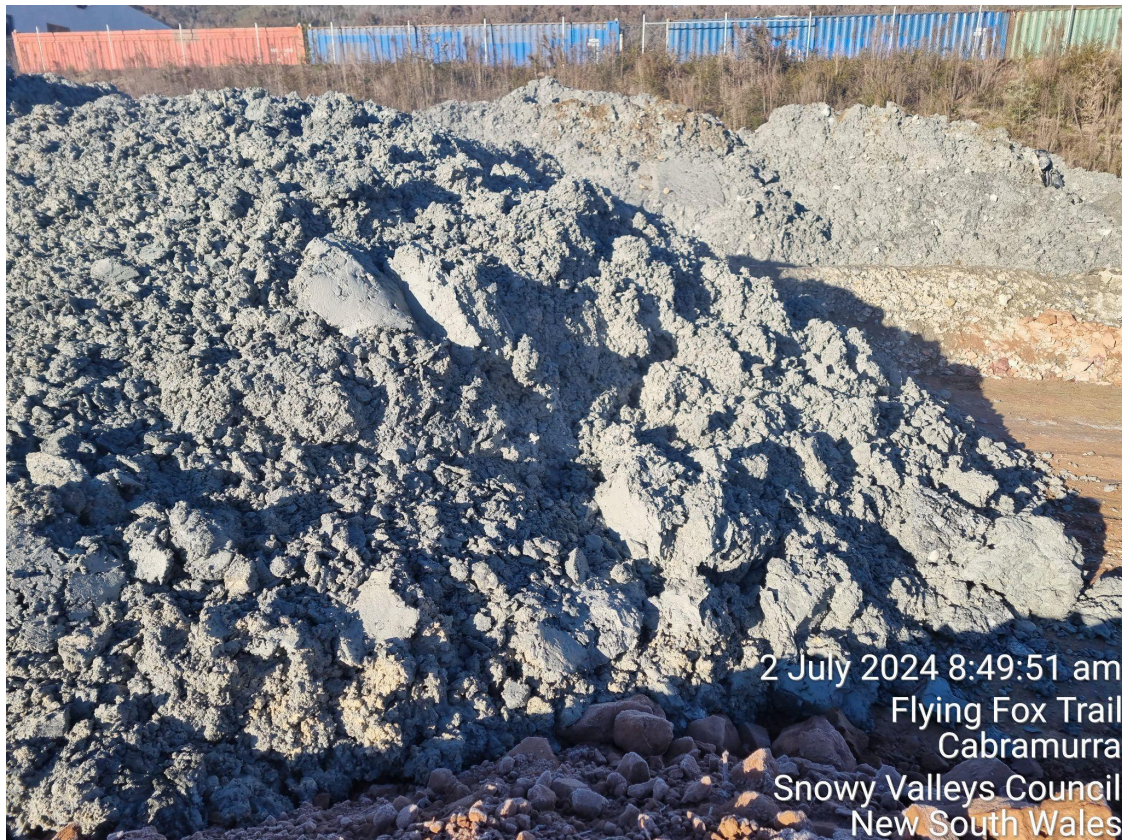
03/07/2024 - The unclassified mix of sludge material from the Talbingo wedge pit that was blended with Spoil Material was deposited at Pad50.

- The grey material is awaiting waste classification results prior to off-site disposal

1. FGJV Environment team to carry out pre & post-rainfall inspections to ensure no run-off from the material
2. Upon receipt of waste classification, material stored at Pad50 to be disposed appropriately offsite.
