## Snowy 2.0 External Agency Incident Notification Form

| Sediment laden water reporting to Yarrangobilly River at GF01 gully - SHL-ENV-INC-002 | |
| Date of Incident | 09/07/2024 |
| Site | Lobs Hole - GF01 gully |

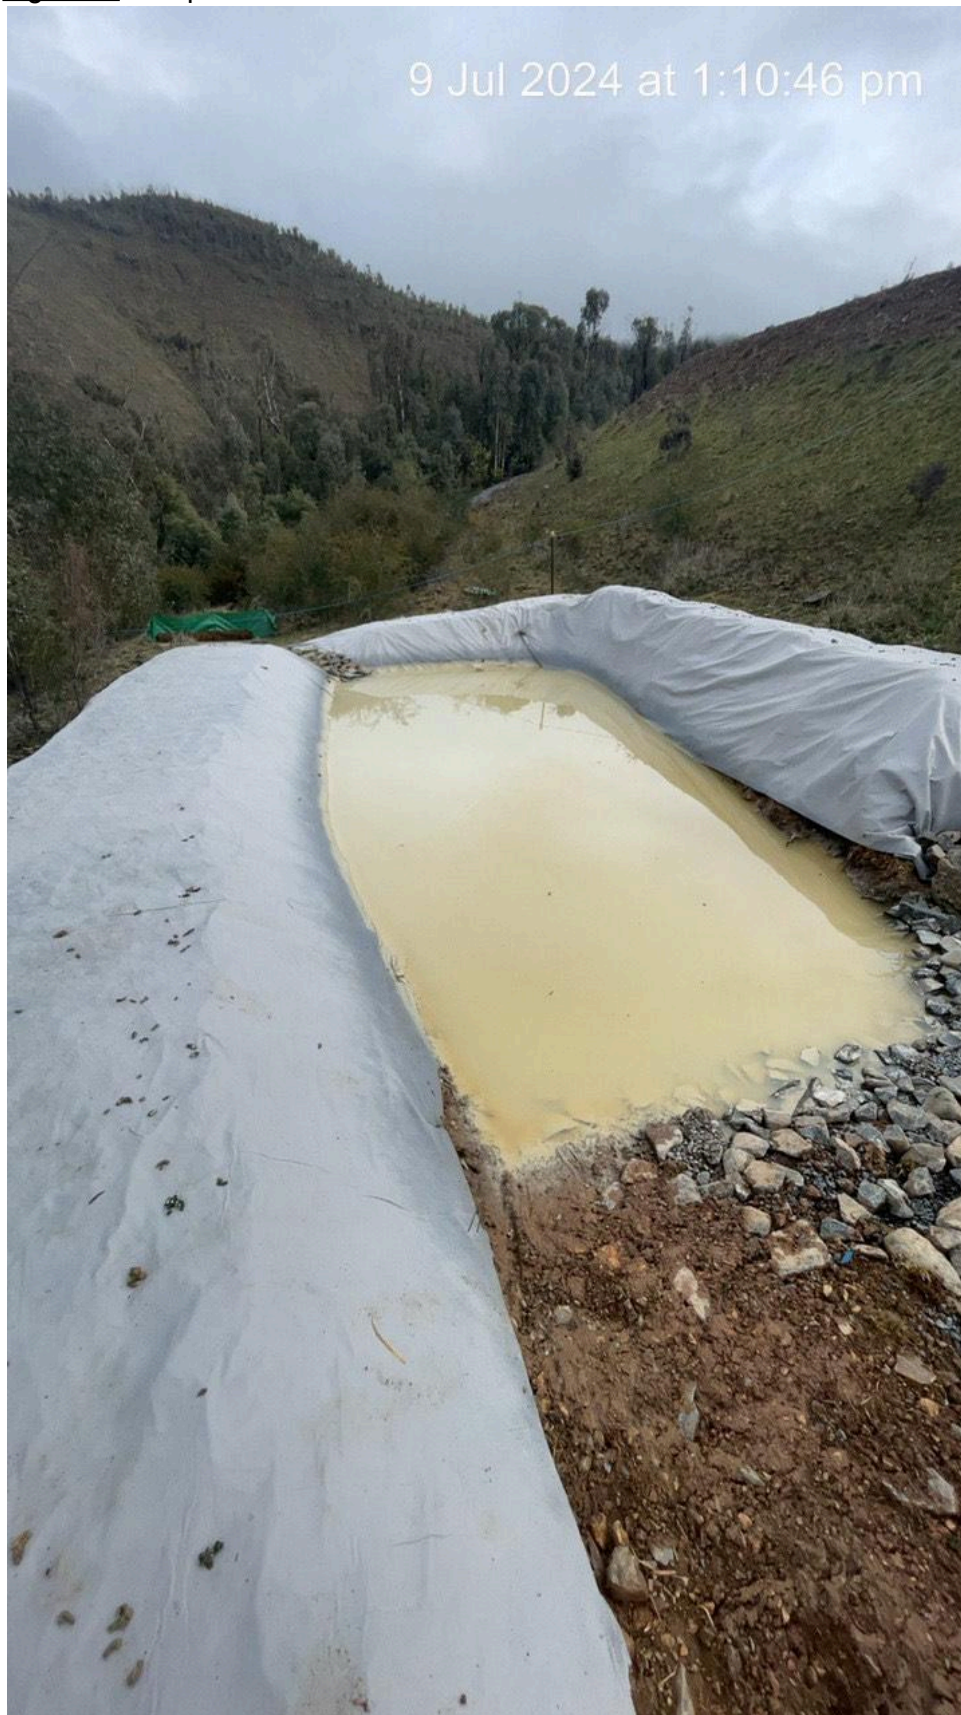
- On July 9, 2024, at approximately 12:40pm, during routine surface water sampling of EPL55B and EPL 55 Confluence the FGJV Environment team observed sediment laden water ingress into the Yarrangobilly River.
- Upon further investigation, it was observed that GF01 Gully Sump A was leaking into the natural gully, reporting to the Yarrangobilly River.
- The Lobs Hole weather station on July 9, 2024, recorded 13 mm of rain in the 24 hour period.

Figure 2: Sump A at the time of the incident.

- Water samples were collected at the sump, upstream (of confluence) and the mixing zone (EPL55 confluence). The downstream sampling location was inaccessible.
- Leed Engineering and Construction Pty Ltd were engaged to reconstruct the sump. Rectification works were completed on 13/07/2024.
- On 16/07/2024, during rainfall, the reconstructed sump was inspected and observed to be holding water. No signs of leakages were identified during the inspection.

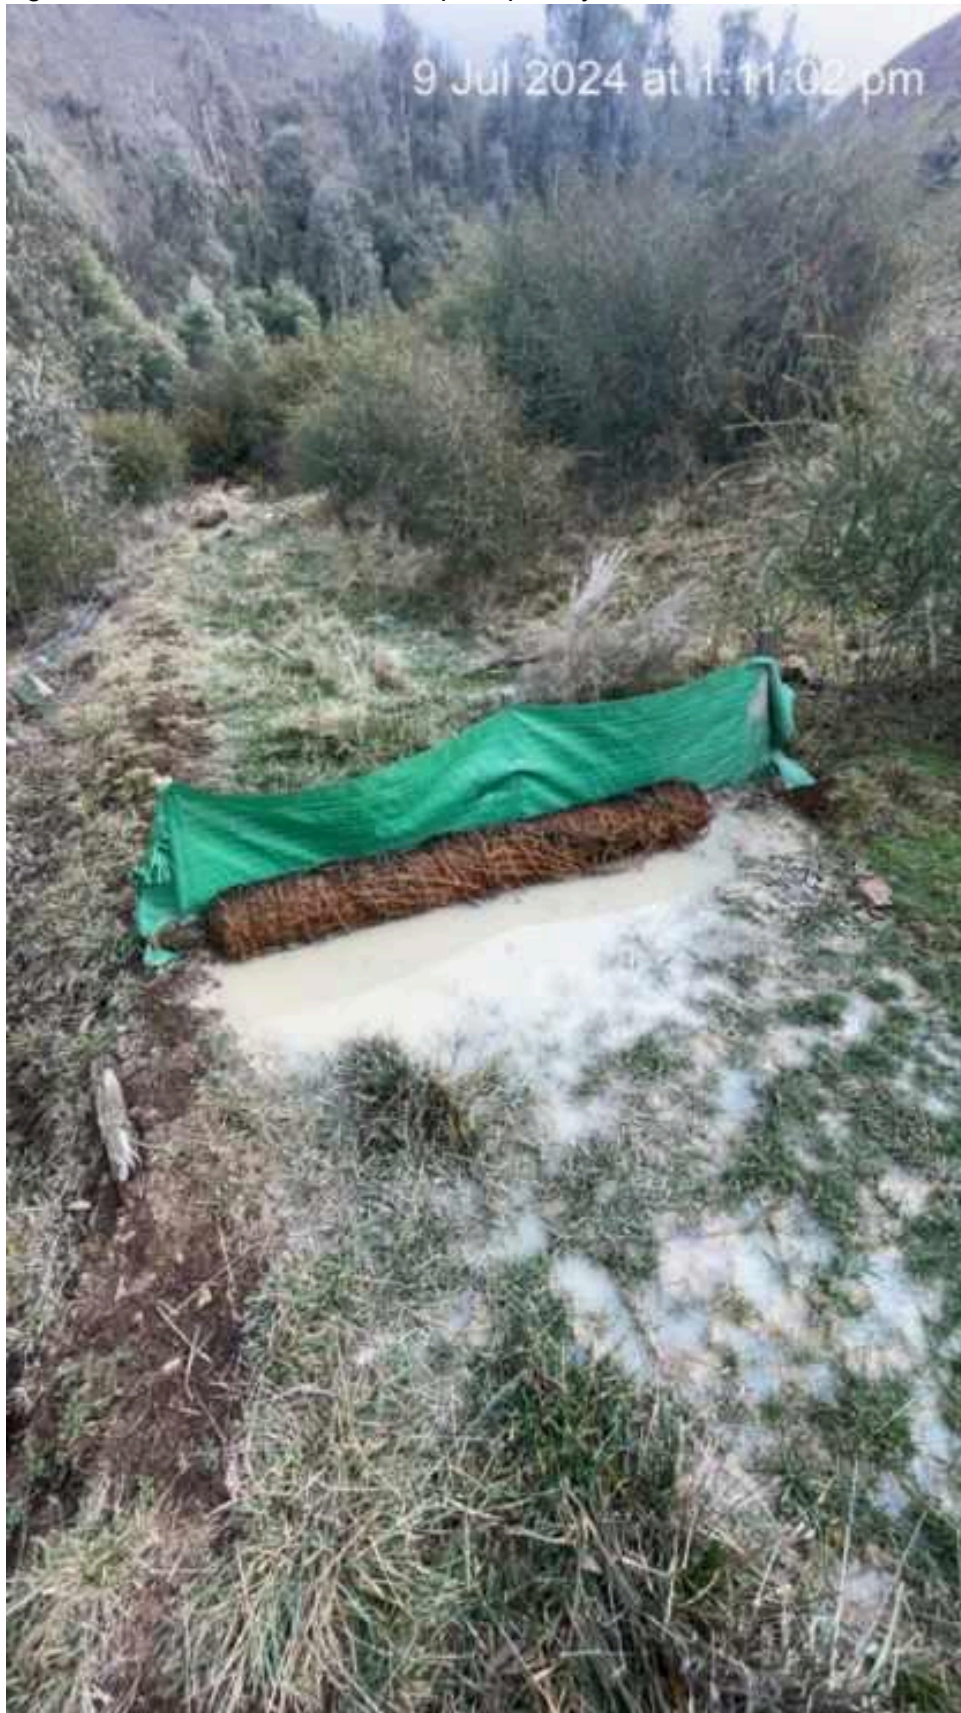
Figure 3: Downstream of the Sump A spillway

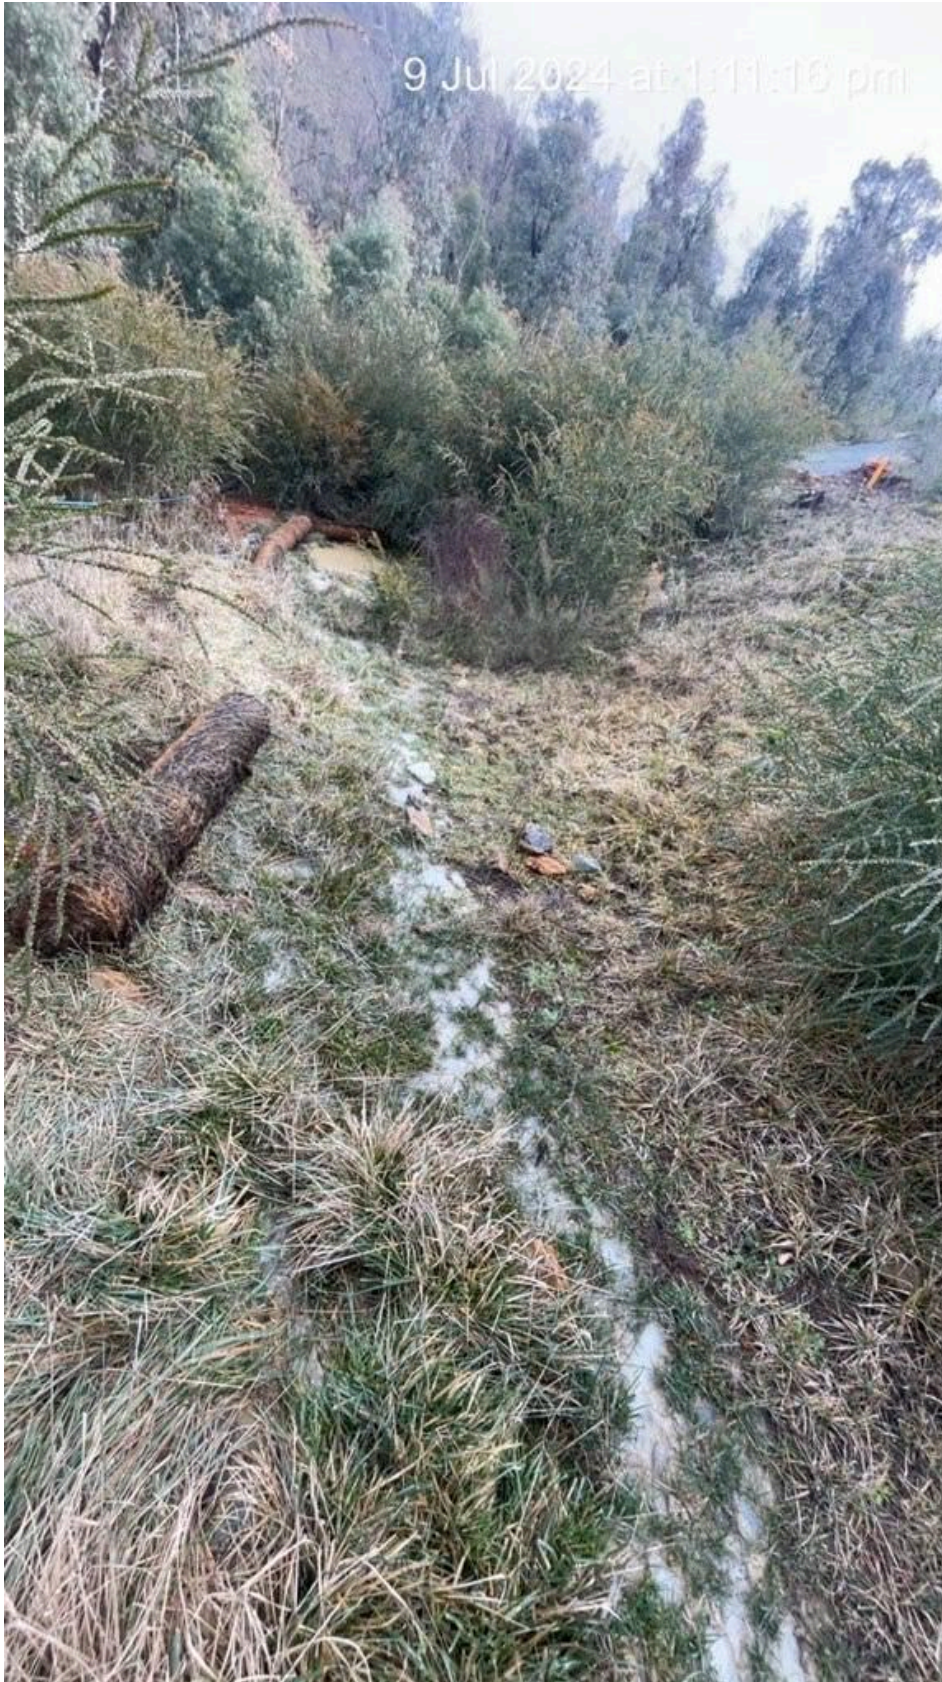
**Figure 4:** Downstream of Sump A spillway. Sediment laden water flowing into the natural gully.

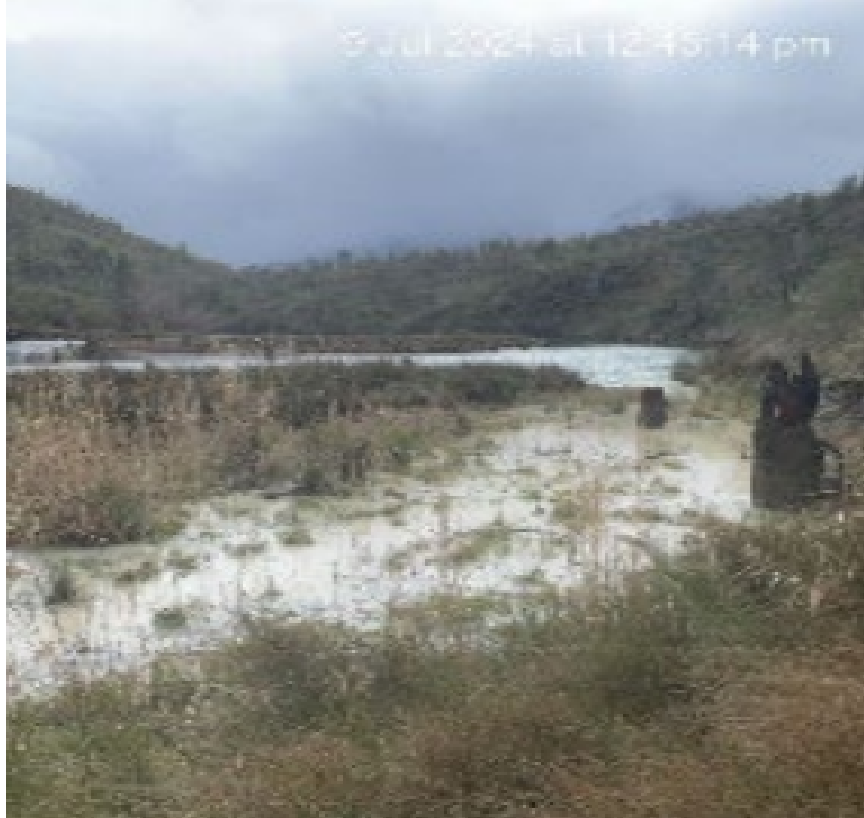
Figure 5: Mixing zone of Yarrangobilly River (EPL55 confluence) at the time of the incident.

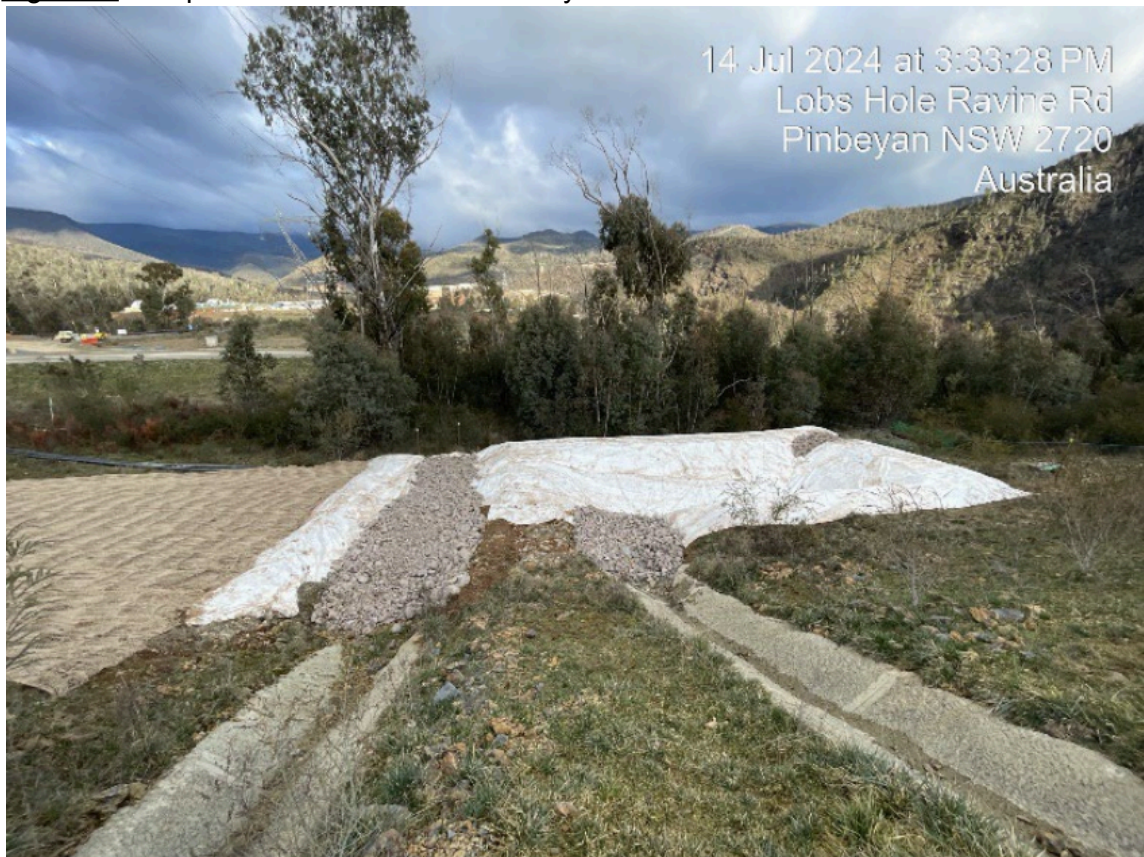
Figure 6: Sump A after rectification works by LEED contractor.

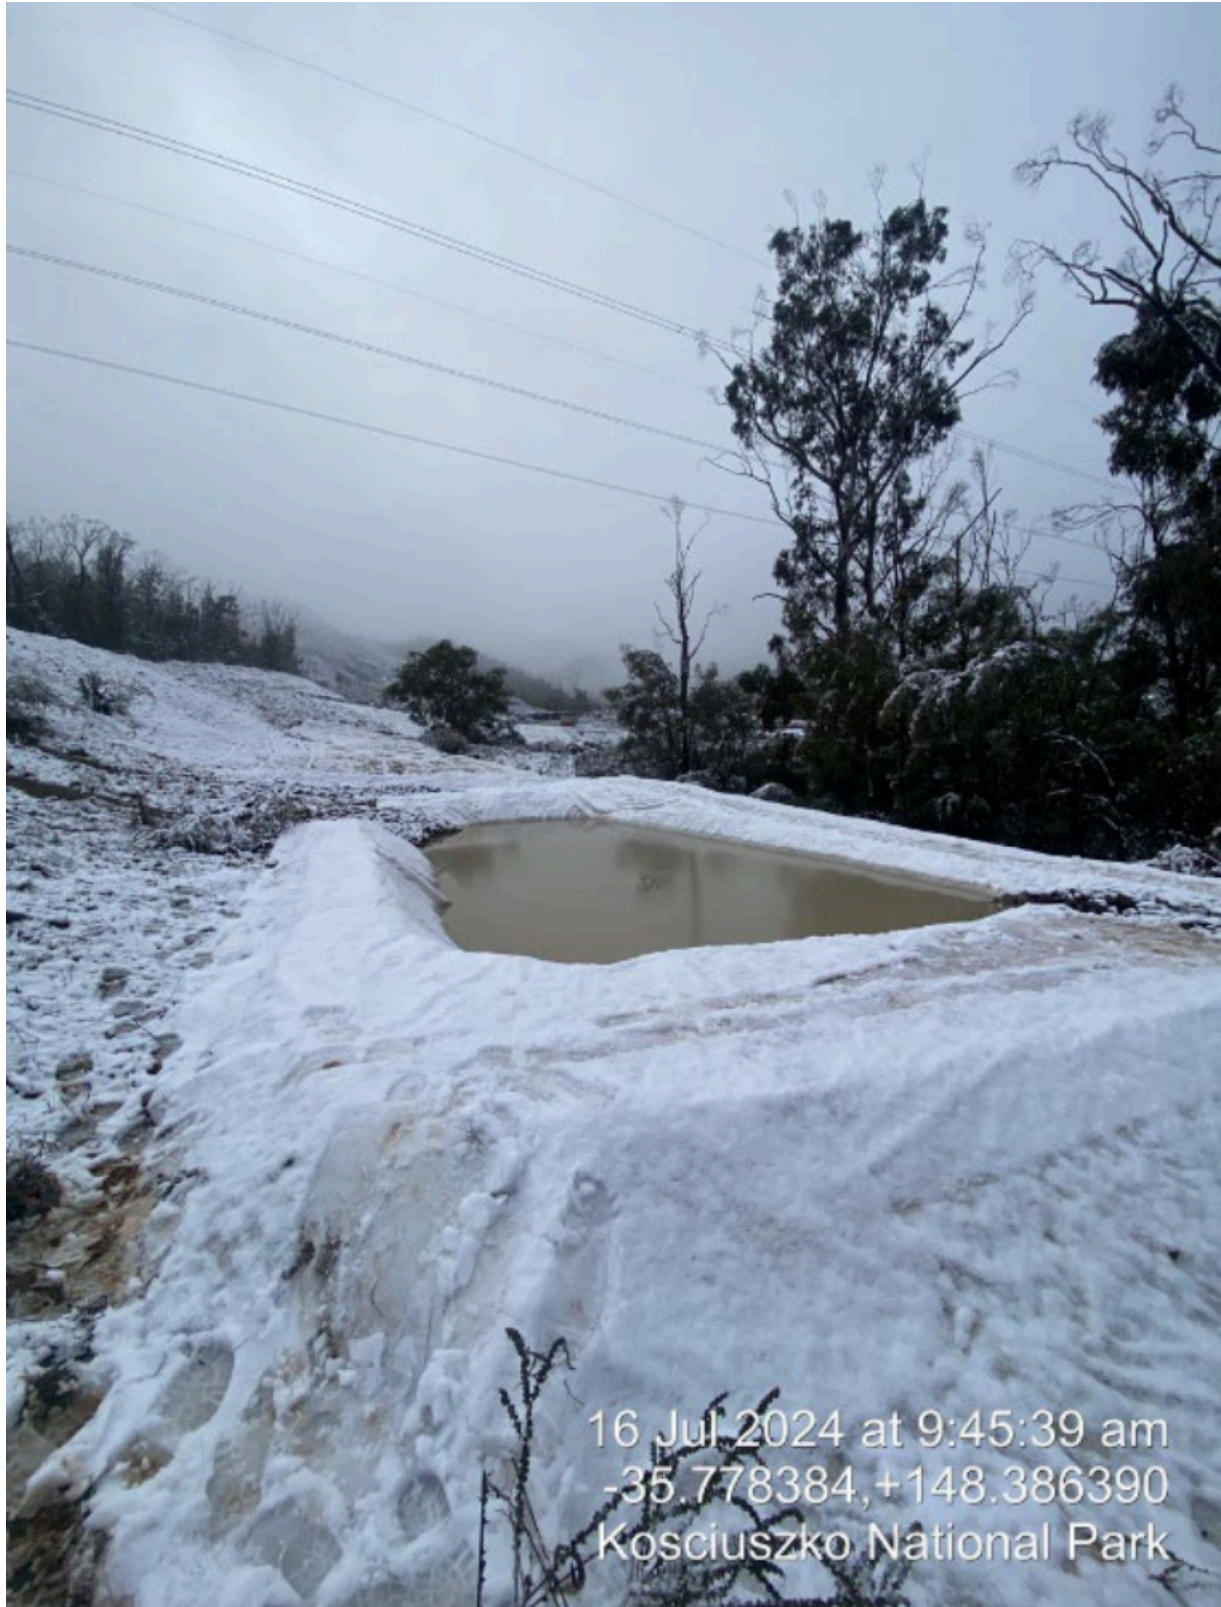
Figure 7: Sump A during rainfall after rectification works. No signs of leakages were identified during the inspection.
