## Snowy 2.0 External Agency Incident Notification Form

| Sediment-laden water entering Yahoo Gully from F10.5 basin - SHL-ENV-INC-003 | |

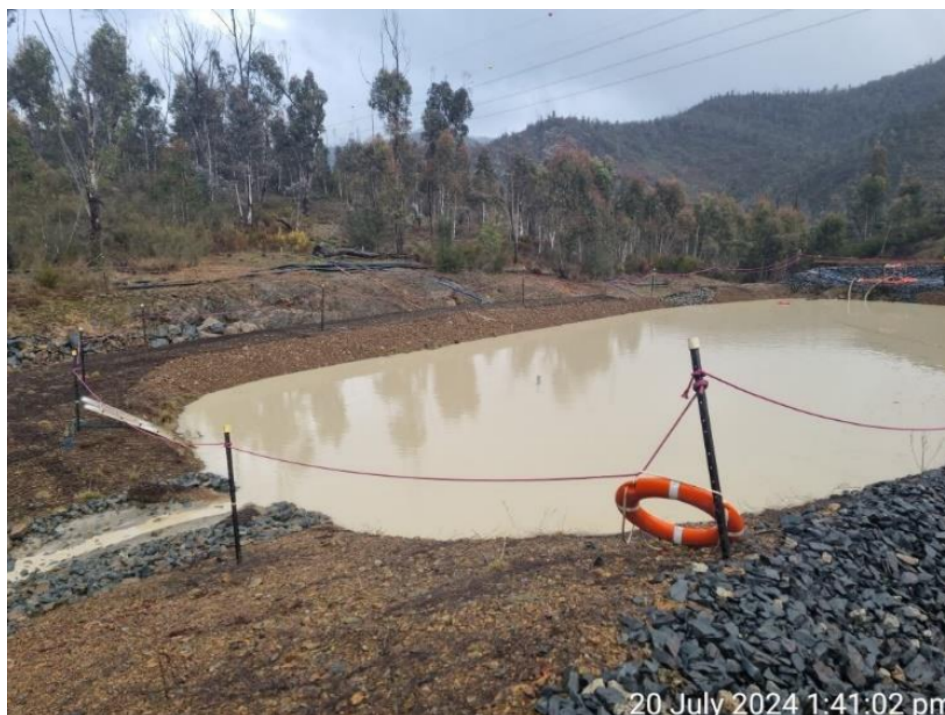
“Rain event commenced on 15/07/2024, with 53 mm of rain received in Lobs Hole from 11:00 on 15/07/2024 to 11:00 on 20/07/2024. As a result, F10.5 basin was receiving stormwater runoff from the haul road and was full. During an inspection, the SHL environmental assurance officer identified sediment laden water entering Yahoo Gully from F10.5 basin. By 16:30 when the environment team went to inspect the basin and incident sample, it was unclear if F10.5 basin was overtopping or if it was the suspected leak that was causing sediment laden water downstream at EPL24. Comprehensive and basic sampling was completed at F10.5 basin, upstream, downstream (EPL24) and the impact site.”

Figure 2: F10.5 basin full following rainfall on 20/07/2024

1. Construct watercart access into F10.5 basin and install a standpipe and pump.
2. Dewater F10.5 basin to assess leak and investigate options for repairs.
3. Comprehensive and basic water quality sampling was completed at F10.5 basin, upstream, downstream (EPL24) and the impact site.

1. Complete action from incident #114414 and #114732 - “De-water F10.5 basin and investigate options for water cart and standpipe access as well as a liner.”
2. Once dewatered, inspect the integrity of basin walls to identify leaks and organise to repair the basin.
3. Repair broken water carts and confirm delivery date of new water carts.”

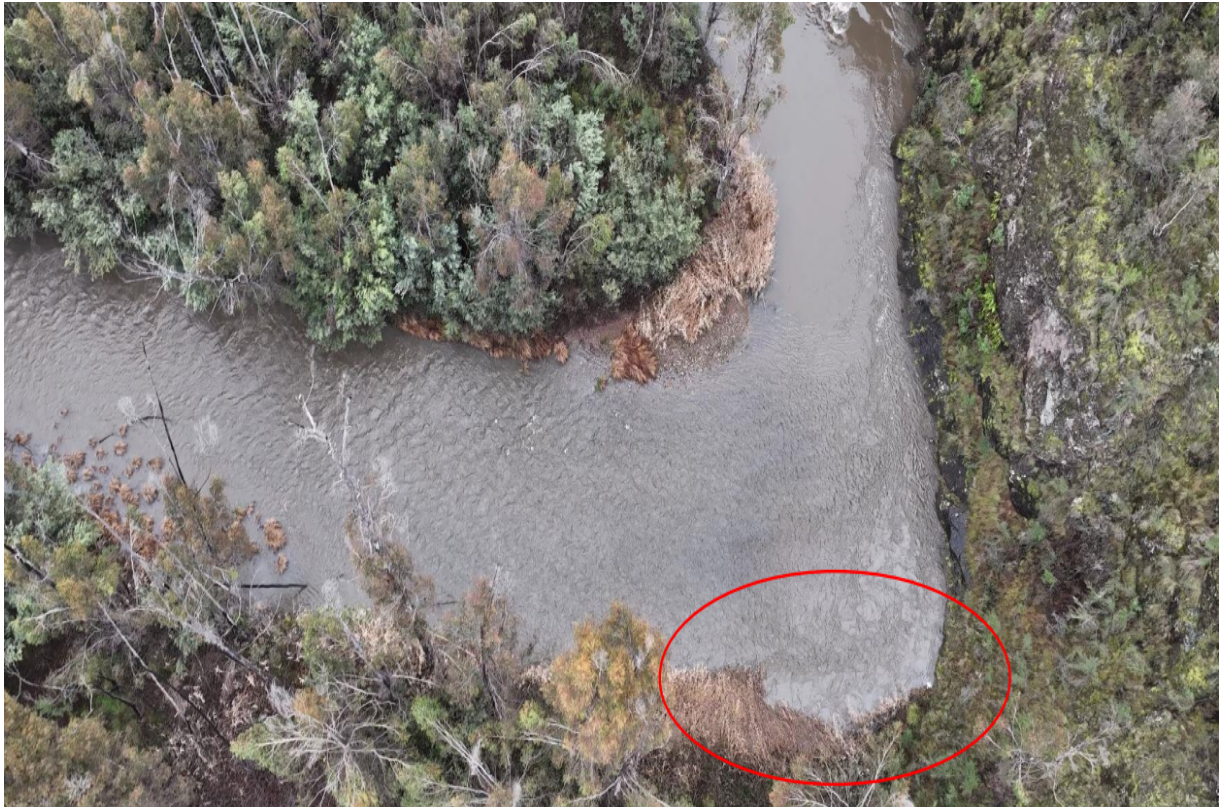
Figure 3: Yahoo Gully confluence into Yarrangobilly River on 21/07/2024.

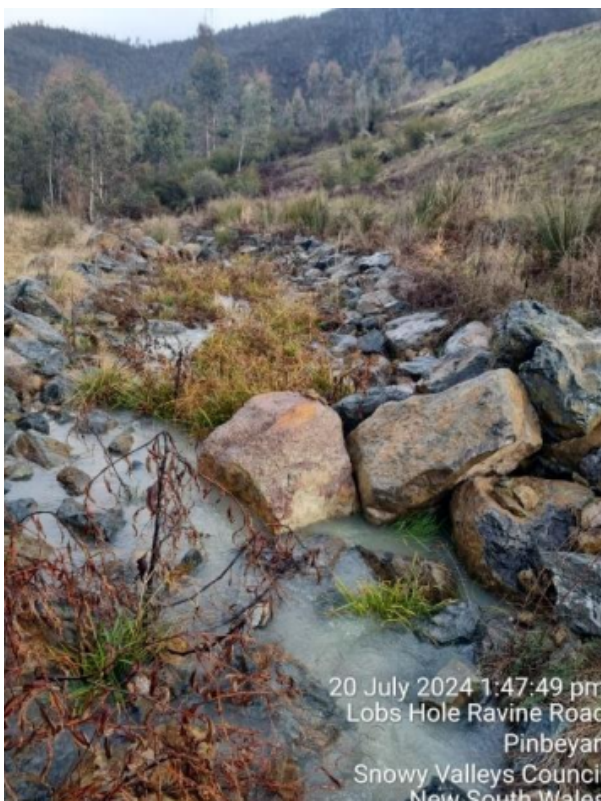
Figure 4: Sediment laden water observed downstream of F10.5 basin on 20/07/2024.
