# BOTANY RAIL DUPLICATION

Technical Report 5 –  
Contamination  
Assessment

Document No. BRD-G2S-CT-TPP-0001-05\_Contamination  
26 September 2019

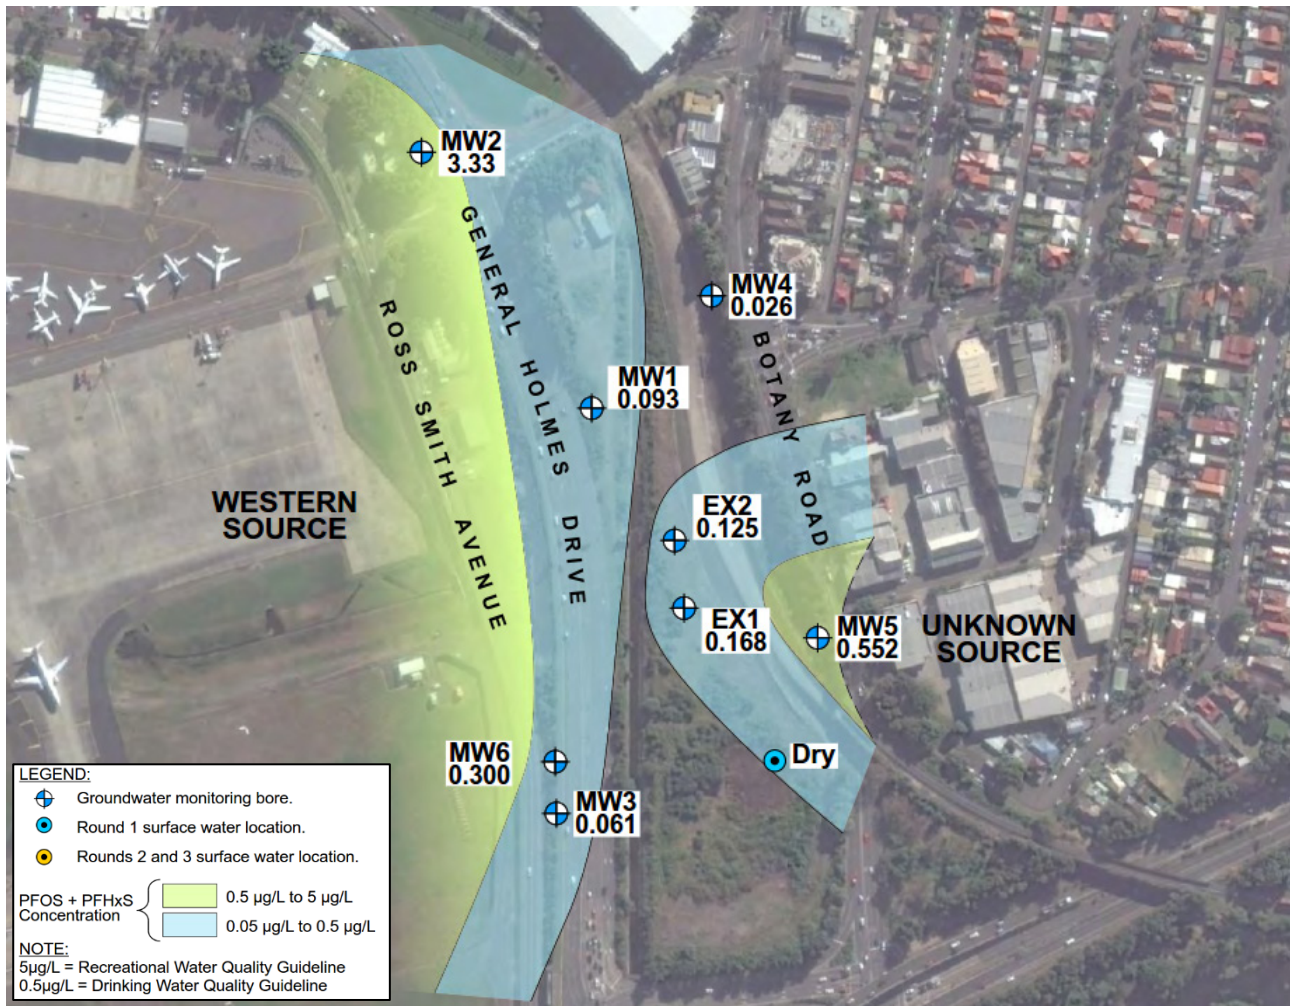
Figure 6.1 PFOS + PFHxS plume map (extract from Figure 4, EES (2018))

EES concluded that PFAS levels “recorded in groundwater monitoring bores MW2 and MW6 are believed to originate from a western source, while exceedances at monitoring bore MW5 possibly originate from an unknown likely industrial source to the east.” The extent of the PFAS plume for PFOS and perfluorohexane sulfonate (PFHxS) defined by EES is illustrated in Figure 6.1.

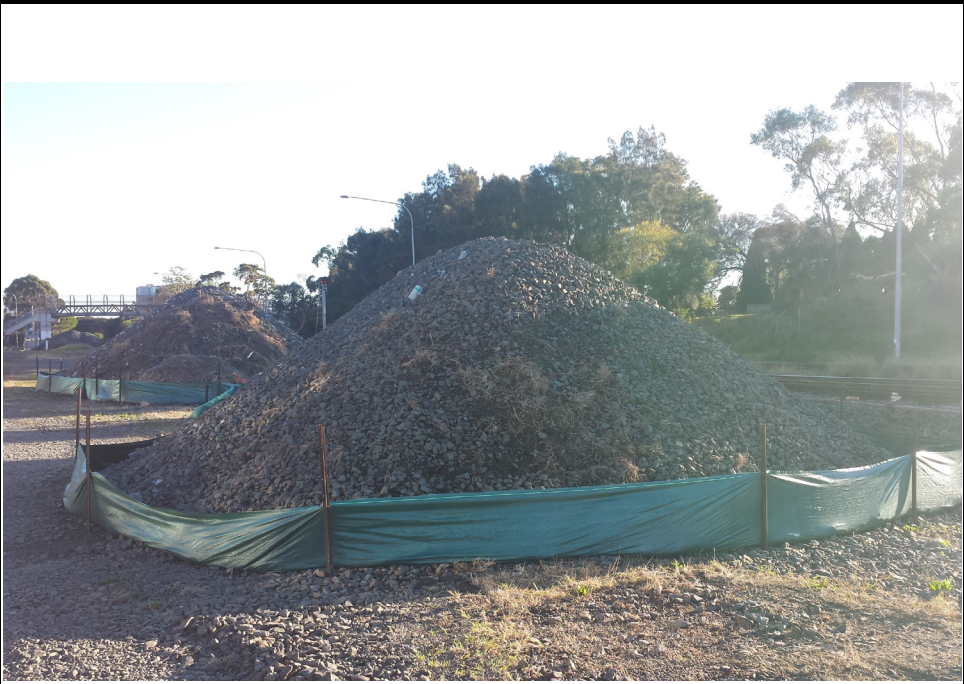
| Photo No. | Date | |
|---|---|---|
| 3 | 06.07.2018 | |

| Photo No. | Date | |
|---|---|---|
| <b>Description</b><br><br>Rail ballast stockpiles with organics and general debris throughout.<br><br>Chainage 9.800 km (approximate). | | |

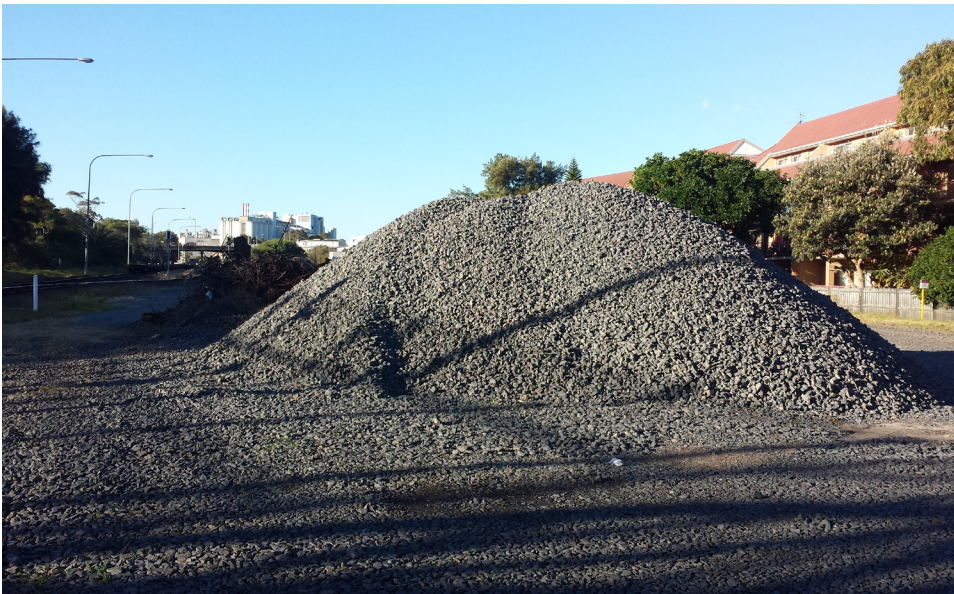
| Photo No. | Date | |
|---|---|---|
| 5 | 06.07.2018 | |

| Photo No. | Date | |
|---|---|---|
| <b>Description</b><br><br>Rail ballast and mixed vegetation stockpiles.<br><br>Chainage 9.900 km (approximate). | | |

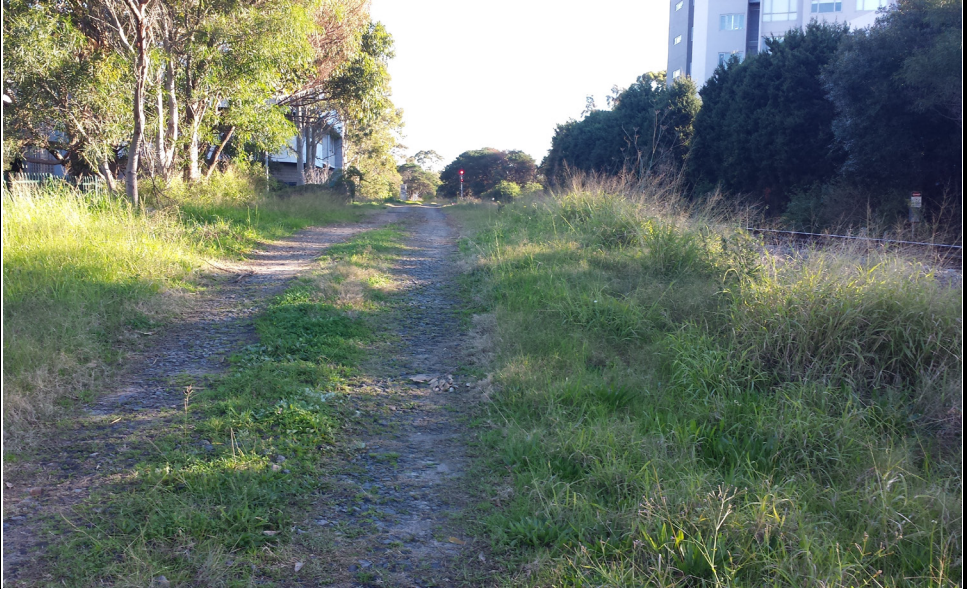
Ground level alterations via earthworks and filling was noted in several portions of Area 1. The access road along the rail corridor was noted to be about 1 metre higher than the train tracks between the area to the north of Banksia Street Pedestrian overpass and the overgrown area near Mill Stream Bridge (Photographs 8 and 9). The ground levels were about the same for the access road and train tracks between the Stephen Road Bridge and Banksia Street pedestrian overpass. However, in the vicinity of the rail sleeper area, ground levels were lower along the western fence line than along the main access road or tracks (Photograph 2).

| Photo No. | Date | |
|---|---|---|
| <b>Description</b><br><br>Roadway alongside the rail tracks elevated from natural slope of land/surrounds by approximately 1 m, indicating the presence of fill material.<br><br>Chainage 10.100 km (approximate). | | |

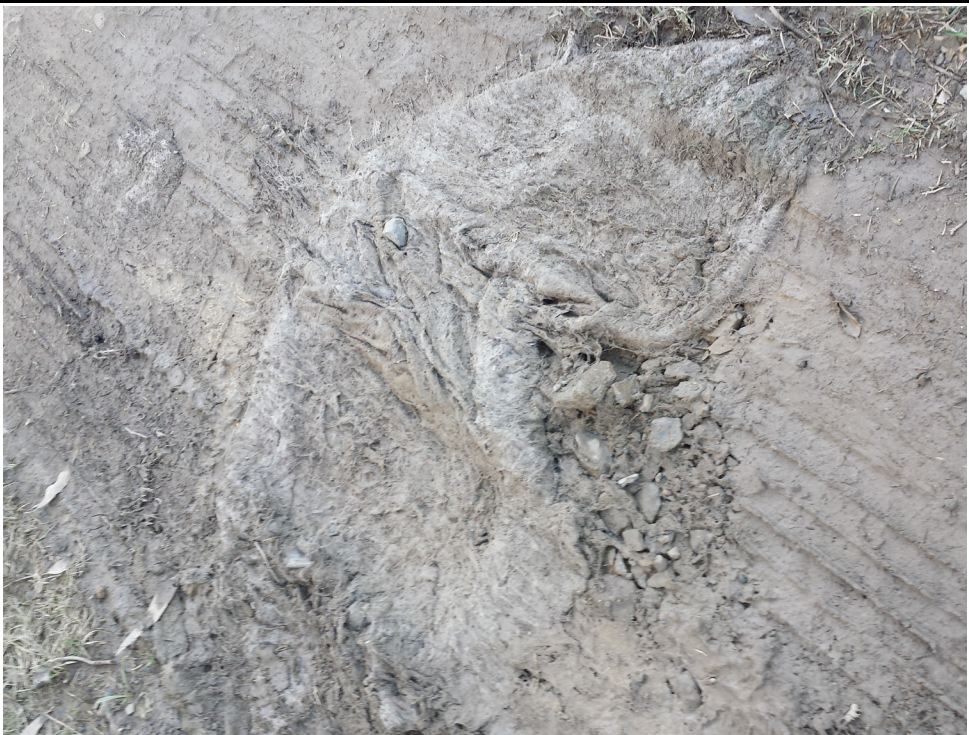
| Photo No. | Date | |
|---|---|---|
| 9 | 06.07.2018 | |

Signage indicating the presence of asbestos along the rail corridor was present at multiple locations. No ACM fragments were observed in the raised roadway but exposed geofabric was observed in several areas (Photograph 9). Anecdotal evidence provided by ADE (email dated 31 March 2016) identified that an “emu pick” involving the systematic manual collection of asbestos surface fragments had been conducted previously in the eastern portion of the area to remove ACM fragments from the site surface. Slightly overgrown vegetation was observed along most of the raised roadway. The northern portion of Area 1 (near and to the west of Mill Pond Bridge) could not be accessed due to overgrown vegetation. In addition, the access bridge was too narrow to be crossed.

| Photo No. | Date | |
|---|---|---|
| <b>Description</b><br><br>Exposed geofabric layer observed in multiple areas along the roadway surface. Strong indicator of the presence of fill material in the elevated roadway. | | |

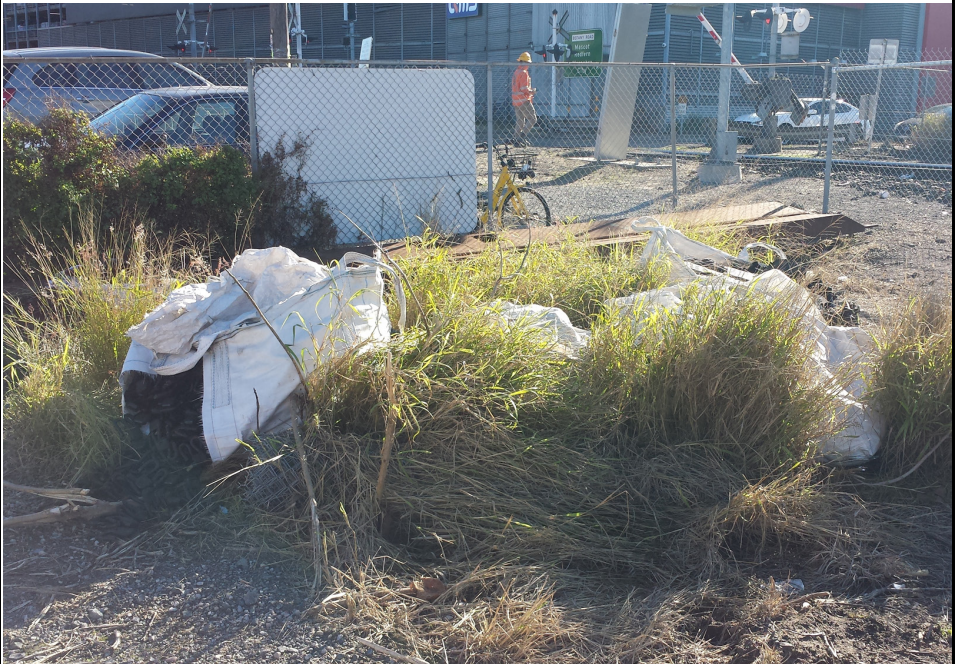
| Photo No. | Date | |
|---|---|---|
| 2 | 06.07.2018 | |

| Photo No. | Date | |
|---|---|---|
| <b>Description</b><br><br>General debris observed east of the General Holmes Drive level crossing<br><br>Chainage 11.735 km (approximate). | | |

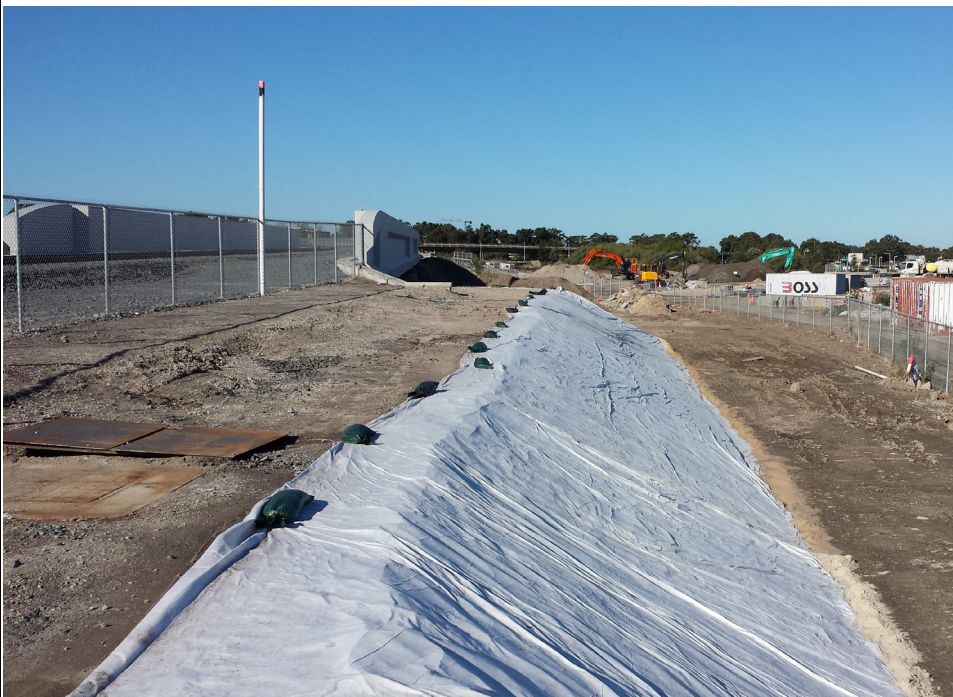
The southern portion of Area 2 (from Southern Cross Drive to the intersection between Botany Road and Wentworth Avenue) could not be accessed. In addition, the rail corridor area between Botany Road Bridge and the intersection between Botany Road and Wentworth Avenue is currently a construction site. The construction site could not be accessed but it was noted that earthworks were being undertaken in the area (Photograph 3).

| Photo No. | Date | |
|---|---|---|
| <b>Description</b><br><br>Significant earthworks observed in this area associated with the large scale construction site (John Holland).<br><br>Unauthorised to proceed beyond this point due to narrow culvert/bridge.<br><br>Chainage 11.600 km (approximate). | | |
