Proposed Carpark – New Maitland Hospital Preliminary Geotechnical Investigation

Metford Road, Metford

NEW18P-0242A-AA 6 February 2019

RE: PROPOSED CARPARK – NEW MAITLAND HOSPITAL – METFORD ROAD, METFORD PRELIMINARY GEOTECHNICAL INVESTIGATION & TESTING

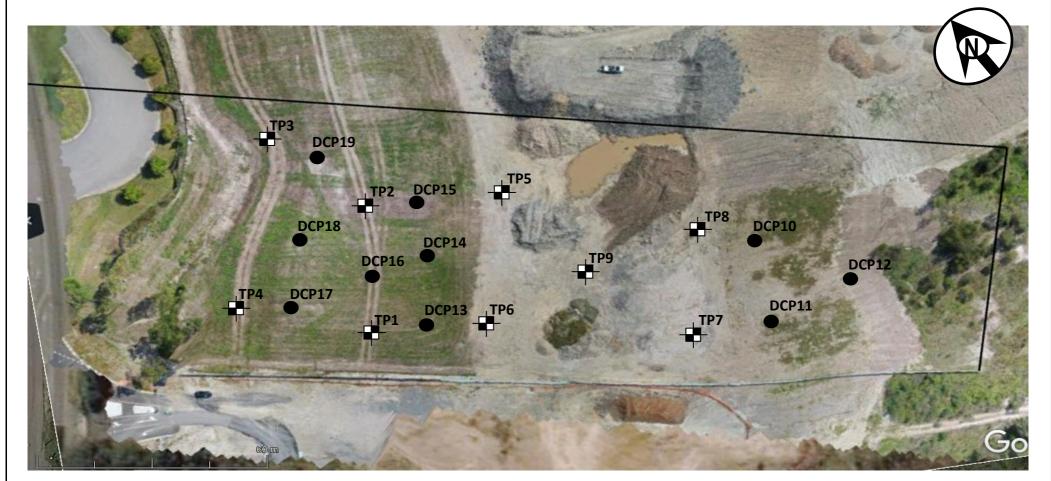
Figure AA1 – Site Plan and Approximate Test Locations

Approximate test pit locations are shown on the attached Figure AA1.
