## ATTACHMENT 1 — REPORTED DAMAGE CASES

### ROSE BAY REPORTS

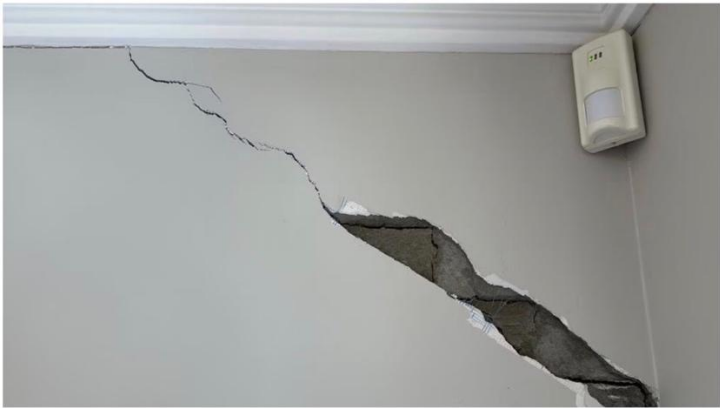
| STREET | DESCRIPTION OF REPORTED IMPACT |
|---|---|
| HAMILTON STREET<br>(MULTIPLE HOMES) | <p>Severe structural cracking reported in several homes following deep basement excavation at the Old South Head Road corner.</p> <p>Cracks which developed in a home 200 metres away from a construction site in Rose Bay, which the resident claims are linked to excavation. Picture: Rose Bay Residents Action Group</p> |

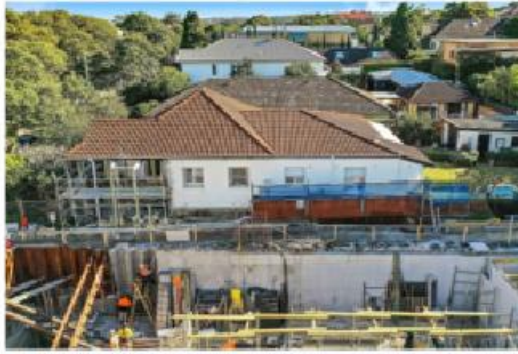
| STREET | DESCRIPTION OF REPORTED IMPACT |
|---|---|
| WILBERFORCE AVENUE | Partial collapse of a house beside development whilst excavating single storey basement; structure needed to be demolished. See picture c2022 |

The front rooms of a house next to a development site on Wilberforce Avenue in Rose Bay caved after the excavation of a single storey. Ray White

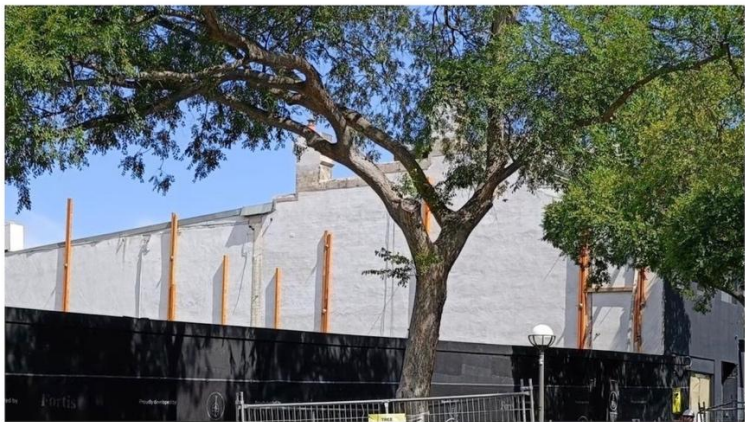
| STREET | DESCRIPTION OF REPORTED IMPACT |
|---|---|
| BAY STREET | <p>Reports that work halted after major cracking (up to ~10 cm) and wall movement in adjoining property from excavation works; residents evacuated, building braced (see image). Community reports suggest possible demolition of a building due to extent of impacts</p> <p>- c2025</p> <p>A business in Double Bay was forced to relocate due to cracks that appeared after construction next door, with the building now held up by piles. Picture: NewsLocal</p> |
