Catherine fields Community Road Safety Audit/ Review

Report

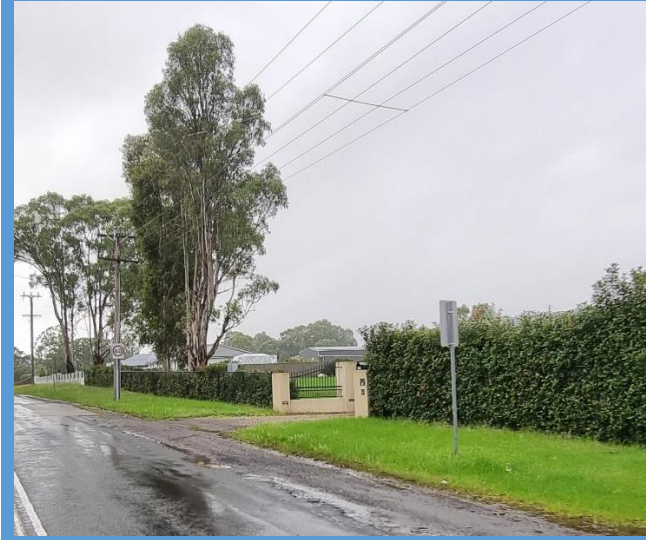
Risk: Speed Zone changes

<p>Vehicles travelling north-west/ south-east may continue to travel at speeds more than 60km/h on approach to and through the proposed location given the close proximity to the speed zone change. This increases the likelihood of crashes occurring. Vehicles were observed to be exceeding the 60km/h speed limit through this location during the site inspection</p> <p>The picture shows the street sign, travelling southeast. The sign is atypical of the street scape with no lighting. The typical speeds in this area were observed to be greater than the signposted 60kmph</p>	Risk
		High

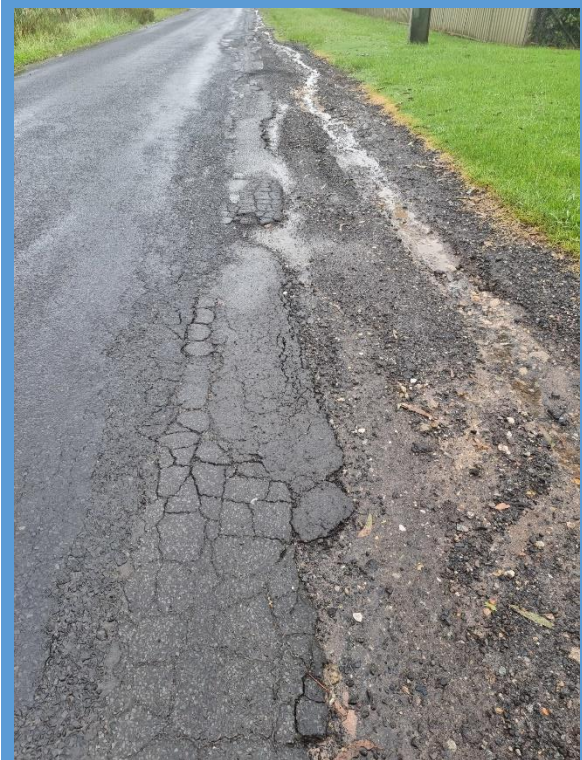
Risk: no constructed shoulders to support road safety outcomes

<p>There are no constructed shoulders on the roads. This means there is no clear delineations. This is exacerbated by no line marking, and no street lighting. This impacts the overall safety through the corridor. Notably this impacts any pedestrians and cyclists, where there are no safe access paths along the corridors. There are also no safe bus stops to support safe transportation of students via bus operations. If there is not a significant corridor upgrade, any increase to pedestrians along the corridor and the increase in vehicular movements will create a higher risk environment</p>	Risk:
		High

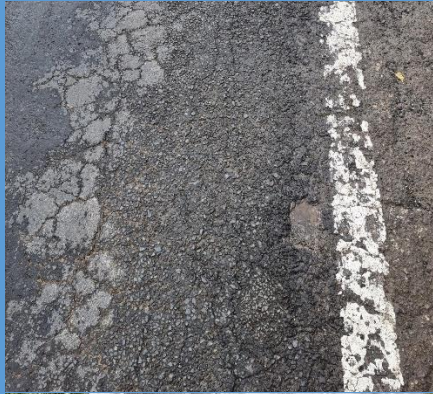
There are poor road conditions on all corridors, including potholes and very poorly constructed temporary hot and cold mix patches across a large percentage of the corridor. These features create hazards for motorists and increase the risk of traffic incidents, vehicle wear and tear and present significant challenges relating to interface risks with pedestrians and motorists.

Photo 1- 10cm depression, divet in road surface. Indicative of type of condition over 60% of the road/ corridor

Risk:
High

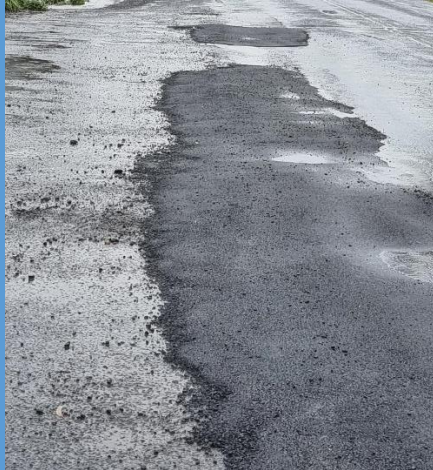
Photo 2- Example of potholes and poor line delineation of the road surface. The pothole is 15cm by 8 cm, and 3 cm deep. This is indicative of potholes across the corridor

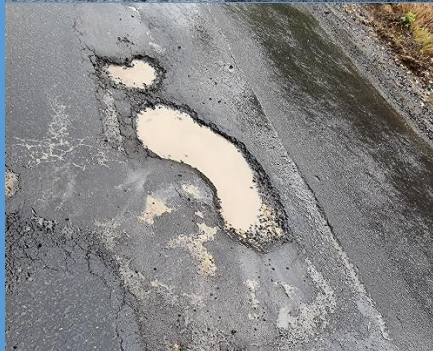
Photo 3- Example of patchwork hot/cold mix applied to surface. This creates a 24-hour fix, but otherwise presents a hazard and the mix mis forms due to heavy wear and tear. This picture is also indicative of road flooding in weather events.

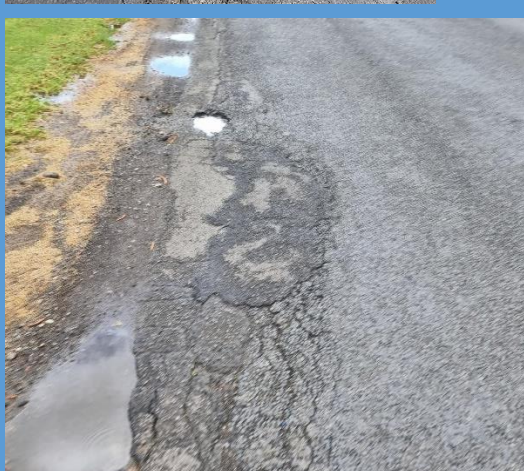
Photo 4- Example of potholes, wear and tear and poor line marking and edge protections for motorists

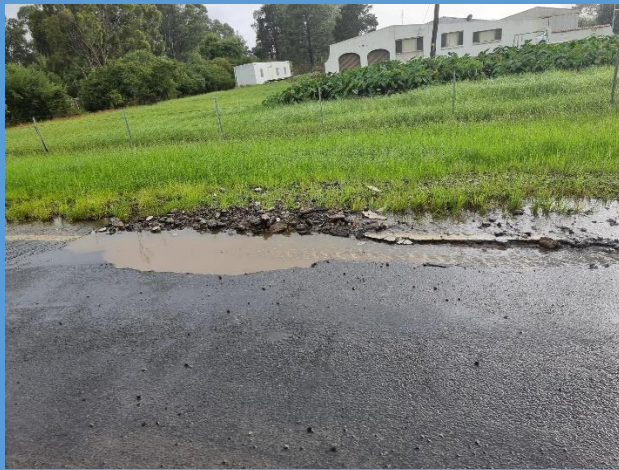
Risk: lean mix sub-base concrete comprehensive strengths, geometry

There have been no major road upgrades or full-scale resurfacing works on this corridor in the last 15 years excepting the 1km from the Camden Valley way to the temporary roundabout along Springfield Road. The normal pavement life is 10 years when constructed effectively. Based on inspections of the site, and the patchwork of repairs, the structural integrity of the pavement is not ideal. The practice of use of cold and hot mix patch repairs has delivered no outcomes, and the warping of this surface in most cases presents significant hazards for motorists in this environment. A higher volume of traffic will enhance this risk

Risk:
High

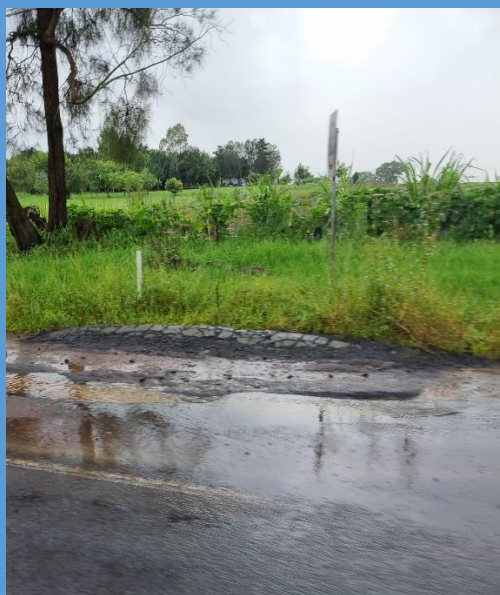
Risk: Lack of culverts structures

There are currently no culverts under or adjacent to the current road structures along the corridor like embankments or natural subterranean channels. There is also no sewerage pipes and other infrastructure. As the properties in the area are semi-rural as are the roads, any further large-scale developments will require significant considerations to upgrade the corridor structures. The impacts to road safety are direct impact to road flooding. Road flooding occurs regularly with any rains due to lack of infrastructure. This impacts the risk rating of the road and impacts safe thoroughfare. With current volumes it is somewhat managed but any increased volumes in the area will continue to increase risk exposure.

The pictures embedded reflect significant flooding in the corridor after rains and also are pictorial representations of the problem with cold mix solutions being applied instead of effective pavement repairs

Risk:
High

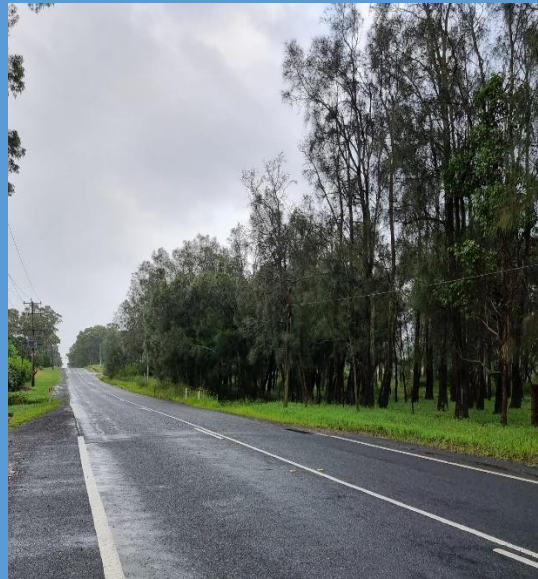
Risk: Crest vertical curve in the immediate proximity of the school location restricting site distances

Immediately adjacent to the proposed school location is a crest curve that is a danger when considering any changes traffic conditions in this area. The line of sight is restricted from the bottom of the crest to under 200mtr. Any banked traffic or slowed movements in this area will create an end of queue accident risk. This is further informed by nil pedestrian and cycle paths which would enhance the risk to this group if there were no significant upgrades to separate traffic movements. This is impacted further by the lack of edge protection, poor line marking and poor conditions of the roadway along the corridor.

Risk:
High

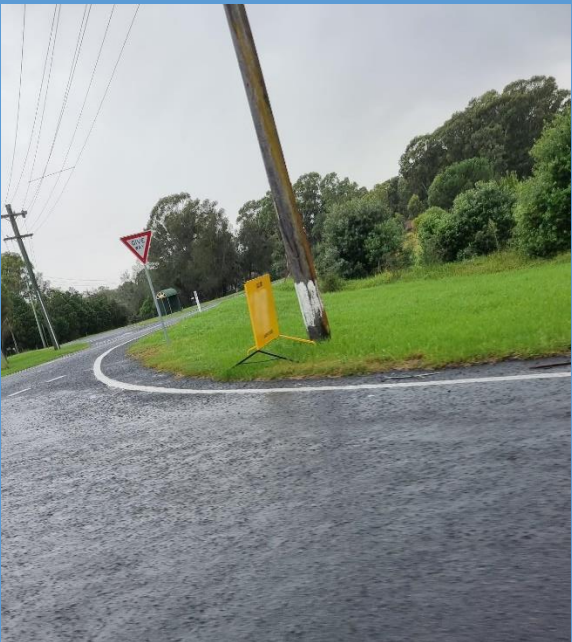
Risk: Inter-section safety- Poor line of site Catherine fields road/ Deep fields road

<p>The inter-sections in the area will be expected to have increased traffic movements. In particular there is a risk at the current major Catherine fields and Deep fields road inter-section for major changes to traffic movements. There is already a significant risk due to lack of visibility and high-speed road movements. Any further traffic bank ups will case significant end of queuing incidents at the point of turning. This is the case for traffic turning right into Catherine fields road from Deepfields road, but also queuing at Catherine fields in the lead up to the intersection which in less than 100 metres from a 65% bend.</p> <p>The picture here represents a driver view on the exit of Catherine fields road. There is limited line of sight in the right-hand direction</p>	
		Risk: High
