## **CULLEN VALLEY MINE ANNUAL REVIEW**

1 January – 31 December 2020

March 2021

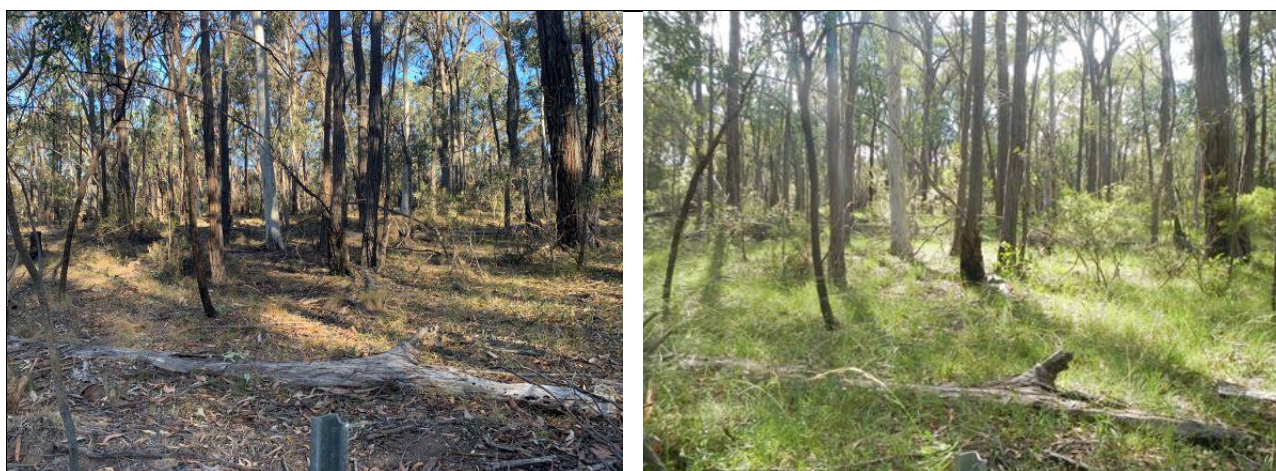
**Plate 6.2** Condition of CHA monitoring location CH6 (Left - 2019; Right - 2020)

Native vegetation within the Compensatory Habitat Areas was considered to be in good condition across all woodland and forest habitats however it was found to be affected by previous drought conditions. Monitoring in 2020 recorded a significant increase in the overall floristic composition and vegetation condition for most Compensatory Habitat Area monitoring locations compared to monitoring in 2019. Woodland and forest habitats demonstrated substantial increase in the vegetative cover throughout the ground stratum (**Plate 6.2**), whereas foliage cover in the canopy while the midstory strata was generally sparse and continues to recover following the drought. In 2020 bare earth was infrequently observed across all Compensatory Habitat Area monitoring locations. Where ground layer vegetation was present an increase in native species diversity was observed, compared to 2019. The vegetation of the Compensatory Habitat Areas demonstrates minimal degradation due to human influences with the exception of vehicle tracks, minor logging and rubbish dumping by others. Given the above information, no flora management activities are recommended at this time. While the 2020 monitoring observed increased cover and abundance of native species it should be noted that the cover and abundance of these species is expected to decrease slightly in subsequent monitoring events as is typical of native flora species following a period of increased growth after a drought.

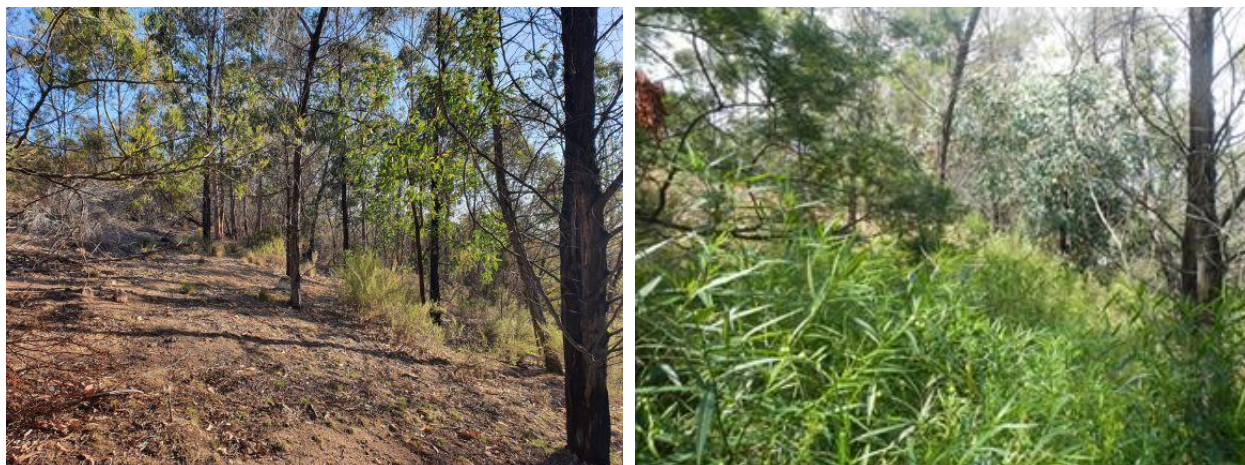
**Plate 6.4** Condition of CVM Rehabilitation Monitoring Location FP6 (Left – 2019; Right – 2020)

During the 2020 monitoring, a significant increase of vegetative cover was observed within the ground strata of the monitoring sites within the Rehabilitation Zones. This is a marked difference to the low ground cover recorded in 2019 indicating that the vegetation within the Rehabilitation Zones is recovering post-drought (**Plate 6.4**). The middle and upper strata within the Rehabilitation Zones continued to show some form of dieback, likely due to the drought and natural senescence of acacia in particular. However, it is expected that the species within these strata will continue to recover over time. Encouragingly, the presence of the mycorrhizal orchid species (*Calochilus sp.*) recorded at monitoring site R1 is an indication of ecosystem functionality of the Rehabilitation Zones. Approximately 10 mycorrhizal orchids were recorded during the 2020 surveys whereas no records were observed in 2019 and only one record observed in 2018.

In 2020 evidence of improved ecosystem functionality and developing habitat features was found in most monitoring sites of the CVM Rehabilitation Zones. This has assisted with maintaining the midstory and canopy species as they establish and assisted to develop landscape function. Salvaged woody debris was commonly recorded in younger areas of rehabilitation, however the production of leaf litter and woody debris as a natural process was limited.

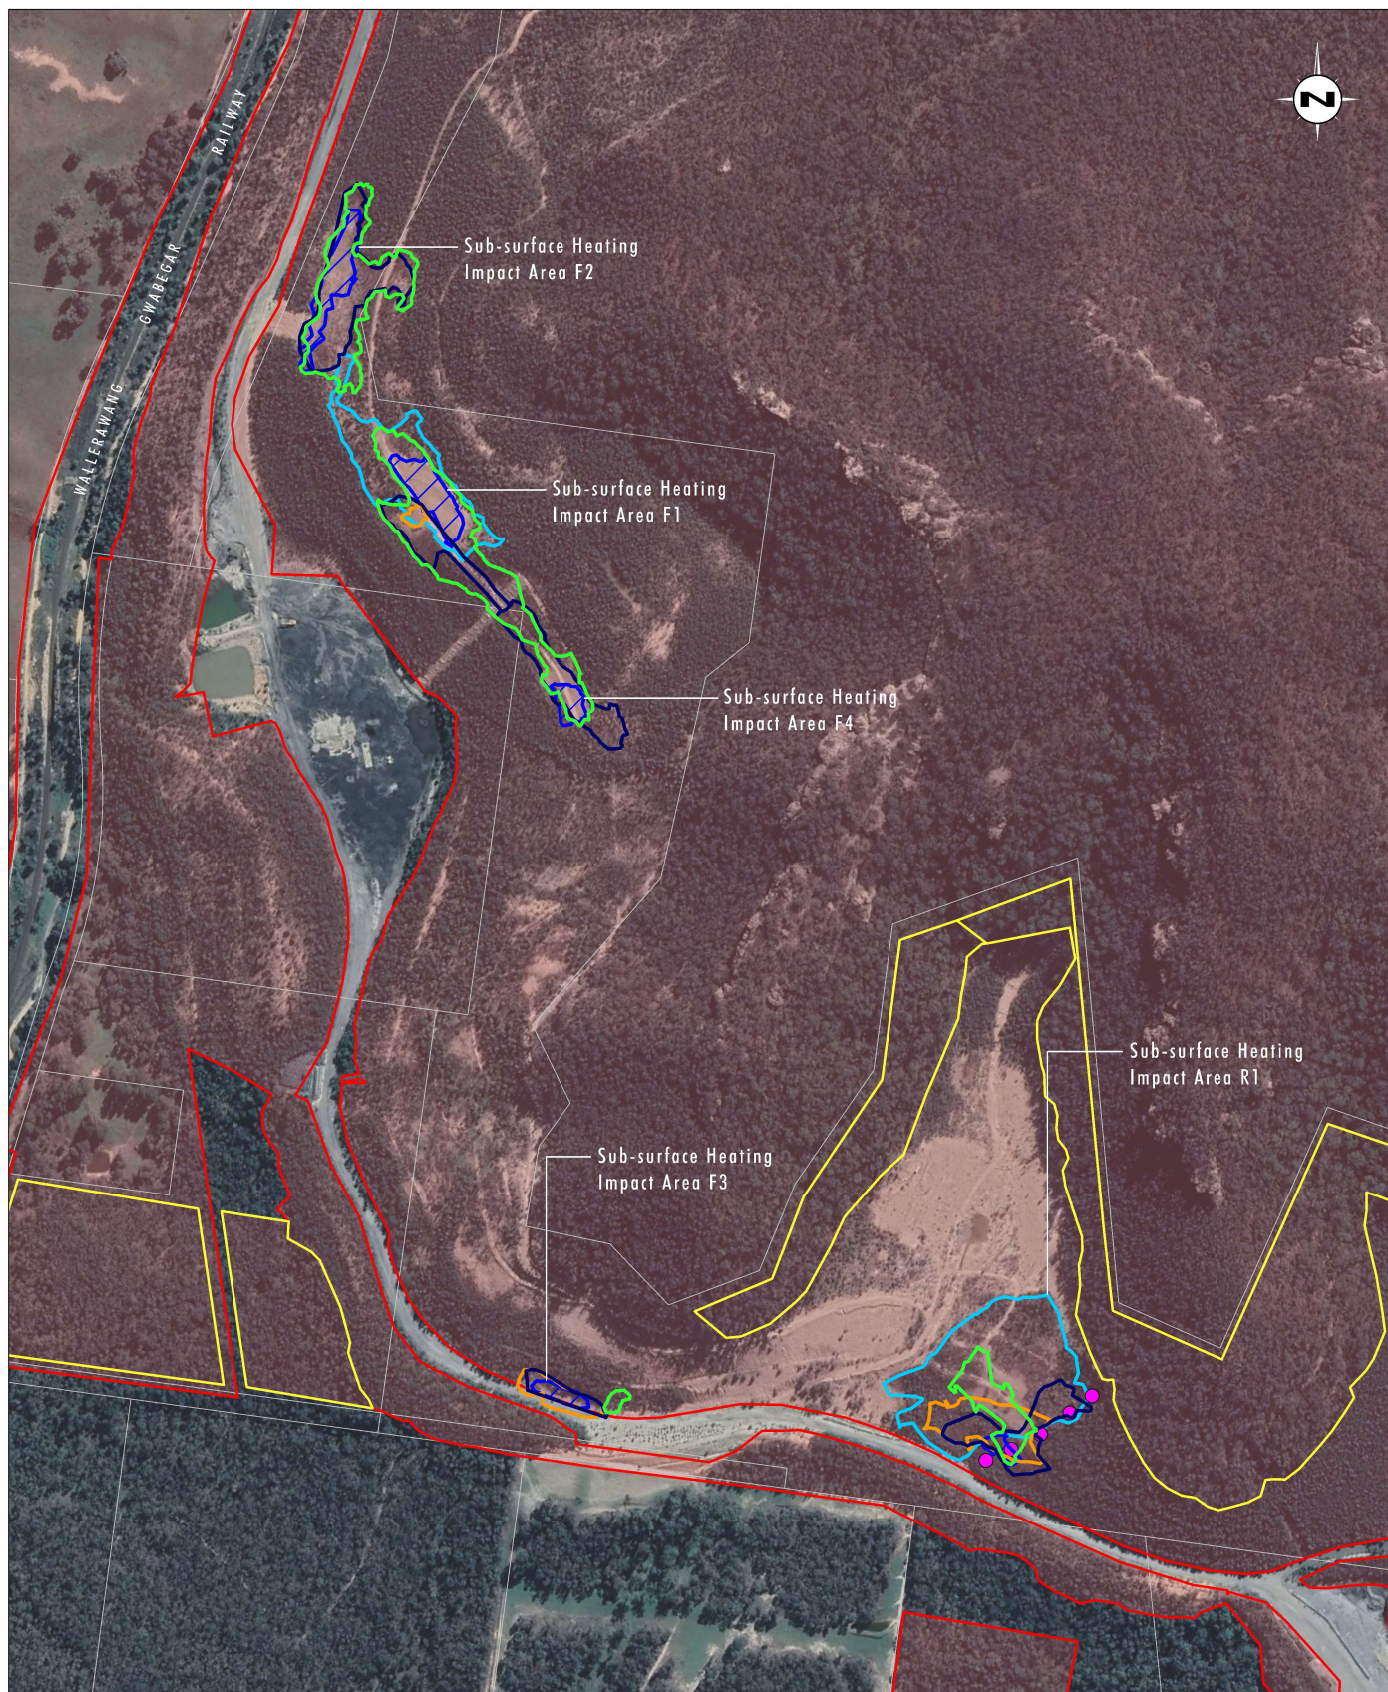
Subsurface heating at CVM has been observed in five main areas being area R1, F1, F2, F3 and F4 (refer to **Figure 6.4**). The active extent of the subsurface heating has been mapped for applicable years (**Figure 6.4**).

| Subsurface Heating Area Name | Extent of Active Heating | Vegetation Response |
|---|---|---|
| <b>R1</b> | Largely remains in the previously mapped footprint. | Acacia recovery in the south west edge of remediation. The north-west to north-east of the mapped area demonstrated continued recovery of Eucalypts and Acacias and groundcover vegetation growth (grasses and forbs).<br>Severe vegetation death in the south-east of the mapped area with active cracking and gas venting and yellow ooze. |

During 2019, minor repair works (i.e. localised earthworks – excavation of cracks and backfilling with inert material and compacting and filling cracks with concrete) was undertaken in subsurface heating areas with the exception of Area F3.

During 2021, CVM will continue to monitor for subsurface heating and undertake treatment measures in accordance with the updated Plan of Works (**Section 6.9**). Further investigations into subsurface heating sources and potential treatment methods will also continue (**Section 6.9**).
