# Arboricultural Impact Assessment

Prepared for the Australian Turf Club  
Site Address: 77-79 Alison Road Randwick  
11th February 2022

Date	Revision	Change	Stage
15/2/2022	A	Plan	DA

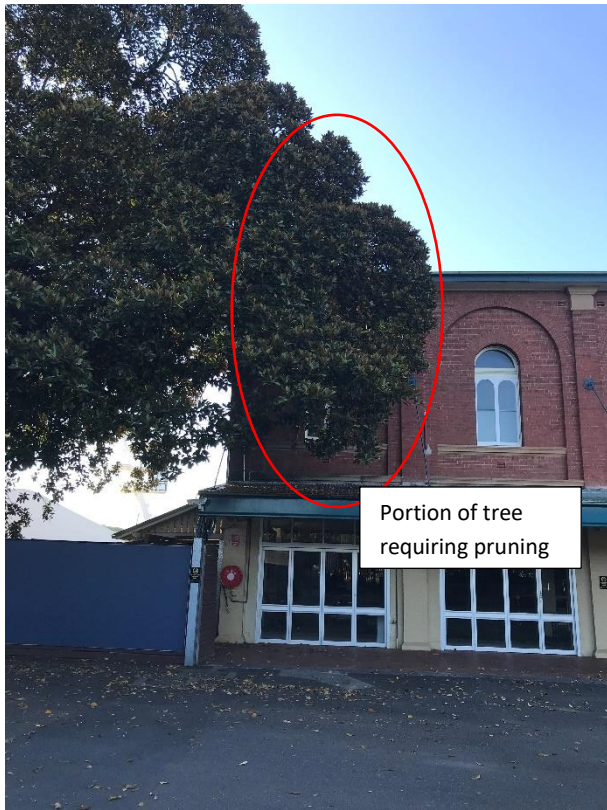
The position of the light post is approximately 8 metres from this tree. The light post is within the (Tree Protection Zone) TPZ of 15 metres and outside the SRZ (Structural Root Zone). The estimated impact to this tree is less than 10% and this conforms to the Australian Standard 4970-2009. As this is an assumption, exploratory excavation should be undertaken prior to construction to ensure that no major tree roots are severed for this project.

Figure 4 Tree 1 and light post position

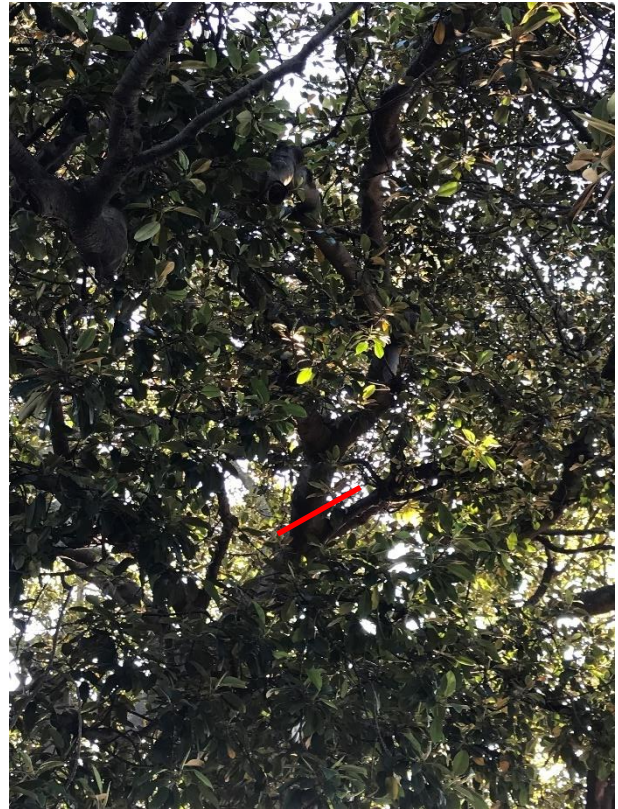
Pruning of the canopy will be required to install the light post. It is likely less pruning will be undertaken, however the removal of the large limb pictured below will clear all vegetation from the

Figure 3 Possible pruning required

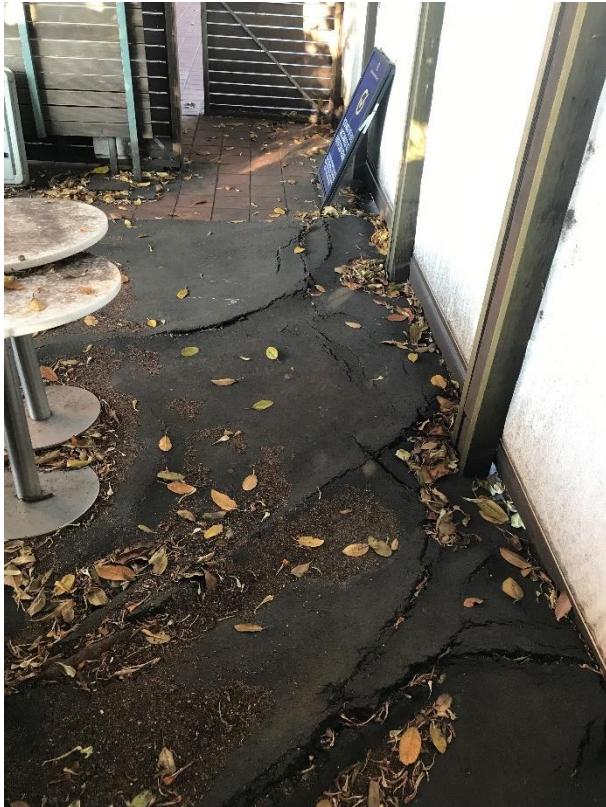
Figure 6 Surface tree roots from tree 1

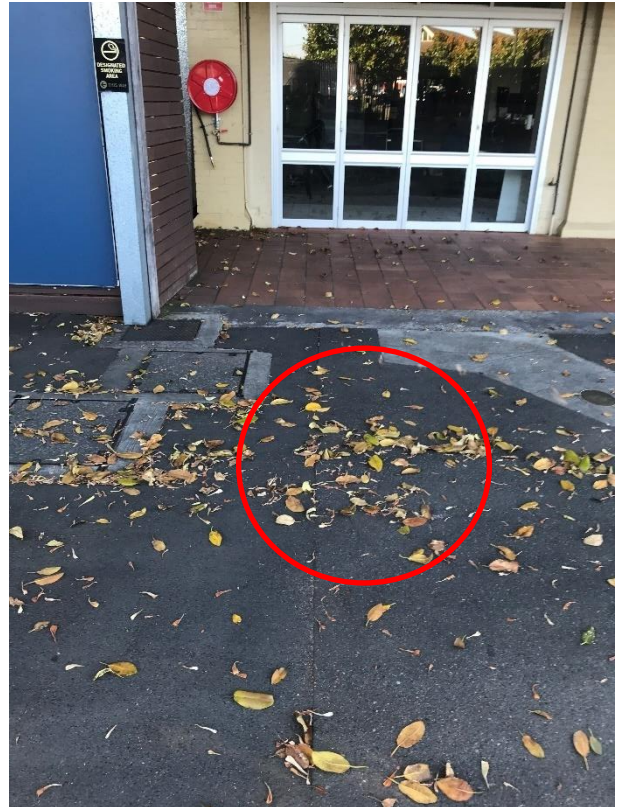
Figure 5 Estimated light post position

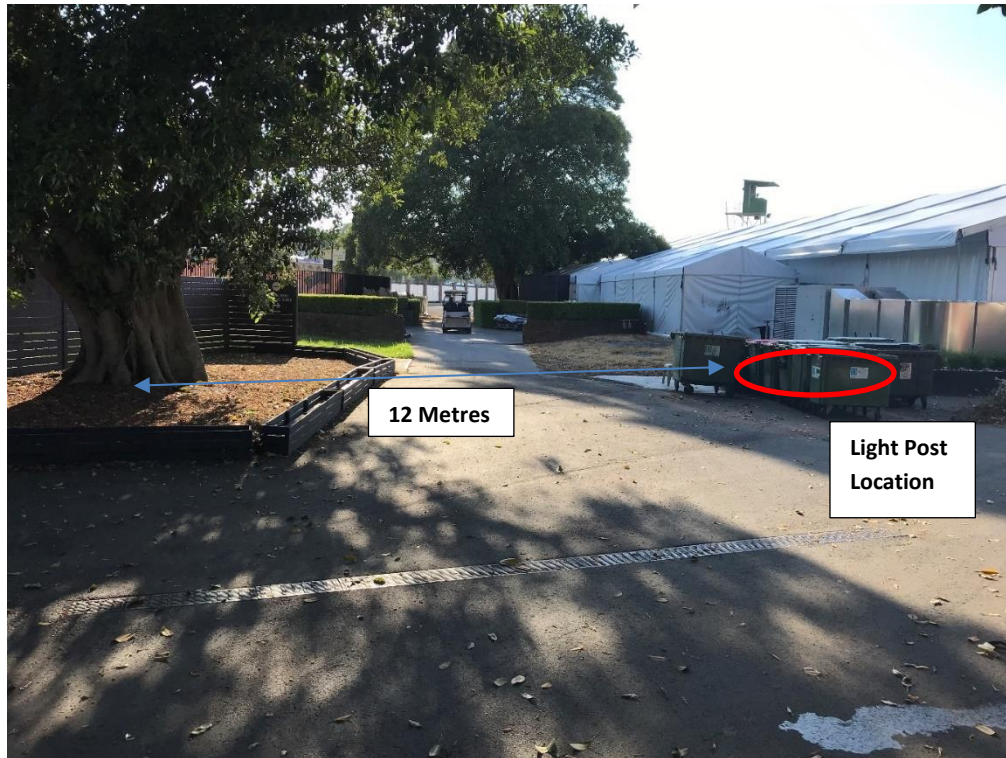
The position of the light post is approximately 12 metres from this tree. The light post is within the (Tree Protection Zone) TPZ of 15 metres and outside the SRZ (Structural Root Zone). The estimated impact to this tree is less than 10% and this conforms to the Australian Standard 4970-2009. As works are at the periphery of the TPZ, prior excavation to locate tree roots is not necessary.

Figure 7 Tree 2 and light post position A12

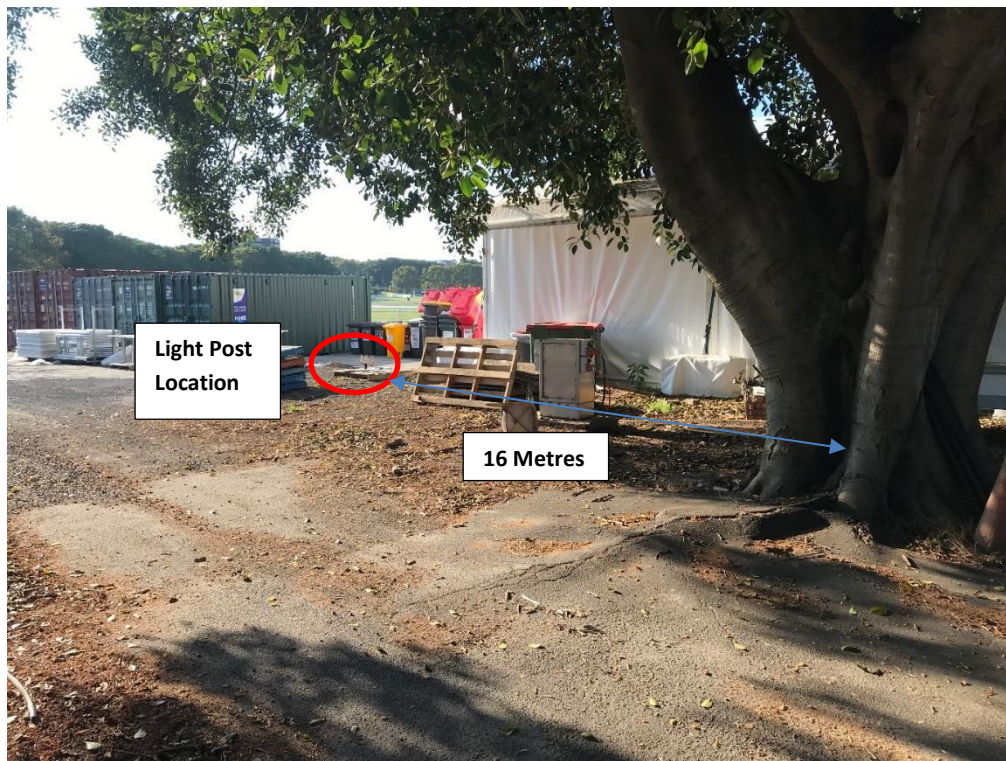
The position of the light post is approximately 16 metres from this tree. The light post is outside the (Tree Protection Zone) TPZ of 15 metres and outside the SRZ (Structural Root Zone). There is likely to be no impact to this tree. As works are outside the TPZ, prior excavation to locate tree roots is not necessary. See Figure 8 below.

Figure 8 Tree 3, light post A13

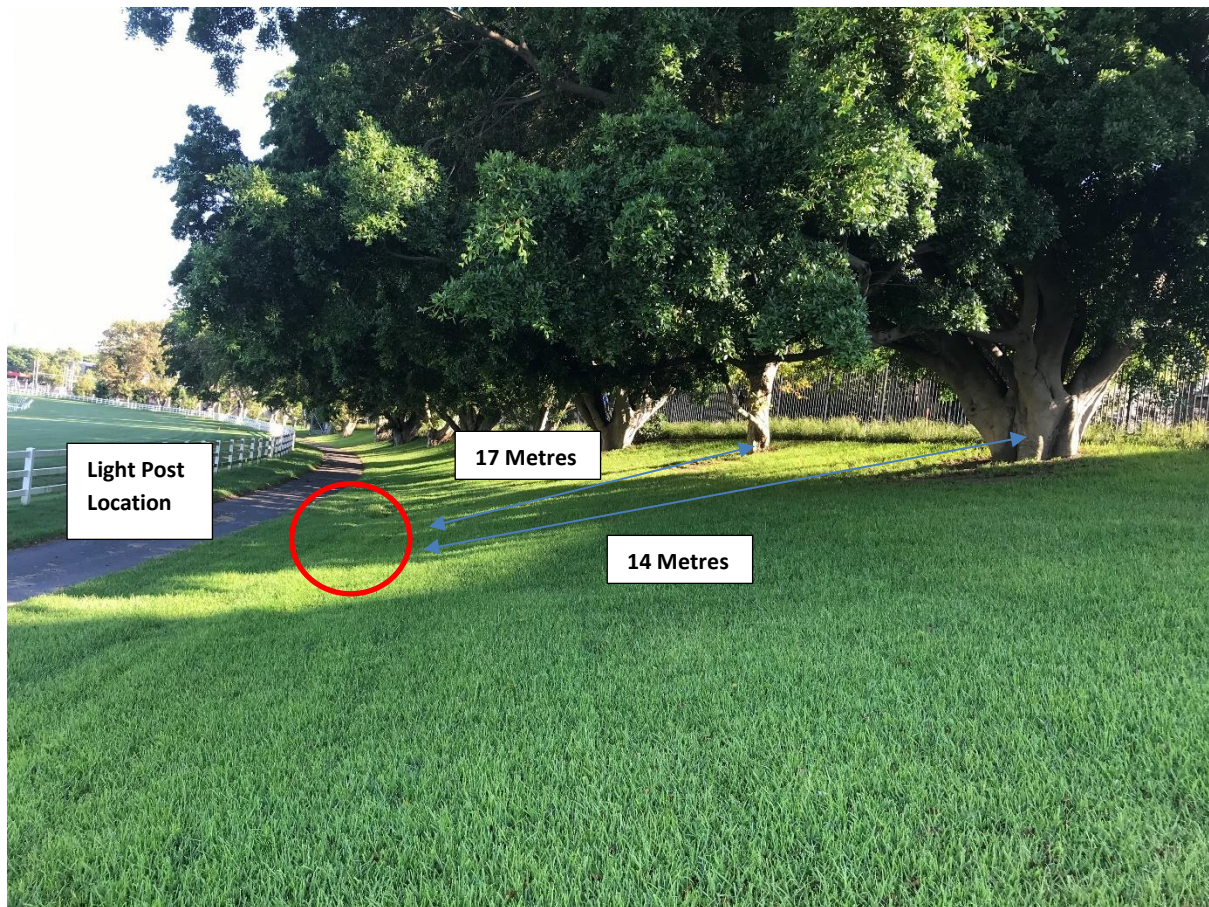
The position of the light post is approximately 17 metres from tree 4 and 14 metres from tree 5. The light post is outside the TPZ of tree 4 and at the periphery of tree 5. There will not be any impact to tree 4 and unlikely to be any impact to tree 5. As works are outside the TPZ or at its periphery, prior

Figure 9 Trees 4 and 5 beside proposed light post C1

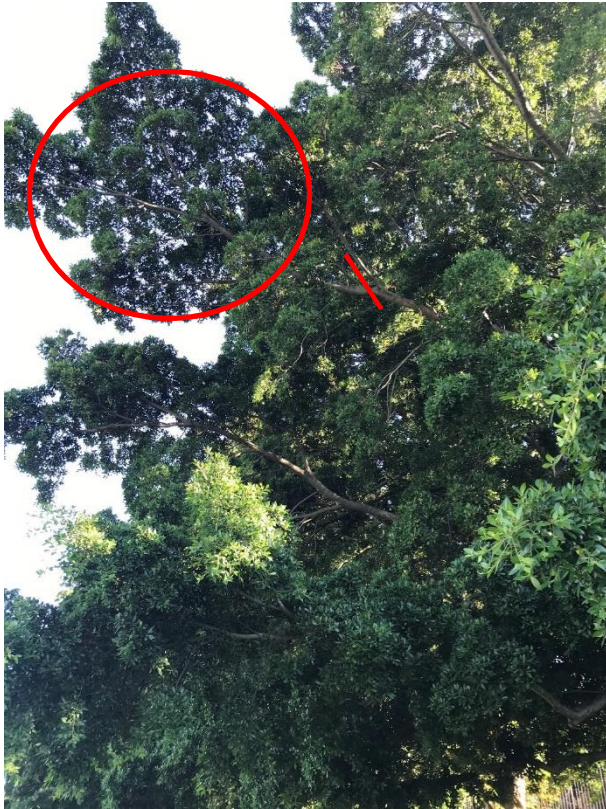
Figure 11 Prune upper canopy limb that potentially affects light post

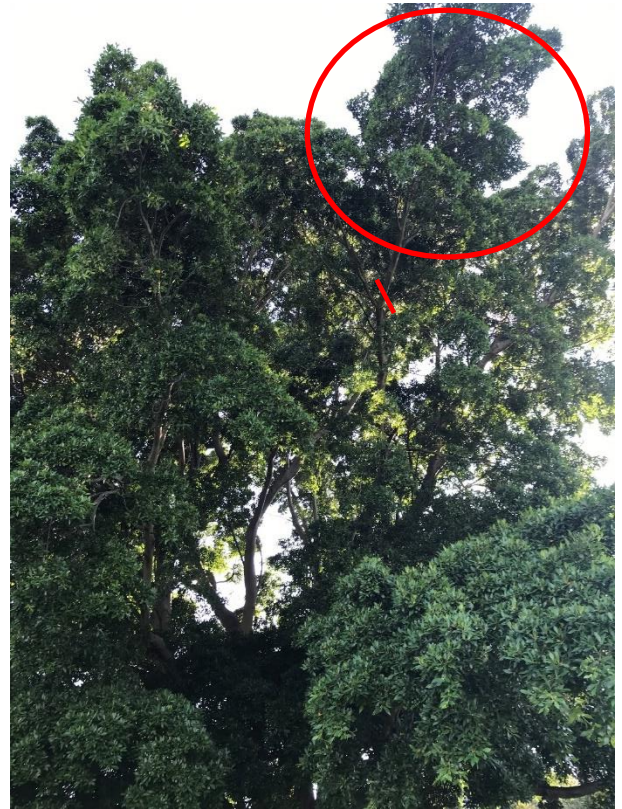
Figure 10 Prune upper canopy limb that potentially affects light post

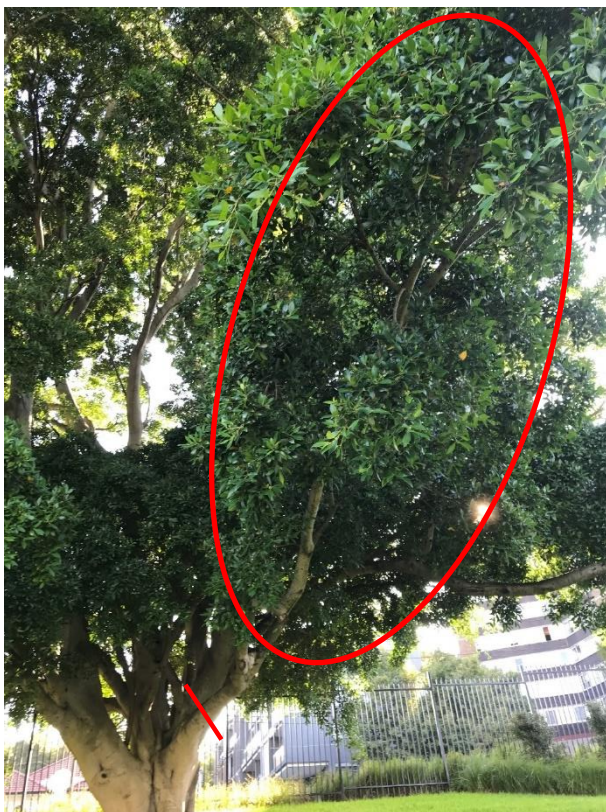
Figure 12 Prune lowest branch from tree 5 back to the trunk

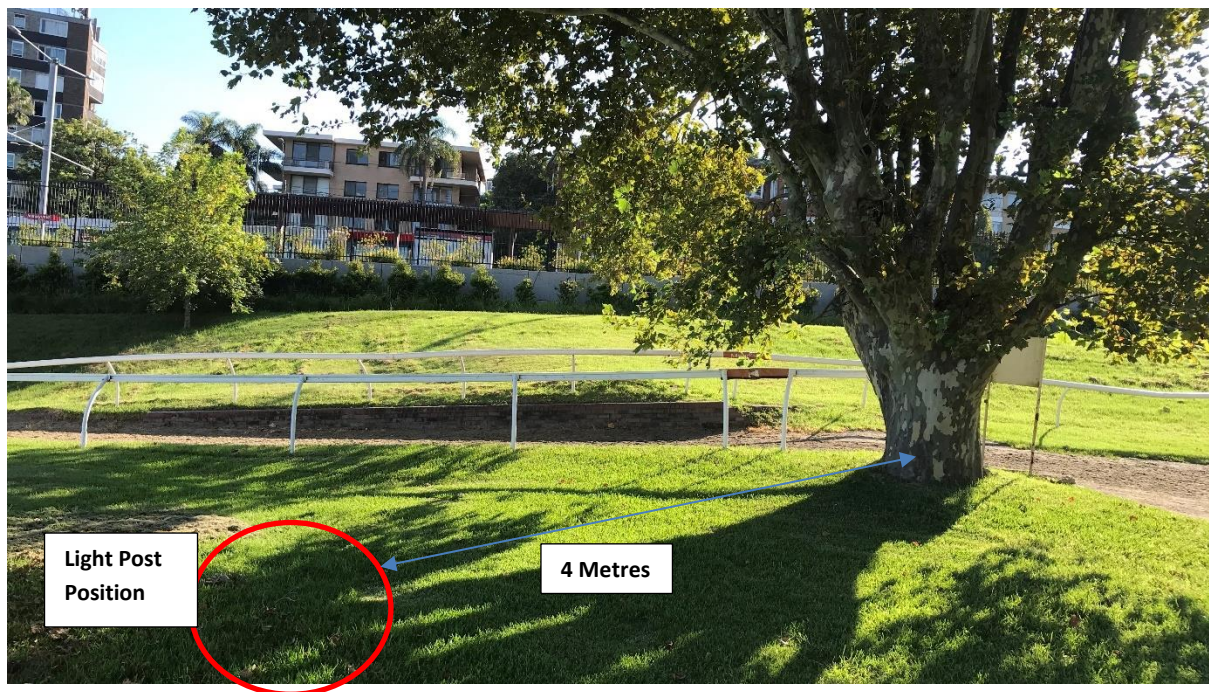
The position of the light post is approximately 4 metres from tree 6. The light post is within the TPZ of tree 6, yet outside the SRZ of this tree. This tree species is tolerant of tree root disturbance and Figure 14 shows the estimated incursion of a 2 metre hole 4 metres from the tree. The incursion is less than 10% and complies with Australian Standard 4970-2009. The diagram assumes that tree roots radiate out from the trunk in an even manner, this is one of the assumptions used when assessing tree impact against AS4970-2009. As tree root growth is unpredictable a tree root survey should be undertaken to identify any roots. Any proposed works must be outside the SRZ. Tree 6 will require canopy pruning to accommodate the light structure.

Figure 13 Tree 6 and light post C3

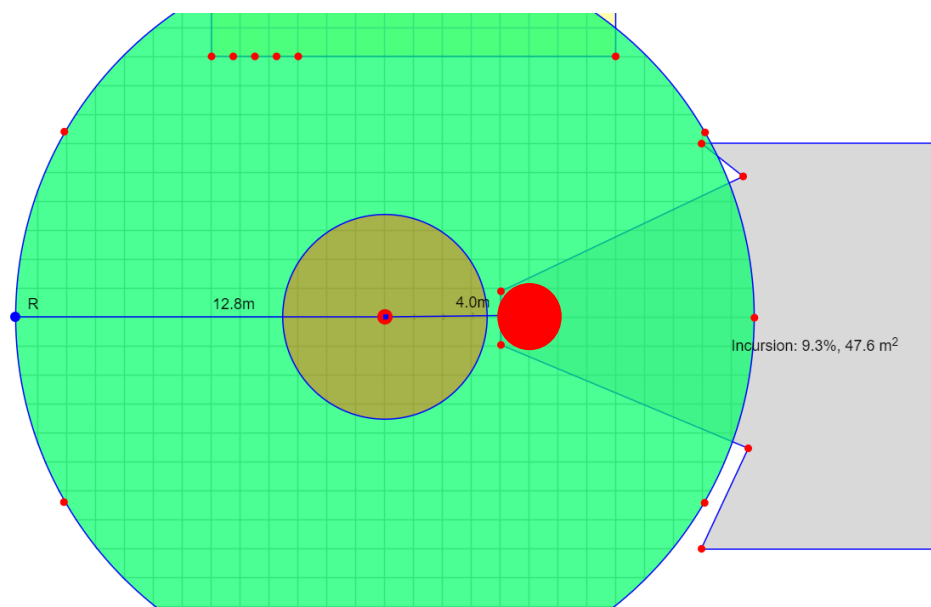
Figure 14 Diagram showing incursion of TPZ of light post

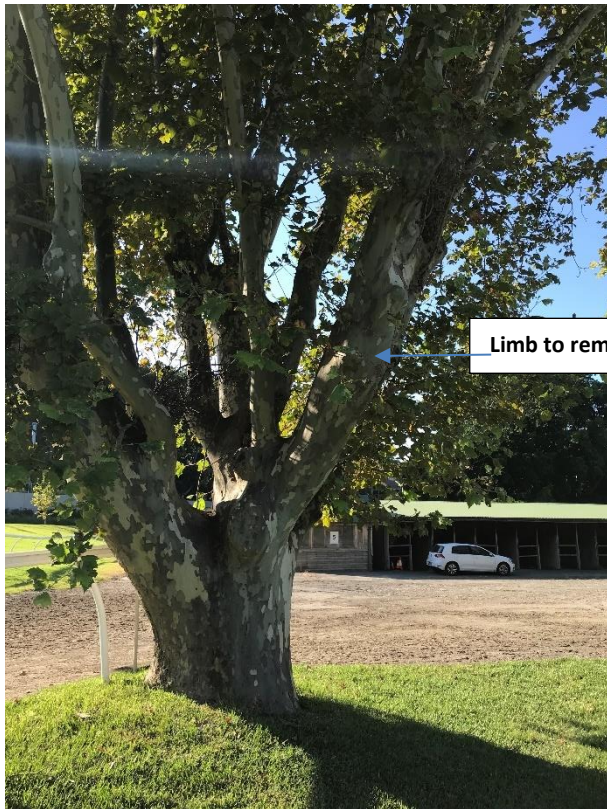
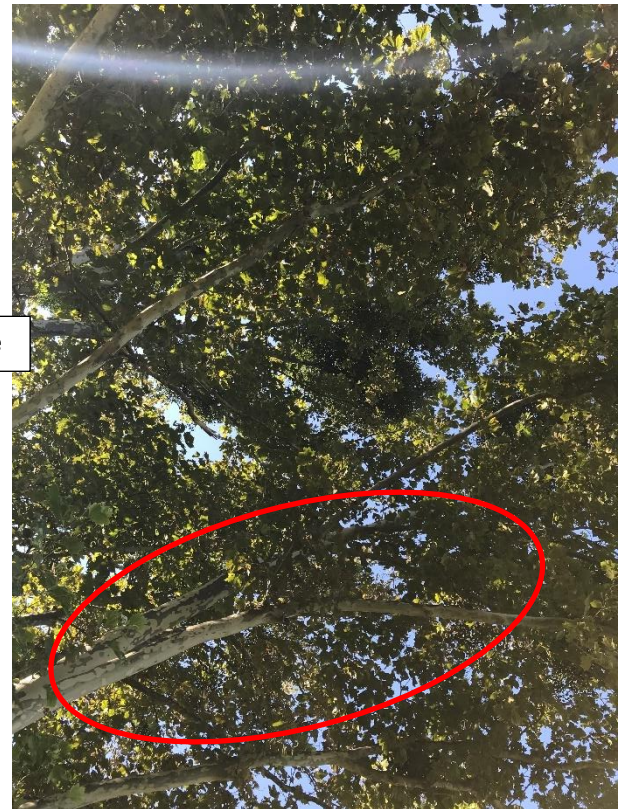
Figure 15 Limb to remove

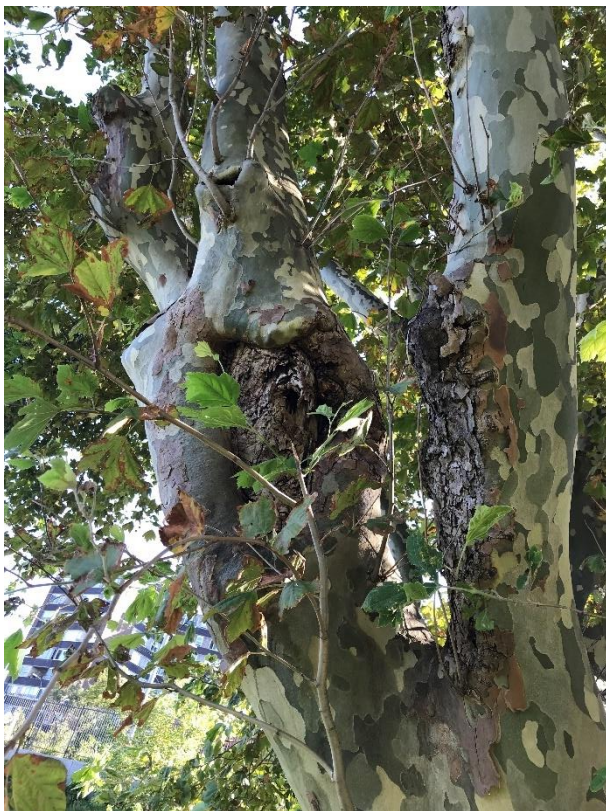
Figure 16 Decaying limb requiring removal

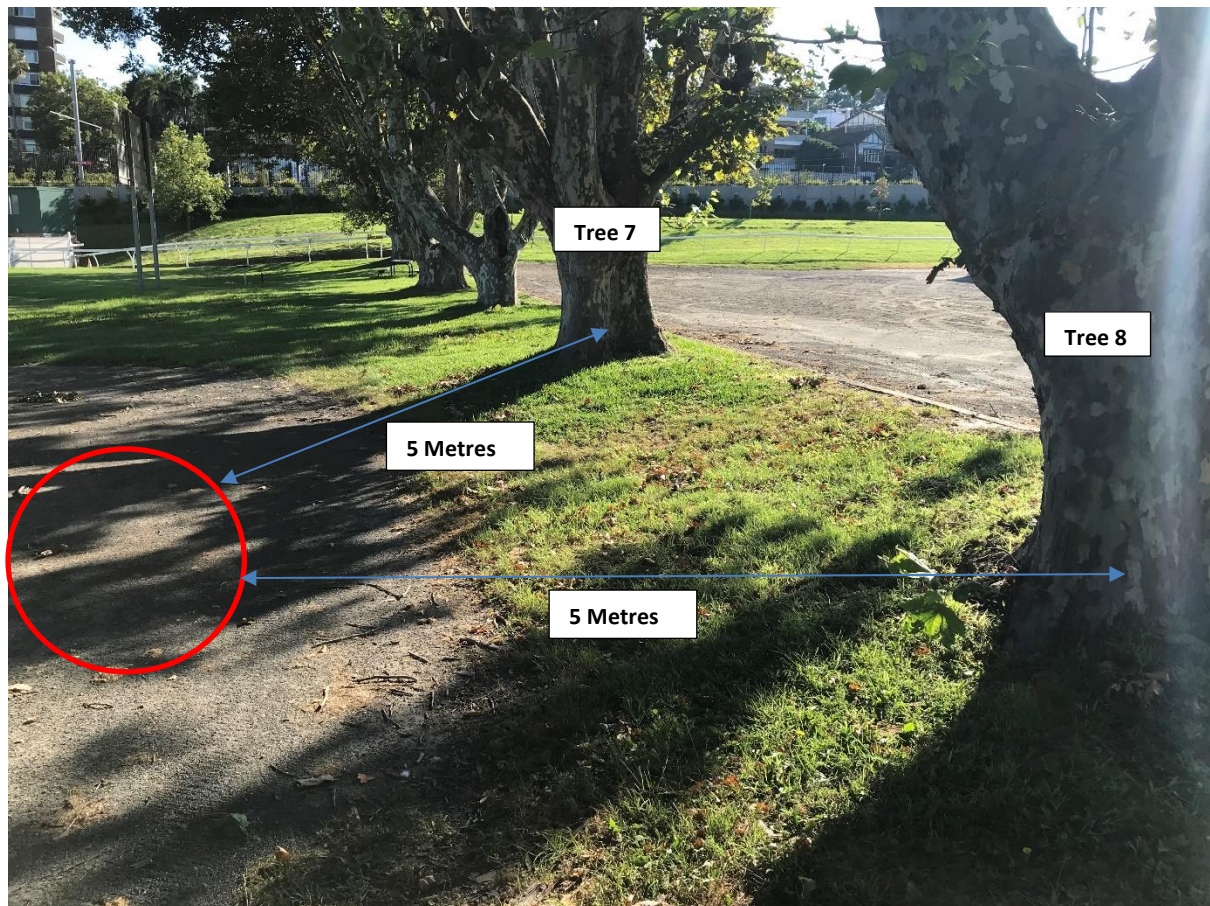
The position of the light post is approximately 5 metres from trees 7 and 8 and 12 metres from tree 9. The light post is within the TPZ of tree 7 and 8, yet outside the TPZ of the 9. There is unlikely to be any affect to tree 9 as works are outside the TPZ. This tree species (Trees 7 and 8) is tolerant of tree root disturbance and the estimated incursion is less than 10% this complies with Australian Standard 4970-2009. As tree root growth is unpredictable a tree root survey should be undertaken to identify any roots. Any proposed works must be outside the SRZ. Trees 7 and 8 will require canopy pruning to accommodate the light structure. See Figure 17, Figure 18 and Figure 19.

Figure 17 Trees 7, 8 and light structure position C4

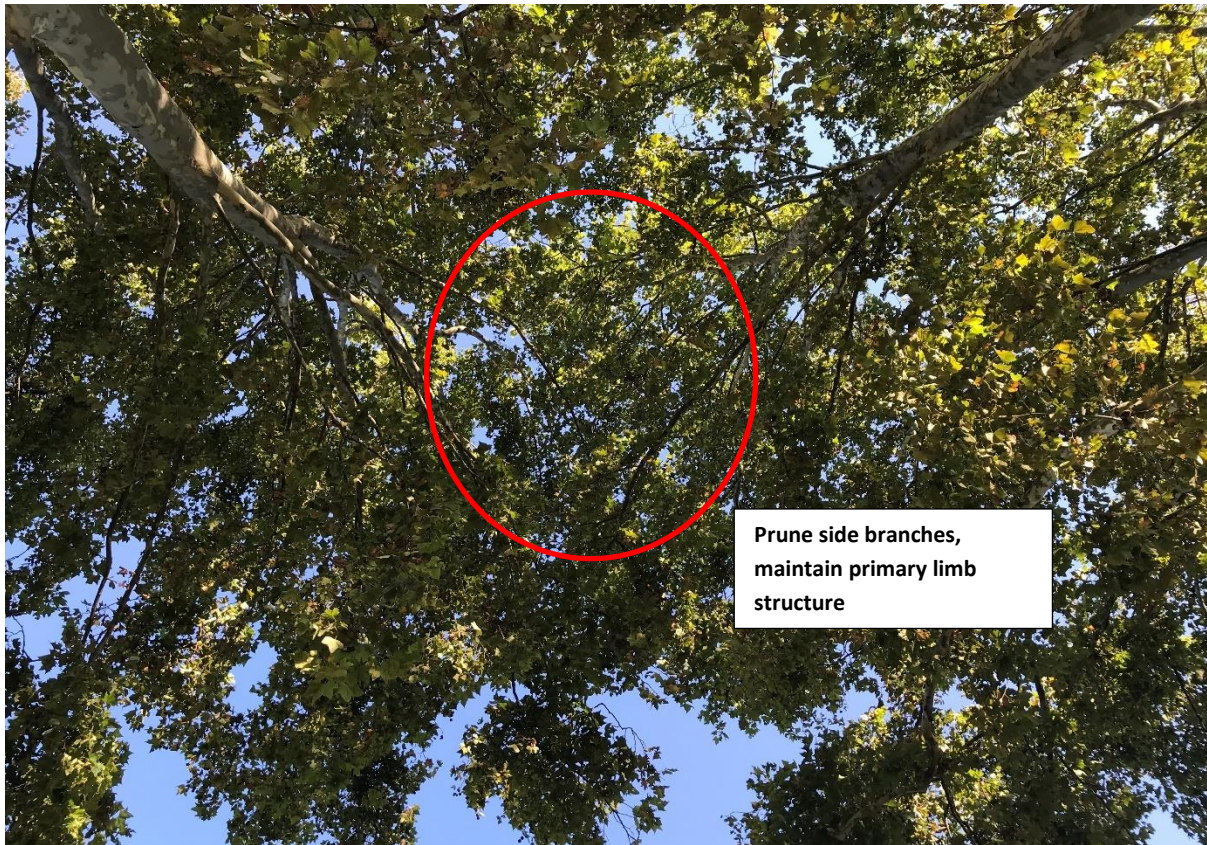
Figure 18 Proposed pruning of trees 7 and 8 to accommodate light structure

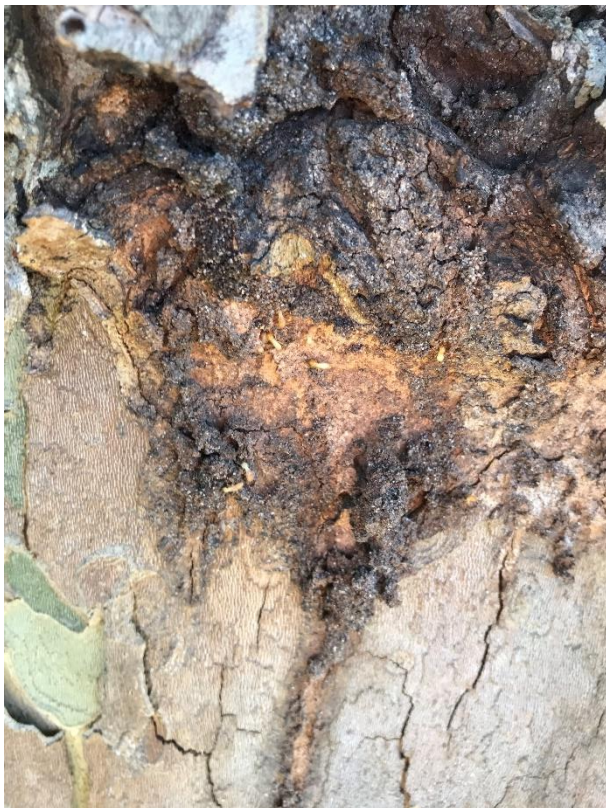
Figure 19 Active termites located on tree 8

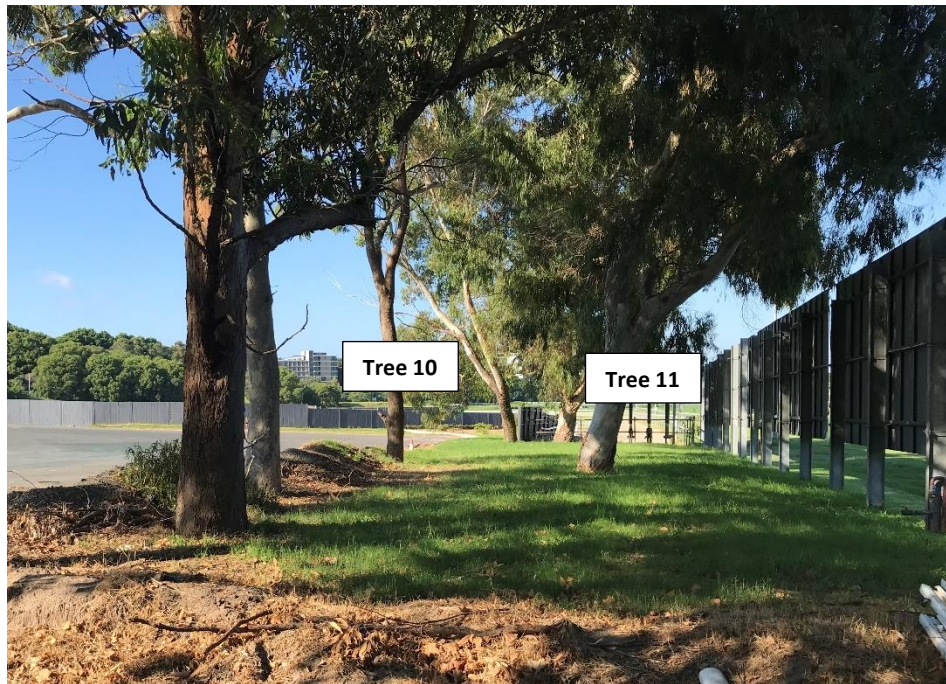
The position of the light post is approximately 6 metres from tree 10 and 5 metres from tree 11. There is unlikely to be any affect to tree 10 as works are outside the TPZ. This tree however, is in very poor health and removal should be considered.

Figure 20 Trees 10 and 11

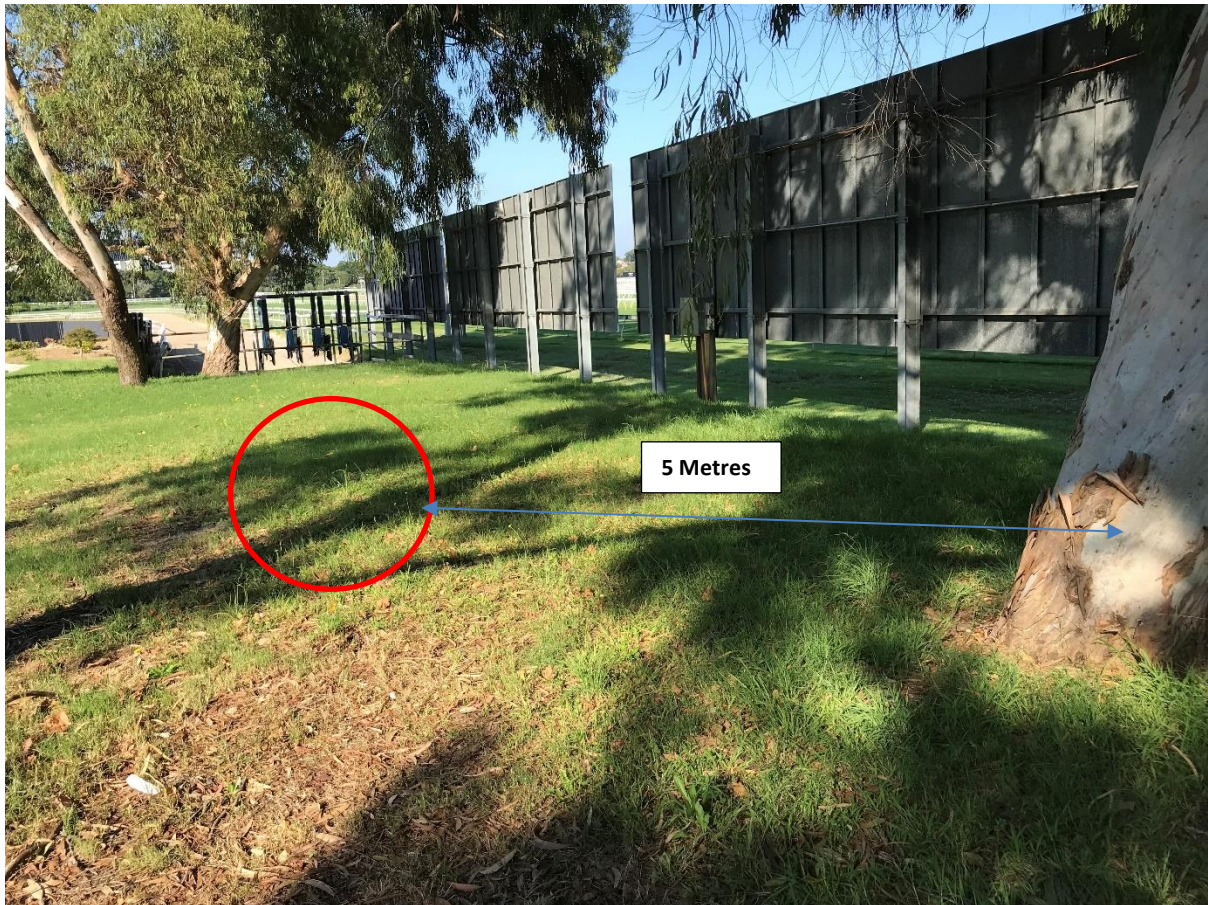
The light post is within the TPZ of tree 11 and outside the SRZ, yet within the TPZ. The incursion is less than 10% and complies with Australian Standard 4970-2009. As tree root growth is unpredictable a tree root survey should be undertaken to identify any roots. Any proposed works must be outside the SRZ. Tree 11 may require minor pruning to accommodate the light structure. See Figure 20, Figure 21, Figure 22 and Figure 23 below.

Figure 21 Tree 11 and light post C5

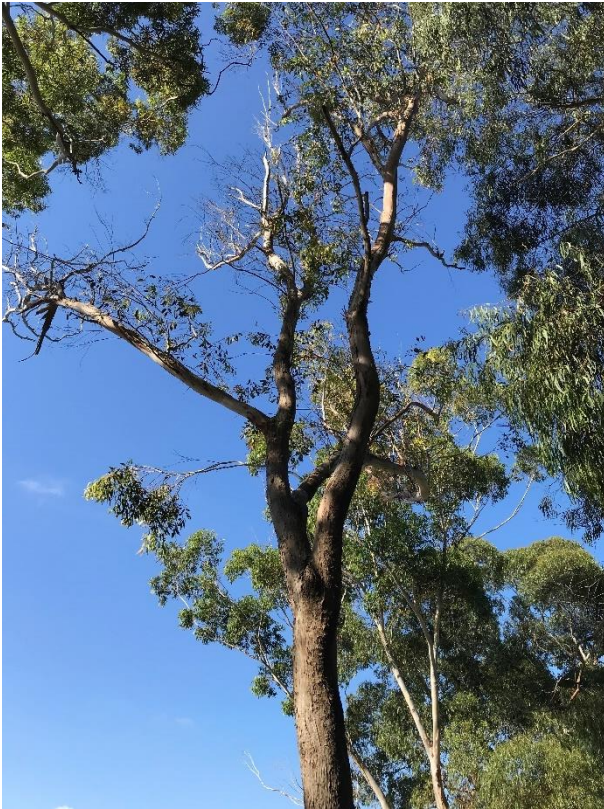
Figure 22 Tree 10, removal recommended due to poor health

1. Retain trees 1-20, consider removal of tree 10 due to poor health.
2. Appoint project arborist. Minimum AQF Level 5 with 5 years' experience.
3. Survey light post locations and size of excavation required. Re-assess the potential impact to any surrounding trees.
4. Minor re location of light posts C4, C5 and C6 to minimise impacts to trees may be required.
5. Requirements prior to issuing a construction certificate.

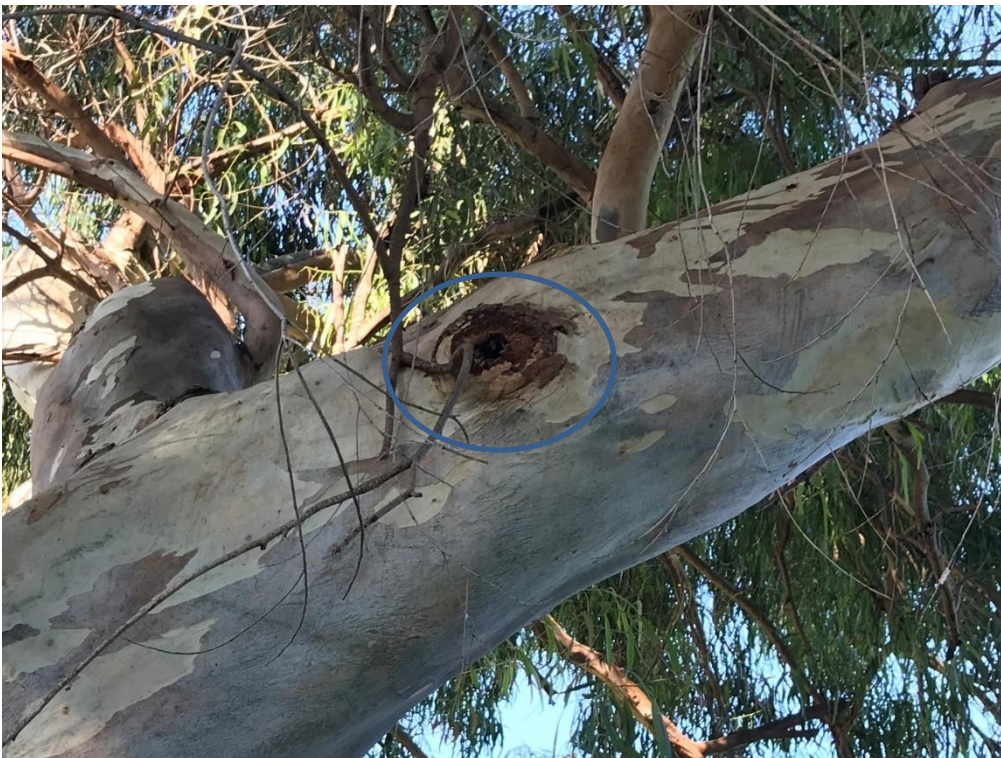
Figure 23 Bee hive identified

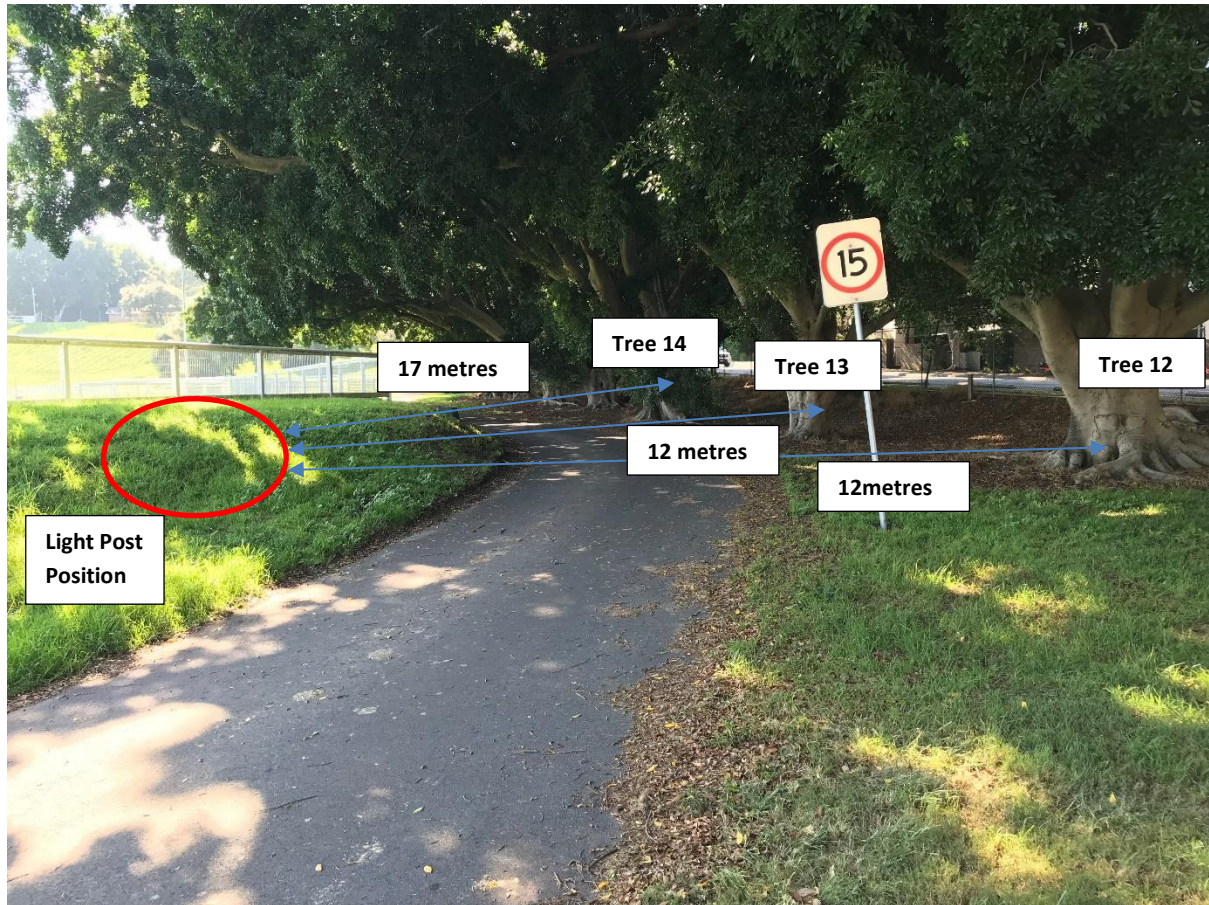
The light post is within the periphery of TPZ of tree 13 and 14, it is unlikely these trees will be affected by the installation of the light post. A tree root survey is not required. The further the structure is from the tree the less the impact. Trees 13 and 14 will require minor pruning to accommodate the light tower. It is anticipated 2 x 120mm branches should be pruned from tree 13 and 3 80mm branches from tree 14. See Figure 25, Figure 26, Figure 27 and Figure 28.

Figure 25 Trees 12, 13, 14 and light post C20

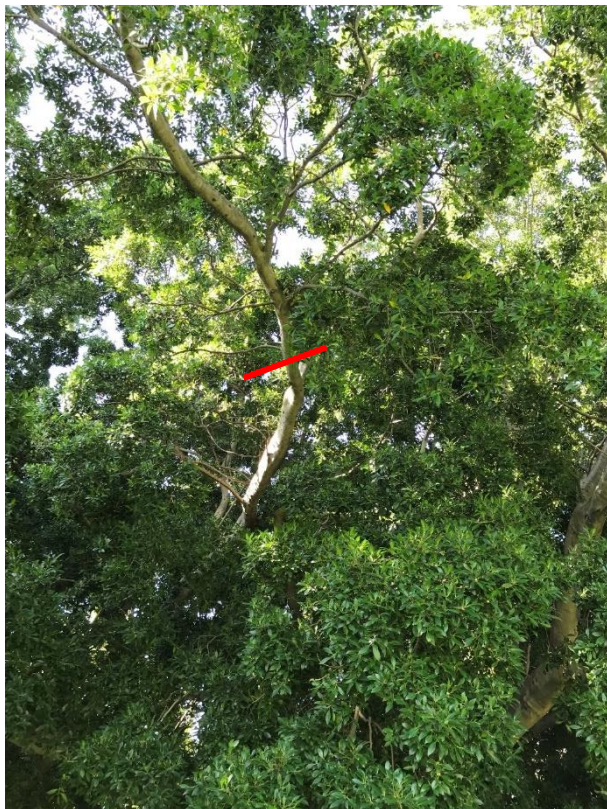
Figure 27 Prune canopy of tree 13

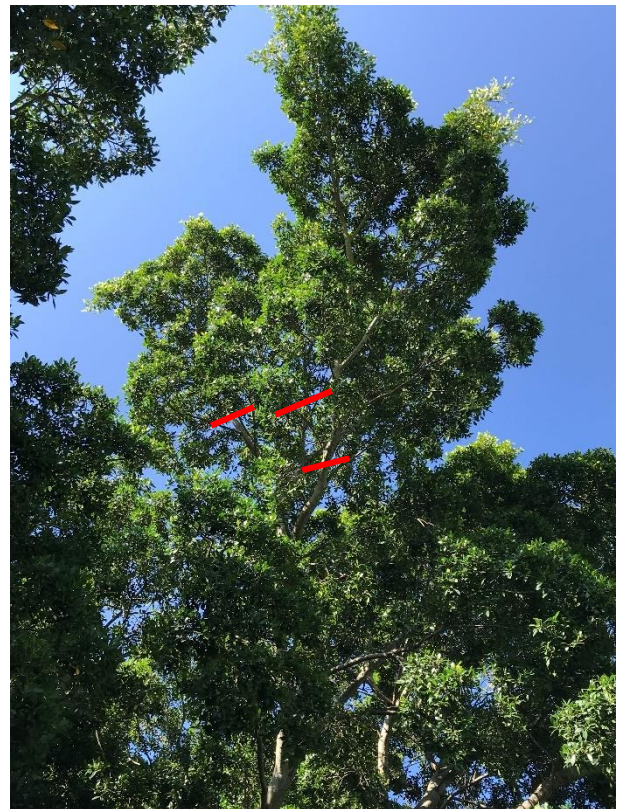
Figure 26 Pruning canopy of tree 14

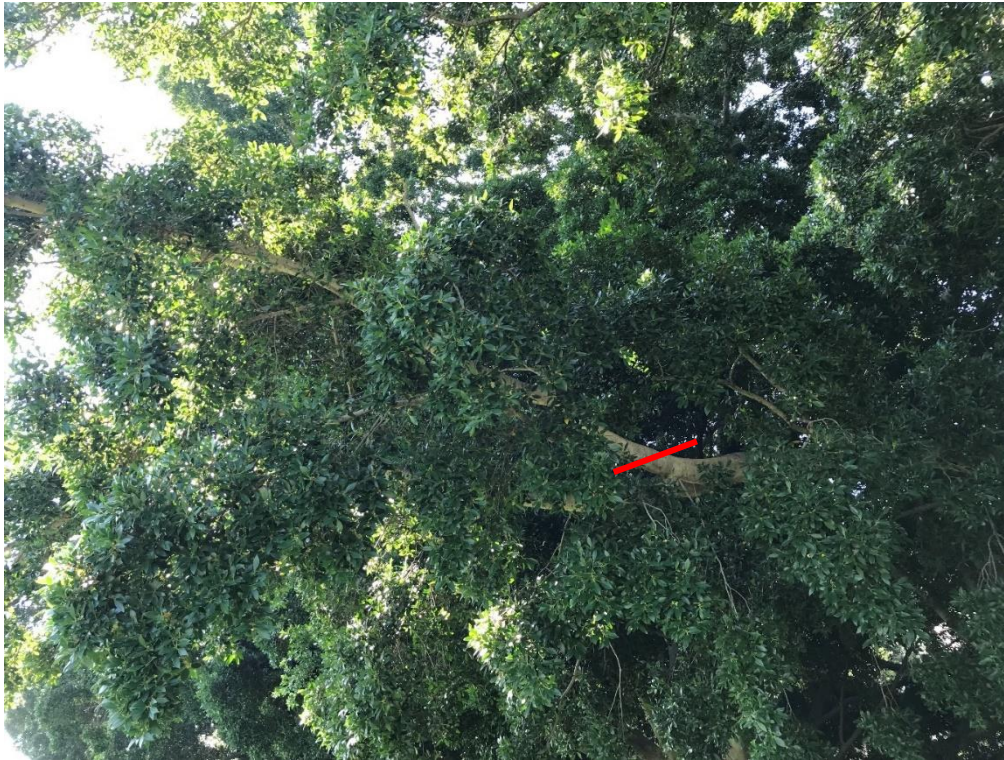
Figure 28 Prune lower canopy of tree 13

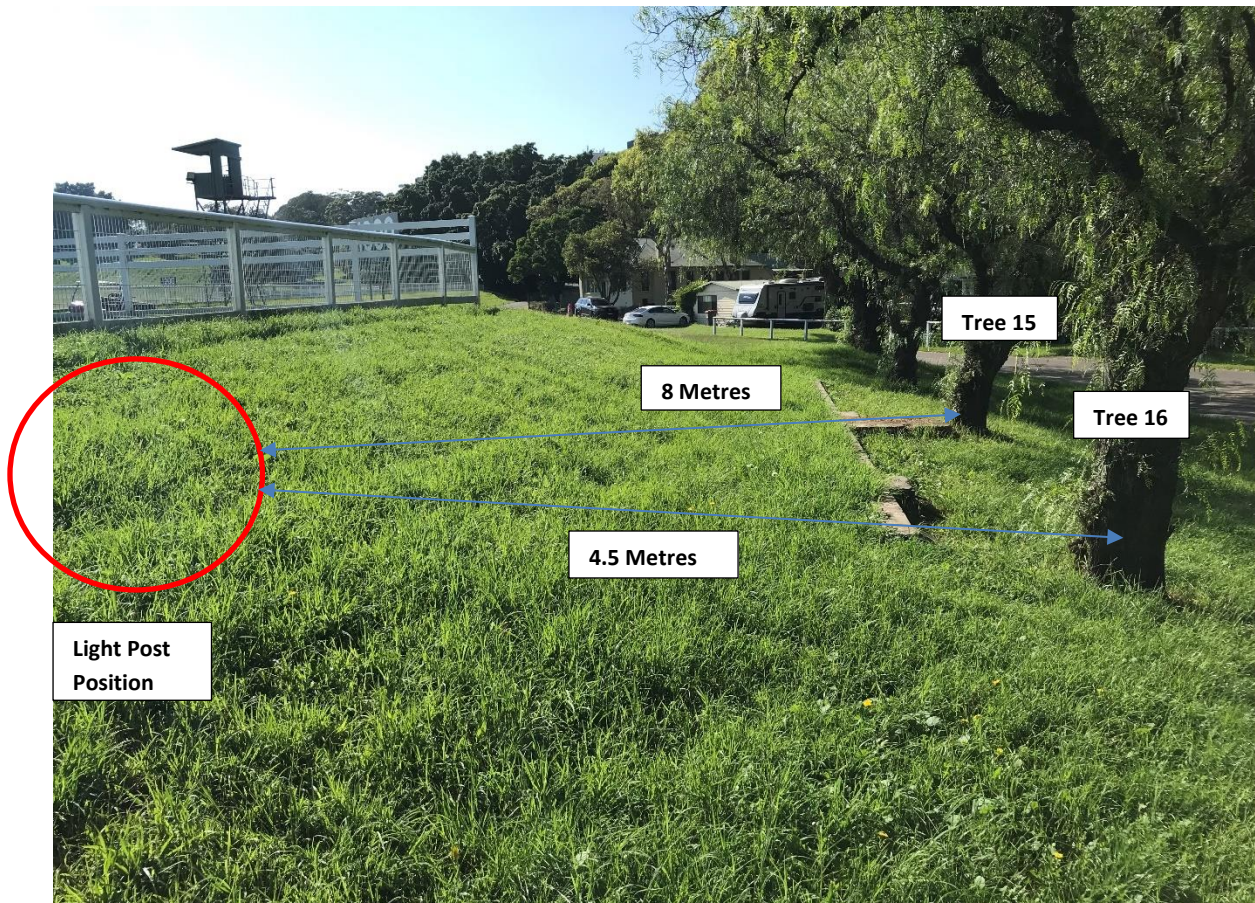
The light post is within the TPZ of tree 16 yet at the periphery, it is unlikely these trees will be affected by the installation of the light post. A tree root survey is not required. The further the structure is from the tree the less the impact. No pruning is required. See figure Figure 29.

Figure 29 trees 16, 17 and light post C23

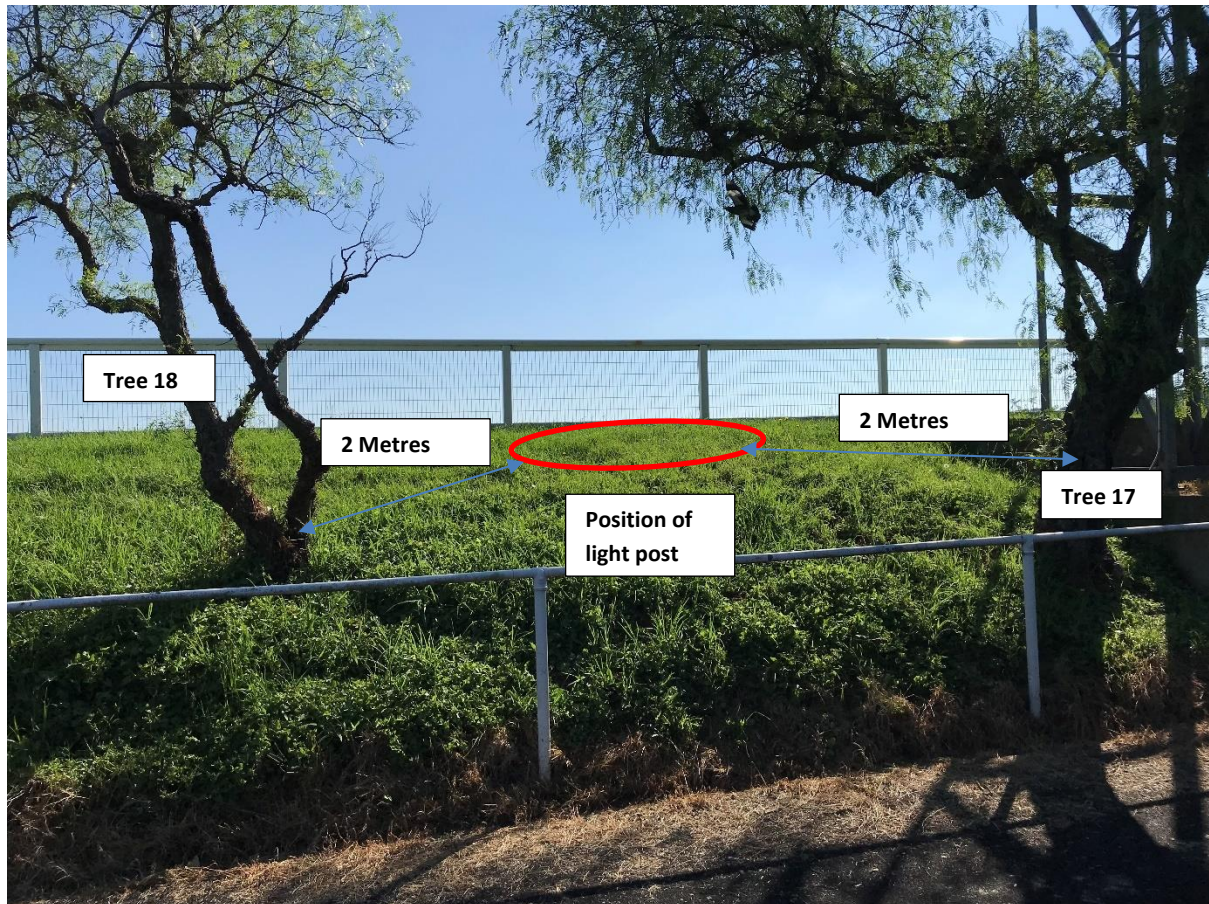
The proposed light post is within the TPZ of trees 17 and 18, it is also within the SRZ of tree 17. The expected impact to these trees will be minimal as only a minor portion of the TPZ is being affected. To confirm the effects a tree root survey should be undertaken to determine the exact impact. See Figure 30.

Figure 30 Trees 17, 18 and light post C24

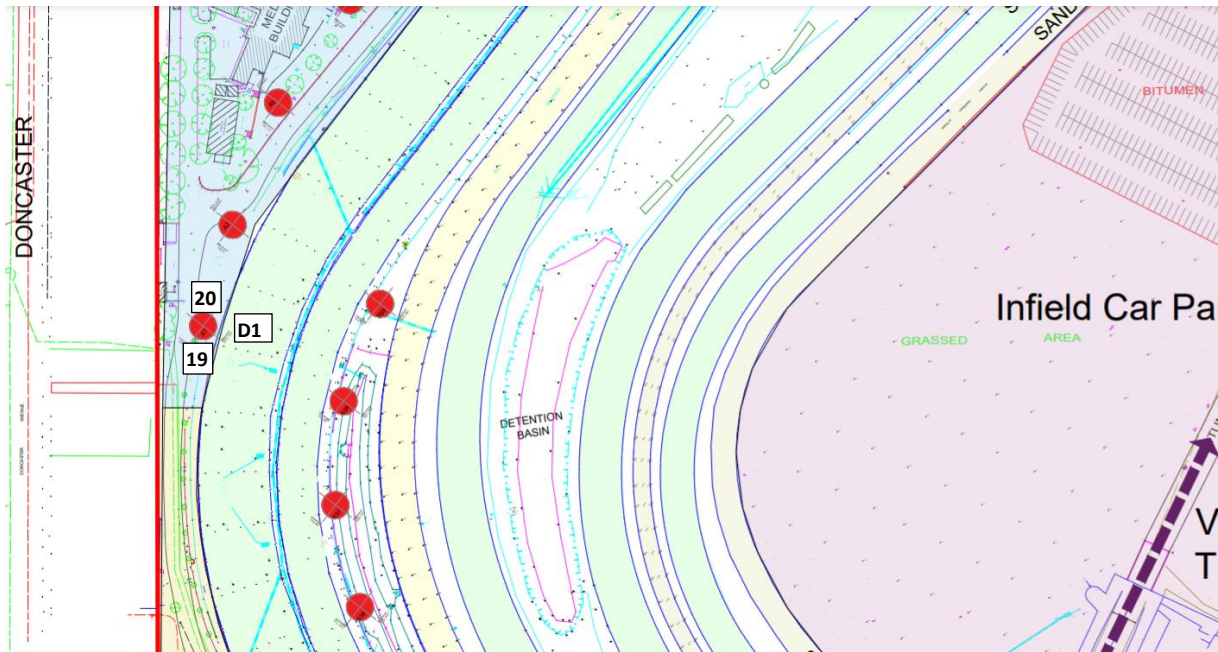
Figure 31 Light post D1

The proposed light post location is between trees 19 and 20. This is at the periphery of the TPZ for both trees. The impact to these trees is expected to be minimal as the percentage of the TPZ affected is low and these trees are young and can tolerate a greater level of tree root disturbance. A tree root survey is not required. See Figure 31 and Figure 32

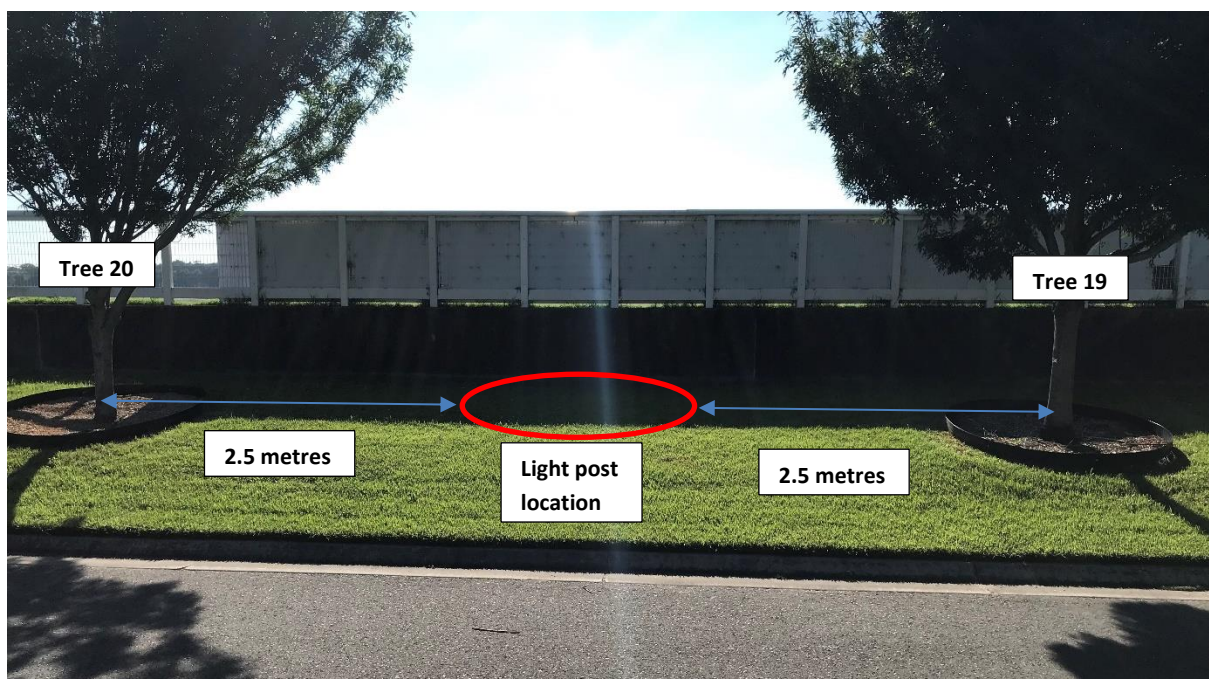
Figure 32 Trees 19, 20 and light post A1
