SINSW Centre Of Excellence (Richmond)

Road Safety Audit

Detailed Design Stage

JN22024_Report01 Rev01 - TTW Richmond COE

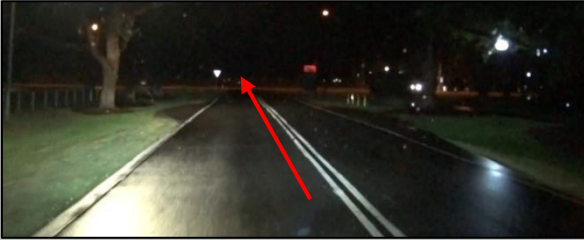
Item Location	Safety Hazard Finding	Frequency	Severity	Level Of Risk	Project Manager Response
1. Intersection Delineation Londonderry Road	<p>There is no delineation on the terminating leg of the T-intersection.</p> <p>There is a risk at night or during adverse weather that a motorist may not sight the intersection point and approach the intersection at high speed (accelerating after exiting the 40 zone) with insufficient time to decelerate to a stop before entering the through lane resulting in side impact collisions from through vehicles.</p>

Improbable	Minor	Medium	Signage and line marking plan to be developed for this area, including retro-reflective pavement markers (RRPMs), T-intersection advance warning signage, and T-intersection terminating signage (<<< >>>).

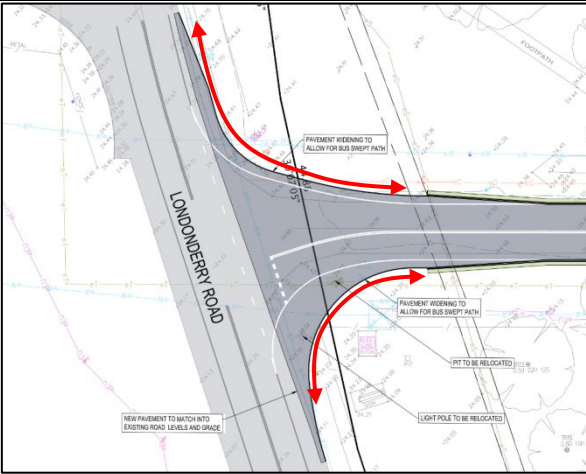
2. Drainage Londonderry Road	<p>The proposed widening works at the Londonderry Road intersection creates a road formation cut profile and no drainage infrastructure is proposed.</p> <p>There is a risk that water may pond into the through travel lanes of a 60 km/h zone resulting in aquaplaning incidents.</p> <p>There is a risk that ponding water may damage the pavement surface creating vehicle/motorcycle destabilisation incidents resulting in run-off-road or head-on collisions, particularly when negotiating a corner.</p> <p>There is a risk that water flows may erode the edge of the pavement creating a vertical drop that may</p>	Probable	Serious	Intolerable	<p>Existing blocked pipe to be replaced and improved as part of intersection works which should reduce ponding.</p> <p>A drainage channel to bring water off the roadway will also be considered in the detailed design.</p> <p>Pavement and/or kerb design to be reviewed to avoid erosion.</p>

Item Location	Safety Hazard Finding	Frequency	Severity	Level Of Risk	Project Manager Response
	<p>snag an errant vehicle resulting in vehicle roll incidents.</p>

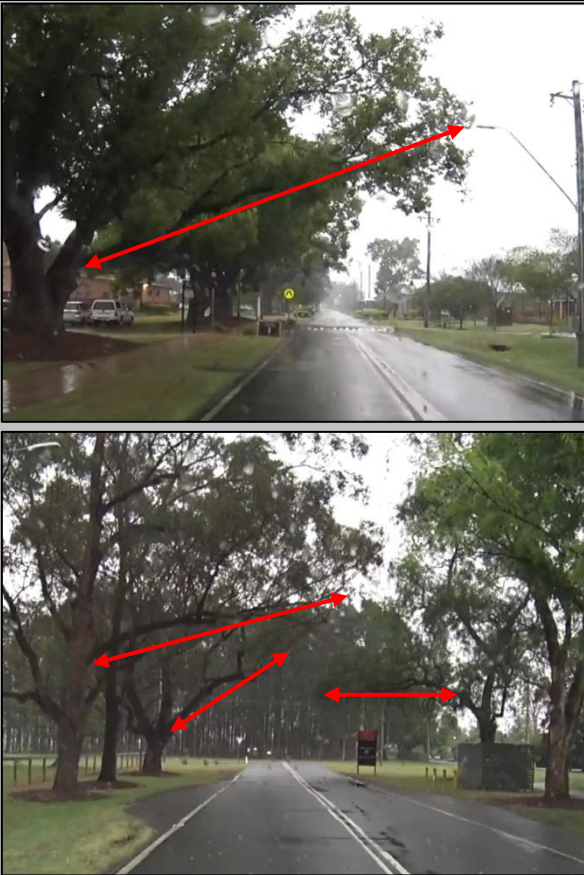
3. Overhanging Branches Extent of Works	<p>There are low and overhanging branches throughout the extent of works.</p> <p>There is a risk that a branch may fall on a vehicle or fall into the travel lane and be impacted by a vehicle resulting in injury to vehicle occupants.</p> <p>There is a risk that a vehicle may impact overhanging branches causing them to fall onto the vehicle or into the travel lane and be impacted by another vehicle resulting in injury to vehicle occupants.</p>	Improbable	Minor	Medium	<p>Height clearances and tree conditions under review with arborist, it is anticipated that pruning will be required to various trees.</p> <p>Some residual overhang of trees is expected as part of the urban design of the space and to retain tree canopy coverage of the area. Ongoing review and maintenance may be required by WSU.</p>

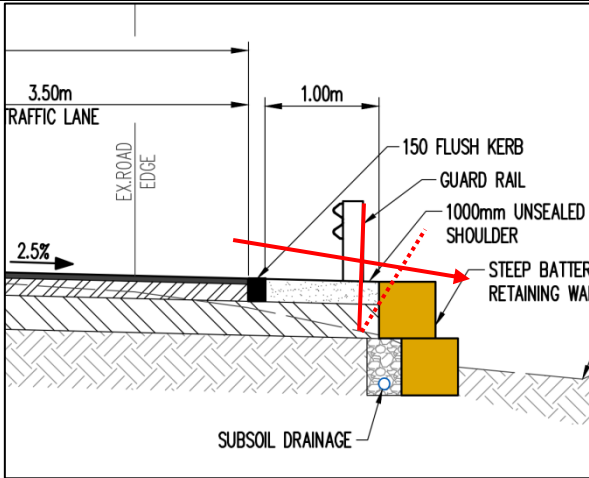
4. Barrier Post Support Extent of Works	<p>There is insufficient support provided behind the barrier post.</p> <p>There is a risk that an errant vehicle may not be contained by the barrier resulting in a vehicle reaching a hazard, snag/roll incidents and injury to occupants.</p>	Improbable	Serious	Medium	Road sections will be designed to provide the required support distance behind guard rails; design to manufacturer requirements once a barrier product is selected.

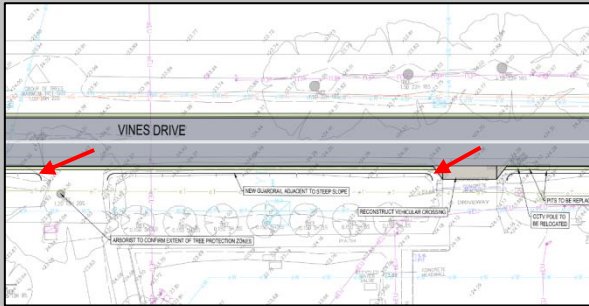
5. Barrier Terminals Extent of Works	<p>There are no barrier terminals provided.</p> <p>There is a risk that an errant vehicle may impact the exposed end of a barrier rail resulting in spearing of a barrier rail into a vehicle cabin and vehicle occupant.</p>

Probable	Serious	Intolerable	Terminal treatments to be provided; consider replacing barriers with a suitable swale/runoff treatment where appropriate.
6. Barrier Extents Extent of Works	<p>It is unclear to the audit team if the barrier point of need is met, particularly where short breaks are provided in the barrier system.</p> <p>There is no hazard free zone provided at barrier end points.</p>	Occasional	Minor	Medium	Swale area to be reviewed to remove points of need and delete barrier where possible.

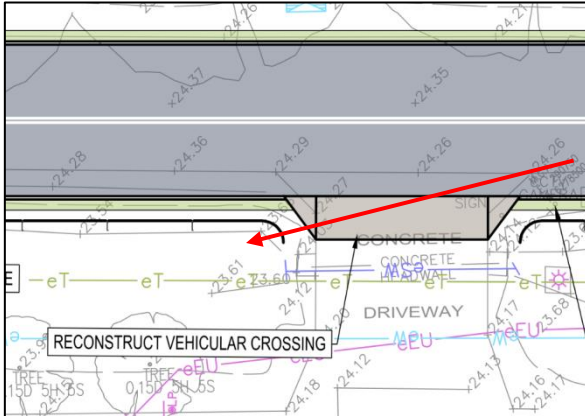
Item Location	Safety Hazard Finding	Frequency	Severity	Level Of Risk	Project Manager Response
	<p>There is a risk that an errant vehicle may impact a hazard behind a barrier end resulting in injury to vehicle occupants.</p>

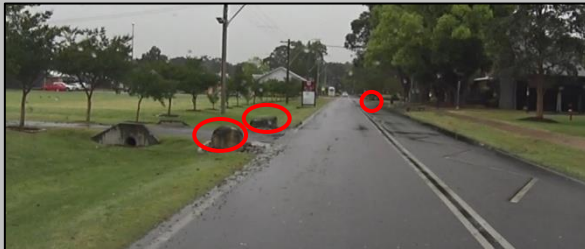
<p>7. Large Rocks Extent of Works</p>	<p>There are large rocks adjacent to the travel lane throughout the extent of works.</p> <p>There is a risk that an errant vehicle may impact a non-frangible hazard resulting in vehicle damage or injury to vehicle occupants.</p>

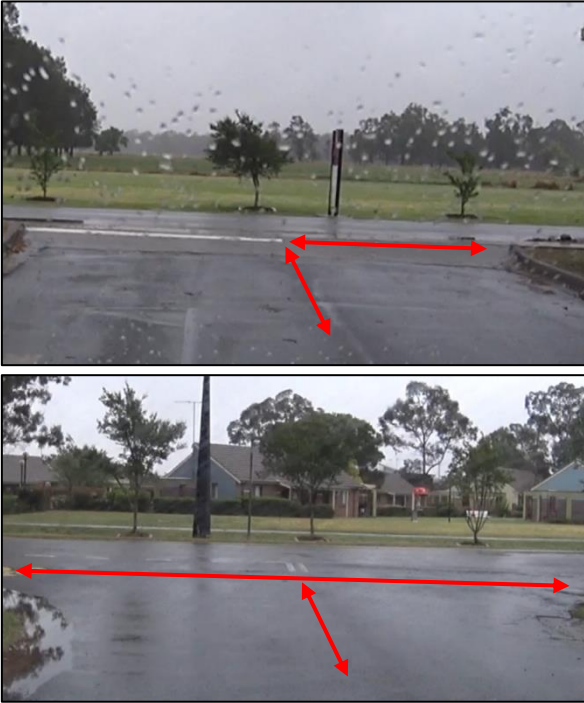
Occasional	Minor	Medium	To be reviewed with WSU and deleted where possible.
<p>8. Intersection Controls Extent of Works</p>	<p>The existing line marking and signage at intersection points is faded/damaged, particularly Horticulture Road.</p> <p>It is unclear to the audit team on the requirement to replace an intersection control with a vehicle crossing, tying into an existing road and leaving part of the intersection control signage and line marking in place.</p>	Probable	Minor	High	All new signs and line marking to new work.

Item Location	Safety Hazard Finding	Frequency	Severity	Level Of Risk	Project Manager Response
	<p>Incomplete arrangements may increase driver confusion.</p> <p>There is a risk at night or during adverse weather that a motorist may not sight the intersection point and approach the intersection with insufficient time to decelerate to a stop before entering the through lane resulting in side impact collisions from through vehicles.</p>

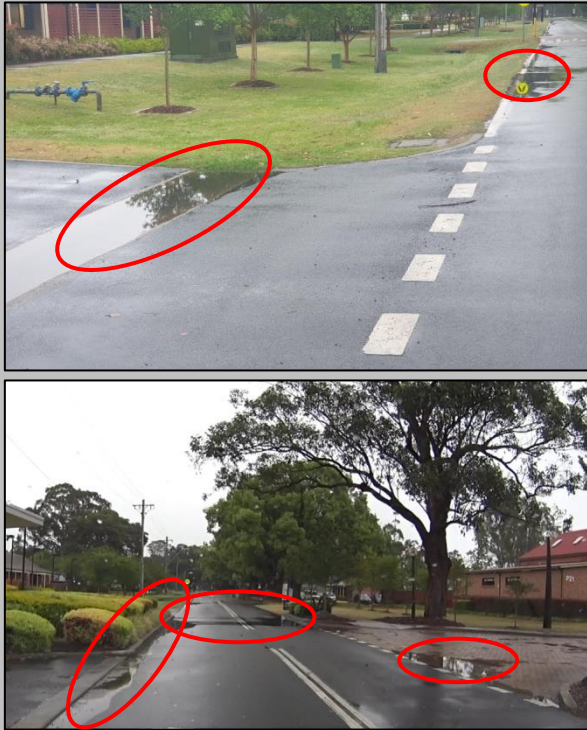
9. Ponding water Extent of works	<p>On site it was observed that pavement water was ponding against raised pedestrian crossings, against the raised grassed verge, at blocked drains and at pavement depressions throughout the site.</p> <p>Specific locations include Vines Drive at Yarramundi Road and side road opposite Yarramundi Road.</p>	Occasional	Minor	Medium	Stormwater strategy to be finalised in detailed design.

Item Location	Safety Hazard Finding	Frequency	Severity	Level Of Risk	Project Manager Response
	<p>There is a risk that ponding water may damage the pavement surface creating vehicle/motorcycle destabilisation incidents resulting in run-off-road or head-on collisions.</p> <p>There is a risk that water flows may erode the edge of the pavement resulting in vehicle snag/roll incidents.</p>

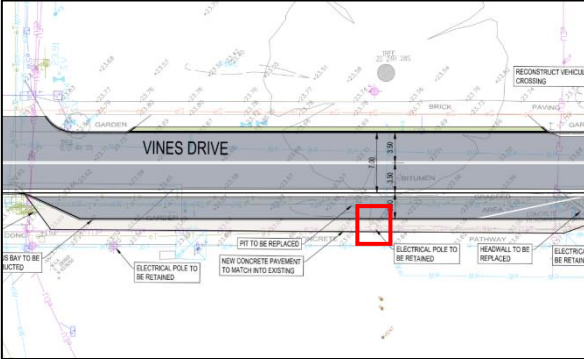
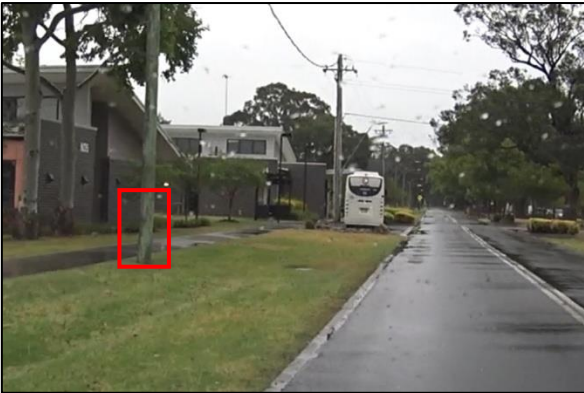
10. Existing Pole Bus Zone	<p>There is an existing pole to be retained at the back of kerb in the proposed bus zone.</p> <p>There is a risk that a bus entering the bay may impact the pole, resulting in vehicle damage, or that the falling pole may impact a waiting/passing pedestrian.</p>	Occasional	Limited	Low	Pole to be relocated if possible (TBC by RCC/WSU).

Item Location	Safety Hazard Finding	Frequency	Severity	Level Of Risk	Project Manager Response
	<p>There is a risk that the pole may restrict access to the bus doors, including mid/rear doors, and particularly for elderly, ambulant, disabled passengers attempting to enter/exit the bus.</p>

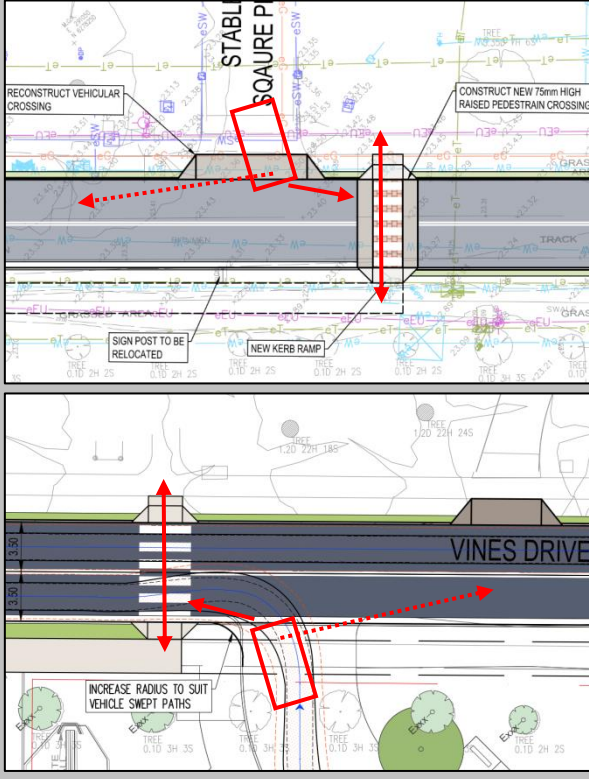
11. Pedestrian Crossing Proximity Extent of Works	<p>There are pedestrian crossings proposed adjacent to intersection points throughout the extent of works.</p> <p>There is a risk that a motorist exiting the intersection may focus on vehicles approaching from the right and not sight a pedestrian entering the crossing from the left resulting in pedestrian-vehicle collisions.</p> <p>This risk is increased given an inconsistent application of pedestrian crossing infrastructure such as approach</p>	Occasional	Serious	High	Distance from intersections/driveways to be increased where possible, or pedestrian crossings to be deleted if demand is low to avoid confusion.

Item Location	Safety Hazard Finding	Frequency	Severity	Level Of Risk	Project Manager Response
	<p>signage from all directions, line marking, and raised thresholds.</p> <p>This risk is increased where vehicle and pedestrian volumes are increasing.</p>

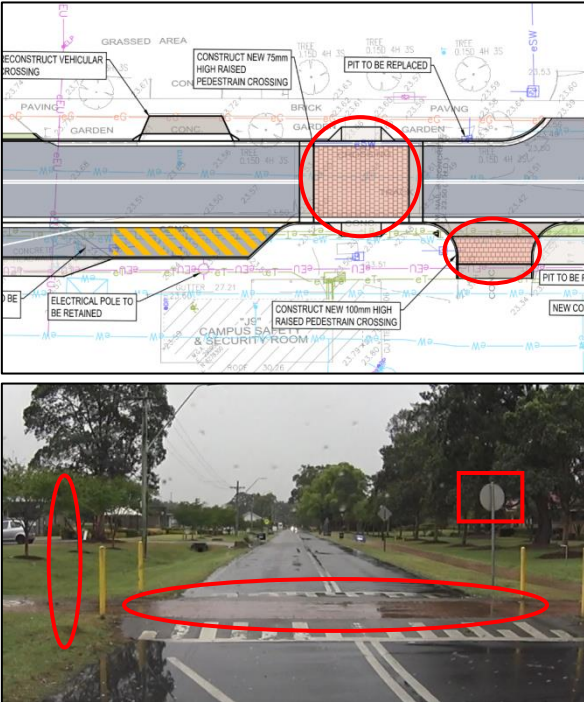
12. Pedestrian Crossing Sight Extent of Works	<p>There are multiple pedestrian crossings, both existing and proposed, without line marking, signage and lighting.</p> <p>The legal requirement for a motorist to give-way at a pedestrian crossing that is not line marked and only sign posted in one direction is not clear.</p>	Improbable	Serious	Medium	Consistency of crossing treatments is under review. Any crossings in the final design will have line marking and signage in both directions.

Item Location	Safety Hazard Finding	Frequency	Severity	Level Of Risk	Project Manager Response
	<p>An inconsistent approach to pedestrian facilities may increase driver confusion/frustration, and decrease pedestrian compliance.</p> <p>There is a risk that an approaching motorist may not anticipate a pedestrian stepping out into the travel lane resulting in pedestrian-vehicle collisions.</p>

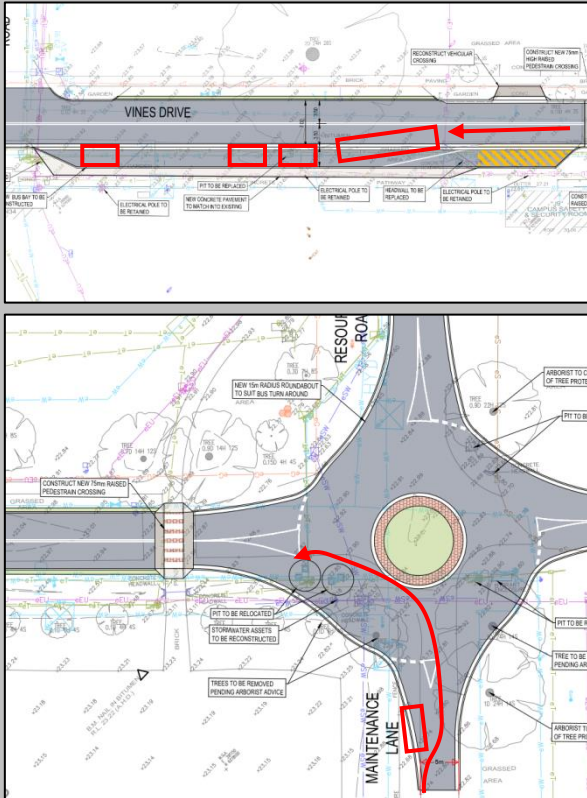
13. Signage Extent of Works	<p>There is insufficient signage provided throughout the extent of works including roundabouts (no stopping, give way), pedestrian crossings, bus stop/contractor parking restrictions, DO-PU parking restrictions.</p> <p>There is a risk that a motorist may park/stop in a location that restricts through vehicles or pedestrian paths resulting in side-swipe collisions or pedestrian-vehicle collisions.</p>	Probable	Minor	High	Kerbside parking signage to be provided to all areas. Bus restrictions will be nominated. No Stopping restrictions at the roundabout and other relevant locations will be nominated.

Item Location	Safety Hazard Finding	Frequency	Severity	Level Of Risk	Project Manager Response
	<p>There is a risk that a motorist may not sight approaching intersections, configurations, hazards due to parked vehicles resulting in run-off-road, side-impact or side swipe collisions.</p>

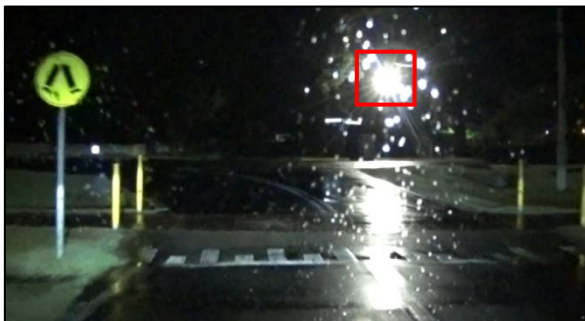
14. Lighting Roundabout	<p>There is no proposed lighting at the proposed roundabout. At the existing curve there is an existing flood light on a pole set back in a paddock that is directed into an eastbound driver's eyes.</p> <p>There is a risk at night or during adverse weather that a motorist may not sight the intersection configuration resulting in impacts with roadside</p>	Probable	Minor	High	Lighting anticipated to be provided at roundabout and pedestrian crossing locations, to be reviewed and confirmed by lighting/electrical consultant.

Item Location	Safety Hazard Finding	Frequency	Severity	Level Of Risk	Project Manager Response
	<p>infrastructure, pedestrians, or other vehicles circulating the roundabout.</p>

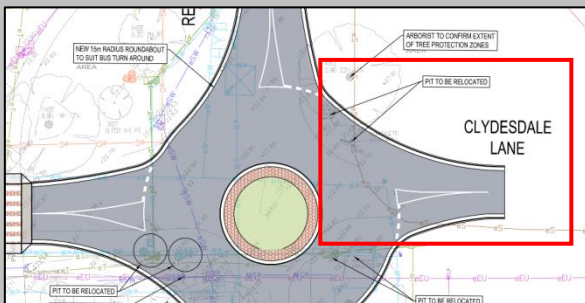
<p>15. Survey Clydesdale Lane</p>	<p>There is no survey provided at the Clydesdale Lane leg on the roundabout. The proposed alignment of the leg appears to be offset from Vines Drive and from the existing Clydesdale Lane. The proposed width does not match the existing width.</p> <p>There is a risk that staggered alignments and incomplete works may resulting in run-off-road incidents.</p>

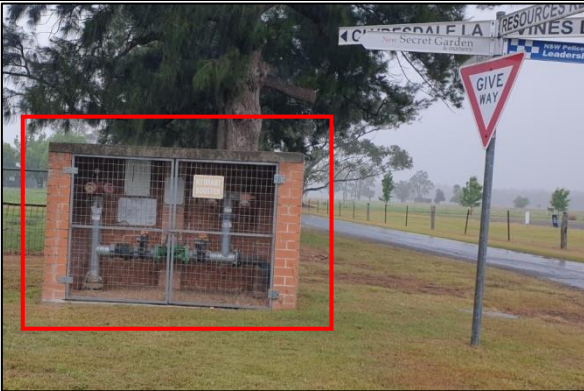
Probable	Limited	Medium	Further survey is being undertaken, final design will suit surveyed configuration.
<p>16. Infrastructure Clydesdale Lane</p>	<p>There is existing infrastructure at the intersection of Clydesdale Lane including a brick hydrant enclosure, stay pole, and CCTV pole.</p> <p>There is a risk that a pedestrian or motorist may impact hazards in pedestrian paths, clear zones, or in the travel lane.</p>	Frequent	Minor	Intolerable	Existing infrastructure to be relocated as part of roundabout works.

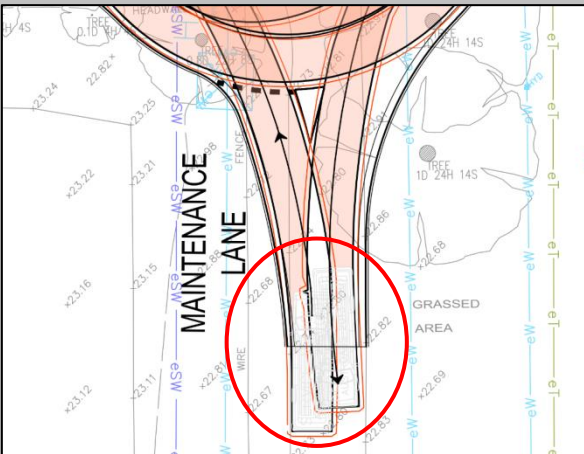
17. Width Maintenance Lane	<p>The turning path plan for the roundabout shows 2-way traffic colliding at the Maintenance Lane splitter island, however the Maintenance Lane Carpark turning path plan indicates there is sufficient width for 2-way traffic.</p> <p>There is a risk that the existing width on Maintenance Lane may not be sufficient for 2-way traffic resulting in side-swipe or head-on collisions with oncoming traffic, run-off-road incidents, or collisions with roadside infrastructure, hazards or pedestrians.</p>

Frequent	Minor	Intolerable	<p>Treatment for two-way traffic along Maintenance Lane is under review. Traffic movements are generally expected to be one-way (e.g. arrivals in the morning, departures in the afternoon) so limited two-way traffic is expected. A priority system can be designed, and will ensure sufficient space for vehicles off the circulating area of the roundabout.</p>

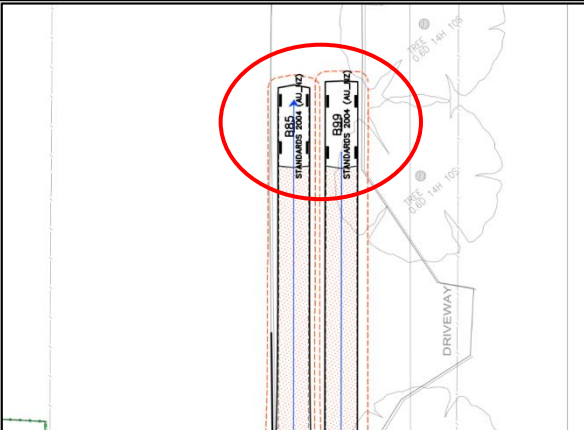
Item Location	Safety Hazard Finding	Frequency	Severity	Level Of Risk	Project Manager Response
18. Vehicle Restrictions Roundabout

Occasional	Minor	Medium	Vehicle restriction signage will be reviewed and considered with the university, however large vehicles may be required to service the surrounding facilities. No Through Road signage may be suitable.
	<p>There are roads with no through route, turn around areas, or termination warnings provided at decision points.</p> <p>There are no vehicle restrictions provided where large vehicle turning paths are not provided to confirm access is achievable.</p> <p>There is a risk that a vehicle may enter a restricted road and undertake unsafe movements such as long reversing, U-turns, multiple point turns, or mounting pedestrian areas to exit out of the road resulting in pedestrian-vehicle collisions, collisions with other vehicles or roadside infrastructure.</p>

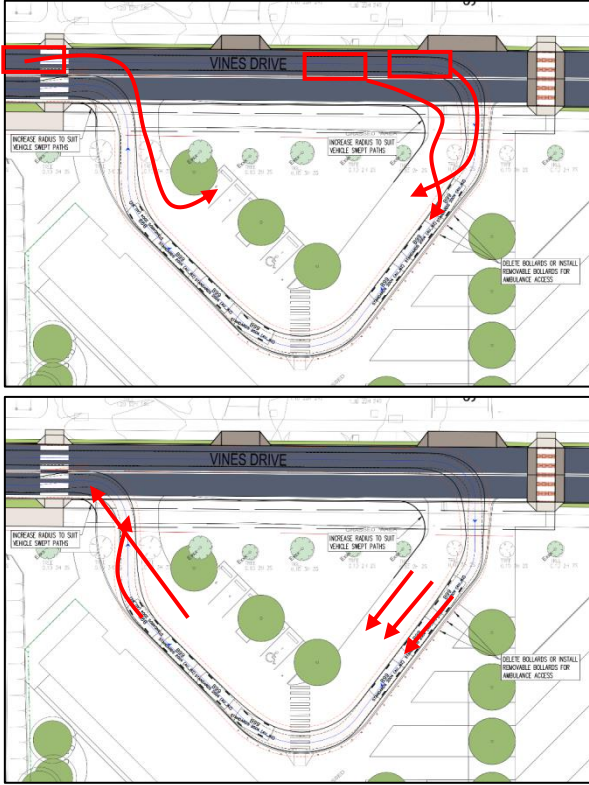
Item Location	Safety Hazard Finding	Frequency	Severity	Level Of Risk	Project Manager Response
20. Delineation DO-PU	<p>There is insufficient delineation provided to advise motorists of the proposed entry/access points, lane configuration and parking areas.</p> <p>There is a risk that a motorist may not comprehend the proposed arrangement and attempt unsafe manoeuvres including U-turns, 3 point turns, long reversing movements, angled parking or stopping in unsafe locations resulting in pedestrian-vehicle collisions, vehicle sideswipe collisions or impacts with roadside infrastructure.</p>

Probable	Minor	High	Signage and line marking plan under development. One-way circulating system including 'No Entry' signage will be provided. Wide driveway (multiple lanes across) are required to facilitate bus/coach movements but can be line marked to a narrower access for typical car usage.

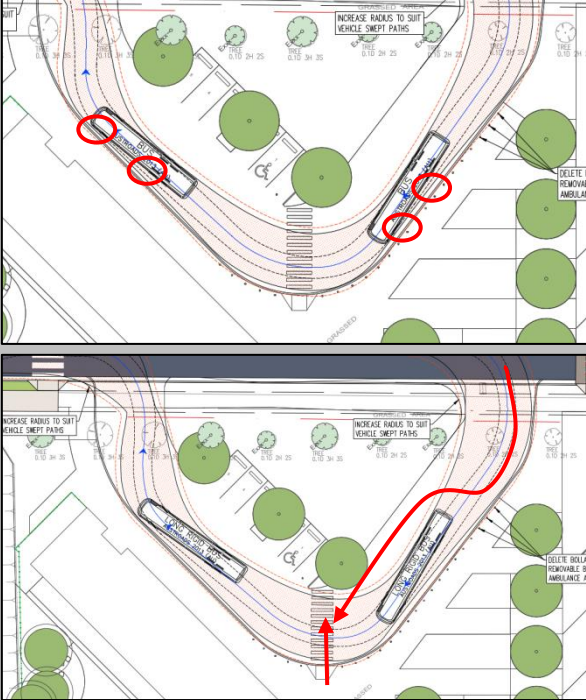
Item Location	Safety Hazard Finding	Frequency	Severity	Level Of Risk	Project Manager Response
21. Large Vehicle Angle DO-PU	<p>The provided turn paths for the large vehicle in the DO-PU facility indicates the vehicle cannot pull up parallel to the kerb, particularly at mid/rear doors.</p> <p>There is a risk that large vehicle may pull up a significant distance from the kerb and require a pedestrian to step across a wide gap or step down onto the road and up to the bus/kerb resulting in trip-fall injuries.</p> <p>There is a risk that a stopped bus may partially block the through lane, encouraging a motorist to travel around the bus in close proximity to a pedestrian crossing, resulting in pedestrian-vehicle collisions.</p>

Probable	Limited	Medium	Acknowledged that some blockages may occur for the largest vehicles. Buses to be encouraged to use Vines Drive bus stop wherever possible. Buses may be required to manoeuvre to be parallel / closer to the kerb.

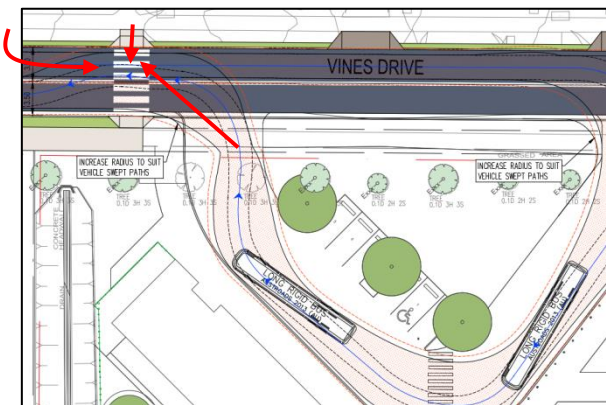
Item Location	Safety Hazard Finding	Frequency	Severity	Level Of Risk	Project Manager Response
22. Large Vehicle Turning DO-PU	<p>The provided turning paths show a large vehicle requiring oncoming travel lanes to exit the DO-PU area in close proximity to intersections and pedestrian crossings.</p> <p>It is unclear to the audit team of the proposed timing of small vehicles and large vehicles using the DO-PU area.</p> <p>There is a risk that a turning vehicle may impact a pedestrian or an oncoming/turning/queued vehicle.</p>

Occasional	Minor	Medium	Frequency of buses is expected to be very low, and not at times when car usage for the drop-off and pick-up area is occurring. Acknowledged that large vehicles may need to use the full carriageway of Vines Drive; visibility in this area is generally good. Pedestrian crossing to be deleted to avoid conflict of priority.

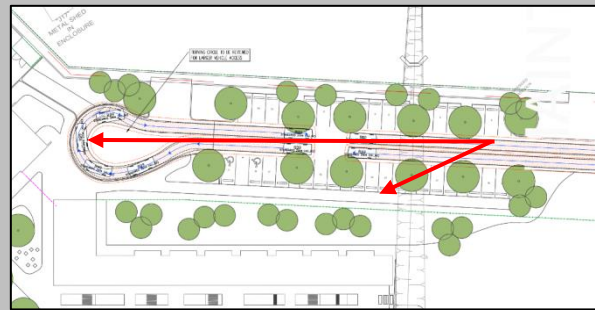
23. Pedestrian Access Southern Parking	<p>It is unclear to the audit team of the proposed pedestrian access from parking spaces to facilities, particularly for the northern side.</p> <p>There is a risk that a pedestrian may travel along vehicle lanes resulting in pedestrian-vehicle collisions.</p>

Improbable	Minor	Low	Footpath is provided along southern side of car park. Some pedestrian activity through the car park aisle may occur.

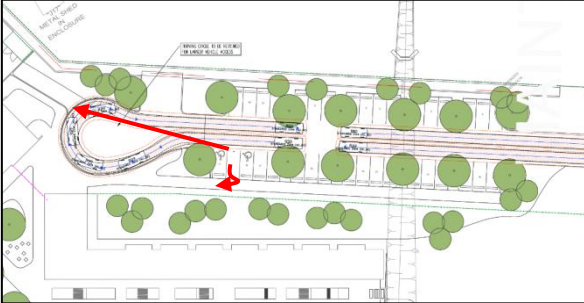
Item Location	Safety Hazard Finding	Frequency	Severity	Level Of Risk	Project Manager Response
24. Disabled Access Southern Parking	<p>It is unclear to the audit team of disabled access from disabled parking spaces to facilities, particularly at kerbs and paths.</p> <p>There is a risk that a disabled pedestrian may trip/fall at the kerb or may attempt to access the path at another location and enter the circulating aisle/ access road resulting in pedestrian-vehicle collisions.</p>

Improbable	Minor	Low	Flush path or kerb ramp to be provided from accessible spaces.
