School Infrastructure NSW
Hazardous Building Materials Survey

Fort Street Public School
Observatory Hill, Upper Fort Street,
Millers Point, NSW

8 August 2019

56262/123,436 (Rev 1)

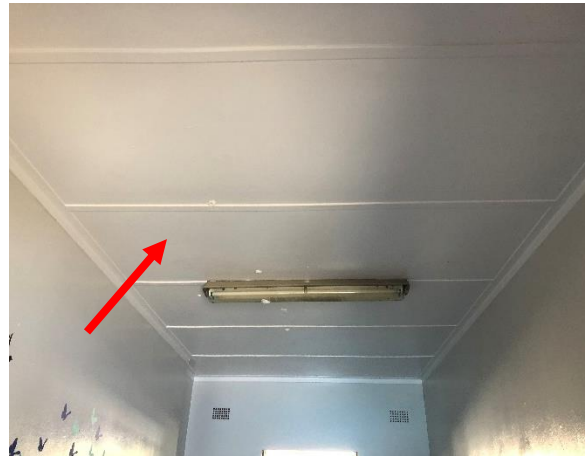
Photo 2: Building A, asbestos containing fibre cement sheeting to ceiling of Room R0012

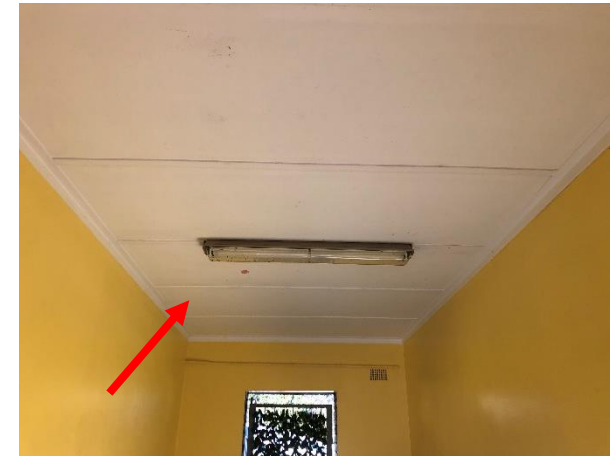
Photo 3: Building A, asbestos containing fibre cement sheeting to ceiling of Room R0015

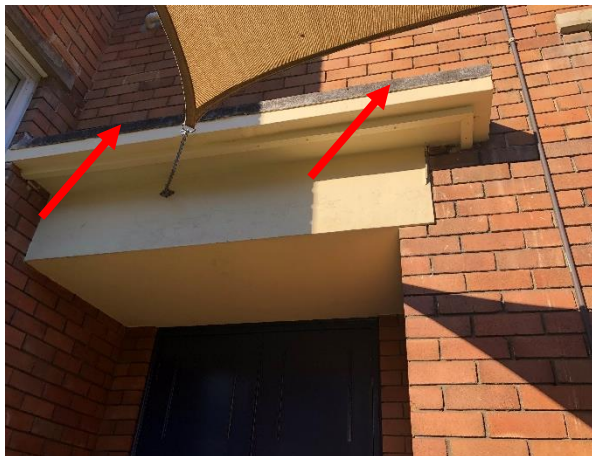
Photo 4: Building A, asbestos containing bituminous membrane to the external concrete roof of Room R0024

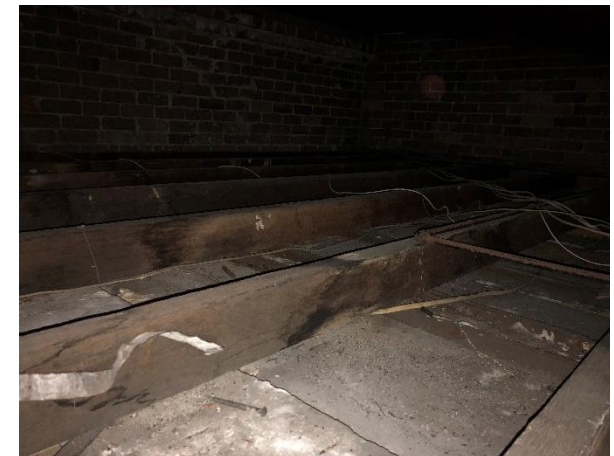
- Asbestos containing weathered fibre cement fragments, bituminous fragments and loose fibre bundles within settled dust (A-AD01) was identified within the roof void (accessed from Room R1011). This material is classified as friable asbestos and is assumed to be present throughout the roof void.

Photo 6: Building A, asbestos and lead containing settled dust within the roof void

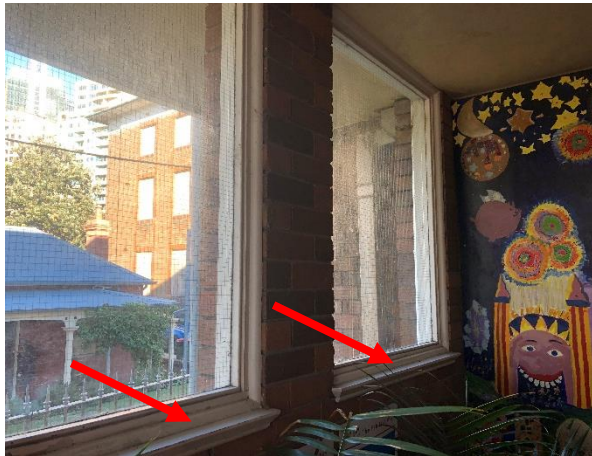
- A number of lead and non-lead based paint systems were identified throughout the structure as discussed below:
 - Lead based cream paint (A-LP01, 0.15% w/w) was identified to the external timber windows of Room R0005. This paint system was in fair condition with minor peeling and flaking observed.

Photo 7: Building A, lead based cream paint to the external timber windows in Room R0005

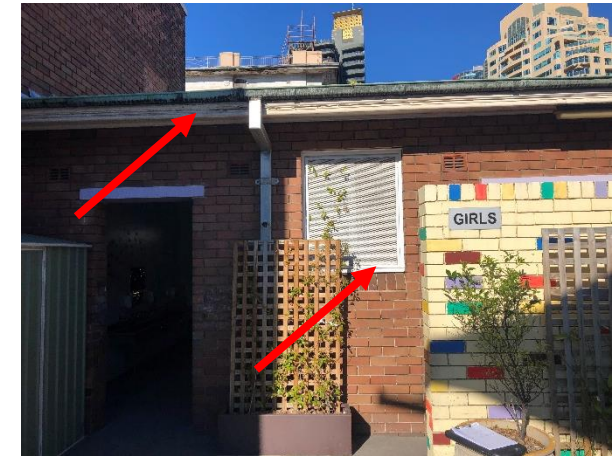
- Lead based white paint (A-LP04, 0.72% w/w) was identified to the external timber fascia and window frames of the toilet block. This paint system was in fair condition with minor peeling and flaking observed.

Photo 9: Building A, lead based white paint to the external timber windows and fascia of the toilet block

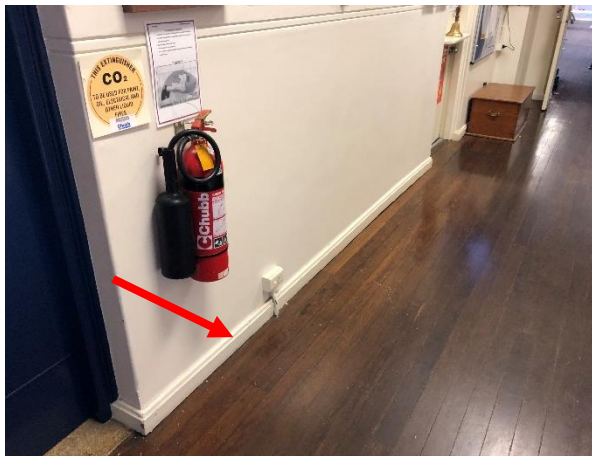
- Non-lead based yellow paint (A-LP05, < 0.01% w/w) was identified to the internal walls of Room R0014.
 - Lead based cream paint (A-LP06, 2.7% w/w) was identified to the timber skirting boards throughout the ground floor and first floor. This paint system was in fair condition with minor damage observed.

Photo 10: Building A, lead based white paint to the timber skirting boards throughout the ground floor and first floor

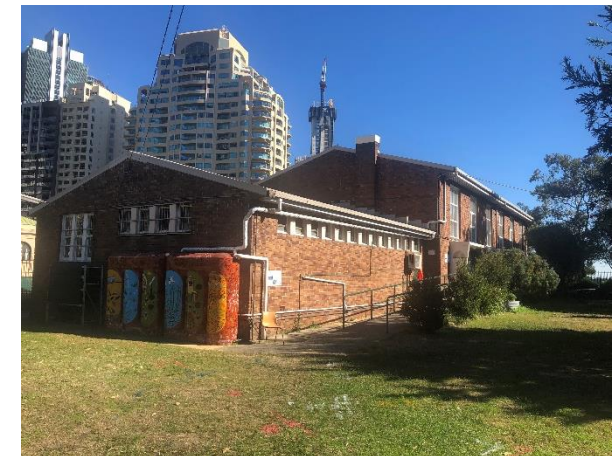
Photo 12: Overview of Building B (EEC)

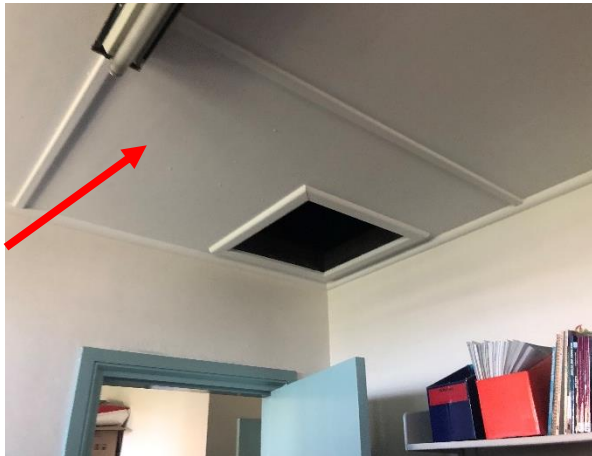
Photo 13: Building B (EEC), asbestos containing fibre cement sheeting to the ceiling of Room R0002

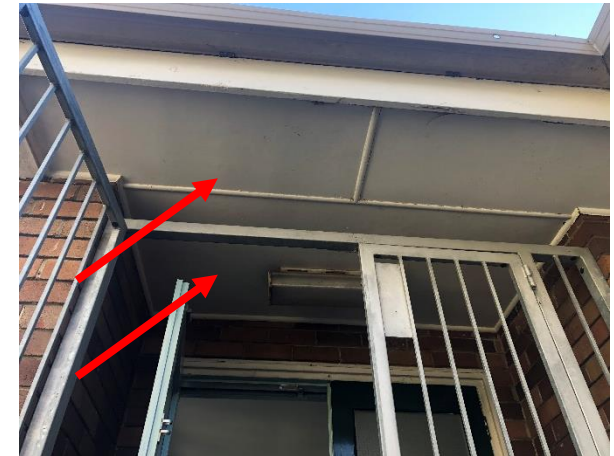
Photo 15: Building B (EEC), asbestos containing fibre cement sheeting to the external soffit lining of Room R0007

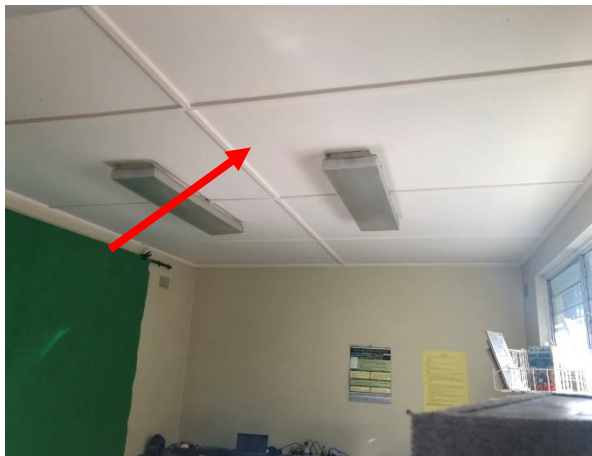
Photo 16: Building B (EEC), asbestos containing fibre cement sheeting to ceiling of Room R0010

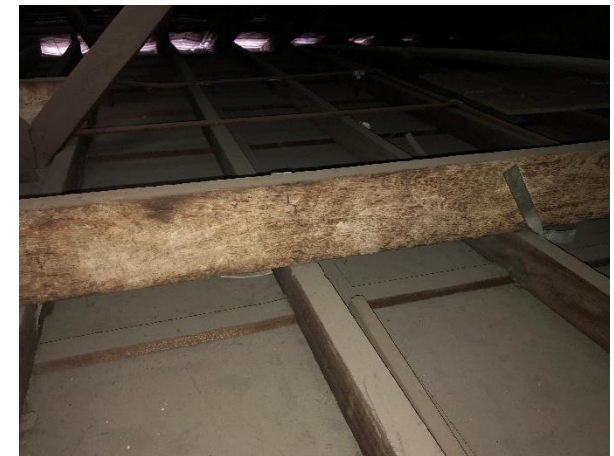
- Ceiling of Room R0010.
- Asbestos containing loose fibre bundles within settled dust (B-AD02) was identified to the surface of the roof beams within the eastern roof void. This dust is classified as friable asbestos. Another sample of settled dust was collected from the floor of the eastern roof void (B-AD01) and was found not to contain asbestos. As loose fibre bundles have been detected within the settled dust the entire eastern roof void should be assumed to be impacted with friable asbestos.

Photo 18: Building B (EEC), asbestos and lead containing settled dust within the eastern roof void

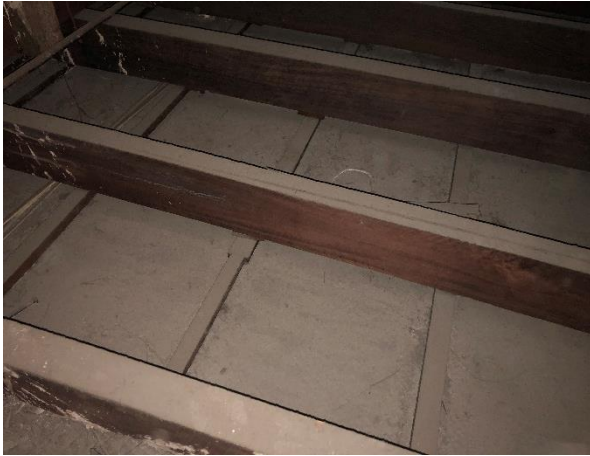
- Asbestos containing loose fibre bundles within settled dust (B-AD03) was identified to the floor surface within the western roof void. This dust is classified as friable asbestos and it should be assumed that the entire western roof void is impacted with friable asbestos.

Photo 19: Building B (EEC), asbestos and lead containing settled dust within the western roof void

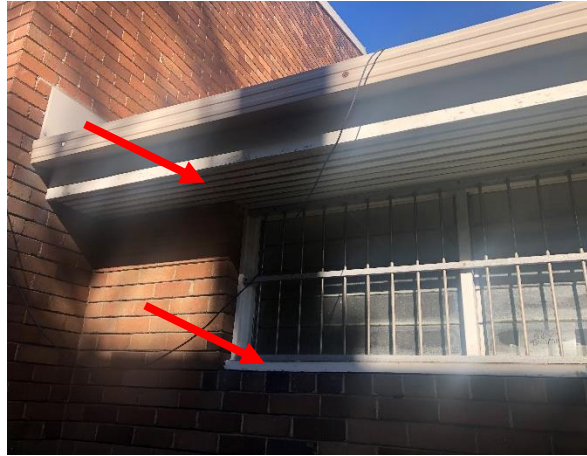
- Lead based white paint (B-LP03, 1.2% w/w) was identified the external timber windows and eaves. This paint system was in fair condition with minor peeling and flaking observed.

Photo 20: Building B (EEC), lead based white paint to external timber windows and eaves

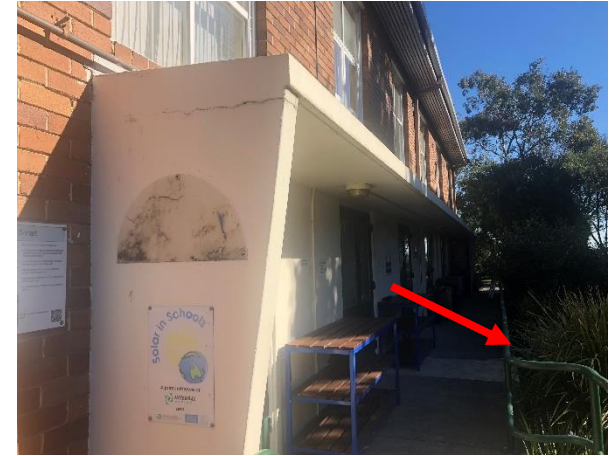
- Lead based green paint (B-LP04, 0.82% w/w) was identified to the external metal handrails. This paint system was in fair condition with minor peeling and flaking observed.

Photo 21: Building B (EEC), lead based green paint to external metal handrails

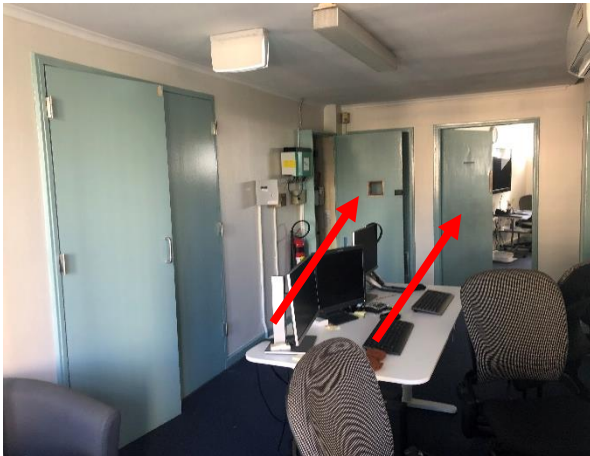
- Lead based blue/green paint (B-LP07, 0.18% w/w) was identified to the internal doors and architraves throughout the office portion of the building (Rooms R0001 to R0006, R0008, R0014 and R0016. This paint system was in good condition with no peeling or flaking observed.

Photo 22: Building B (EEC), lead based blue/green paint to doors and architraves in Room R0008

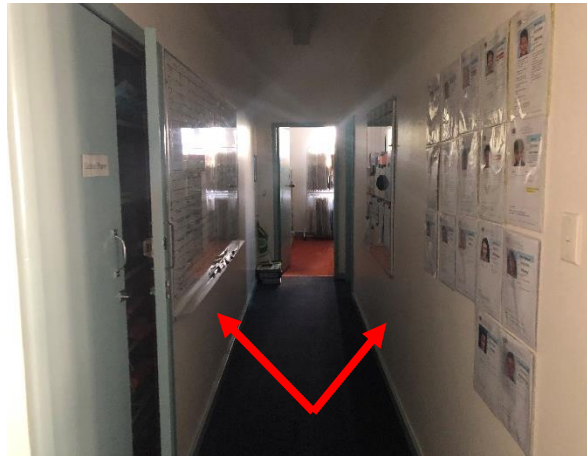
- Lead based white/cream paint (B-LP08, 1.9% w/w) was identified to the internal walls of Rooms R0001 to R0006, R0008, R0014 and R0016. This paint system was in good condition with no peeling or flaking observed.

Photo 23: Building B (EEC), lead based white/cream paint to internal walls in Room R0008

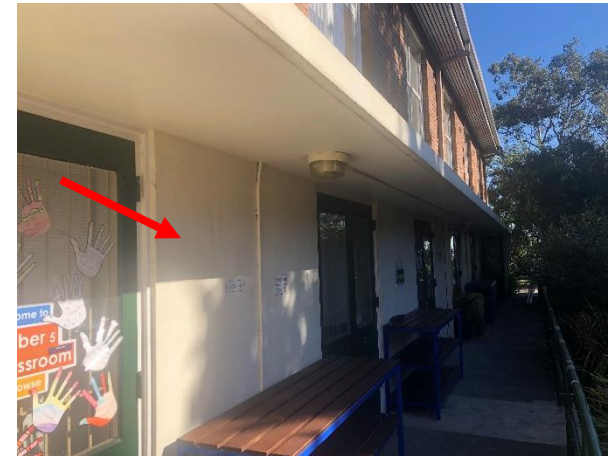
- A number of lead based paint systems were identified throughout the structure as discussed below:
 - Lead based cream paint (B-LP01, 1.5% w/w) was identified to the lower external walls to the northern aspect of the structure (Room R0012). This paint system was in good condition with no peeling or flaking observed.

Photo 24: Building B (EEC), lead based cream paint to lower external walls in Room R0012

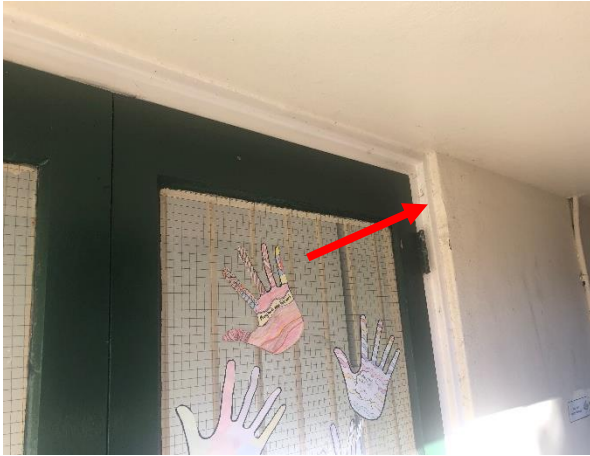
- Lead based white paint (B-LP02, 1.8% w/w) was identified to the external timber door frames of Room R0012. This paint system was in good condition with no peeling or flaking observed.

Photo 25: Building B (EEC), lead based white paint to external timber door frames in Room R0012

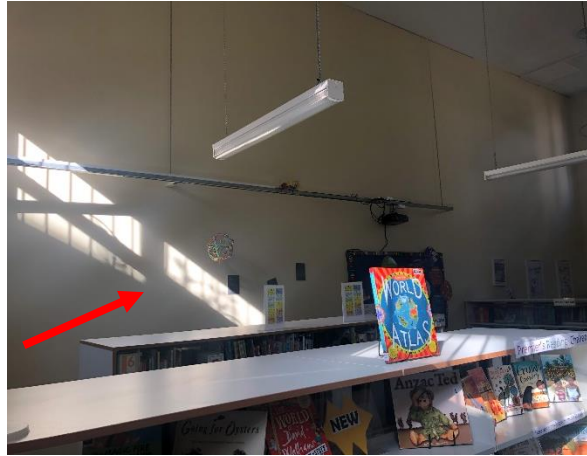
- Lead based cream paint (B-LP05, 0.17% w/w) was identified to the internal walls throughout Rooms R0010, R0017, R0018 and R0019. This paint system was in good condition with no peeling or flaking observed.

Photo 26: Building B (EEC), lead based cream paint to internal walls in Room R0017

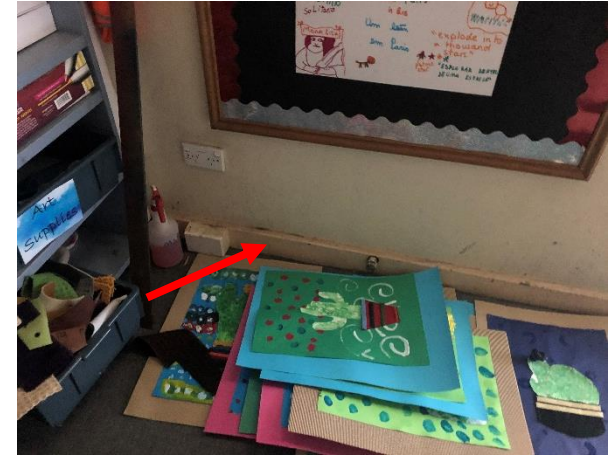
- Lead based cream/pink paint (B-LP06, 0.26% w/w) was identified to the skirting boards throughout Rooms R0010, R0017, R0018 and R0019. This paint system was in good condition with no peeling or flaking observed.

Photo 27: Building B (EEC), lead based cream/pink paint to skirting boards in Room R0018

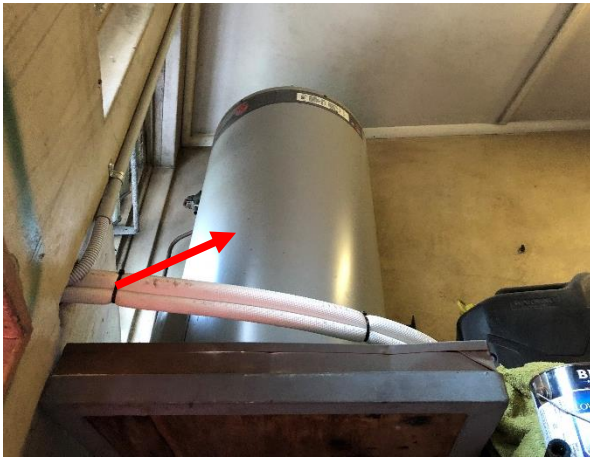
Photo 28: Building B (EEC), assumed SMF insulation core to hot water system in Room R0015

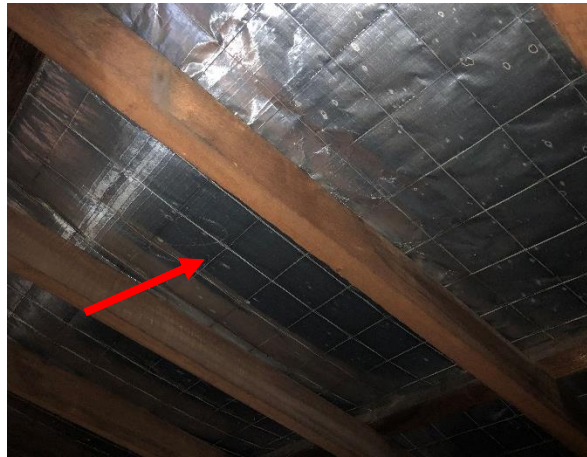
Photo 29: Building B (EEC), assumed SMF insulation to the roof sarking within the eastern roof void

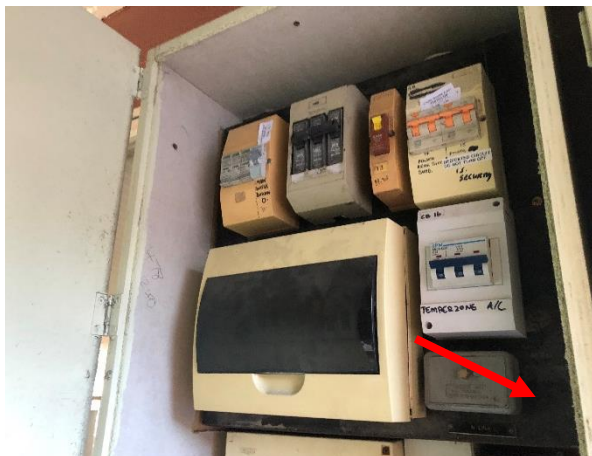
Photo 31: Cottage, assumed asbestos containing electrical backing board within the external electrical cabinet

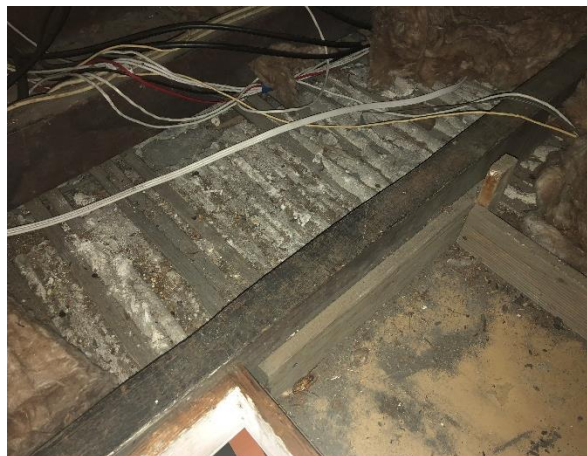
- Non-asbestos containing grey vinyl flooring (C-A02) was identified to the kitchen.
- Elevated levels of lead within accumulated dust above the adopted site criteria (C-LD01, 790 mg/kg) was identified within the roof void. This dust was also found not to contain asbestos (C-AD01)

Photo 32: Cottage, lead containing settled dust within the roof void

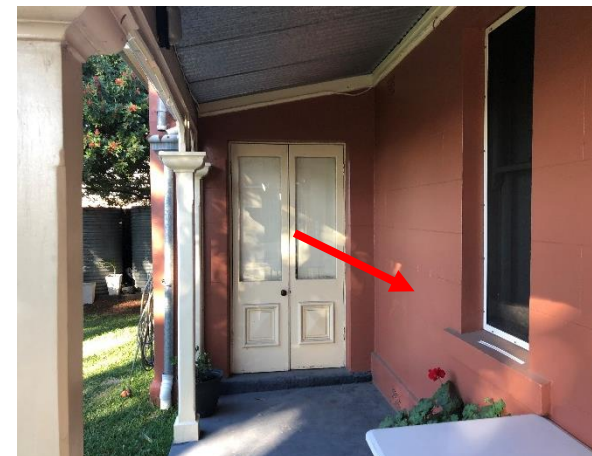
- Lead based brown paint (C-LP02, 2.2% w/w) was identified to the external walls. The paint system was in good condition with no peeling or flaking observed.

Photo 33: Cottage, lead based brown paint to the external walls

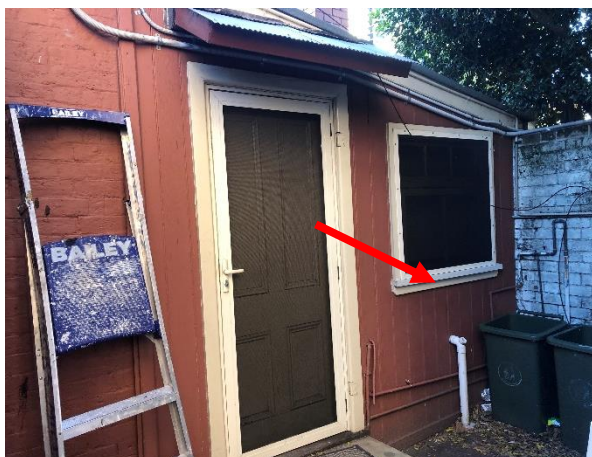
- Lead based white paint (C-LP03, 0.62% w/w) was identified to the external timber window sills and frames. The paint system was in good condition with no peeling or flaking observed.

Photo 34: Cottage, lead based white paint to the external timber window sills and frames

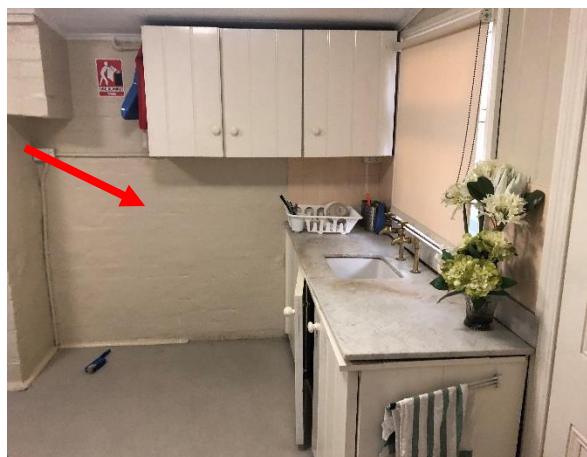
- Lead based cream paint (C-LP04, 1.4% w/w) was identified to the internal walls of the extension portion of the building. The paint system was in good condition with no peeling or flaking observed.

Photo 35: Cottage, lead based cream paint to the internal walls of the kitchen and office/store room

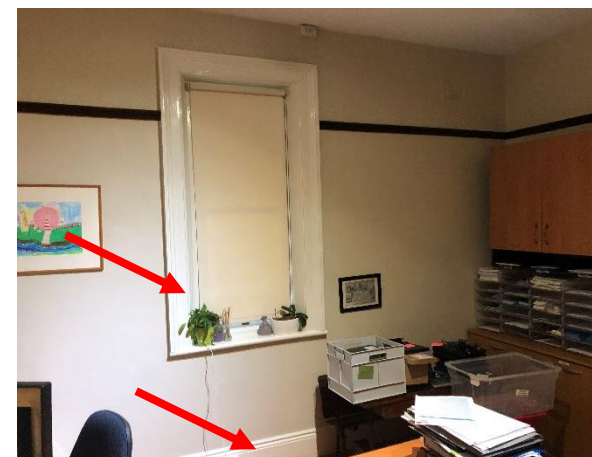
- Lead based white paint (C-LP05, 0.88% w/w) was identified to the internal timber window frames, skirting boards and architraves throughout. The paint system was in good condition with no peeling or flaking observed.

Photo 36: Cottage, lead based white paint to the internal timber window frames, skirting boards and architraves

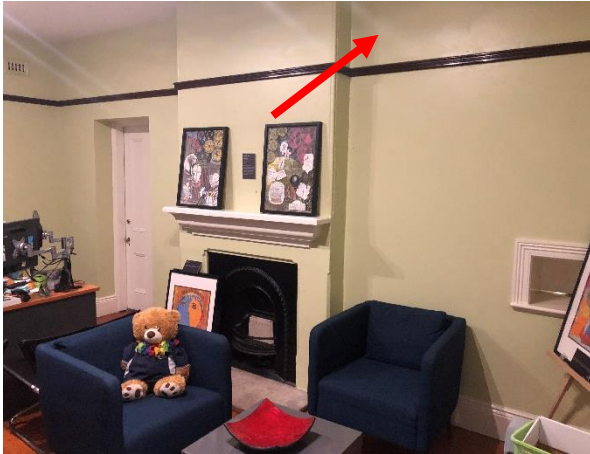
- Lead based cream paint (C-LP06, 1.6% w/w) was identified to the internal walls of the original portion of the building, above the timber picture rail. The paint system was in good condition with no peeling or flaking observed.

Photo 37: Cottage, lead based cream paint to the internal walls above the picture rail throughout the original portion

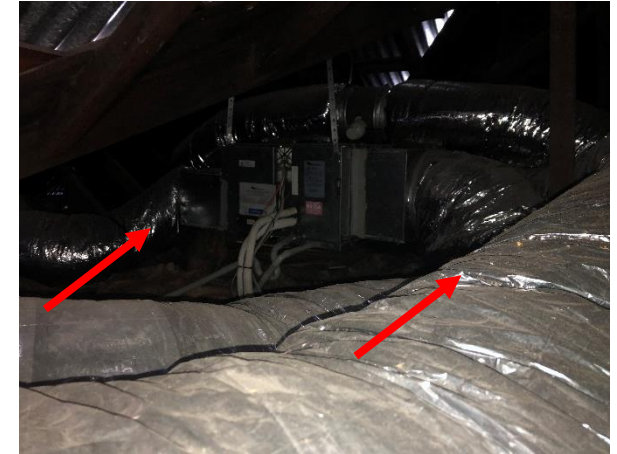
Photo 39: Cottage, assumed SMF insulation to the air conditioning ducting within the roof void

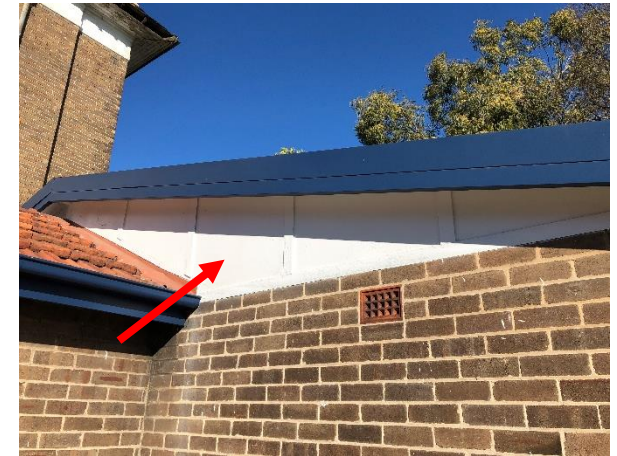
Photo 42: Garage, asbestos containing fibre cement sheeting to the northern gable panels of the southern portion

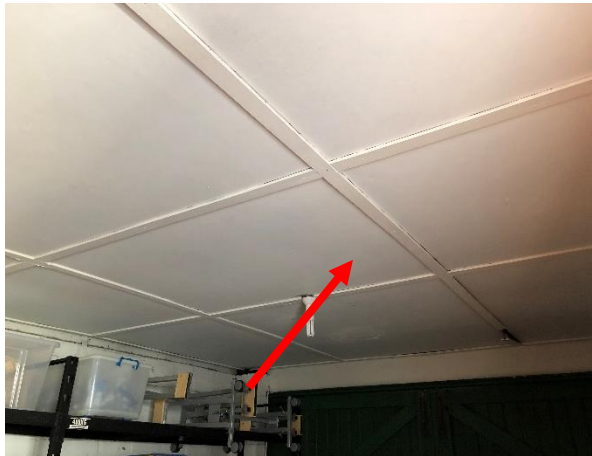
Photo 43: Garage, asbestos containing fibre cement sheeting to the ceiling of the northern portion

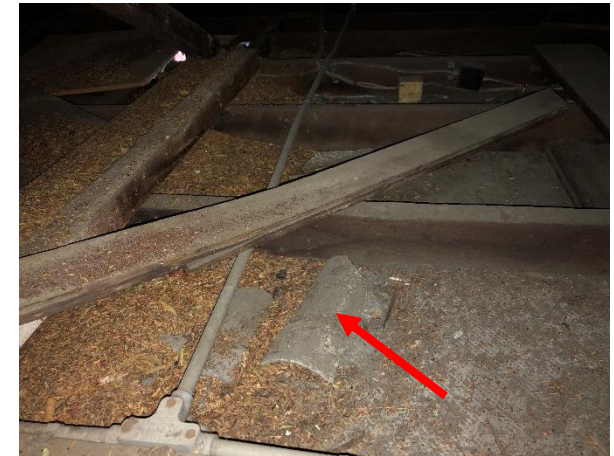
- Asbestos containing corrugated fibre cement sheeting in the form of scattered fragments and debris (G-A03) was identified in the roof void. Additionally, corrugated fibre cement fragments were observed to be lodged between the wire mesh and the timber roof structure.

Photo 45: Garage, asbestos containing corrugated fibre cement fragments and debris within roof void

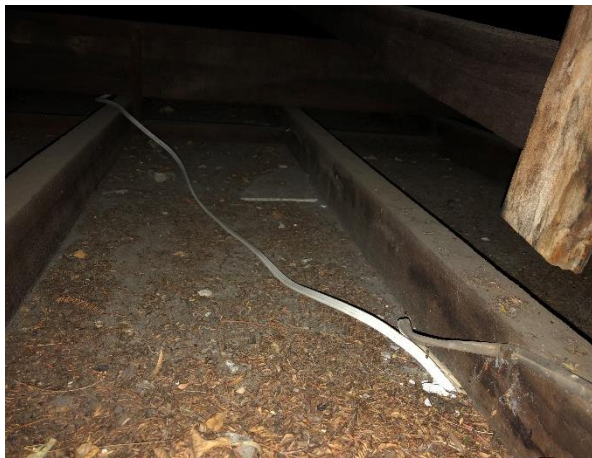
Photo 46: Garage, asbestos and lead containing settled dust within the roof void

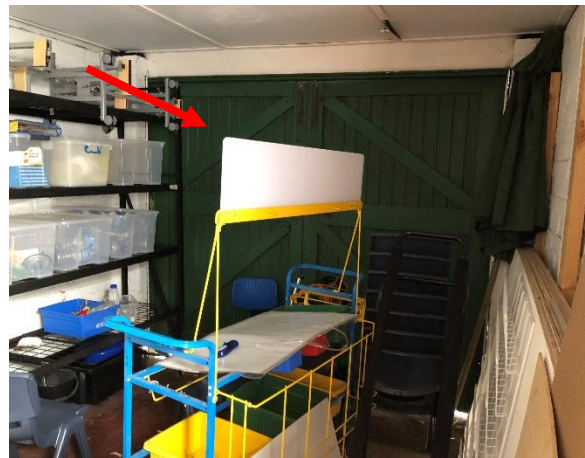
- A number of lead based paint systems were identified throughout the structure, as discussed below:
 - Lead based green and blue paint (G-LP01, 11% w/w) was identified to the timber doors to the garage and was in fair condition due to slight peeling and flaking of the paint.

Photo 47: Garage, lead based green/blue paint to the external timber doors

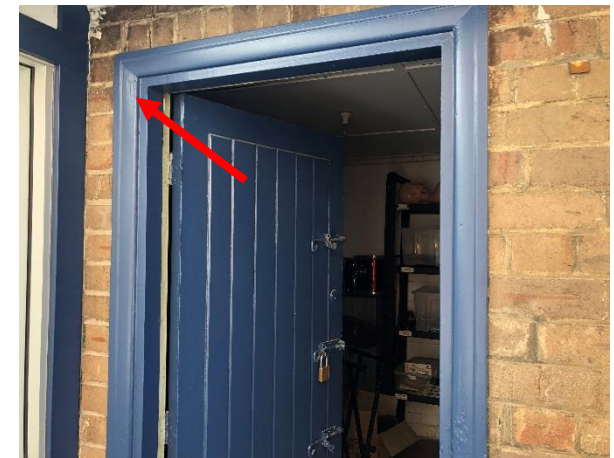
- Lead based blue paint (G-LP02, 32% w/w) was identified to the external framing of the garage doors and was in fair condition due to slight peeling and flaking of the paint.

Photo 48: Garage, lead based blue paint to the external timber door frames

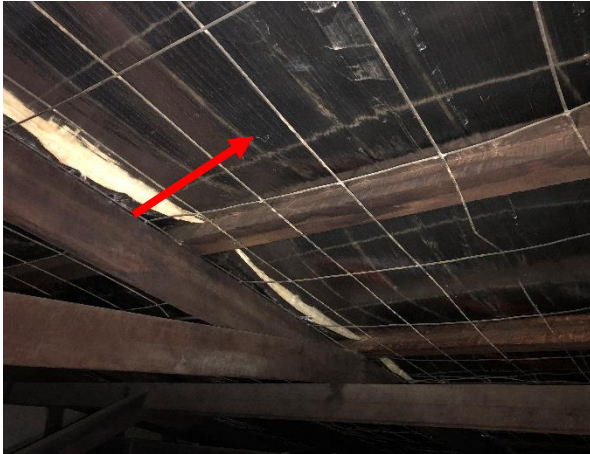
Photo 49: Garage, assumed SMF insulation to the roof sarking throughout the roof void

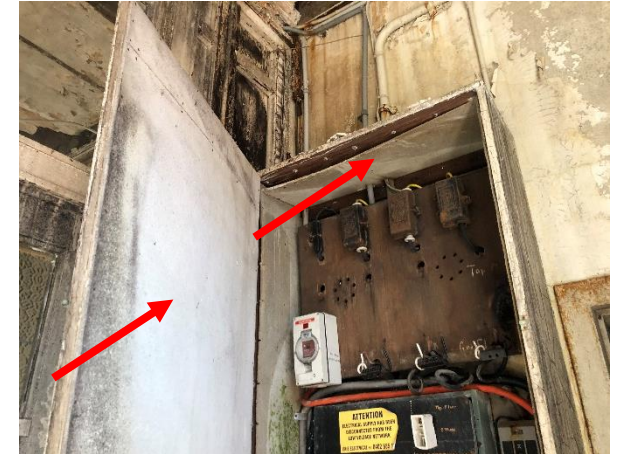
Photo 51: MET Building, asbestos containing fibre cement sheeting to the internal lining of the electrical cabinet within the ground floor entry

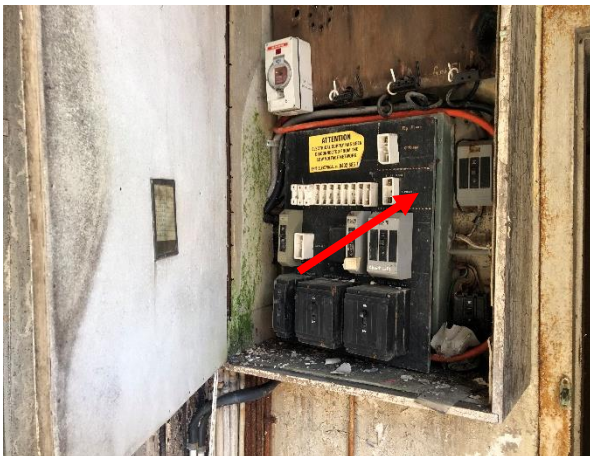
Photo 52: MET Building, asbestos containing electrical backing board within the electrical cabinet in the ground floor entry

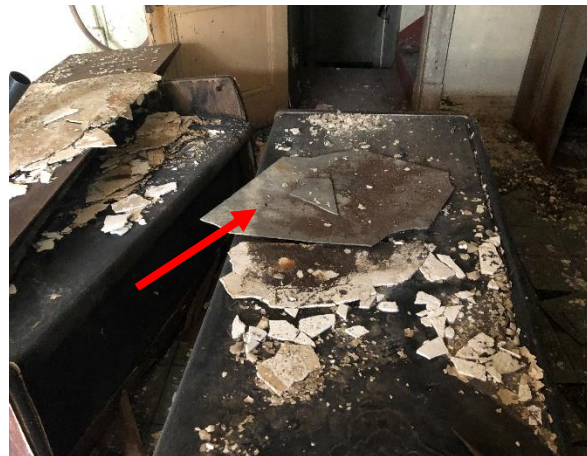
Photo 53: MET Building, asbestos containing fibre cement sheet debris on top of a desk on the ground floor

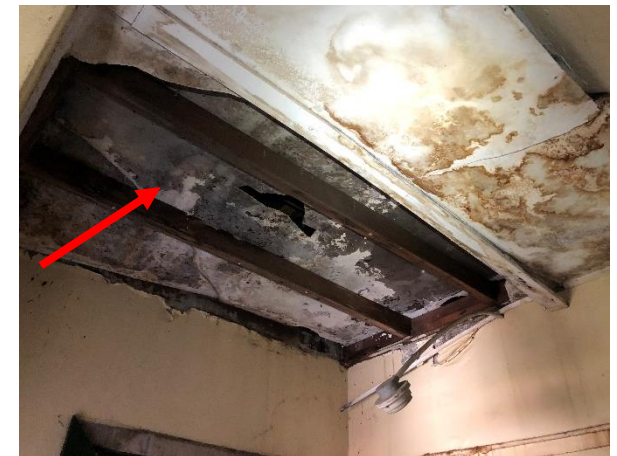
Photo 54: MET Building, asbestos containing fibre cement sheeting to the ceiling of the south-west stair landing on the second floor

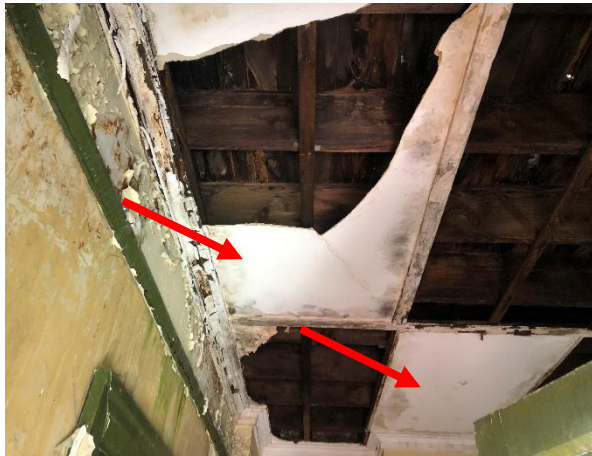
Photo 55: MET Building, assumed asbestos containing fibre cement sheet ceiling panels scattered throughout the first and second floors

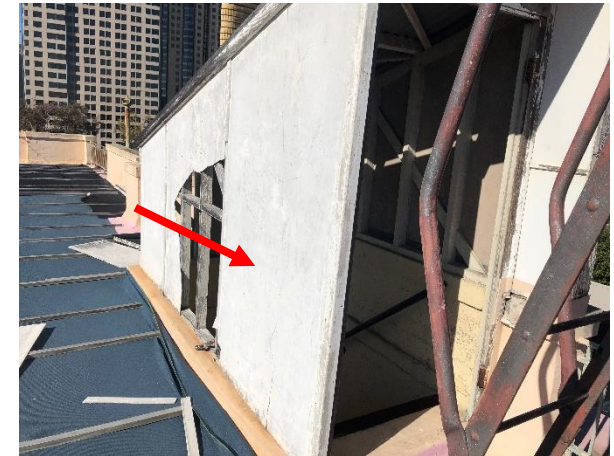
- Asbestos containing fibre cement sheeting (M-10) was identified to the external wall cladding to the south-west stairs on the roof. One of the FCS panels was observed to be significantly damaged with loose debris on the roof surface.

Photo 57: MET Building, asbestos containing fibre cement sheeting to the external wall cladding of the south-west stairs on the roof level

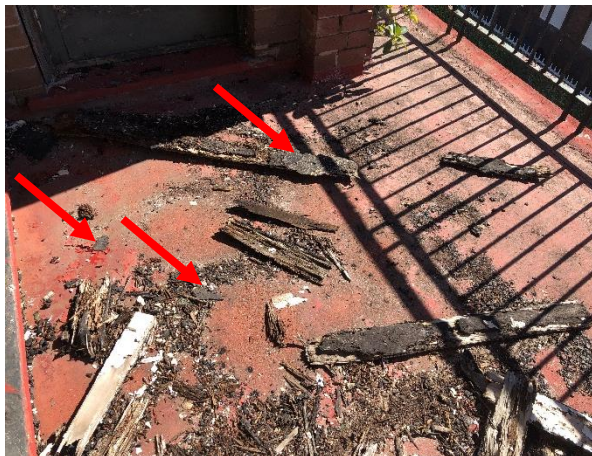
Photo 58: MET Building, asbestos containing bituminous sheet debris on the second floor

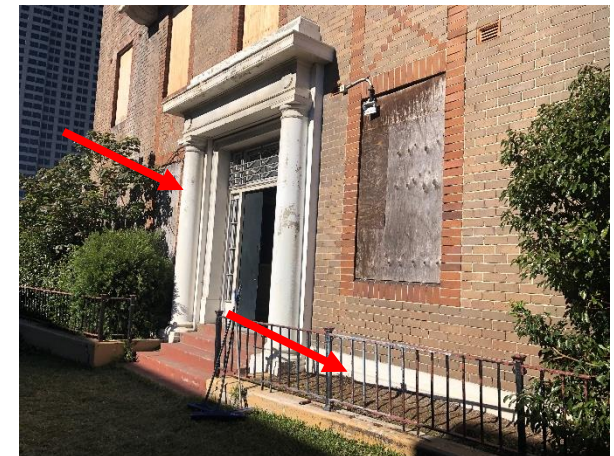
Photo 60: MET Building, lead based white paint to the external footings and northern entry

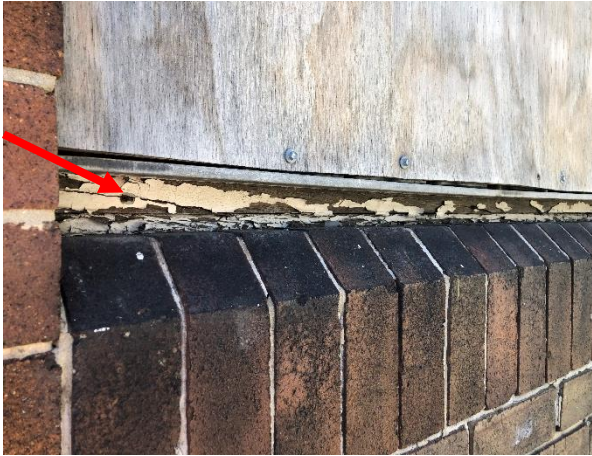
Photo 61: MET Building, lead based cream paint to the external timber windows

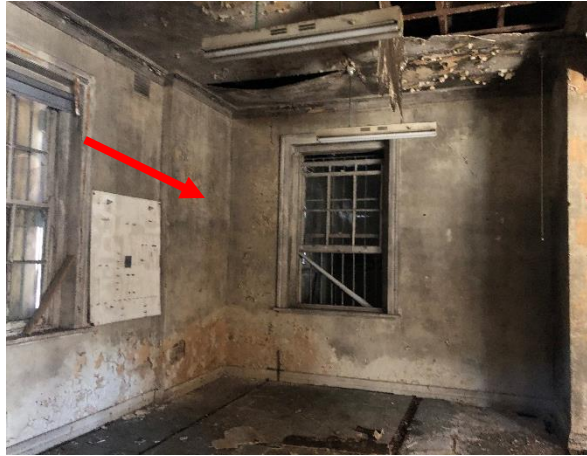
Photo 62: MET Building, lead based white paint to the ground floor internal walls

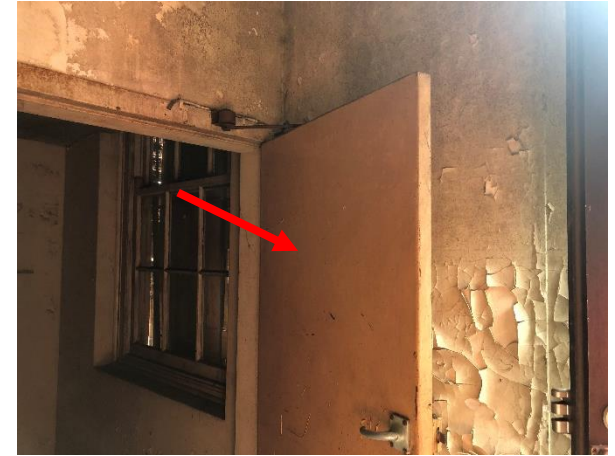
Photo 63: MET Building, lead based pink paint to the metal fire doors of the north and south-west stairs

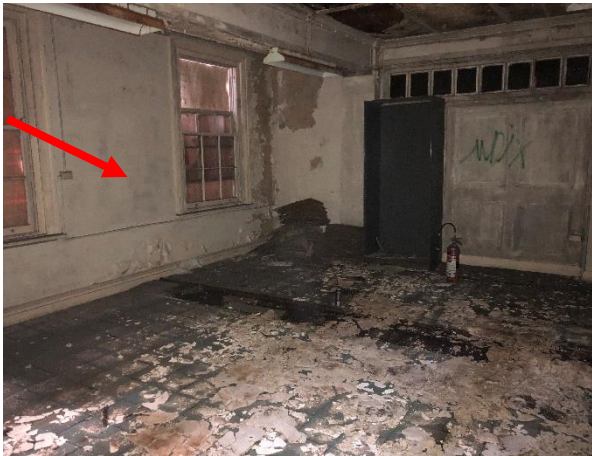
Photo 64: MET Building, lead based white paint to the first floor internal walls

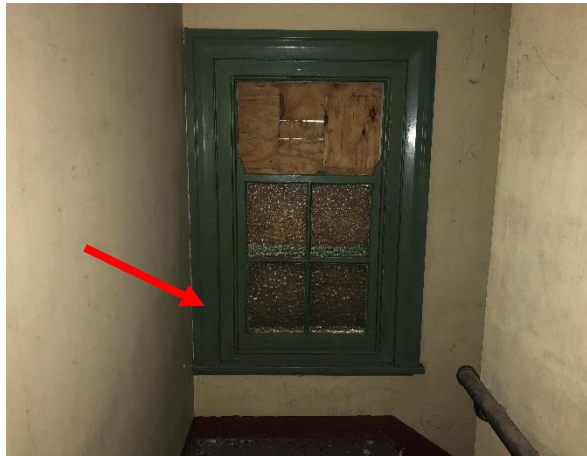
Photo 65: MET Building, lead based green paint to the timber windows and door frames within the south-west stairwell

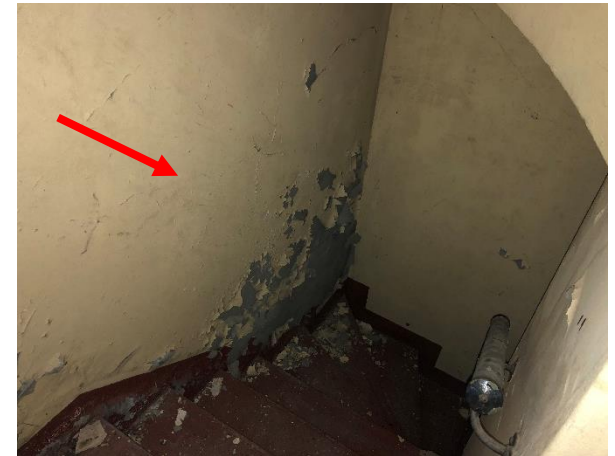
Photo 66: MET Building, lead based cream paint to the internal walls of the south-west stairwell

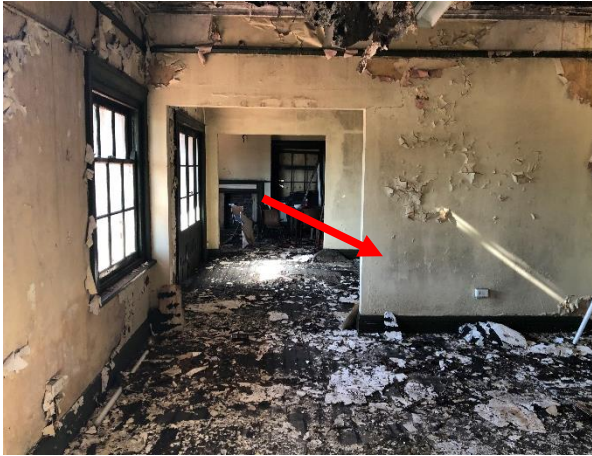
Photo 67: MET Building, lead based cream paint to the second floor internal walls

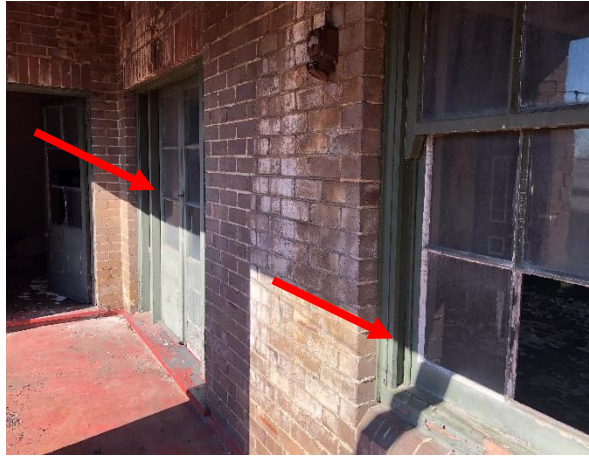
Photo 68: MET Building, lead based green paint to the external timber windows and doors of the second floor balcony

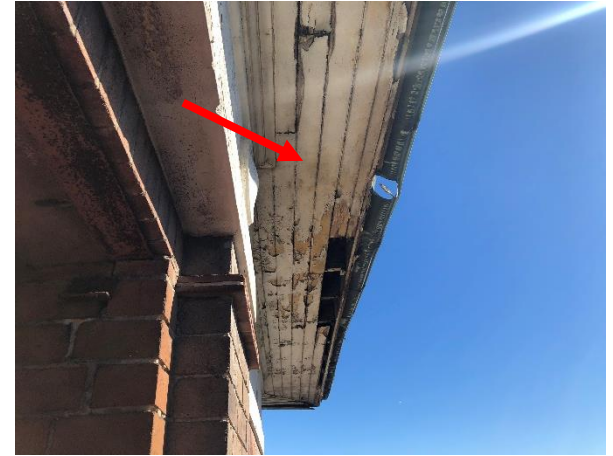
Photo 69: MET Building, lead based white paint to the eaves
