# Mirvac Projects Pty Ltd Preliminary Site Contamination Assessment

Harbourside Shopping Centre Darling Drive, Darling Harbour, Sydney

8 October 2020

### **Preliminary Site Contamination Assessment**

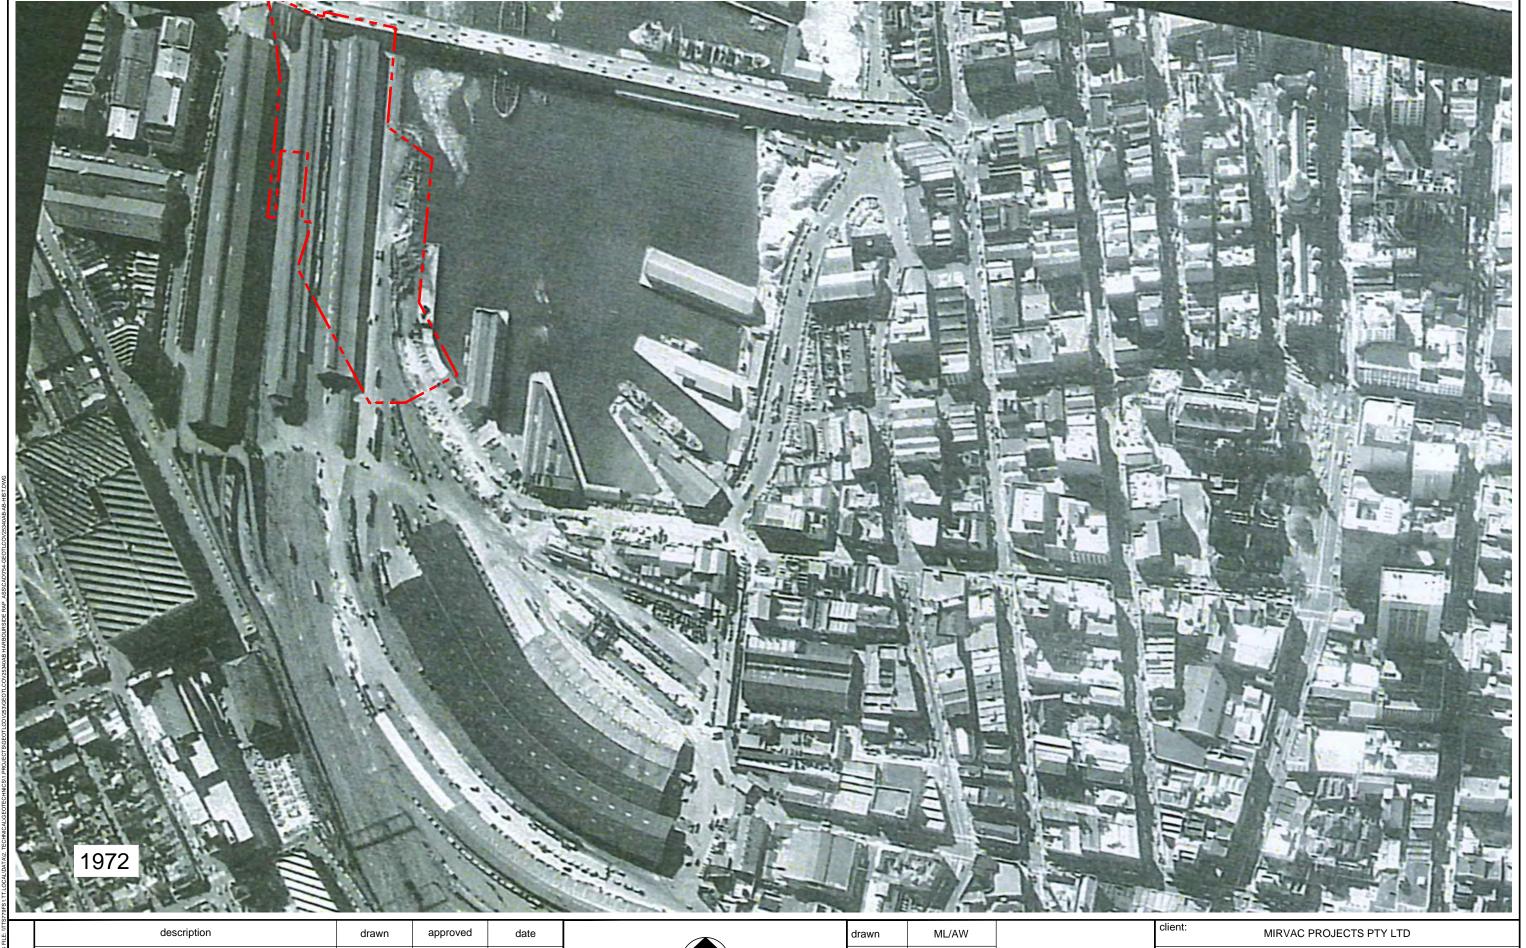
client:	MIRVAC PROJECTS PTY LTD	
project:	HARBOURSIDE SHOPPING CENTRE DARLING HARBOUR, SYDNEY, NSW	
title:	AERIAL PHOTOGRAPH - 1972

August 1972 (Figure 11)	No visible changes to the site are noted. The additional goods yards to the south of the site have been completed.
	High density commercial buildings have replaced many low lying buildings in the commercial district located east of Darling Harbour.
August 1982 (Figure 12)	No visible changes to the site are identified.
	Construction has on the Western Distributor Freeway located to the south of the site.
October 1991 (Figure 13)	The Rail Goods Sheds and associated rail sidings have been demolished. Similarly, existing infrastructure on surrounding land has also been removed. The Harbourside Shopping Centre and landscaped public open space has been established surrounding Cockle Bay foreshore, broadly resembling the current day layout.
	Land uses to the south have substantially changed with the Sydney International Convention Centre and exhibition halls now present. Land uses to the west of the site appear to have remained substantially unchanged from the previous aerial photograph. The Western Distributor Freeway appears to have been fully constructed to the south of the site.
