16th December 2021

RE: Sydney Football Stadium Redevelopment - Section 4.55 Village Precinct & Carpark
Addendum to Arboricultural Impact Assessment, Rev A dated 6th September 2021

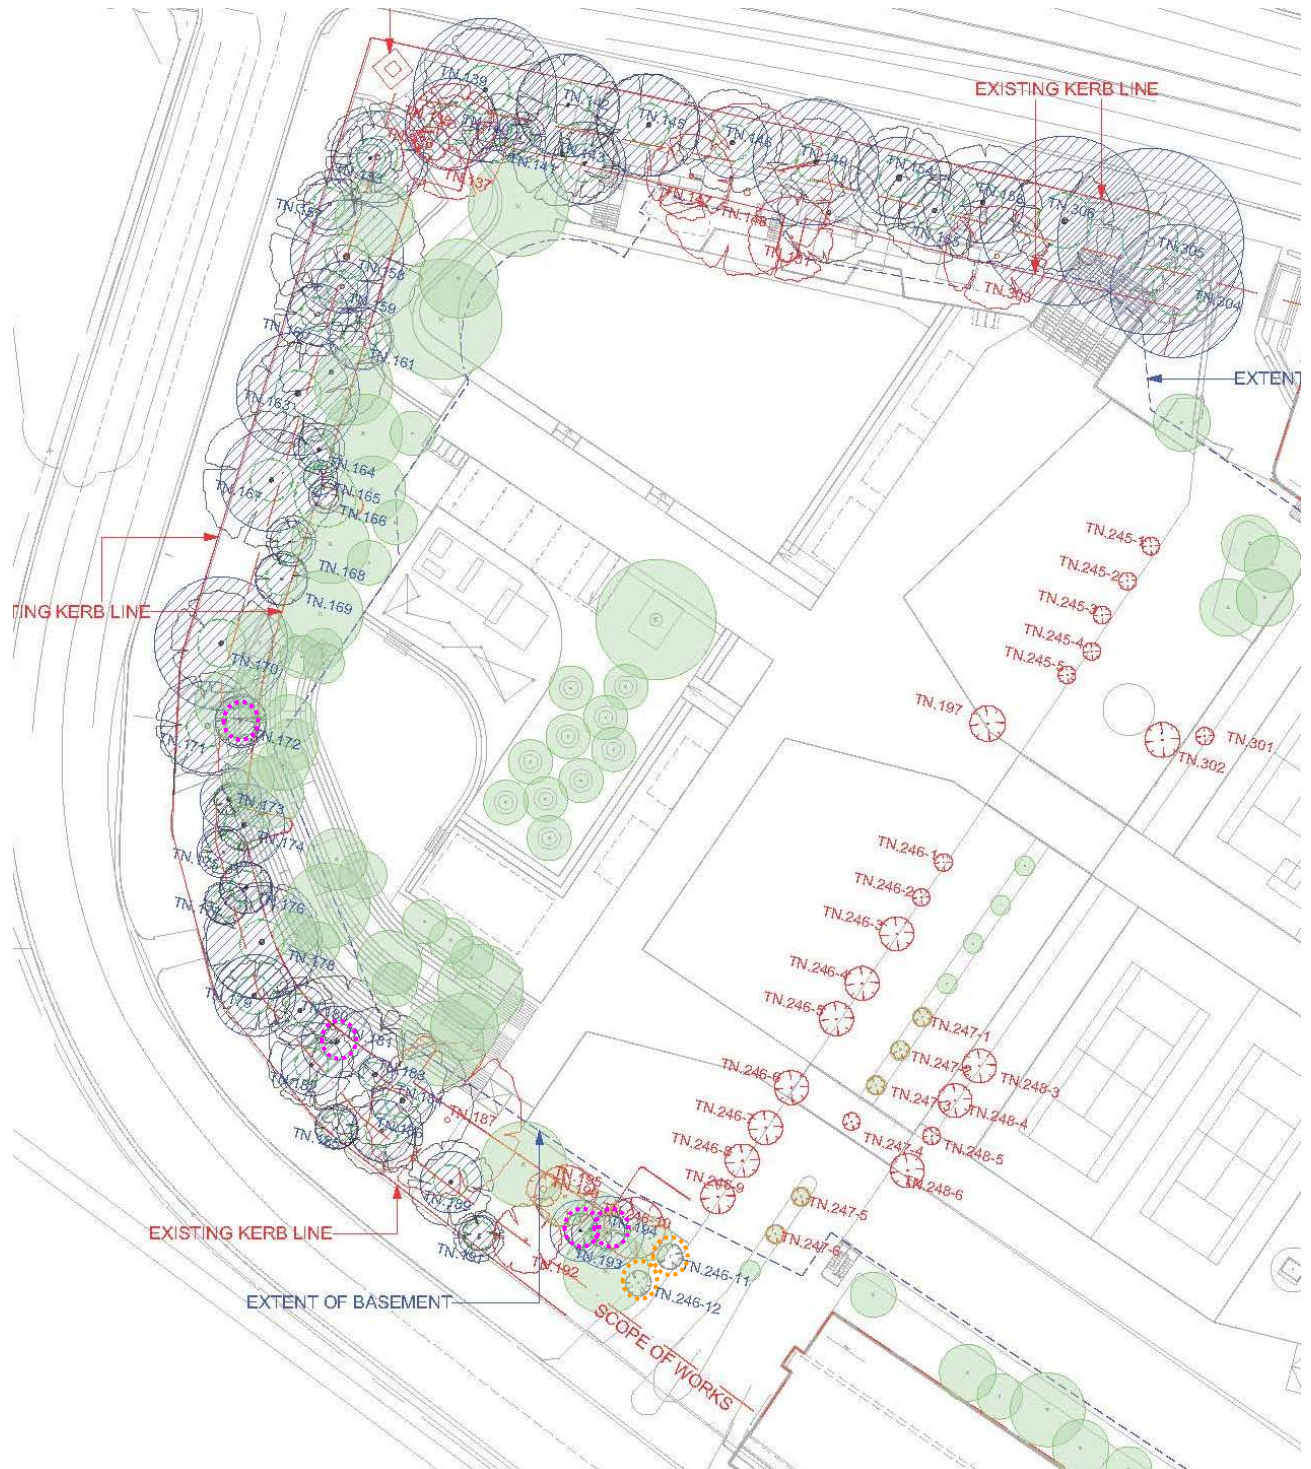
PV&C - CONSTRUCTION STAGE 1 EAST

The supplied plans show a temporary driveway is to be constructed at the entrance of the internal access road off Driver Avenue to the SFS basement to facilitate the construction of a permanent driveway slab. There are two (2) options for the temporary driveway. Both options will require the removal Trees 193, 194, 246-11 and 246-12.

Additional tree to be removed (Consider for Retention)

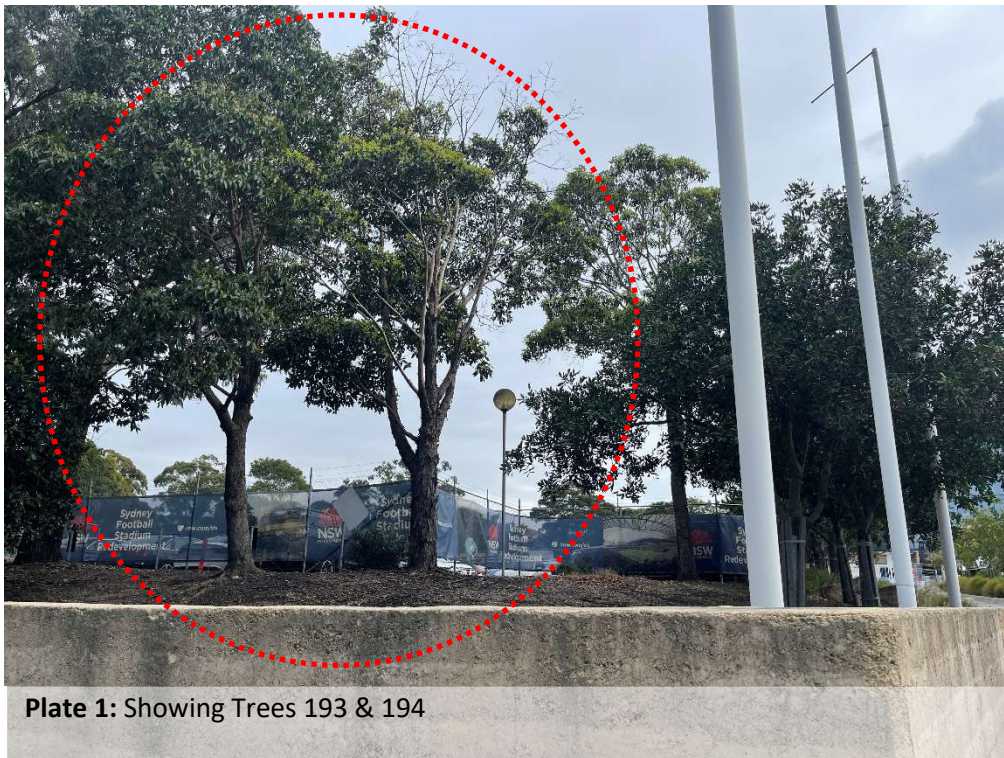
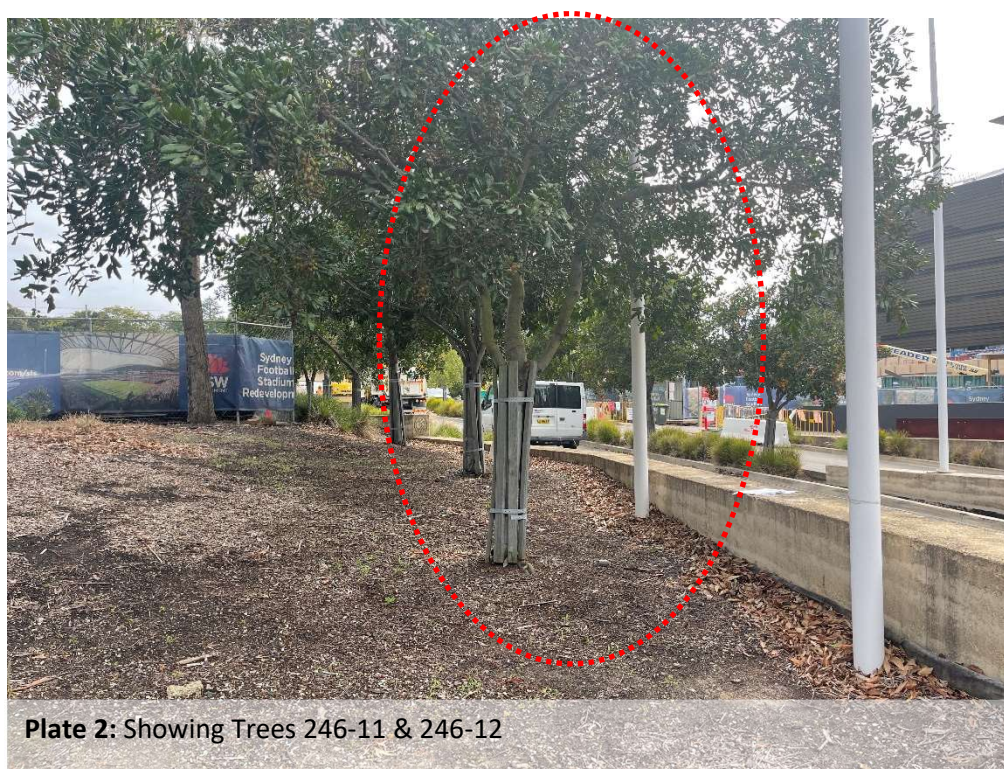
Appendix 2: Plates

Tree 193 was identified as *Lophostemon confertus* (Brush Box). The tree is in good health and structural condition however it has developed an asymmetrical crown form due to suppression from the adjacent tree (Tree 194). The tree is of moderate Landscape Significance and has been allocated a Retention Value of *Consider for Retention*.

Tree 194 was identified as *Lophostemon confertus* (Brush Box). The tree is in fair health due to a reduced crown density of 50-75%. The tree is of moderate Landscape Significance and has been allocated a Retention Value of *Consider for Retention*.

Trees 246-11 and 246-12 were identified as *Cupaniopsis anacardioides* (Tuckeroo). The trees are early-mature specimens in good health. The structural condition of the trees has not been assessed as the inspection was limited by presence of trunk protection. The trees are of low Landscape Significance and have been allocated a Retention value of *Consider for Removal*.
