These photos are of an area which will be undermined by LW27

Date: 06/12/13

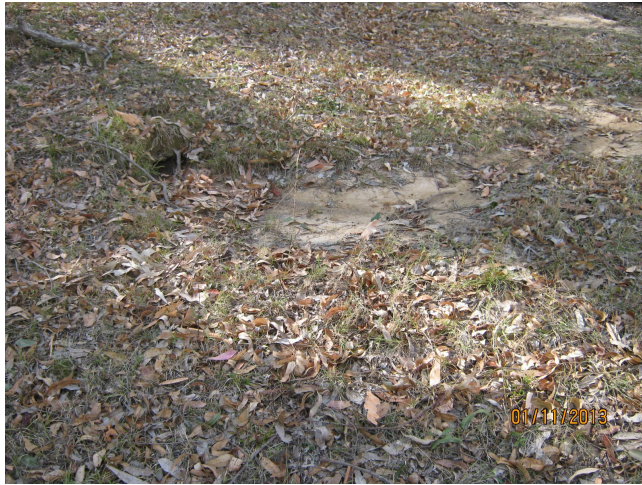
Photo 1. Tunnel discharge

Photo 1 shows the only visible indication that a tunnel has developed but it will get bigger in diameter after heavy rain .There is no visible point at which water enters the tunnel, the process is all subterranean. It can go up the slope for 50 metres and grow to 600mm in diameter before collapsing.

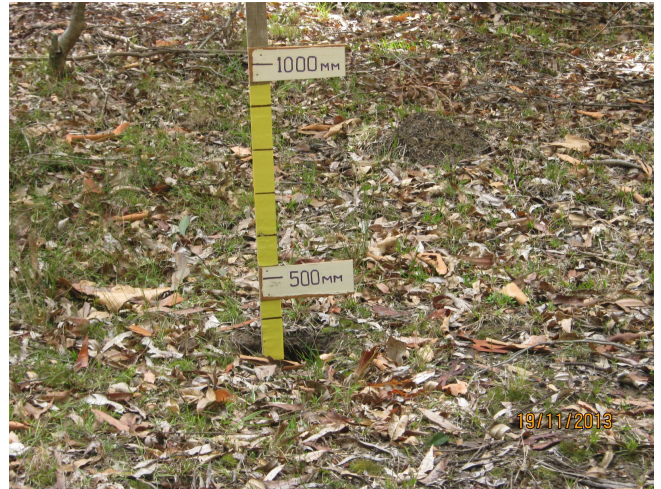
Photo 2. Tunnel roof beginning to collapse

Photo 2 shows first sign of the tunnel roof beginning to collapse.

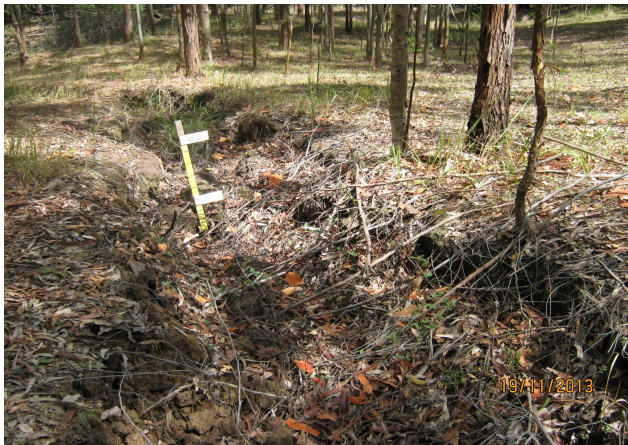
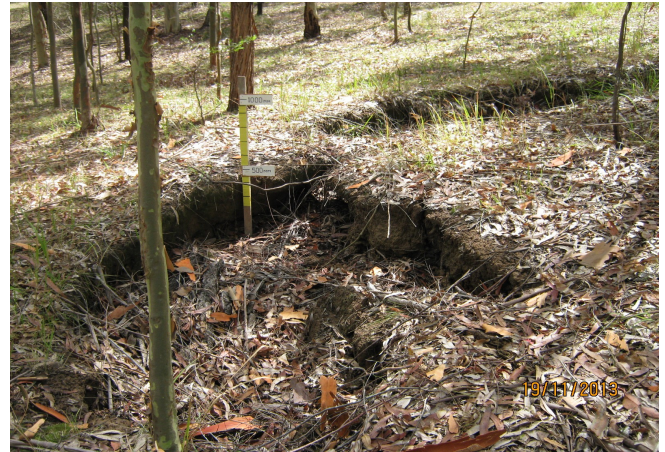
Photo 3 Controlled erosion

Photo 4 Controlled erosion

Photos 3 & 4 show erosion that occurred about 30 years ago and is now (we hope) inactive. The tunnels were about 600mm deep and as shown by the indicator still have parts close to the same depth. Large amounts of organic matter have been used to partly fill the holes.
