Report on  
Additional Geotechnical Investigation

Cranbrook School ECI  
Victoria Road, Bellevue Hill

Prepared for  
Cranbrook School

Project 84944.02  
October 2018

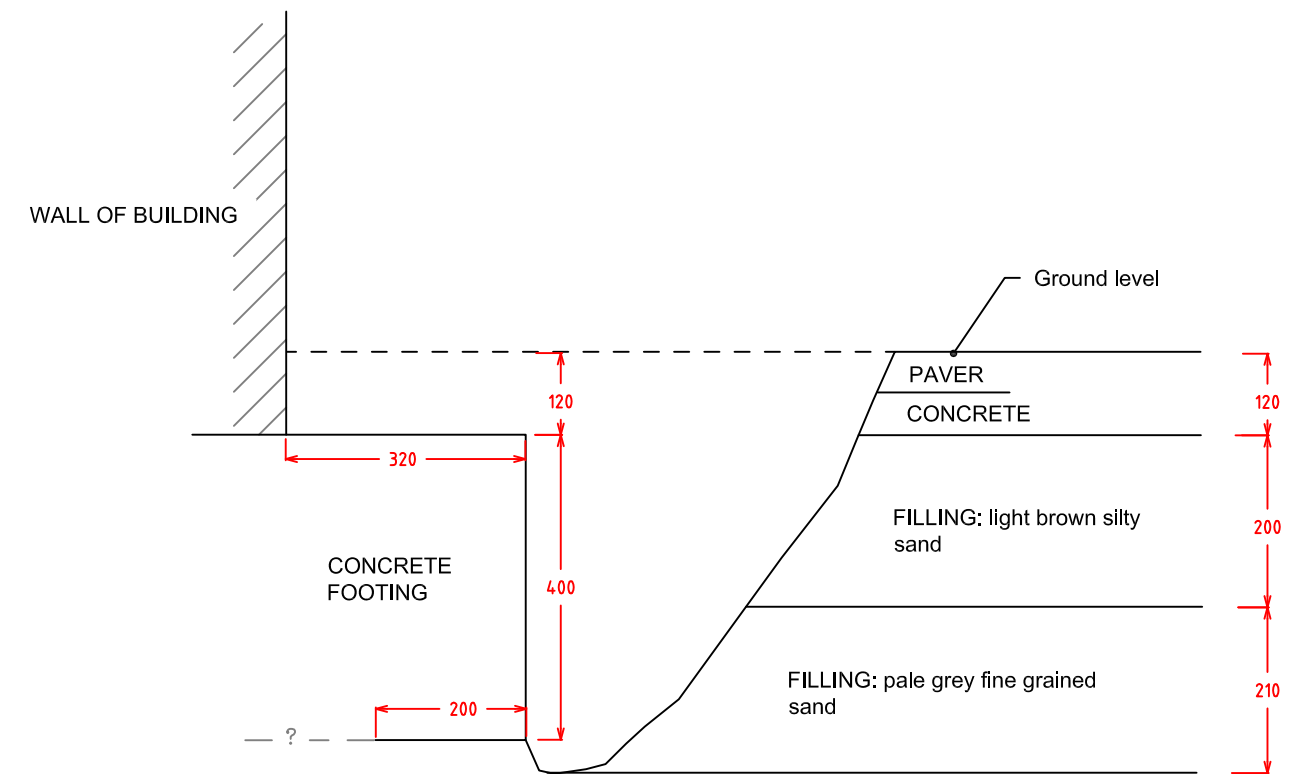
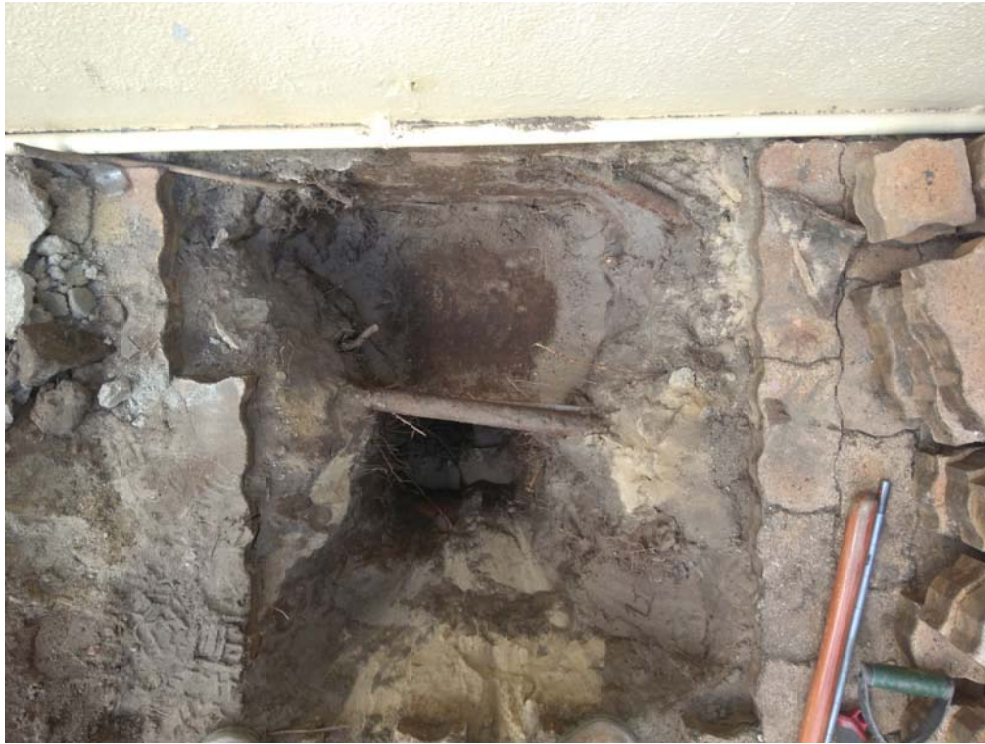
TP401 Section A-A'

DPT rod inserted at the base of the footing at angle of about 45°. It was inserted to a depth of 1.9m and no footing or hard surface was encountered.

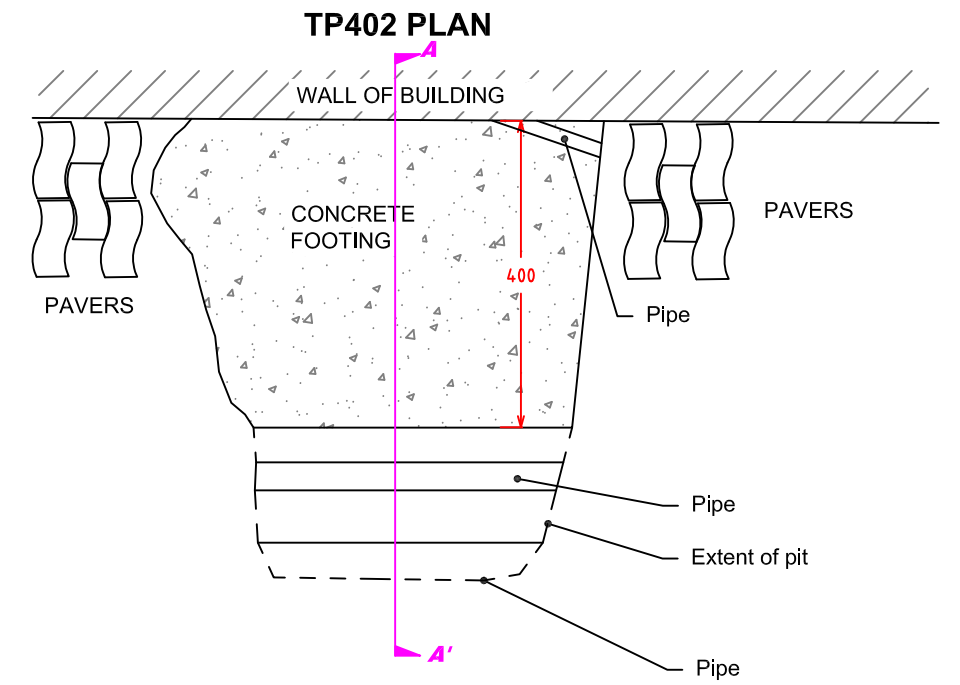
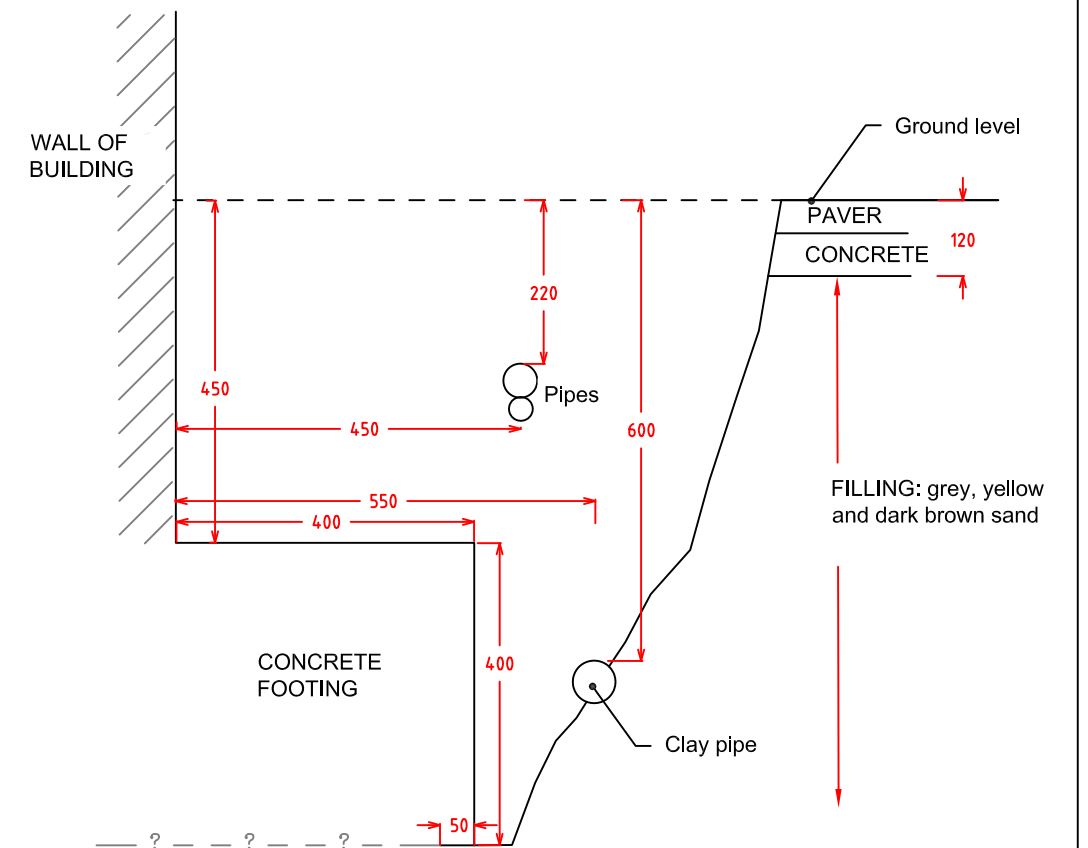
**TP402 Section A-A'**

DPT rod inserted at the base of the footing at angle of about 60°. It was inserted to a depth of 1.9m and no footing or hard surface was encountered.

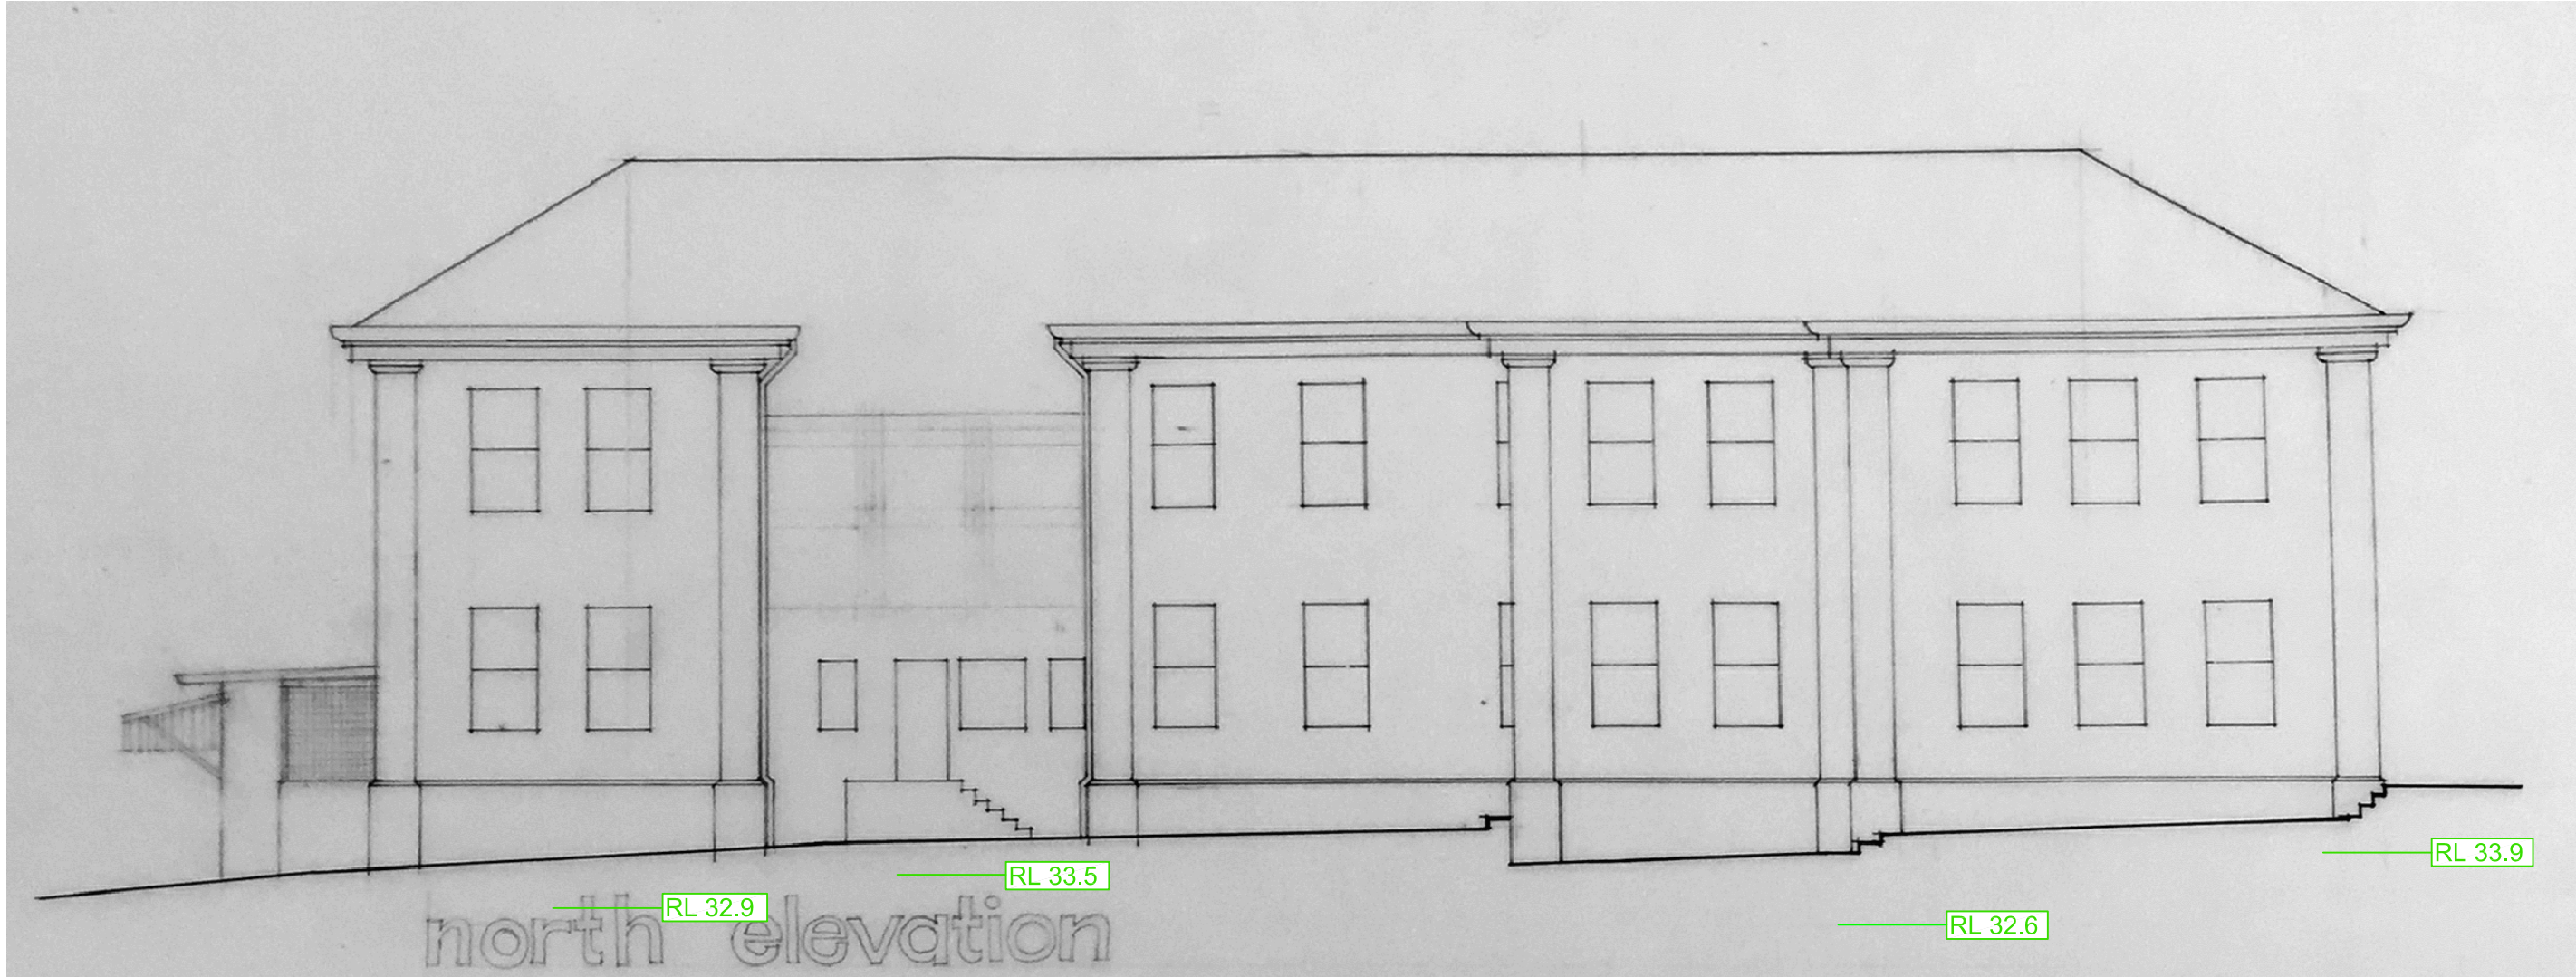
The test pits excavated adjacent to the northern side of the Perkins Building suggest that the building may be founded on strip footings that vary in depth from about 0.5 m to approximately 3 m depth. It is noted that confirmation by physically probing and inspecting the base of the footing could not be undertaken at all locations due to the depth of the pit and the safety and damage risks posed by such deep excavations in very loose sandy filling. The nearest boreholes to the test pits encountered loose sands at these depths.
