**PRELIMINARY GEOTECHNICAL SITE  
ASSESSMENT**

**STAGE 1- SALAMANDER WATERS  
KANIMBLA DRIVE, SALAMANDER BAY**

**Prepared for  
Hill PDA Pty Ltd  
Port Stephens Council**

**Project 39079  
JANUARY 2005**

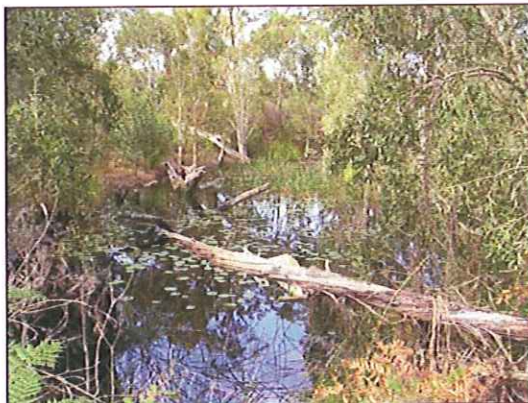
Photo 1 – Pond in North-Eastern Corner of Site

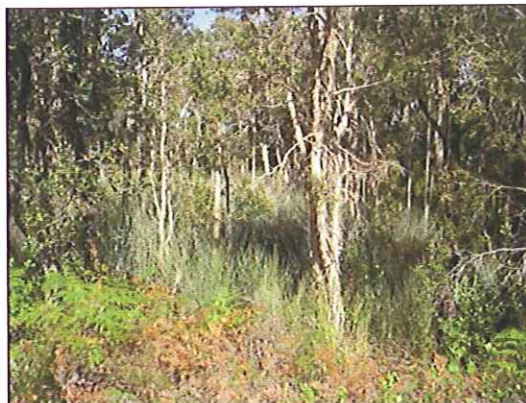
Photo 2 – 'Wetland' on western fringe of site.

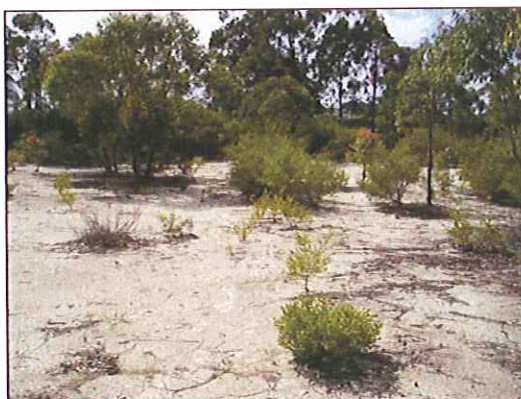
Photo 3 – Open Sand Area in South-East Corner of Site

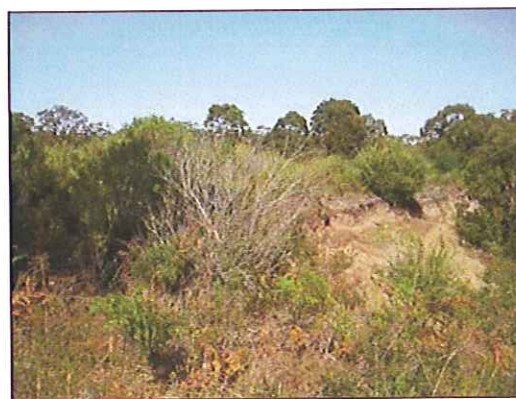
Photo 4 – Typical Steep Batter at Edge of Quarried Area

There was generally no evidence of previous or incipient deep seated slope instability observed over the site. The site is generally considered to have a low risk of slope instability with respect to the natural topography, with the exception of the localised steep cuts into the sand related to the former sand quarrying activities, where there is a medium to high risk of localised instability. This risk could be reduced to low risk by undertaking earthworks to limit batter slopes to no steeper than 2H:1V.

It is therefore considered that the site is suitable for the proposed development with respect to slope instability, subject to localised remedial works.

In the event that significant cuts or fills are proposed for the site, further geotechnical investigation to specifically assess slope stability issues should be undertaken. Such issues are generally managed by limiting batter slopes, drainage measures or suitably designed support.

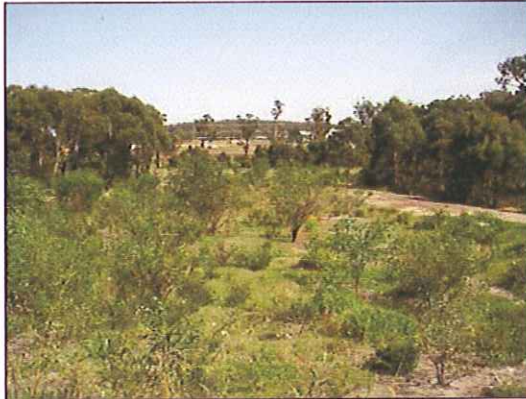
Photo 5 – Filling on Central Portion of Site

It appears that the site has been subject to uncontrolled filling subsequent to sand mining activities. The extent of the filling is difficult to accurately assess, however appears the most substantial thickness is expected to be in the central portions of the site, as shown on Drawing 1, possibly with a thinner spread of filling across the south-eastern corner. Surface visual assessment of the filling suggests the material is primarily sand, however various inclusions including bitumen, bricks, gravel, concrete fragments, scrap metal and plastic were observed. Discussions with Mr Ian Gilkes from Port Stephens Council suggested that much or all of the filling was material excavated during construction of the Salamander Shopping Centre. It is understood that the material may be removed from site for use on the adjacent waste management site.

No obvious contamination was observed at the surface, however as the material has been sourced off-site there is some potential for the presence of contamination. Therefore it is recommended that sampling and testing of the fill material be undertaken to assess for the presence of contamination in order to confirm its suitability for re-use on site, or to classify the material for off-site disposal.

From a geotechnical perspective, the uncontrolled / uncompacted filling is not suitable for the support of structural footings and therefore if the material is to be re-used on site below building footings, appropriate reworking and compaction of the material will be required.

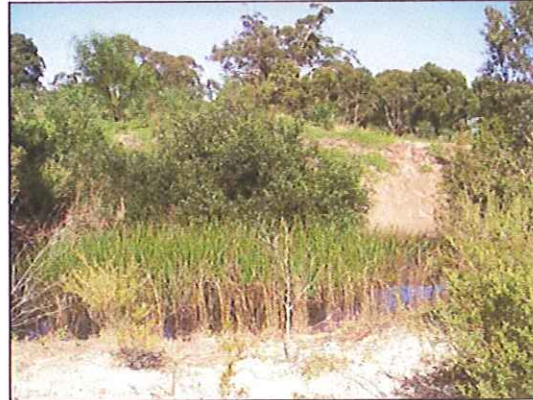
Photo 6 – Pond to East of Mounded Filling

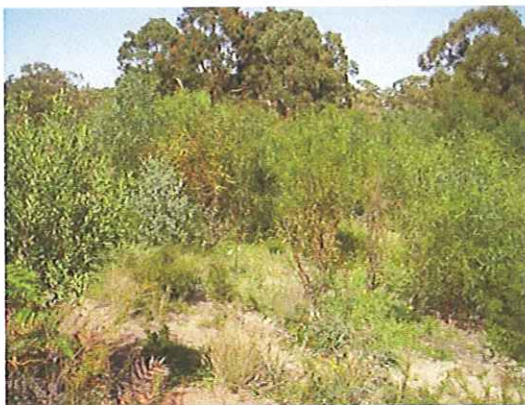
Photo 7 – South-Western Part of Site

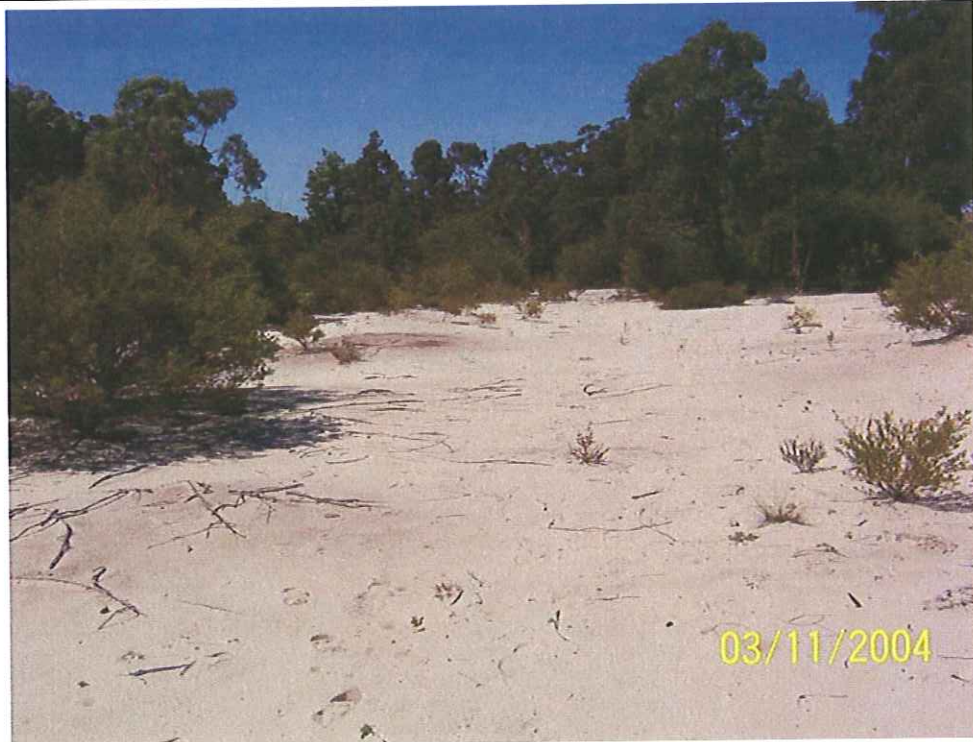
BSMS does have a concern that the area under consideration has been disturbed since the sand mining activities were completed without being surveyed for radiation levels. The central area of the site is relatively bare of vegetation and sand, and if the mining activities had finished by the mid 70's then it would be expected that the vegetation in this area would be greater than the estimated 5-10 year age of the trees and shrubs (see pic 1 in Attachment 5). Supporting this is the lack of erosion of the steep sides of the excavation along the boundary CP2 to CP4.

Picture 1. Central area of site showing lack of re-vegetation.

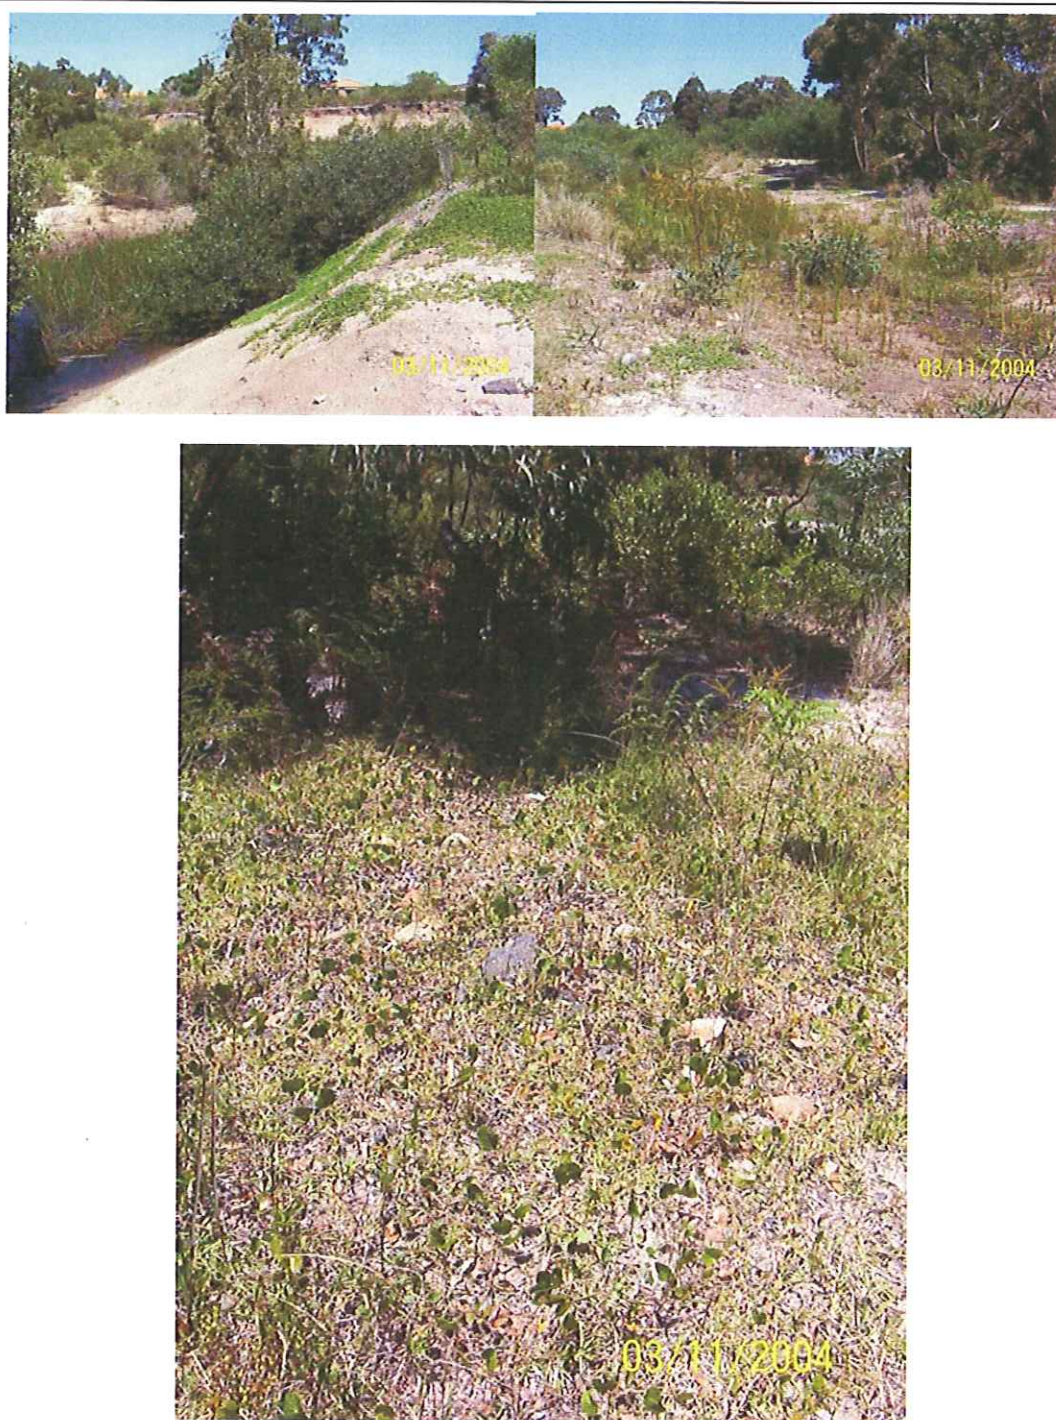
Also there is an area extending from Old Port Stephens Road towards the centre of the site that is elevated by the dumping of landfill from another site. The presence of asphalt and other road building material and by the presence of vegetation that is not found in any other area of the proposed site (see pic 2) are good indicators for this.

Picture 2. From Top left: Picture shows change in topography from the landfill as well as the different vegetation (bright green patch), the slight elevation and gutter formed by the landfill and different vegetation; The rubble in the soil that includes road material not found elsewhere at the site, also note the presence of "Kurnell Curse" vegetation.
