HAZARDOUS MATERIALS AUDIT REPORT

Transpacific Industries Pty Ltd

Lot 223 Kyle Street, Rutherford

AUGUST 2005

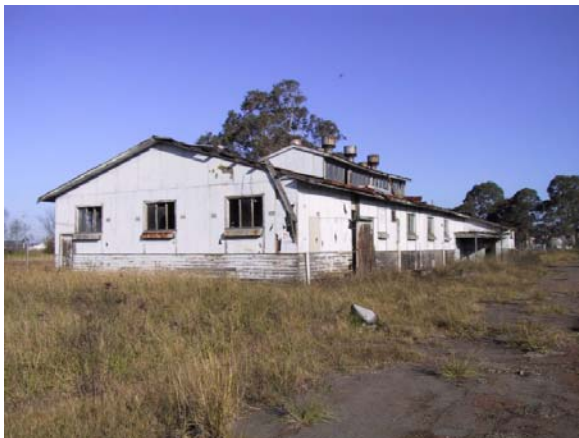
Two of the demolished buildings were located on the eastern boundary of the property. One was identified from original site plans as the former Munitions' Factory laboratory and storeroom (Figure 2) and the other as the Tea Rooms (Figure 3). Another two buildings were located on the western side of the allotment (identified as National Textile's New Boiler House and pump station) adjacent to where the weighbridge is now located. A fifth building which formed part of the former National Textiles Dye House (Building 2 in Figure 1) has been demolished to establish an access road and provide the required fire separation distance between the new workshop and the remaining buildings.

Figure 2. Derelict building 1 (now demolished)

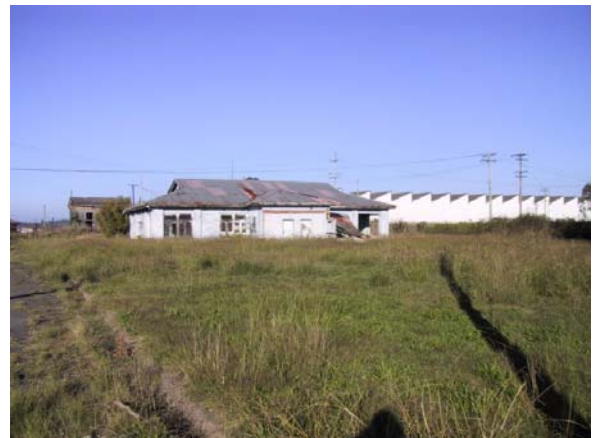
Figure 3. Derelict building 2 (now demolished)

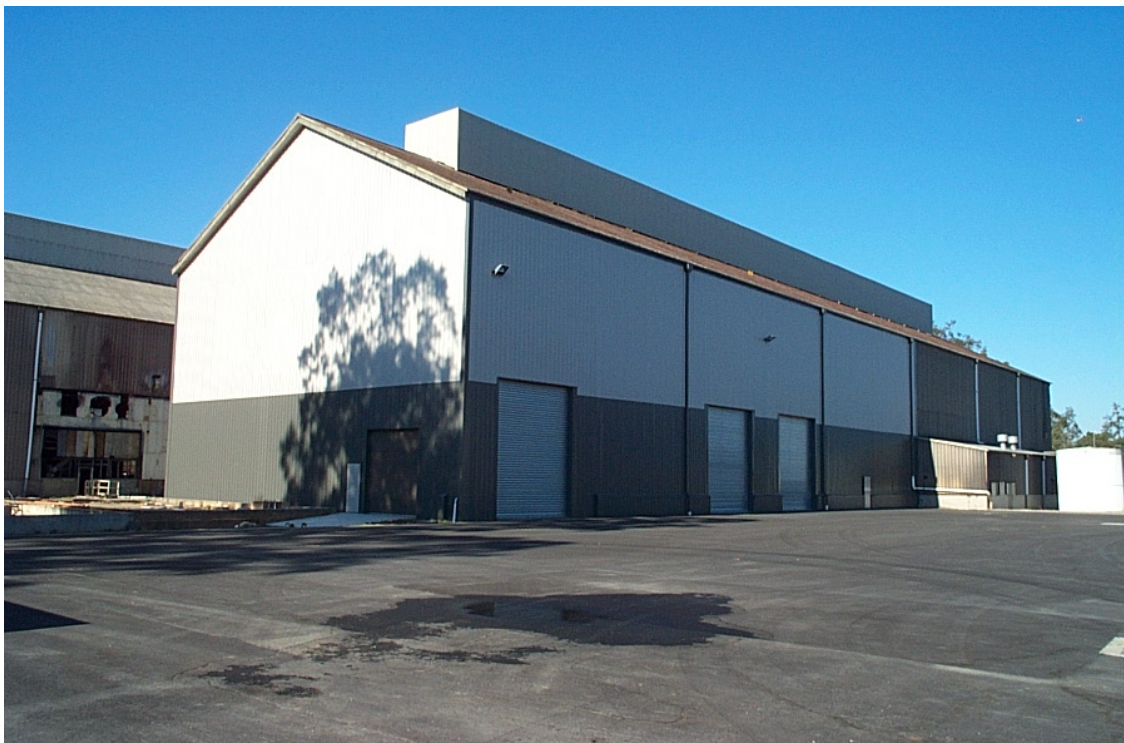
The roof of the new Workshop (Building 1 in Figure 1) comprises asbestos cement sheeting. Broken or damaged sheets have been replaced with non-asbestos sheeting and the remaining sheets sprayed with a PVA sealant to prevent the risk of dispersion of air-borne fibres. Figure 4 shows the Workshop after application of the PVA sealant and new external cladding which will also be used to replace the exterior walls of all existing buildings at the site.

Figure 4. Workshop After New Cladding and PVA-coated Asbestos Cement Sheets

- Monitor the condition of asbestos-cement sheeting and remove and replace as required. Where PVA coating is applied to asbestos, regular integrity checks to be conducted on the sealant by qualified personnel.

- The risk of asbestos fibres from the PVA-coated sheeting is considered minimal unless disturbed or broken. In such cases, TPI will remove and replace the damaged sheets in accordance with asbestos handling and disposal requirements.

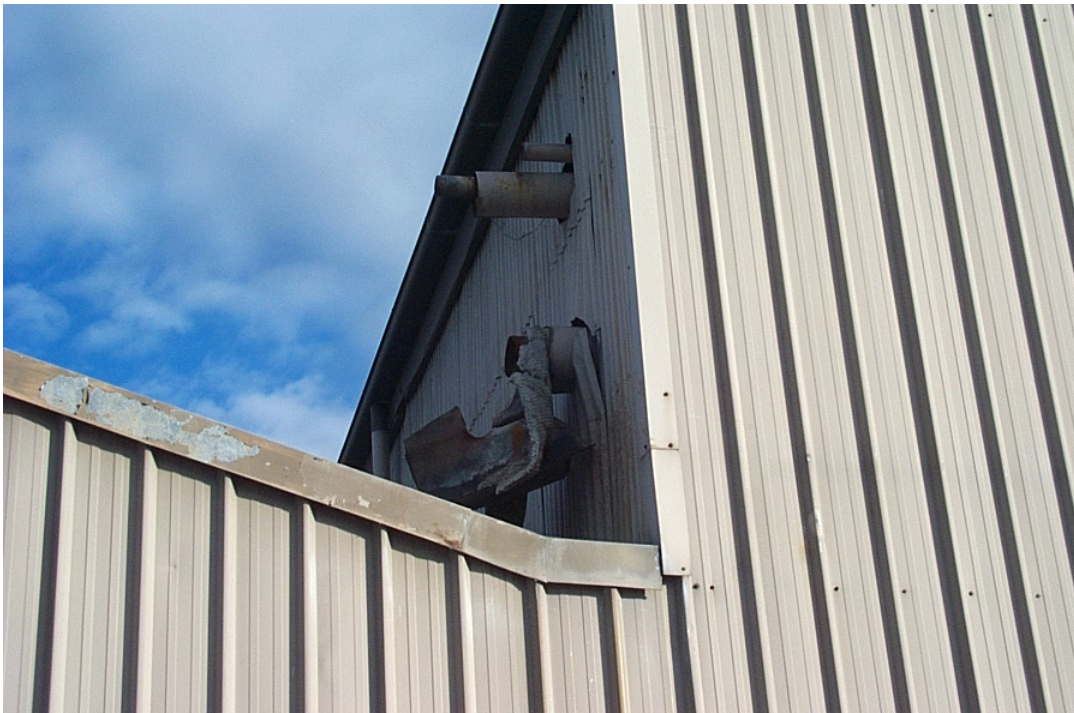
Exposed sections of pipe work and ducting in Buildings 3, 4, 5 and 6 contain insulation which appears to contain asbestos (Figure 5). Pipes are located throughout the buildings and were used to supply steam to drying, pressing and dyeing equipment. The risk of exposure to air borne asbestos products and synthetic mineral fibres is high within these buildings due to the large amount of pipework present. Residual asbestos lagging and insulation has been observed throughout the other buildings. It is also highly probable that further asbestos materials will be encountered, in particular between walls, in ceilings and as pipe lagging.

Figure 5. Exposed insulation from lagged pipes (northern end of Building 5)

- Arrange for specialist asbestos contractors to remove and clean each building of asbestos and synthetic mineral fibres before any construction or demolition work commences.

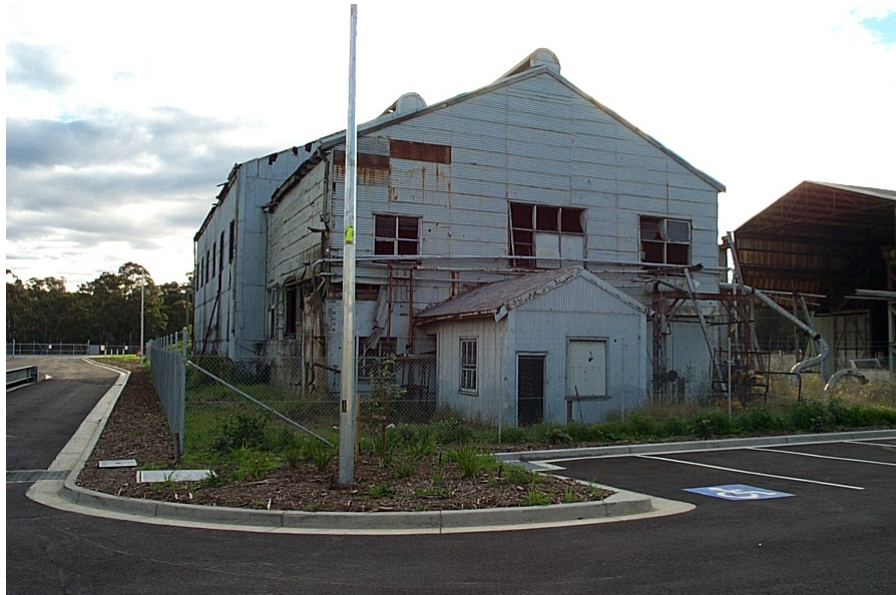
There appears to be a significant asbestos risk from the building identified from earlier plans as the Old Boiler House (Figures 6 & 7) which forms part of the boundary immediately adjacent to the TPI property. The Old Boiler House is located on the adjacent property that abuts the driveway and comes within metres of TPI's Administration Building, car park and weighbridge.

A number of pipes are visible in the derelict building. The pipes are lagged with a fibrous material which is believed to be asbestos based on the age of the building, their purpose and visual assessment. The asbestos removalists who performed the previous removal on the TPI buildings have advised that this building be cleared of asbestos, as it is in very poor condition.

There are also damaged asbestos cement sheets in very poor condition. Much of the material is deteriorating and the risk of exposure to air borne asbestos and synthetic mineral fibres is considered high both within and around the vicinity of this building.

Figure 6. Old Boiler House Adjacent to TPI's Car Park

- The owner of the land on which the Old Boiler House is situated needs to be contacted and requested to undertake immediate steps to remove and dispose of all asbestos-based material. Workcover NSW should also be advised.

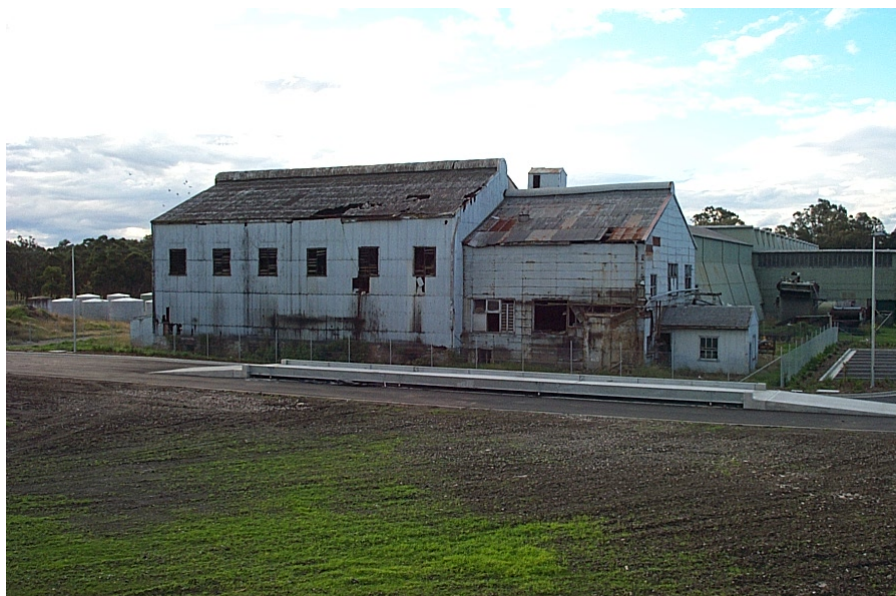
Figure 7. Old Boiler House Adjacent to TPI's Weighbridge (Foreground)
