# Appendix F

## Estuarine assessment

Settlement City Shopping Centre – Port Macquarie  
Environmental Assessment proposed Stage 1

**SETTLEMENT CITY SHOPPING CENTRE  
COASTAL AND ESTUARINE PROCESSES, HAZARDS AND IMPACTS**

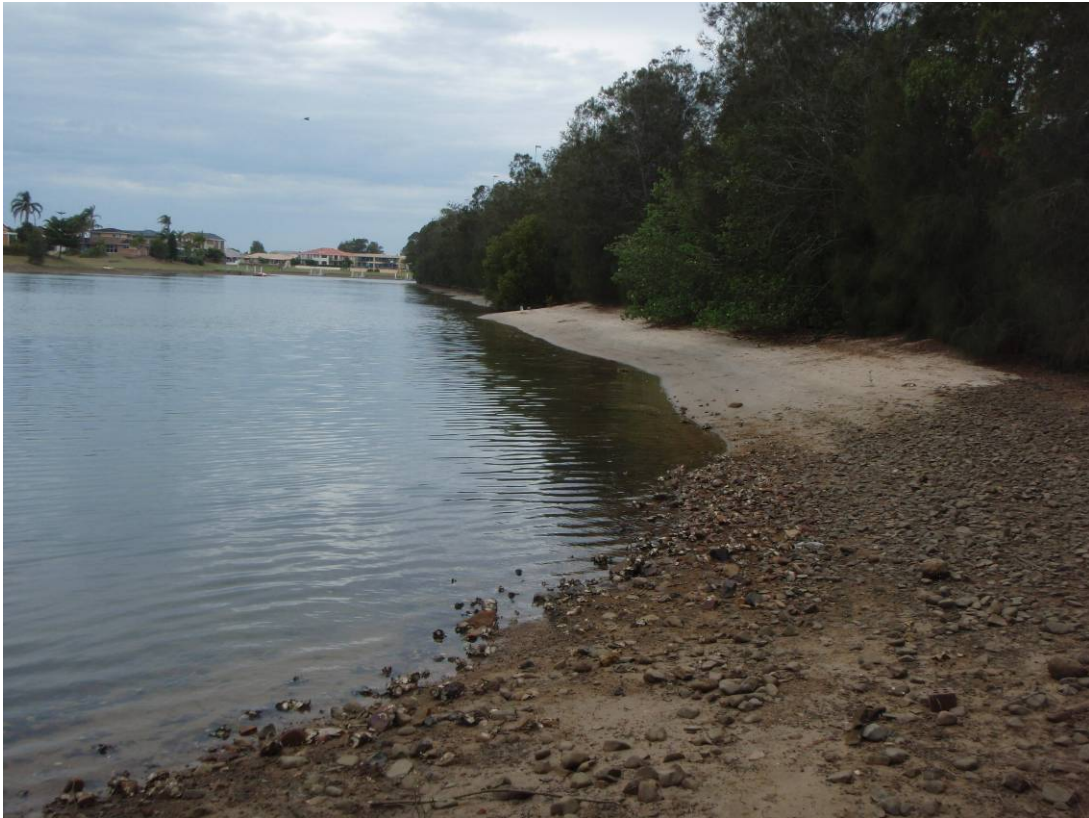
**Photo 1**

Along the western edge of the site (**Photos 1 and 3**) and around to the weir on the northern canal (**Photo 8**), we observed in general a canal edge treatment comparable to an “intertidal beach” cross-section as described in the NSW canal subdivision guidelines (*PWD, 1992*). The structural edge treatment at the site comprises a corrugated sheetpile, possibly asbestos-cement, with concrete capping beam along the crest (**Photos 3 and 4**). The treatment type changes east of the weir where a failed concrete walkway occurs.

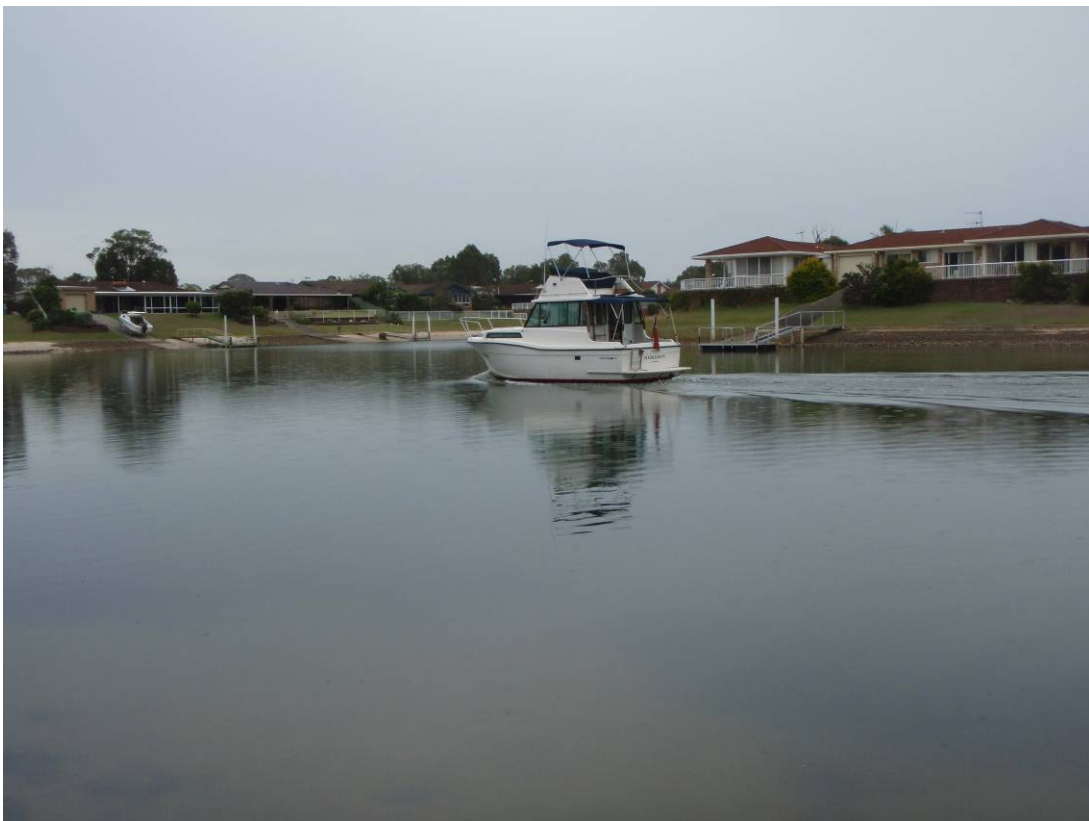
**Photo 6**

We observed a 20' cruiser passing through the canal. It was travelling at low speed, complying with the signposted 4 knot speed limit (**Photo 6**). Estimated boat generated wave height at the shore 30 mm with period less than 0.5 s. A second boat movement was also at low speed.

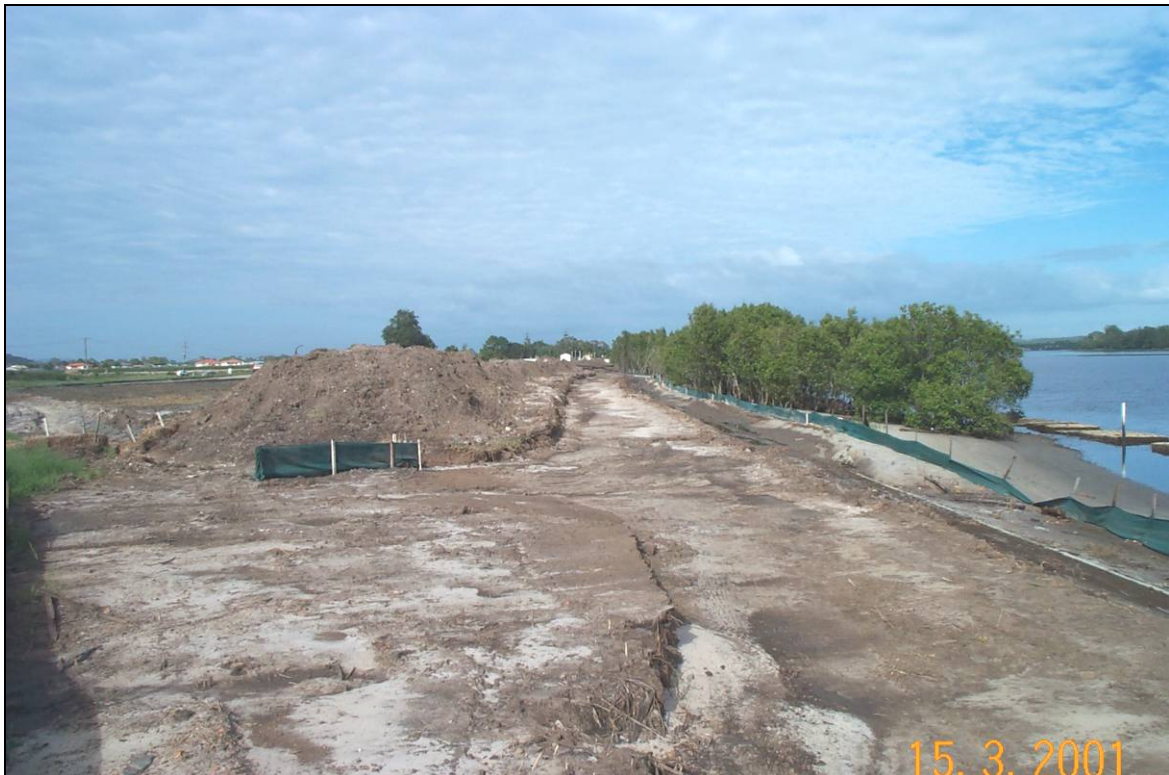
**Photo 11** shows recent civil works for Stage B of the Settlement Shores project. Here one observes the type of soil that might be expected on the adjoining Settlement City site – principally sands with washings of mud. In the same way that silt fences and curtains are shown to control sediment dispersal into the waterway for Stage B, such safeguards would be readily applied at Settlement City.

**Photo 11 - Earthworks for Stage B of Settlement Shores project**  
(Source: McIlwain and Boys, 2001)

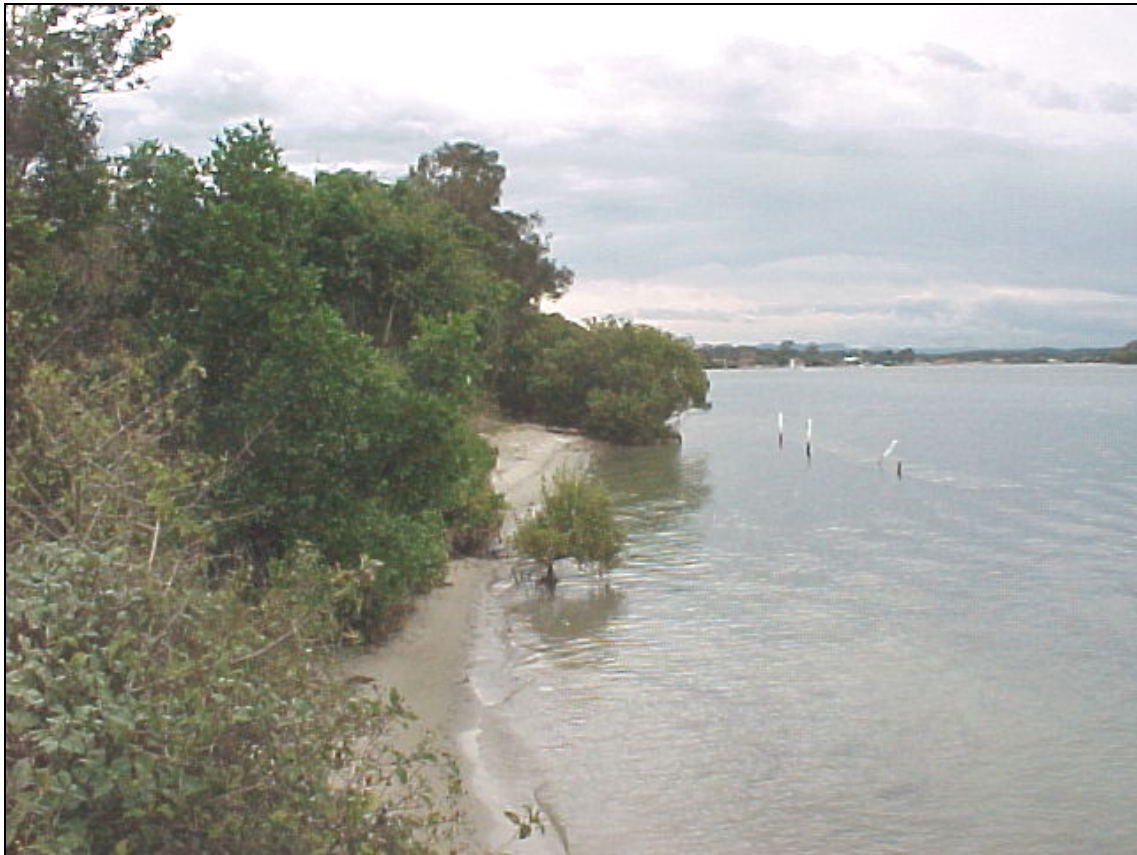
**Photo 12 – Typical riverbank along Lower Hastings estuary  
(Source: McIlwain and Boys, 2001)**

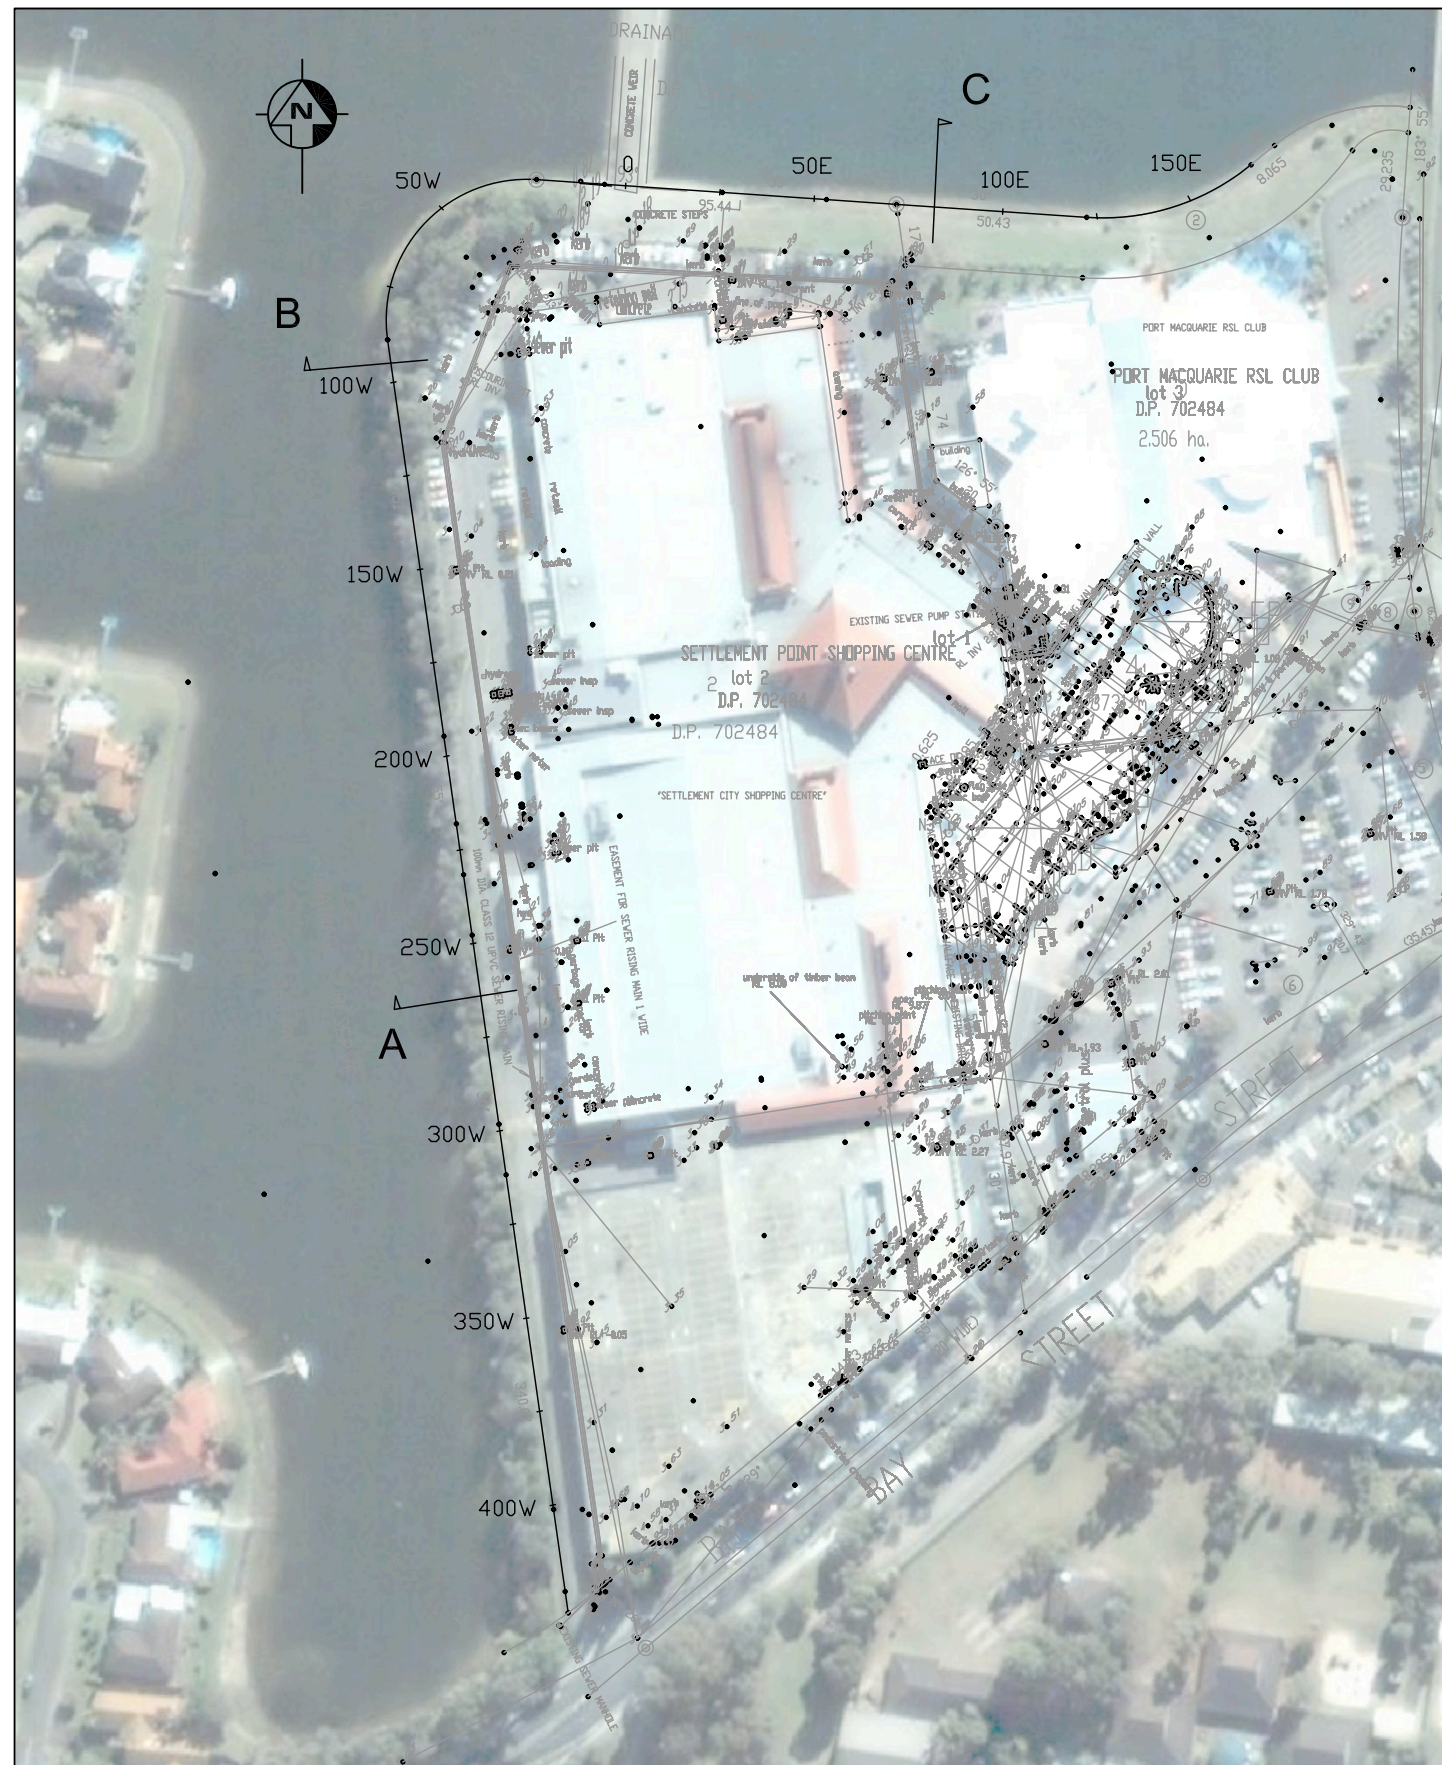
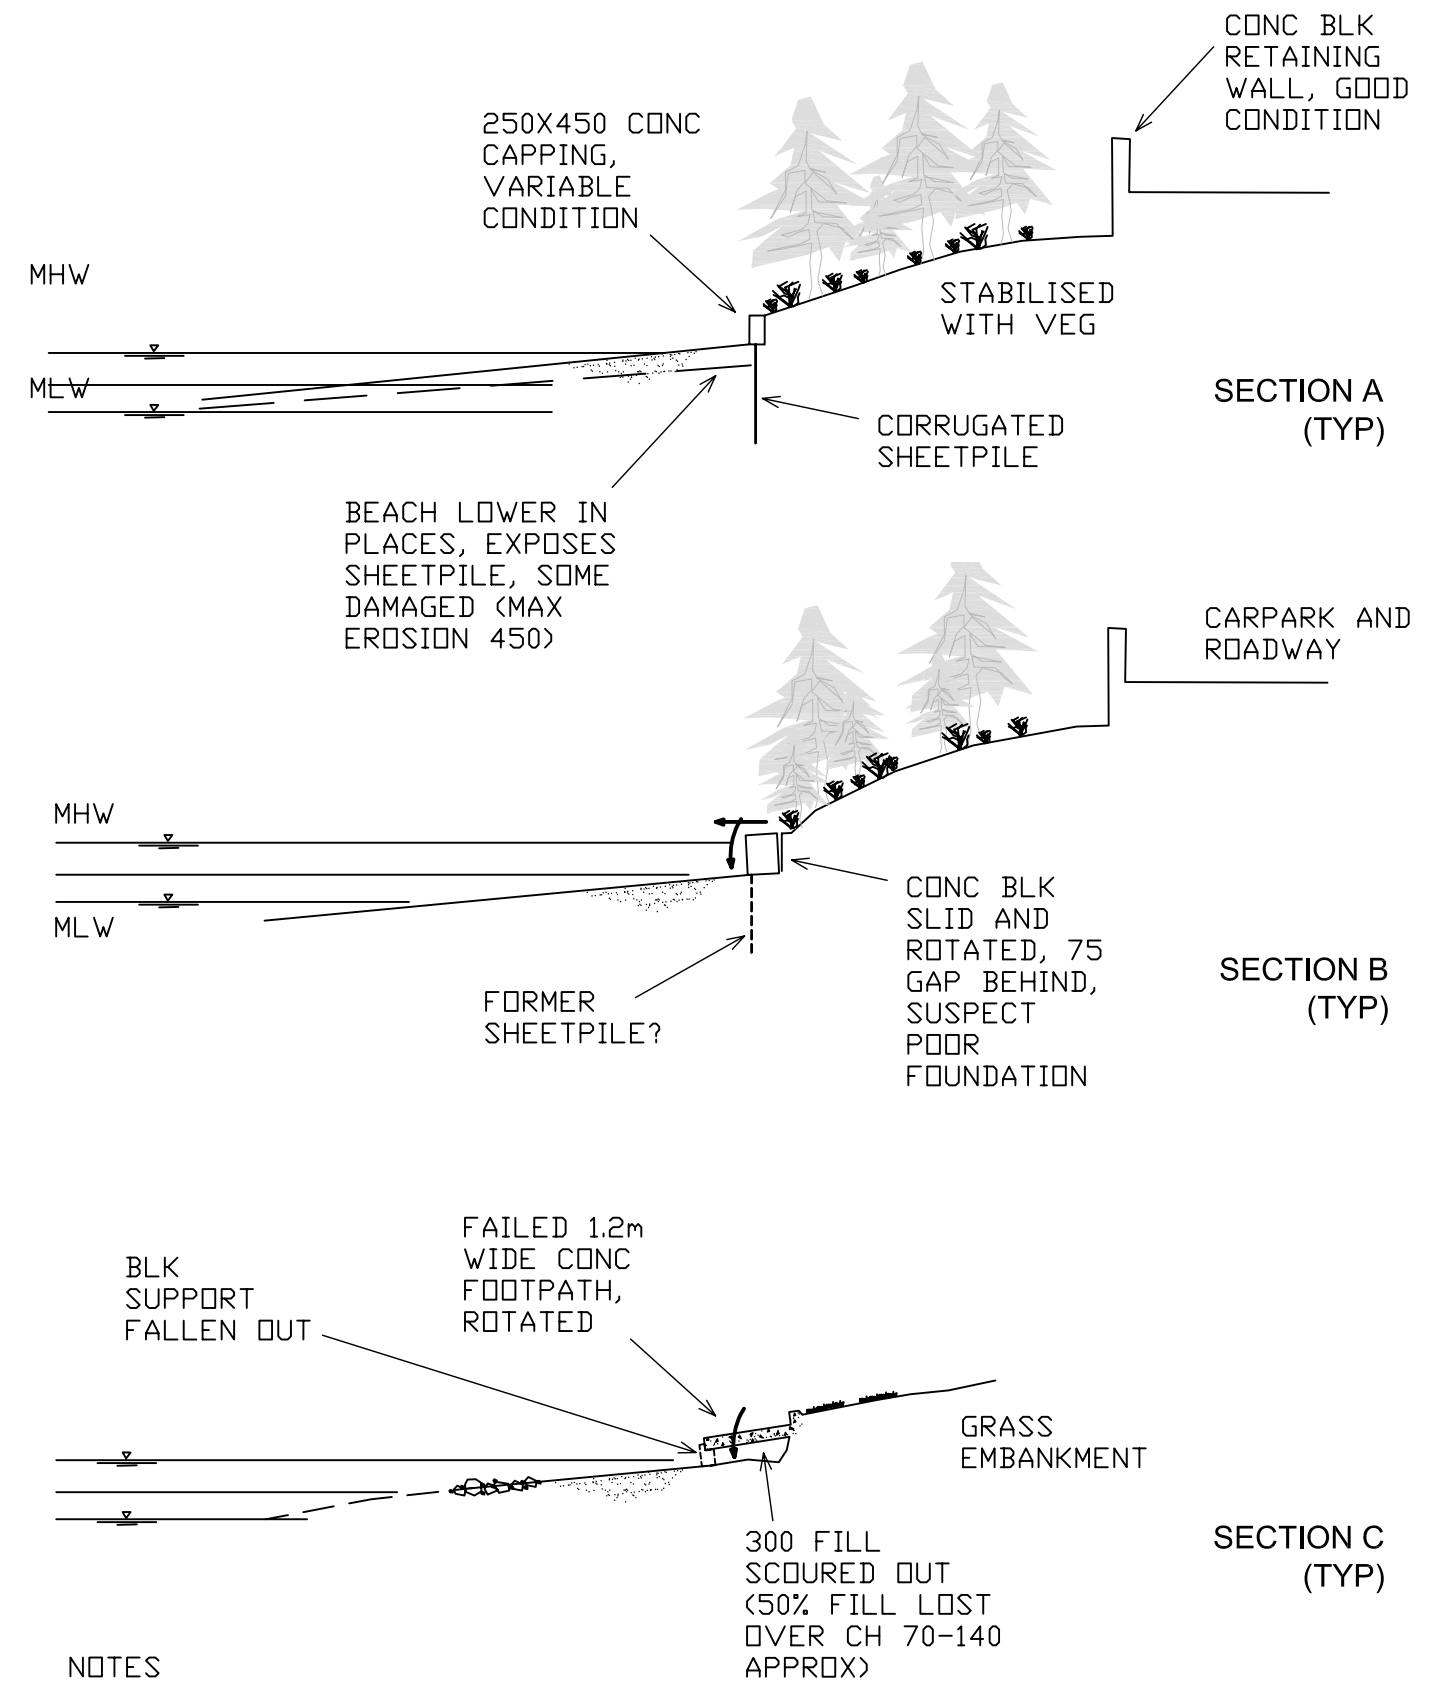
FIGURE 2

**Figure 2** shows the site layout and adopted chainage system used for location during the site inspection. Typical canal edge treatment profiles encountered are also shown.

## CANAL EDGE TREATMENTS AND CONDITION APPRAISAL
