Project 40596.08/1 30 January 2012 RJH

Proposed Vehicle Access Ramp - West Keira Project 71 Market Street, Wollongong

This report presents the results of a preliminary geotechnical assessment undertaken for a proposed ramp at 71 Market Street, Wollongong that will provide vehicle access into the West Keira shopping centre development. The assessment was requested by Hansen Yuncken Pty Ltd, head construction contractors for the project.

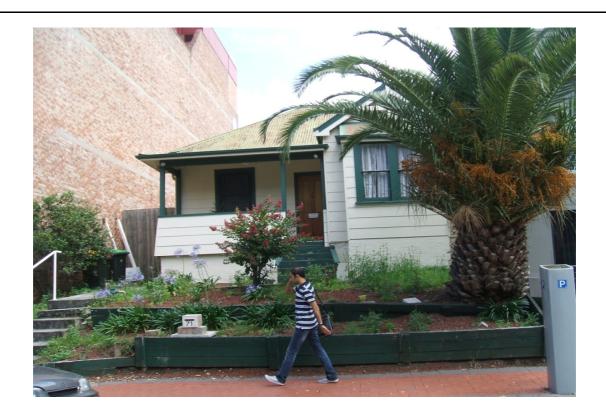
Photo 1: View from Market Street looking south

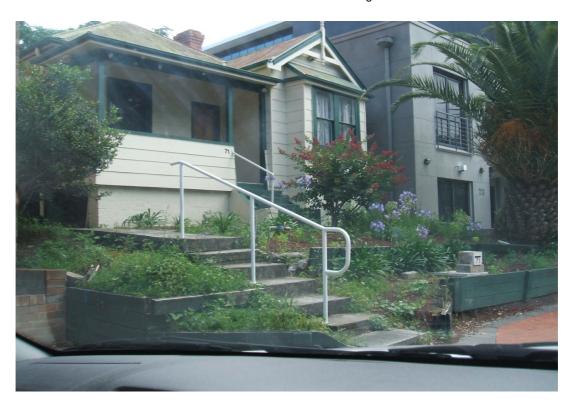
Photo 2: View of Market Street looking south west

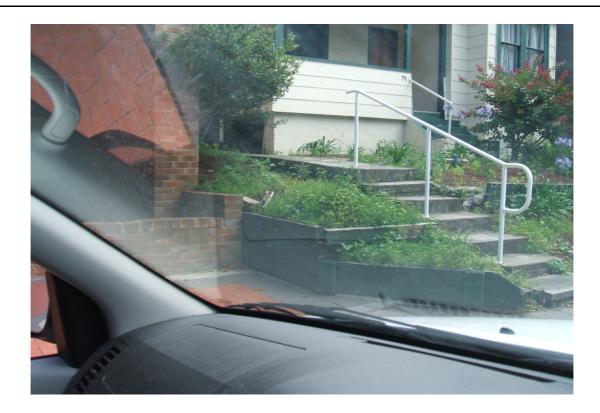
Photo 3: View of retaining walls on eastern boundary

Due care will obviously be required when working adjacent to existing structures. It is recommended dilapidation surveys of adjacent properties be undertaken to provide baseline conditions of structures for assessment of possible claims of damage.

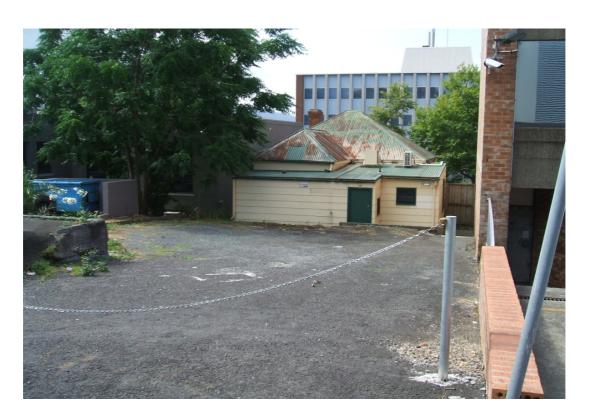
Photo 4: View of site looking north
