**Appendix E. Geological Report on proposed Armidale Dumaresq Council Landfill site, with emphasis on investigation of a possible geological fault**

**Geological report on proposed Armidale Dumaresq  
Council landfill site, with emphasis on investigation of  
a possible geological fault**

EA Systems Pty Ltd

February, 2006

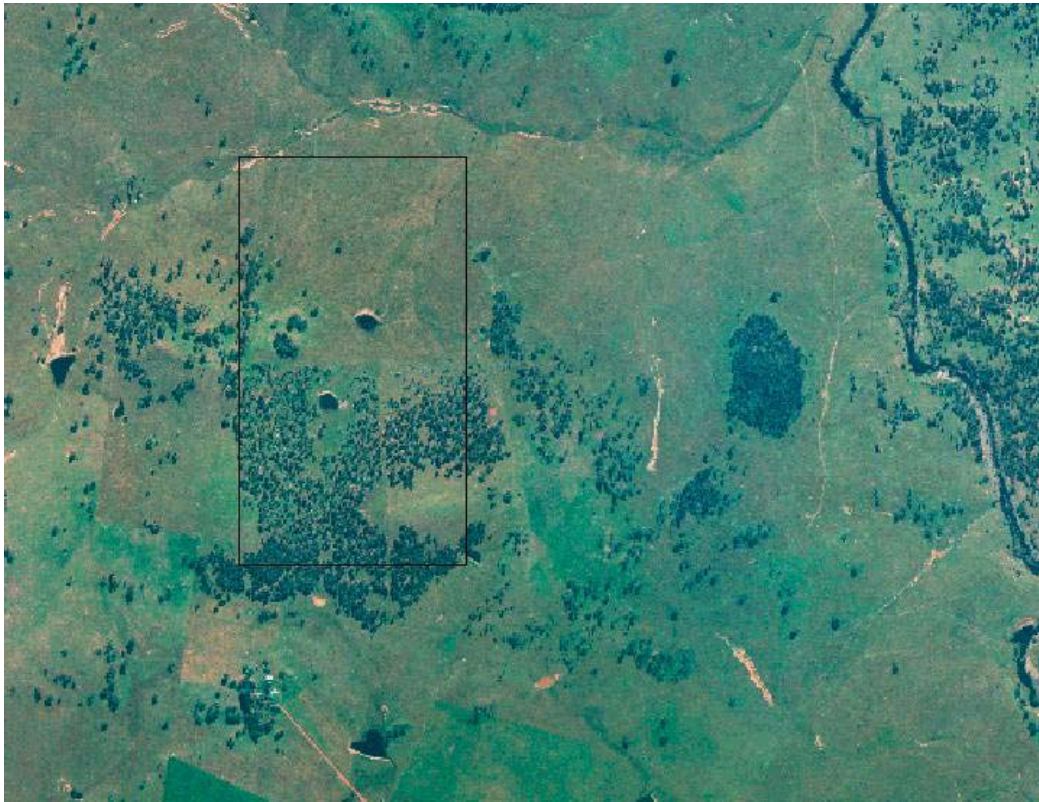
- a) air photo interpretation: no linears or other features are indicated in the topography to suggest the presence of a fault in the projected position (Fig. 3).

**Figure 3:** Aerial photograph of the landfill site and immediate surrounding area. The projected fault trace has been omitted, but it trends approximately northeast across the image from near the southwest corner to the northeast corner. The landfill site occupies much of the wooded area just left of centre. The image is approximately 2 km east-west. It is relevant to note that there is no topographic expression or photo-linear corresponding to the projected position of the fault.

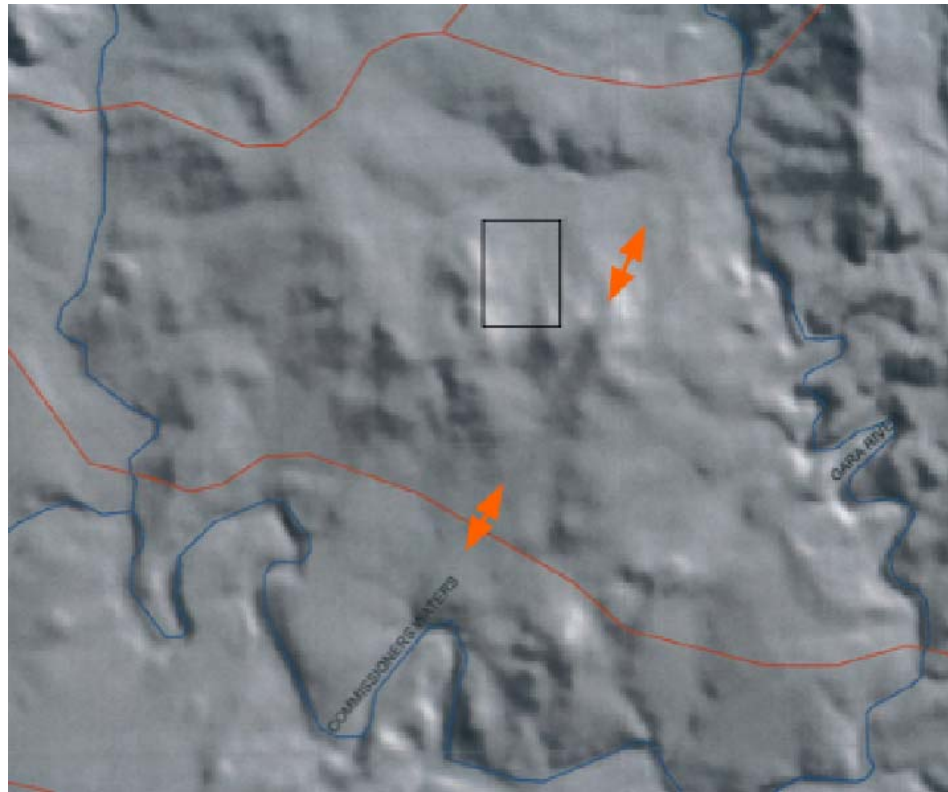
- b) Landsat TM: same result.
- c) Digital terrain model (DTM): There are no linears in the projected position or strike ( $050^{\circ}$ ) of the fault, although there is a single weak linear just southeast of the landfill site with a strike of  $025^{\circ}$  (Fig. 4).

**Figure 4:** Portion of the digital terrain model supplied by the Geological Survey of NSW, covering the area of the landfill site (shown approximately by the rectangle) and surrounds. A single weak linear (indicated by arrows) is evident to the southeast of the site, but has a strike of  $\sim 025^\circ$ , whereas the projected fault has a strike of  $\sim 050^\circ$ .

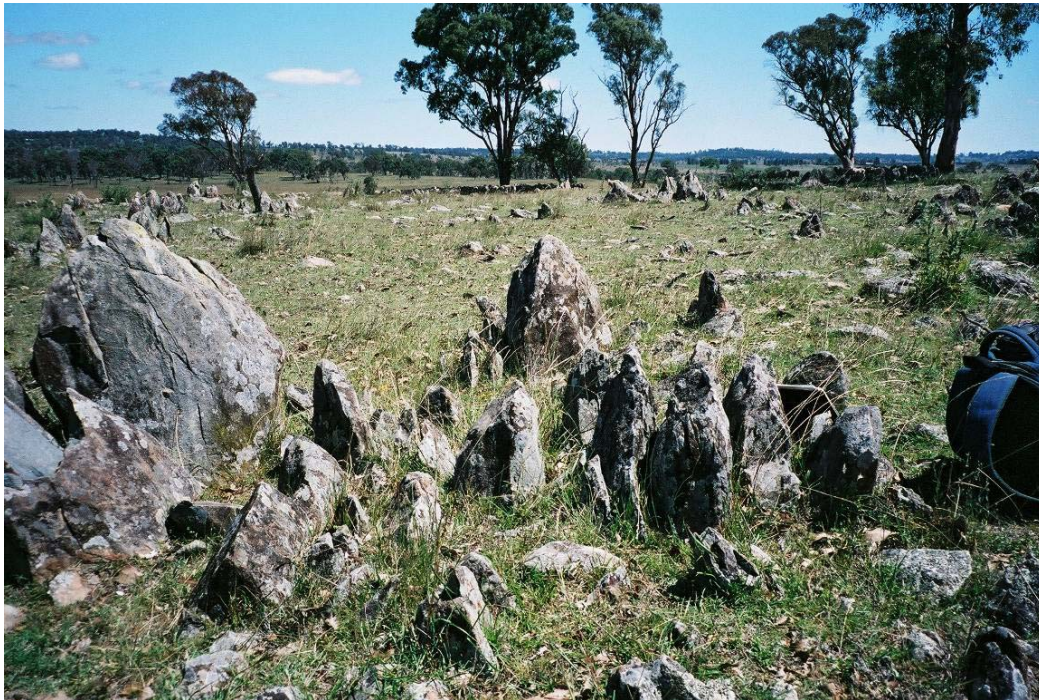
**Figure 6:** Weakly cleaved greywacke at grid reference 381682mE, 6617358mN. Strike of cleavage is 010°-015°M.

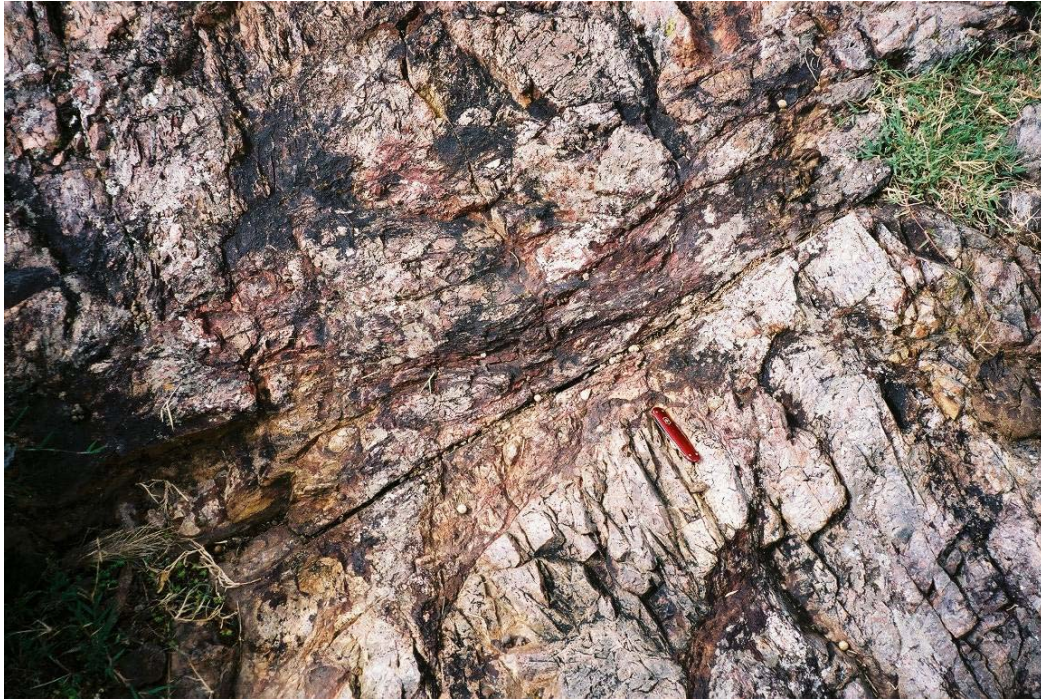
**Figure 8:** Fractured chert, with associated sheared zone in cherty mudstone (centre) at grid reference 383750mE, 6618650mN. Strike of foliation is 060°M.

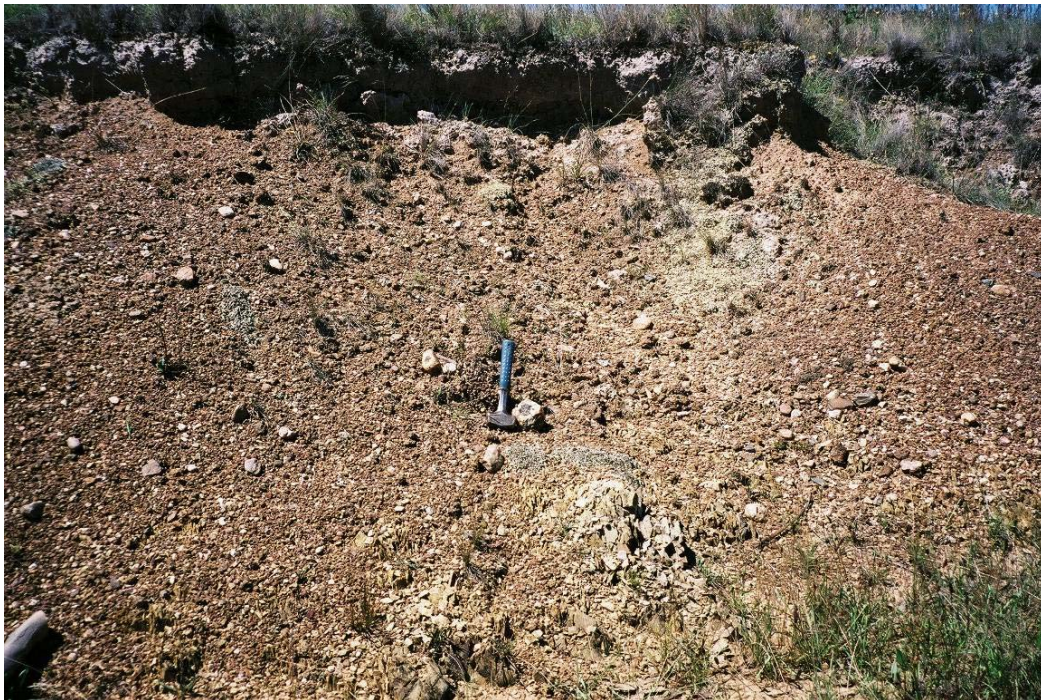
**Figure 9:** Cleaved greywacke-siltstone (bottom of image) overlain by transported Tertiary gravel and ironstone regolith at grid reference 382206mE, 6617524mN. Strike of foliation in bedrock is 020°M.

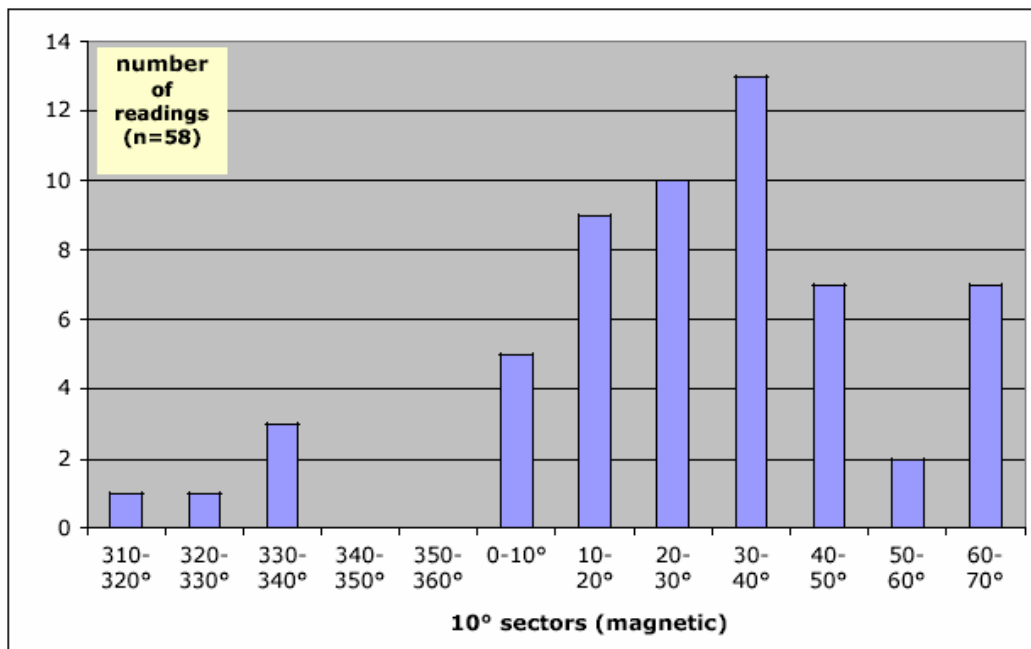
**Figure 10:** Histogram of azimuths (magnetic) measured from rock fabrics (cleavage, foliation, fractures, bedding, fault) in the area mapped. Note that the majority of measurements (50) fall into the sector 005°-060°M, with a mean value of 028°M (about 040° true north) and median value of 030°M (about 042° true north). The strike of the projected “fault” is approximately 052° true north.

Although the average orientation of the main array of measurements is similar to the strike of the fault shown on the Dorriggo-Coffs Harbour geological map, it is not co-incident. Converting the magnetic orientations to true north orientations, the average orientation is 040°, whereas the strike of the fault shown is 052°. In the projected position of the fault, surface outcrops do not display any increased concentration of penetrative structures, e.g. shear zones, stronger cleavage development, or of zones of brecciation or hydrothermal alteration. On the DTM (Fig. 4), there is a single weak linear feature (corresponding in the field to a shallow valley), with a strike of 025°.

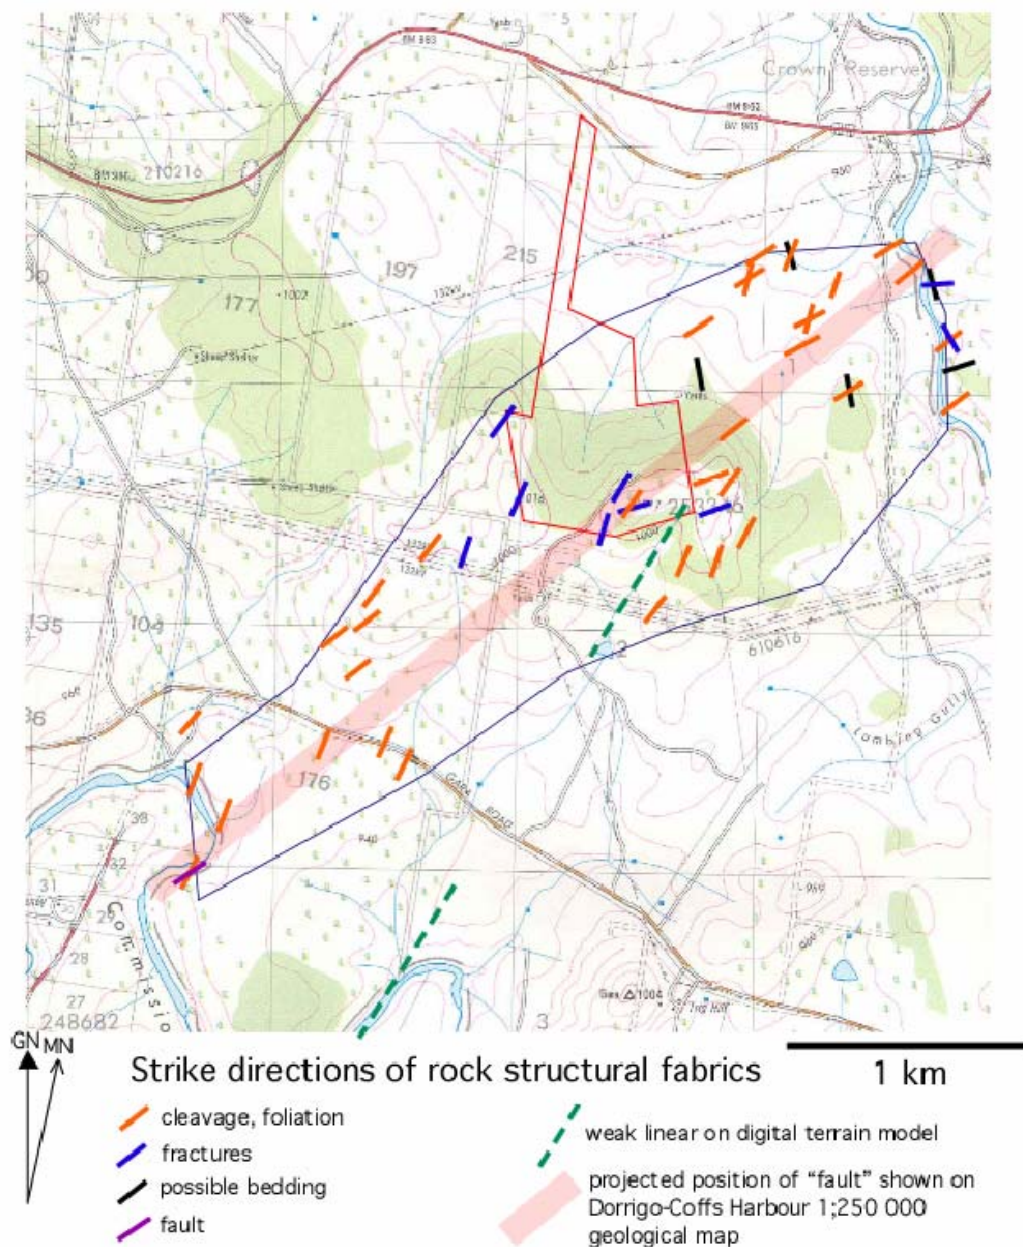
**Figure 11:** Strike directions of rock structural fabrics (cleavage, foliation, fractures, bedding, fault) in the area mapped (blue boundary). Also displayed are the weak linear from the digital terrain model (see Fig. 4), the projected position of the "fault" shown on the Dorrigo-Coffs Harbour 1:250 000 geological map and the approximate position of the landfill site (red boundary).
