**Geotechnical Assessment
(Riverbank Stability)**

**Proposed modifications to DDG Dryer,
biofilters, cooling towers, mill feed silo and
container storage area, Bomaderry NSW**

Geotechnical Assessment

2 April 2016

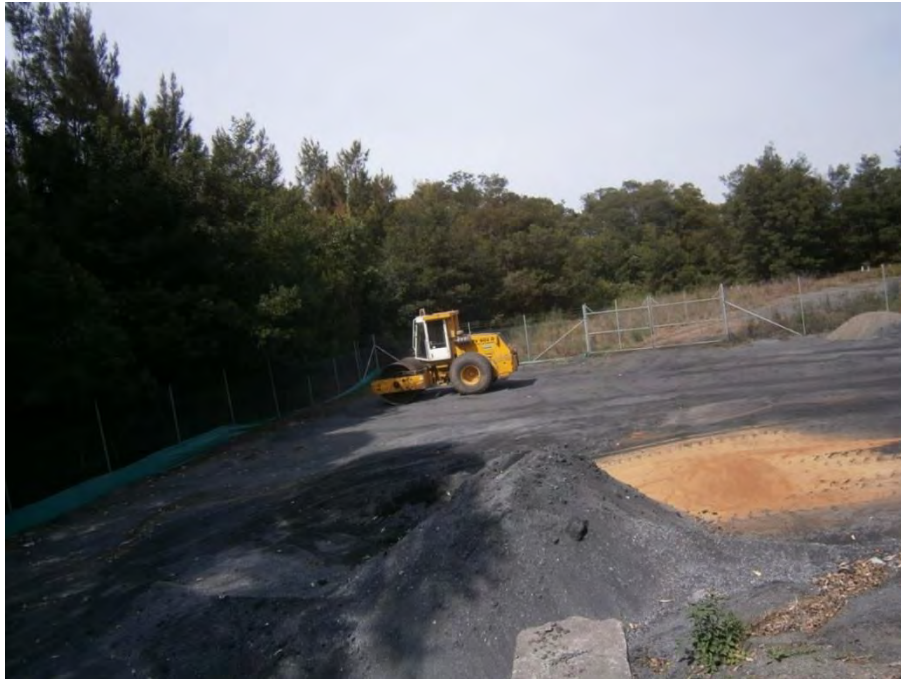
Photograph 1 – View of site for biofilters looking west with riparian corridor to left of photo between the site and the river

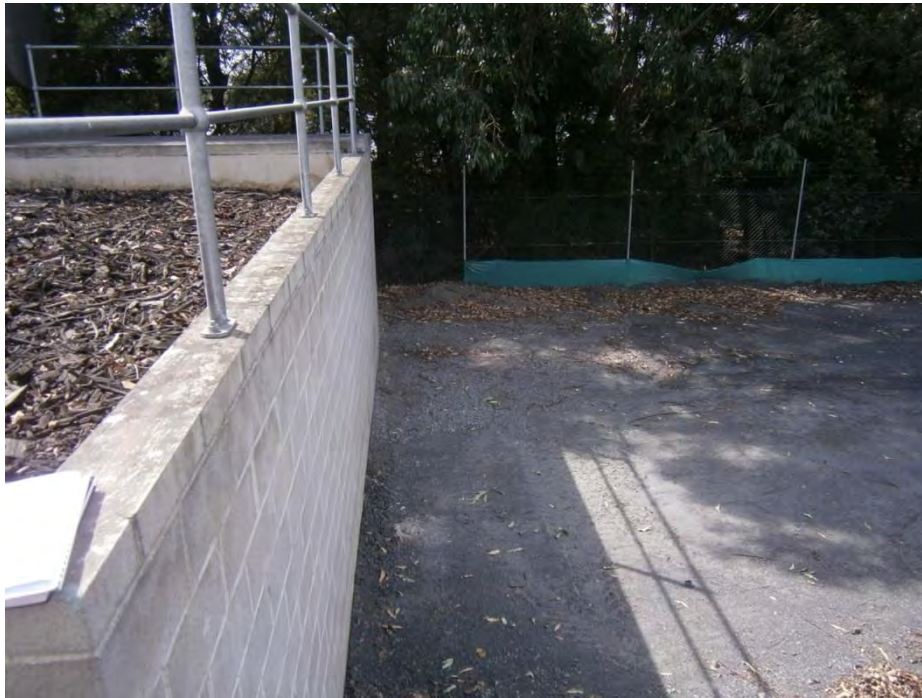
Photograph 2- View of western side of existing biofilter and gravel surfaced area over site of proposed biofilters. Tree covered riparian corridor in background to south of site.

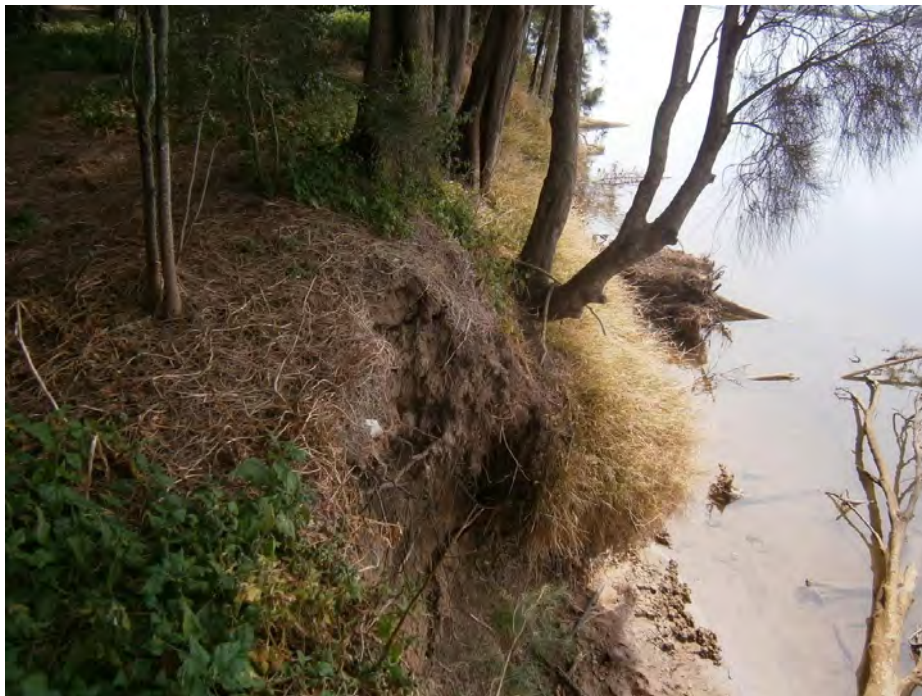
Photograph 3 – View of northern bank of the Shoalhaven River about 25m to south of site for biofilters. Note undercutting and partial collapse of bank with some mature trees along top of bank.

Coffey has assessed that the proposed biofilters for the DDG Dryer Plant will not effect on the stability of the river bank due to the relatively low foundation loads applied to the upper soil profile, the setback of the structures from the river bank and the observed surface and inferred subsurface conditions in the vicinity of the site.

In areas where vegetation has been established along the river and creeks, the trees should be maintained. Drainage from the development should not be concentrated along the top of the creek or river banks that could contribute to erosion or failure of the banks. No fill should be placed along the tops of the river or creek banks. Coffey should be advised of any observed significant changes to the ground surface conditions along the northern bank of Shoalhaven River bank, the banks of Abernethy's Creek, and the eastern bank of Bomaderry Creek.

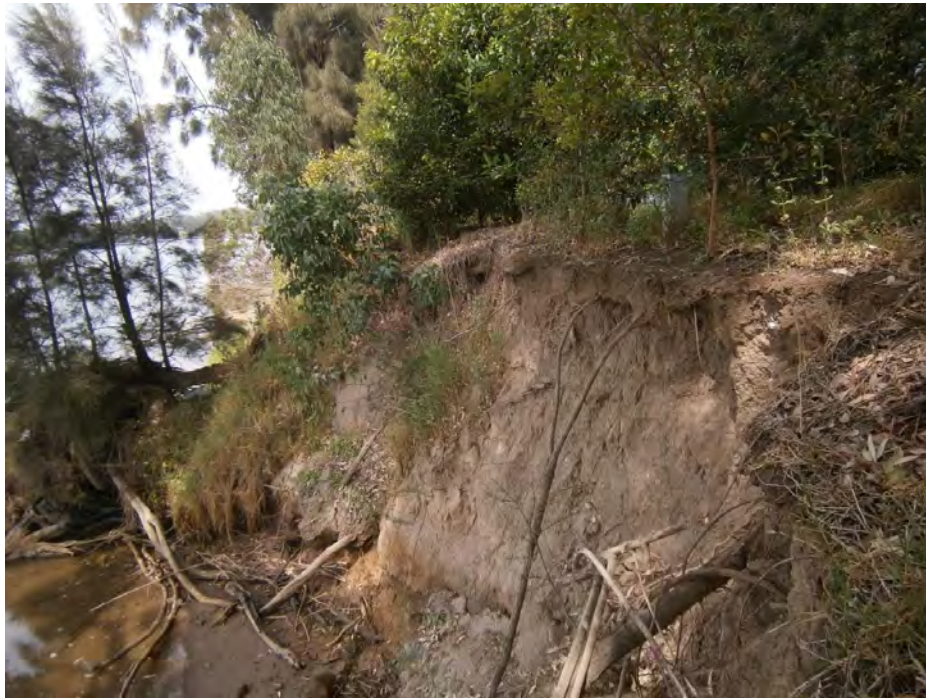
Photograph 4 – View of river bank about 25m south of biofilters showing recent erosion and collapse and edge of river at low tide.

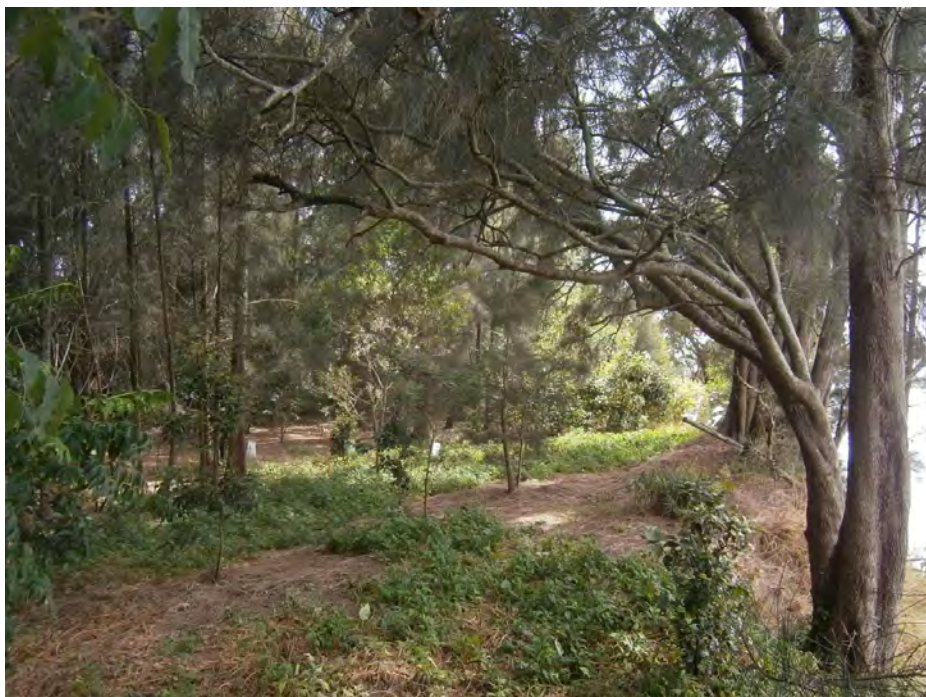
Photograph 5 – View of riparian corridor with medium dense tree cover between the site for biofilters and the river bank, with Shoalhaven River to right of photo.

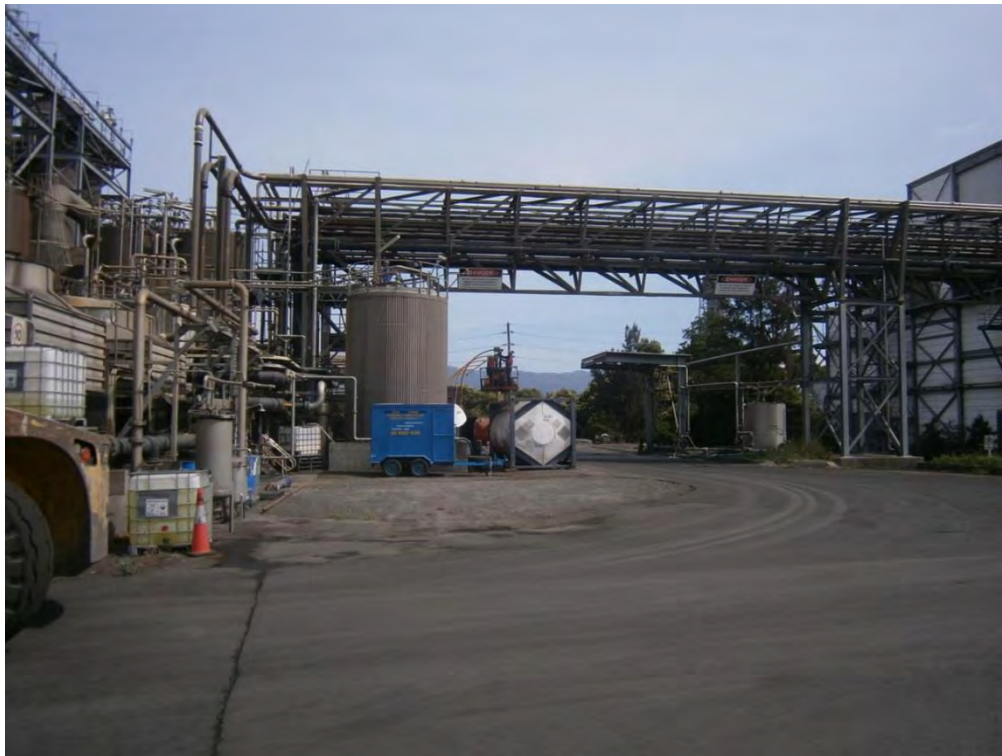
Photograph 6 – Site of proposed Cooling Towers looking north with Abernethy's Creek to far right of photo. Asphalt and gravel paved surface.

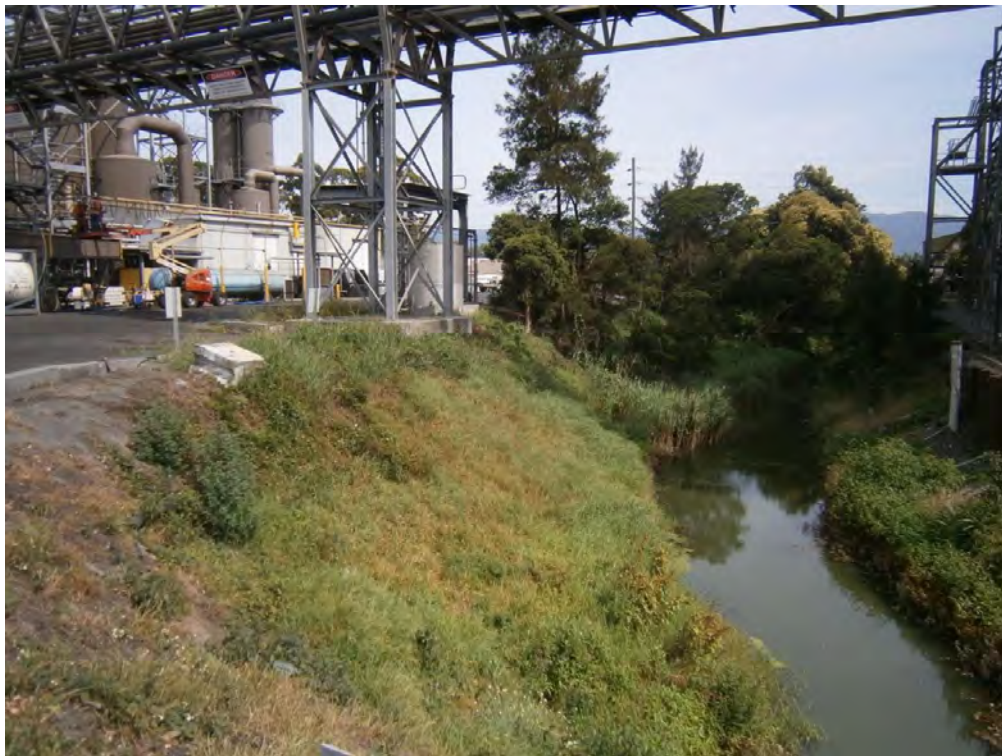
Photograph 7 – View of western bank of Abernethy's Creek looking north. The top of the creek bank is about 20m from the site for the Cooling Towers.

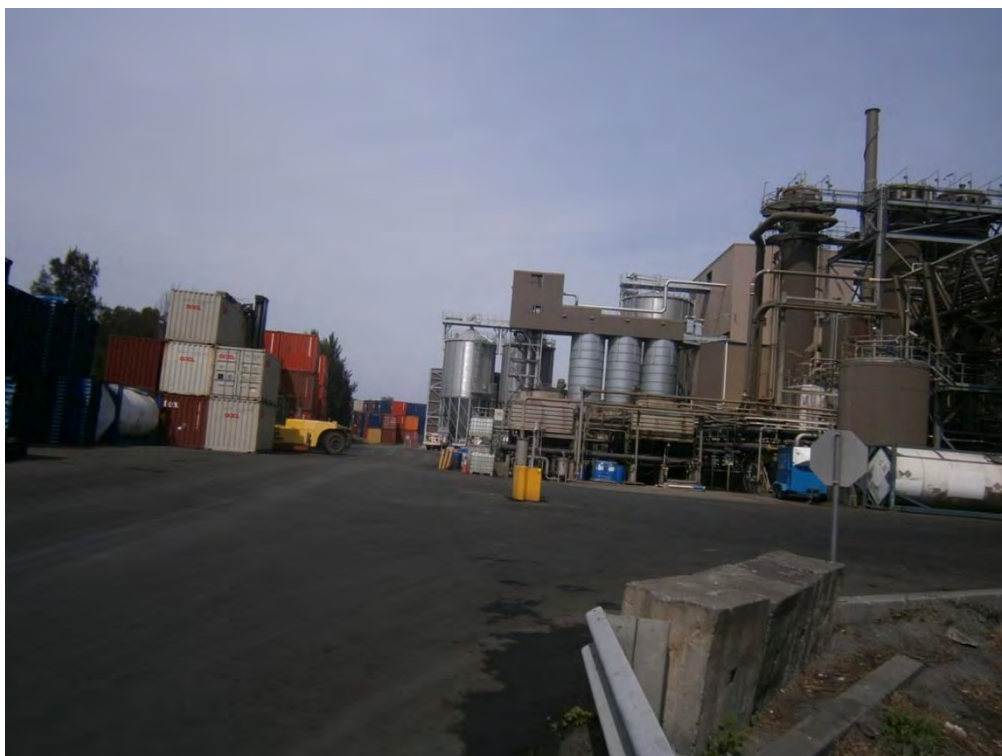
Photograph 8 – View of site for Cooling Towers looking west with top of western bank of Abernethy's Creek in foreground, right lower corner of photograph.

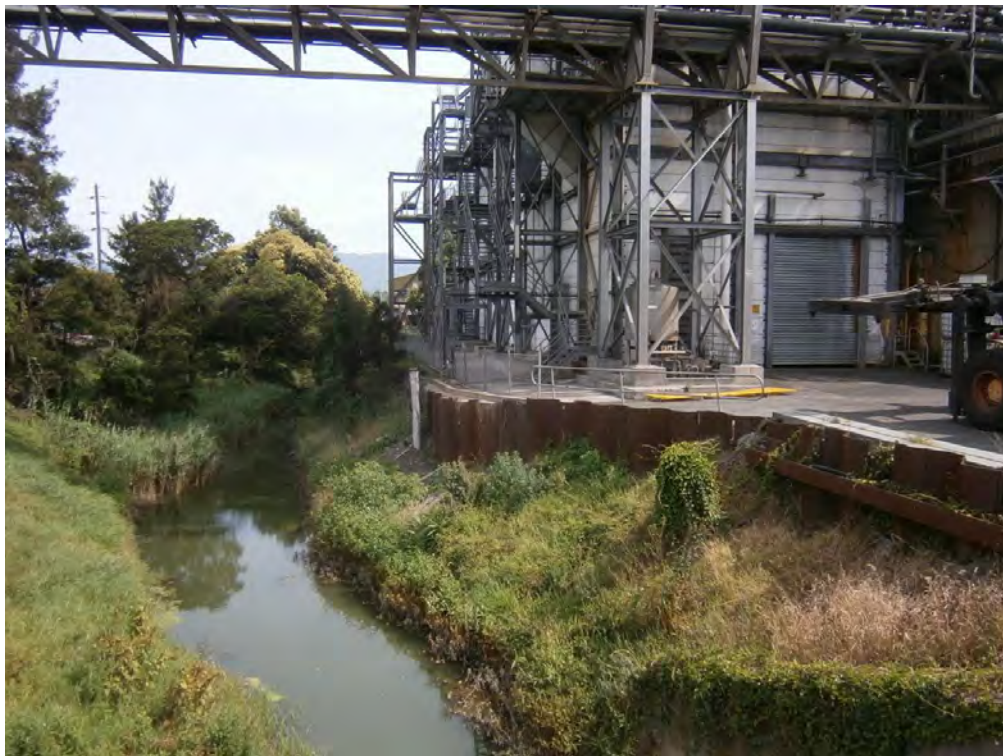
Photograph 9 – View of eastern bank of Abernethy's Creek looking north, with the site for the silo located about 5m to 10m east of the top of bank. Note sheet pile wall along top of bank supporting paved area above the bank.

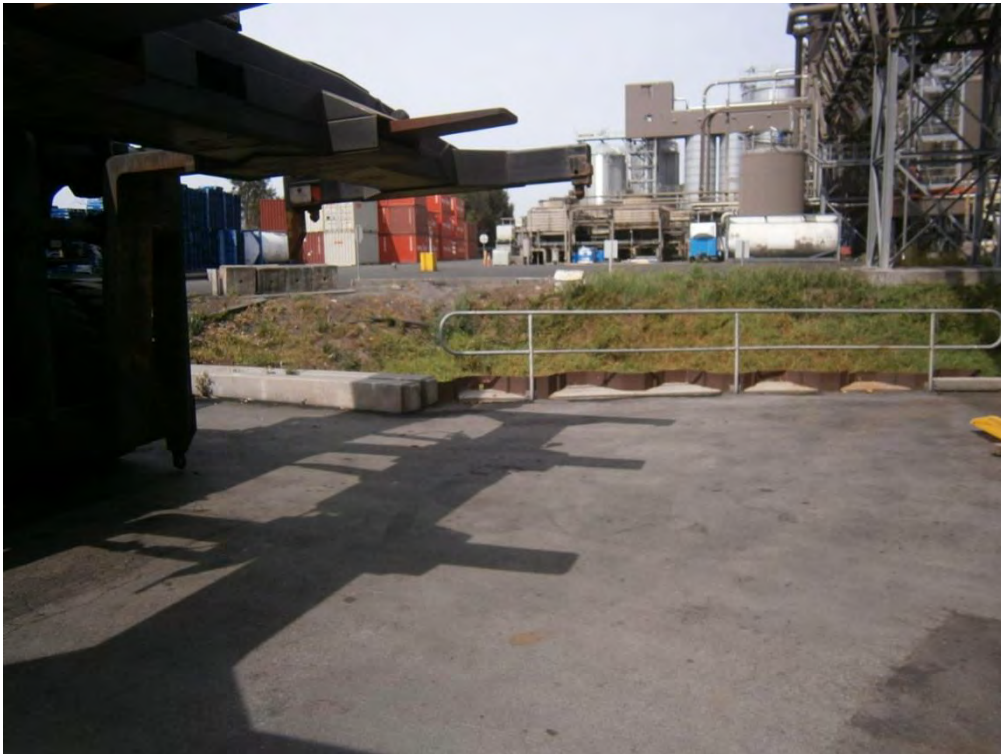
There was no evidence of any significant cracking or displacement of the paved area between the sheet pile wall and the site for the silo.

Photograph 10 – View of near level paved area between site for silo and top of eastern bank of Abernethy's Creek.

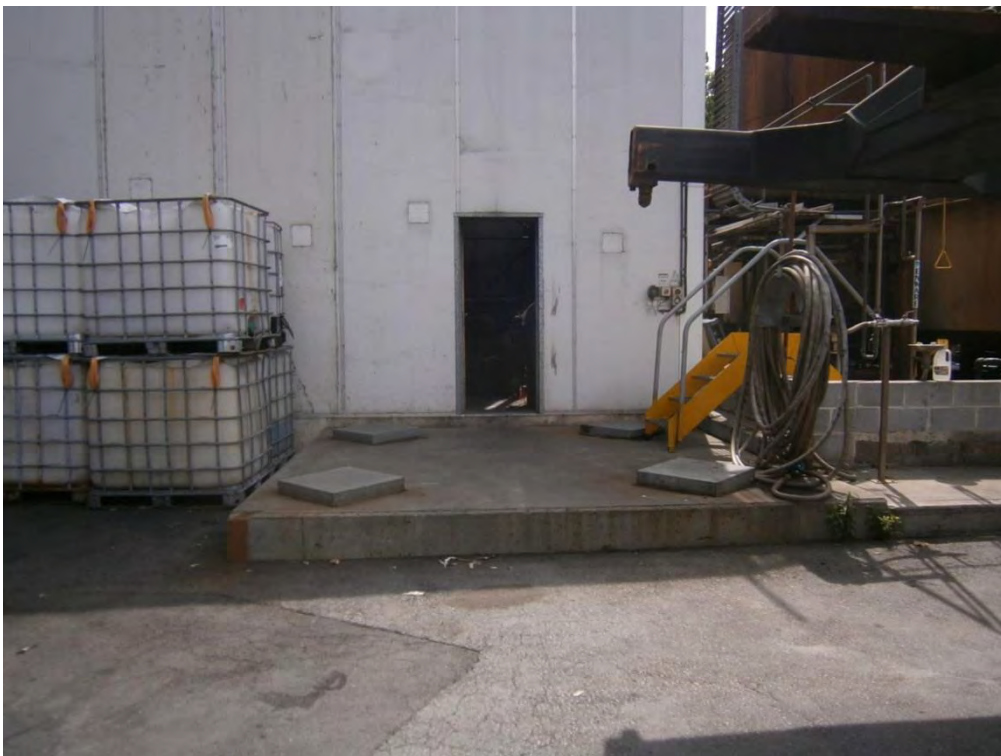
Photograph 11 – View of site for Silo from top of eastern bank of Abernethy's Creek.
Concrete plinth formed for location of silo.

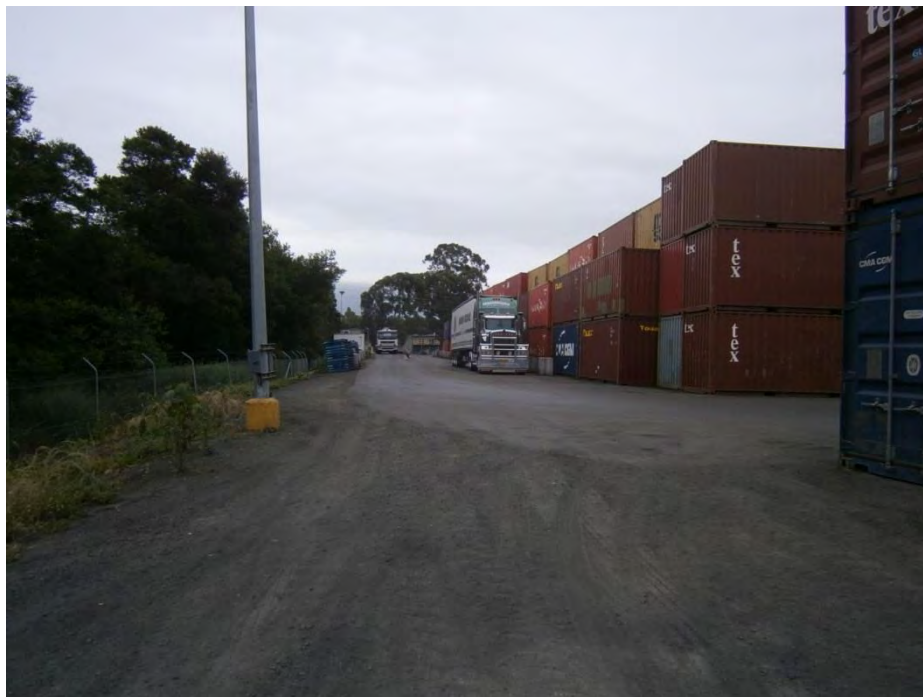
Photograph 12 – View of eastern side of container storage area located over a fill platform, with weighbridge in background to left of photo.

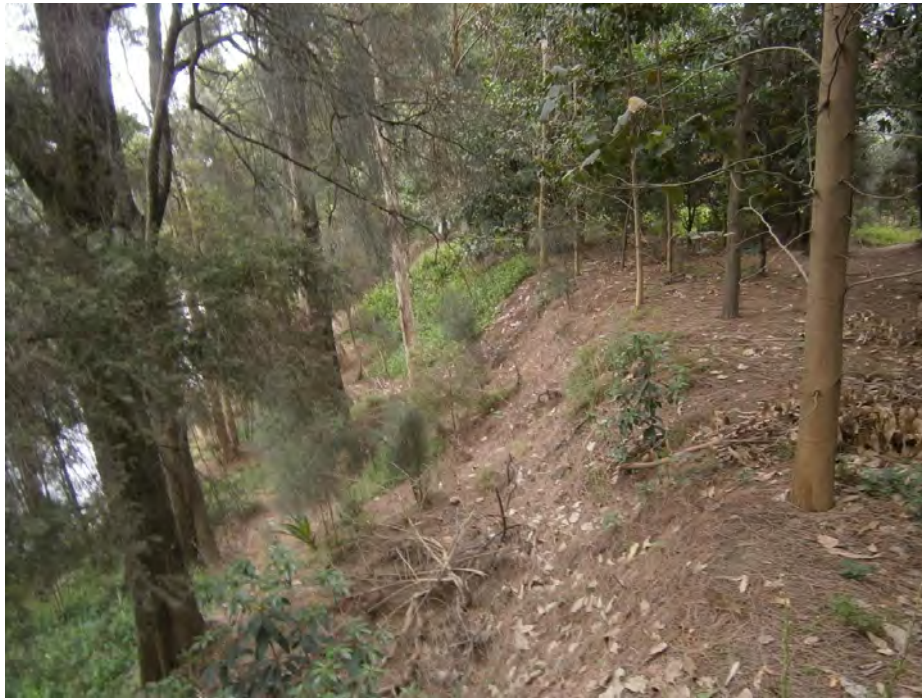
Photograph 13 – View to north-west along the bank of Bomaderry Creek to west of the container storage area. Note riparian corridor with many small to medium trees, steeply sloping creek bank and near level area above bank.

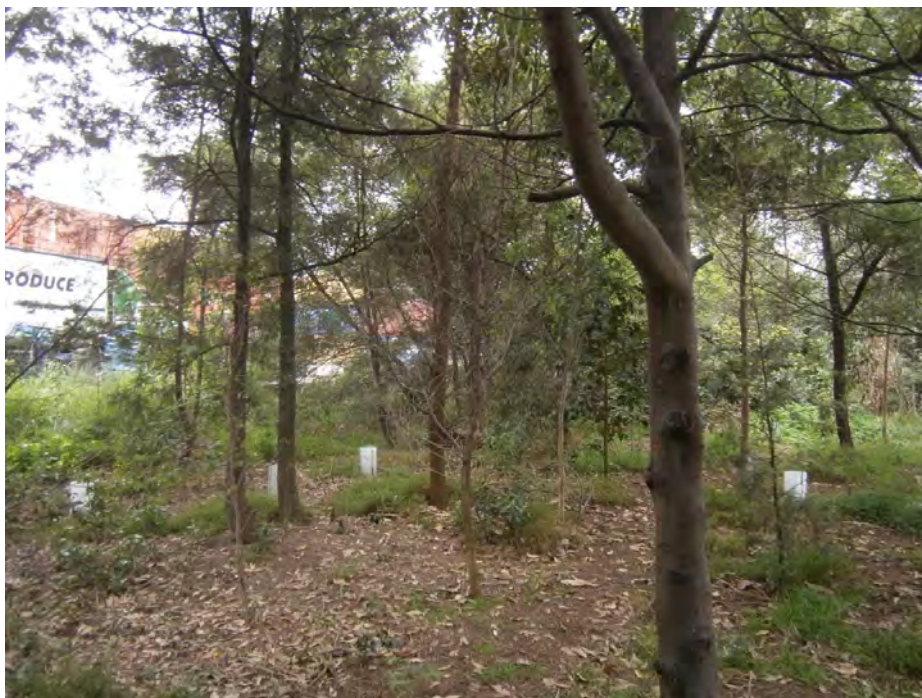
Photograph 14 – View to east from top of creek bank looking towards container storage area. Gently sloping to near level area with numerous small to medium trees.

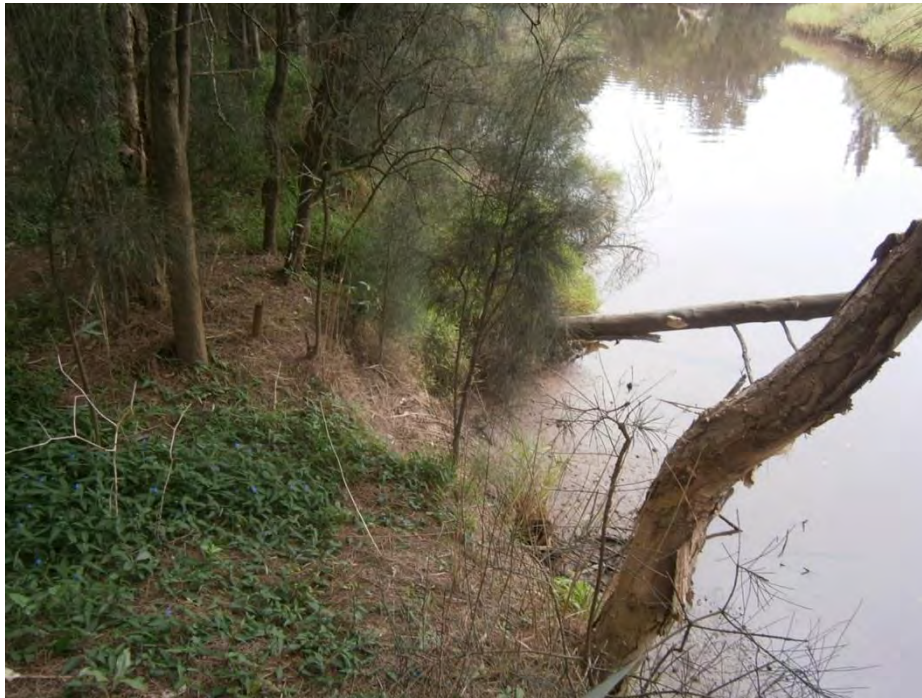
Photograph 15 – View looking south along Bomaderry Creek noting that the creek is tidal at this location and water extends across full width of creek.

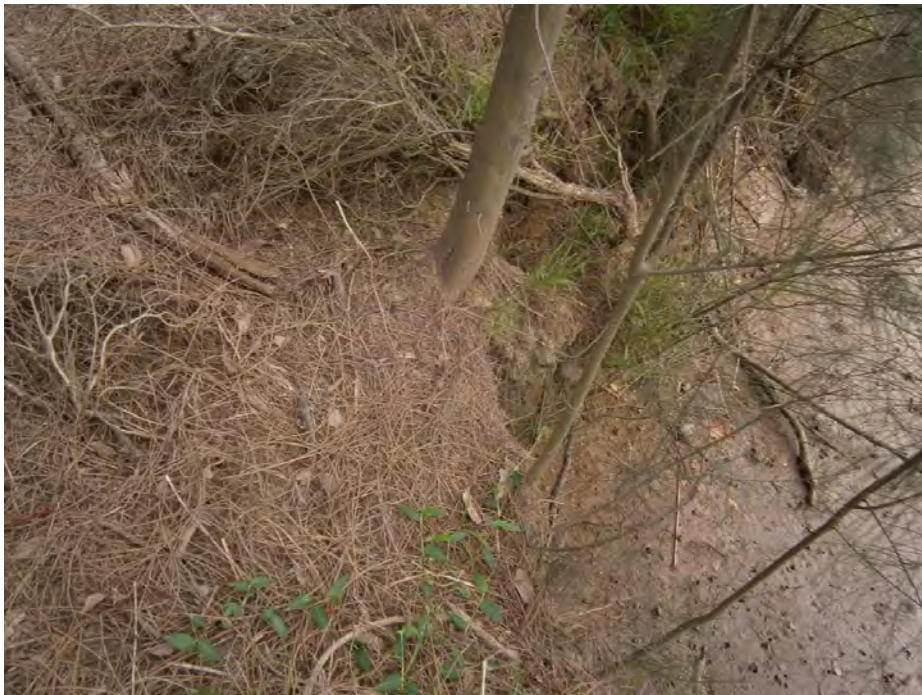
There was some evidence of instability and erosion in the eastern bank of Bomaderry Creek having occurred at various stages in the past, including recent erosion and slumping that likely occurred during the significant rain event that occurred in August, 2015. There was no evidence of any recent large scale failure of the creek bank in this area, and the presence of some large trees in this area also indicates that the trees have not been affected by any significant instability of the creek bank.

Photograph 16- Erosion at toe of eastern bank of Bomaderry Creek with some undercutting present.

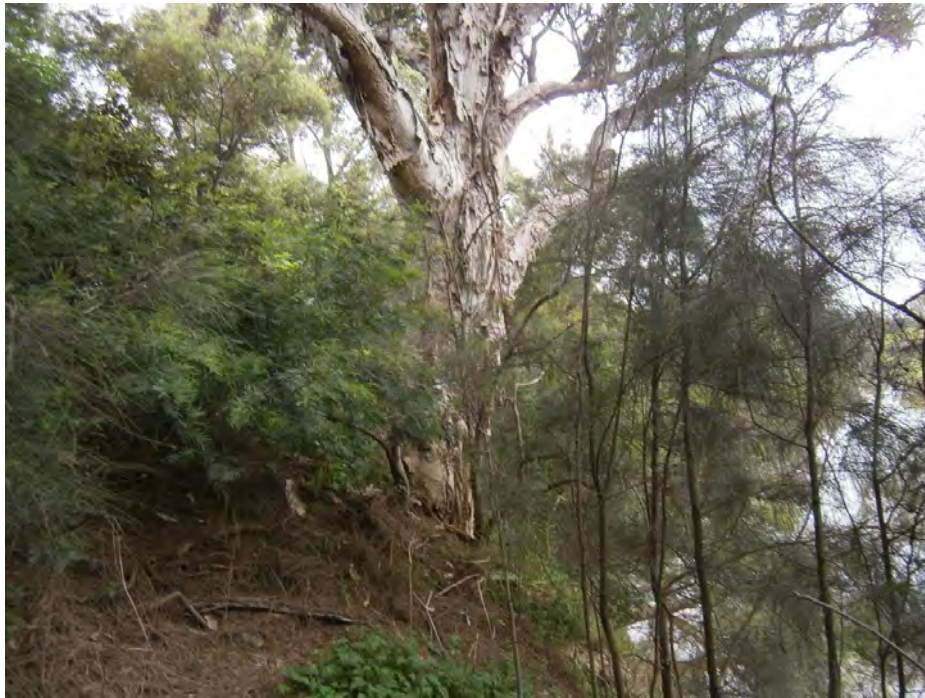
Photograph 17 – Large tree at top of eastern bank of Bomaderry Creek with many smaller trees over slope.

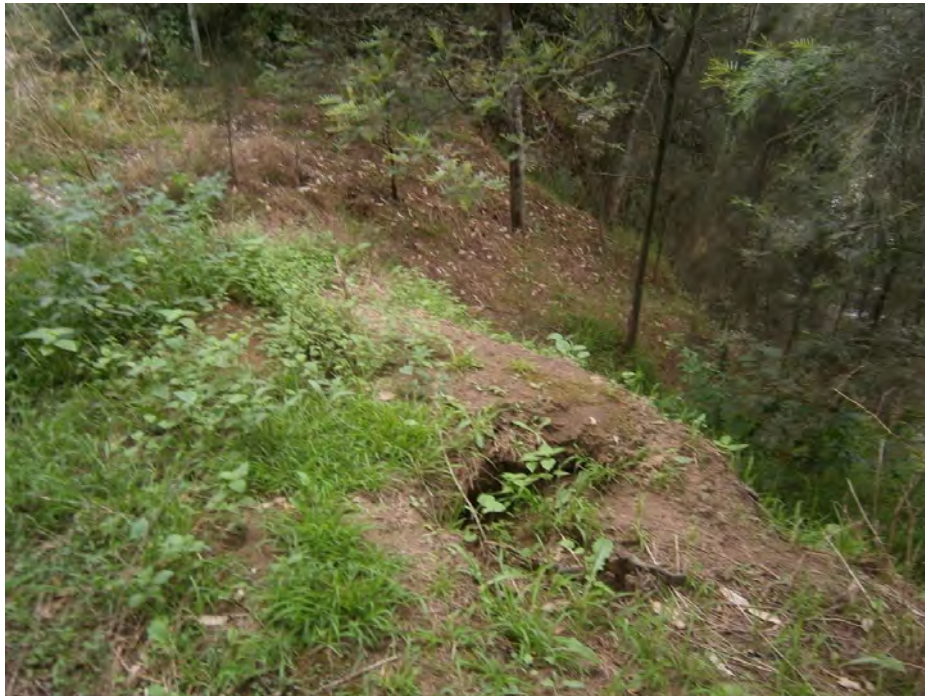
Photograph 18 – View across top of creek bank where erosion has occurred due to rabbit burrows. Undulating shape of creek bank indicates previous slumping and erosion of bank.
